Installation of J-Hook Vanes to Mitigate Bank Erosion as Part of a Time Critical Removal Action

Background

- Time critical removal action on a Michigan river
- Bank stabilization and sediment removal project along 1.7 miles of river
- Unique challenges in the TCRA project area due to dams, bridges, water control structures, natural constriction
- Compressed schedule (data collection, design, and construction complete in 26 months)

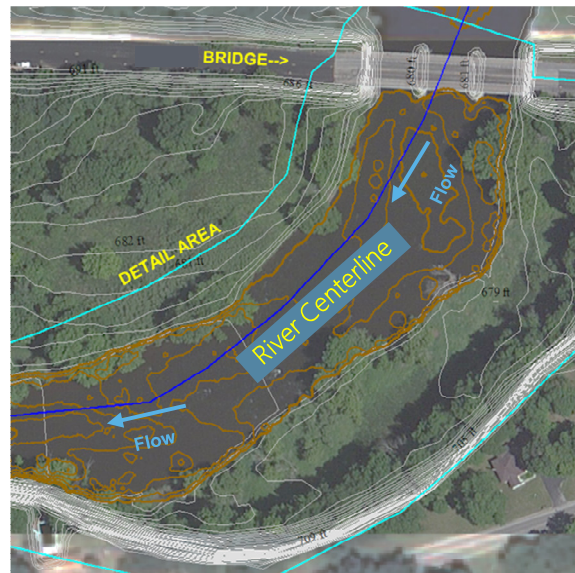
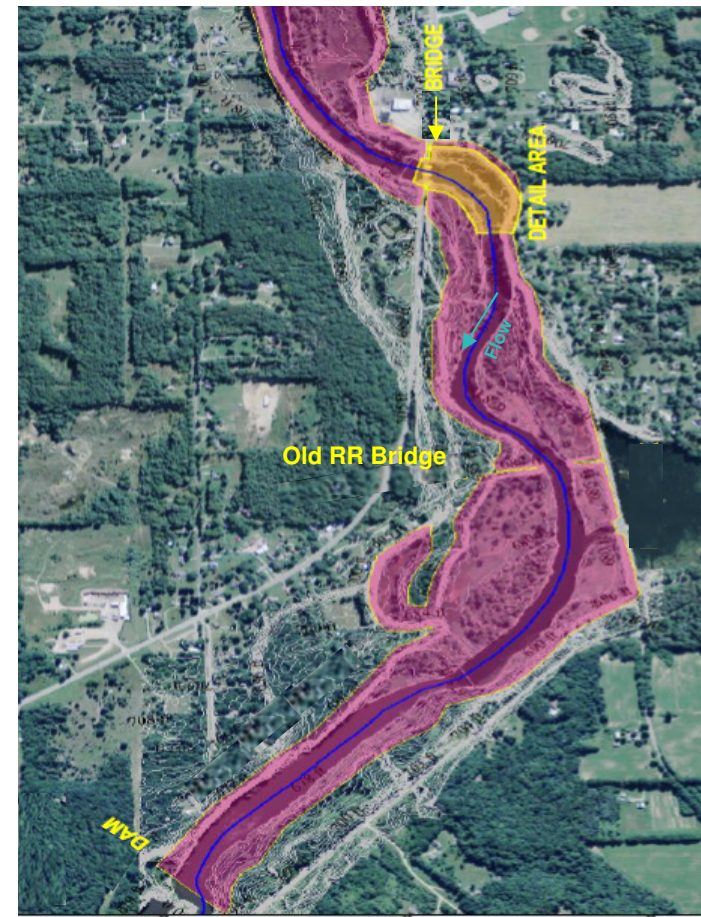
Bridge and other complications

- Constriction at the bridge, higher velocity flows
- Bridge supports deflect flow toward the left descending bank
- Split thalweg downstream of bridge in shallow waters
- Homes on the bluff downstream of the bridge

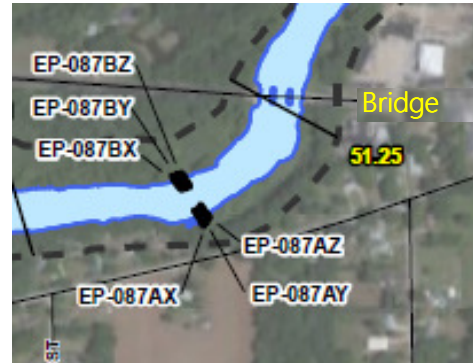
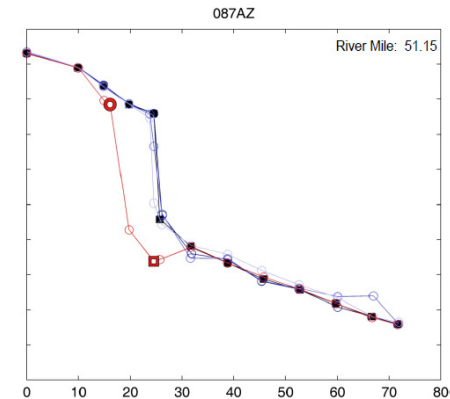
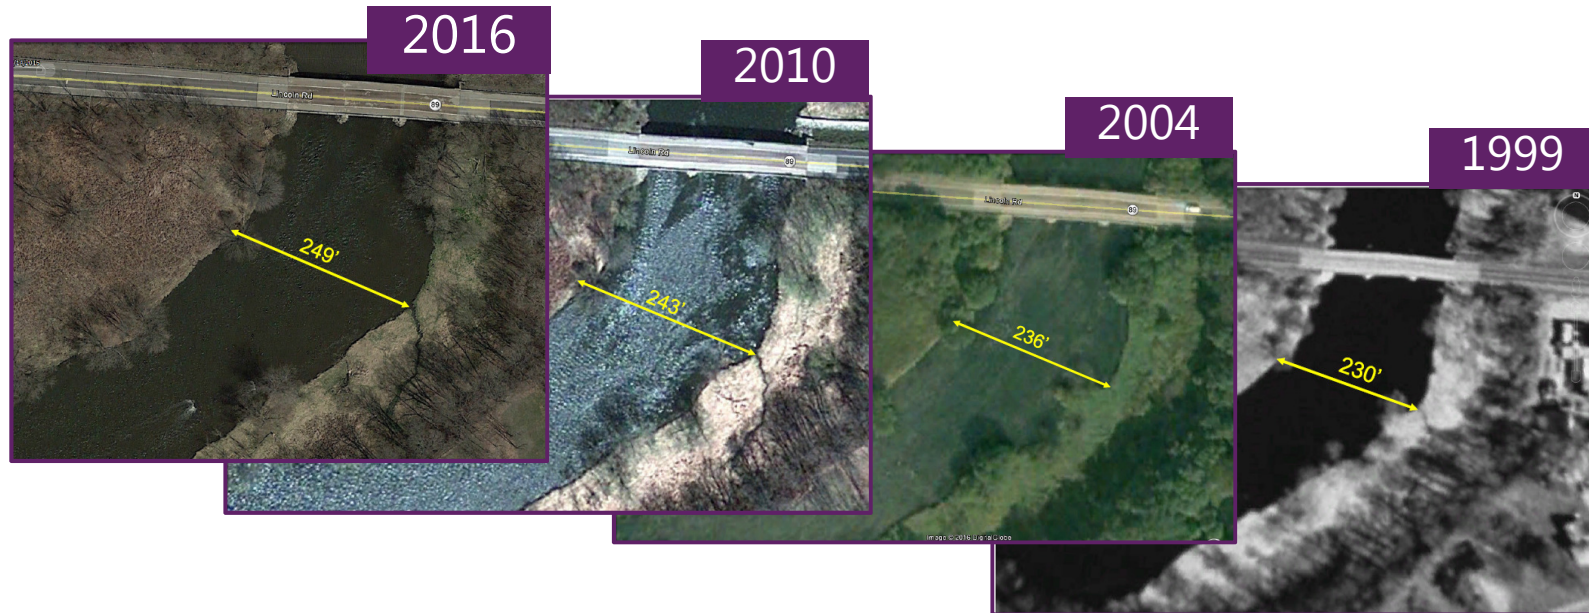
Evidence of erosion

- Erosion pin evidence
 - Loss of ~10-12 feet over 12 years in select areas
- Historical aerials

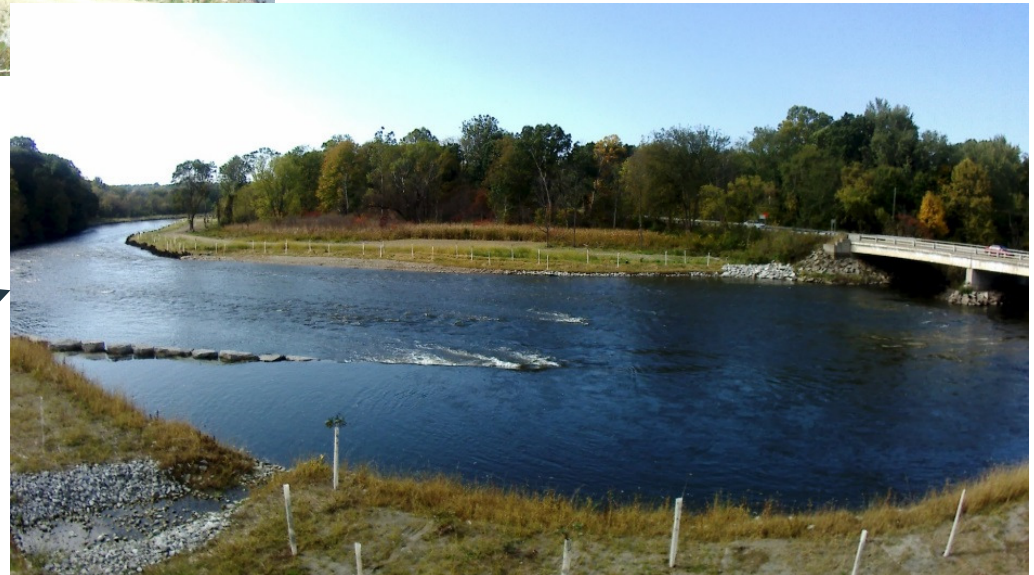
Aerial view after J-hook Installation

6 Months Post Construction

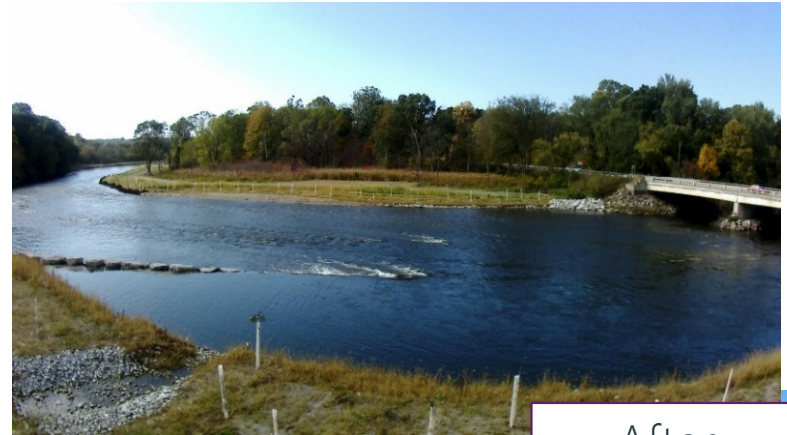
- Post installation surveys confirm mid channel bar removal area is stable
- Experienced a significant flood event following installation – everything remained stable
- Deposition occurring as expected and desired inside of J-hook vanes along the left descending bank
