BANK REMEDIATION & STABILIZATION ALONG THE TITTABAWASSEE RIVER

Kristin Searcy Bell, Brandon Kulhanek and David Heinze (Ramboll); Todd Konechne (The Dow Chemical Company); and Ryan Davis (Anchor QEA)

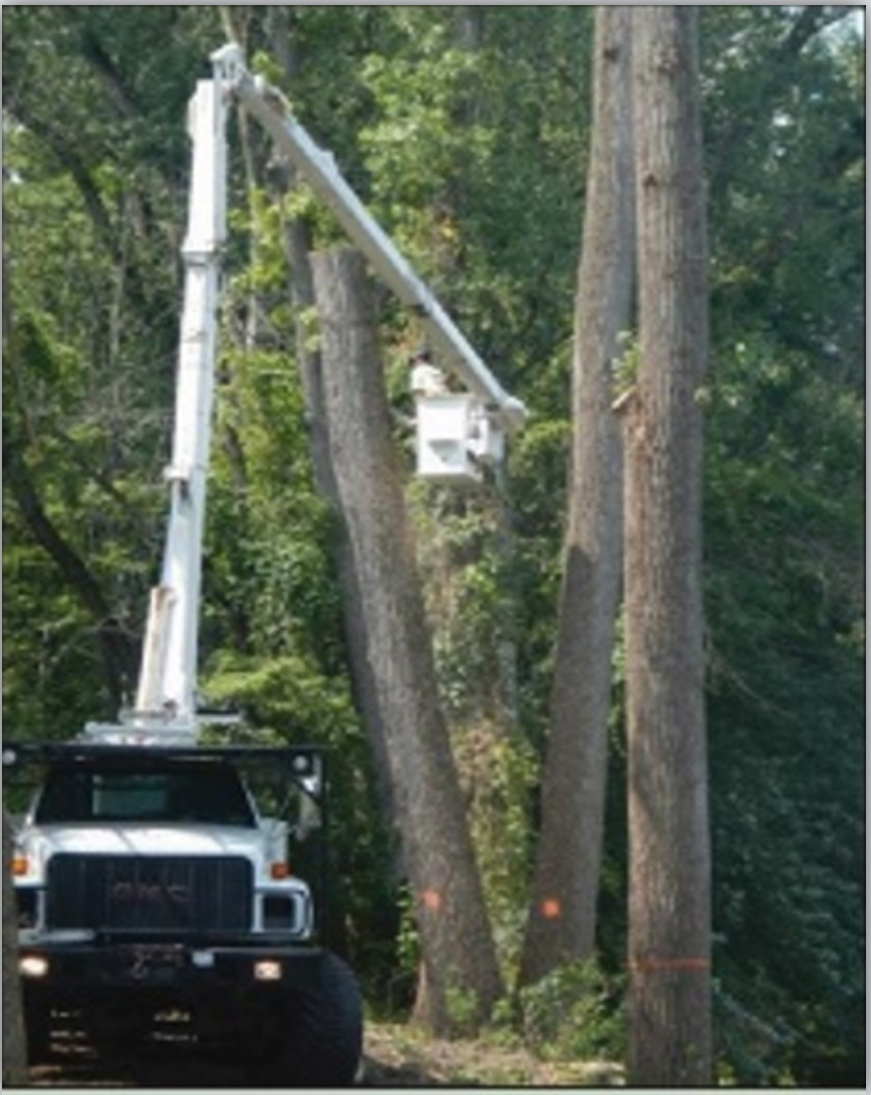
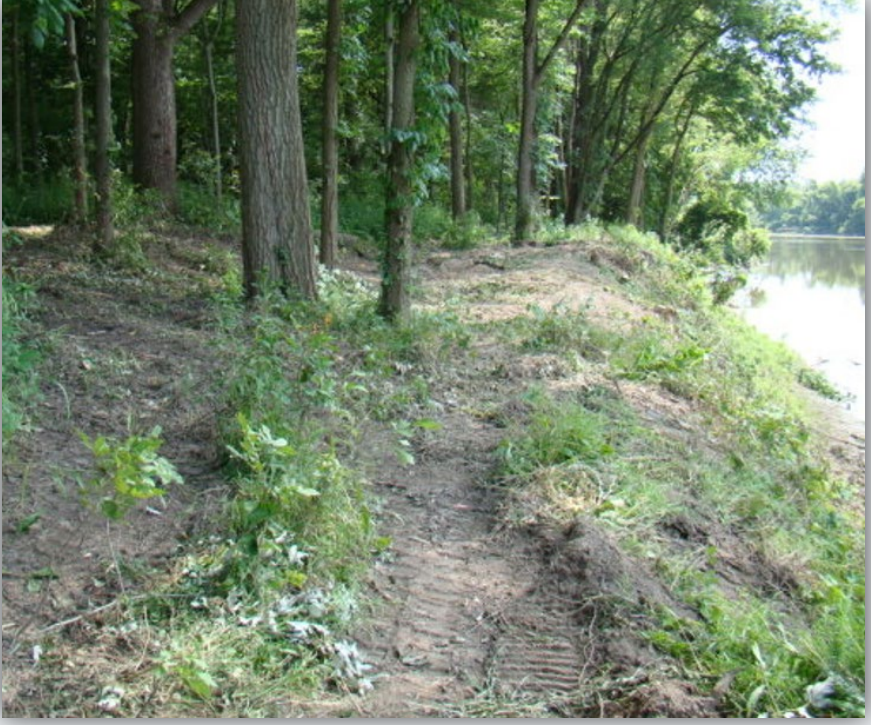
Canopy management	Bank clearing, smoothing and shaping	Native vegetation and erosion control products	Toe armoring
<p>The canopy of targeted trees is cut back to provide more sunlight to the bank areas, fostering growth of deep-rooted vegetation.</p>

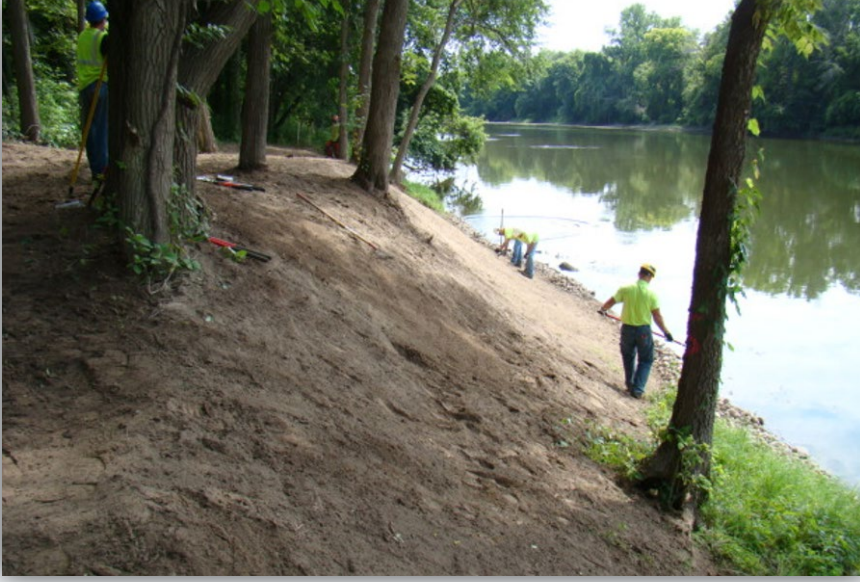
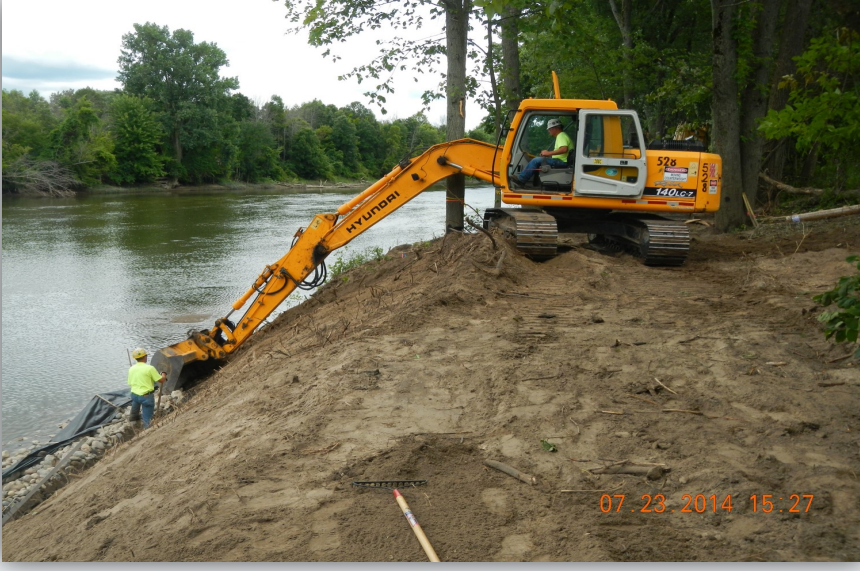
<p>Bank clearing and smoothing involve removing the existing non-beneficial vegetation to implement treatments. Limited bank reshaping with earthmoving equipment may be needed to achieve an appropriate bank angle for stabilization.</p>

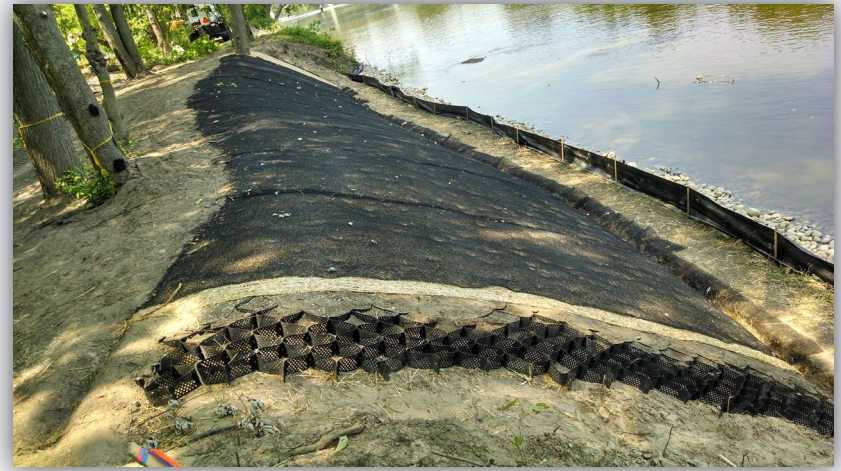
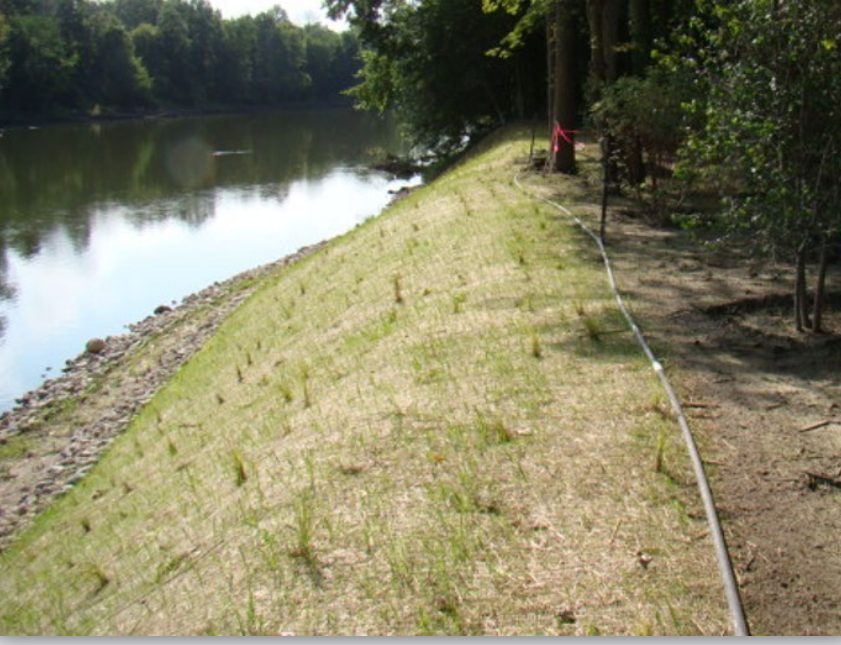
<p>Stabilization always uses native, deep-rooted plants to enhance the bank's stability applied by hydroseeding and live planting of plugs. As needed, treatments through the placement of geotextiles, geocells, turf reinforcing matrices (TRMs), and erosion control blankets, are used to provide protection from short- and long-term erosive forces and allows deep-rooted vegetation to be established.</p>

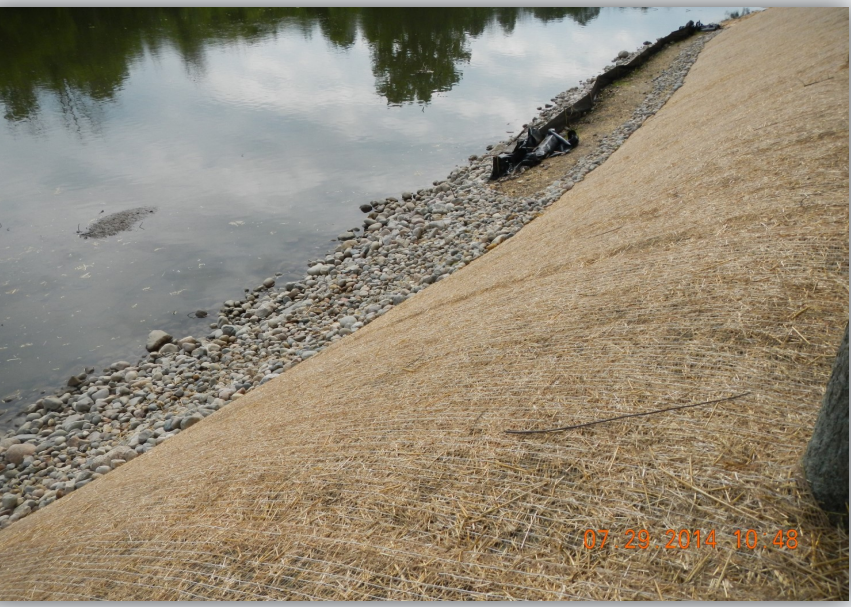
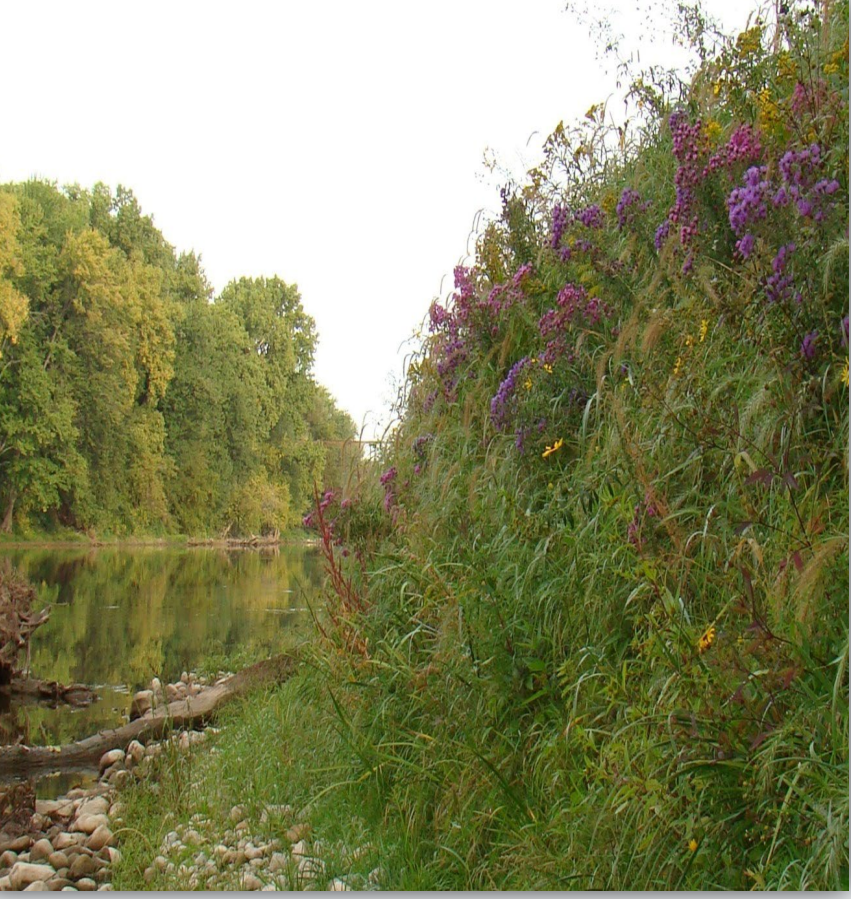
<p>In bank areas where routine river fluctuations prevent vegetation growth, thus reducing the stability of the toe and bank, toe protection may be applied.</p>
