Effects of Land Development on TCE-Impacted Groundwater Boundaries

Piper Roelen, PE, Landau Associates, Edmonds, WA, USA Debbie Taege, The Boeing Company, Renton, WA, USA

Apparent Shift of Formerly Stable TCE-Impacted Area

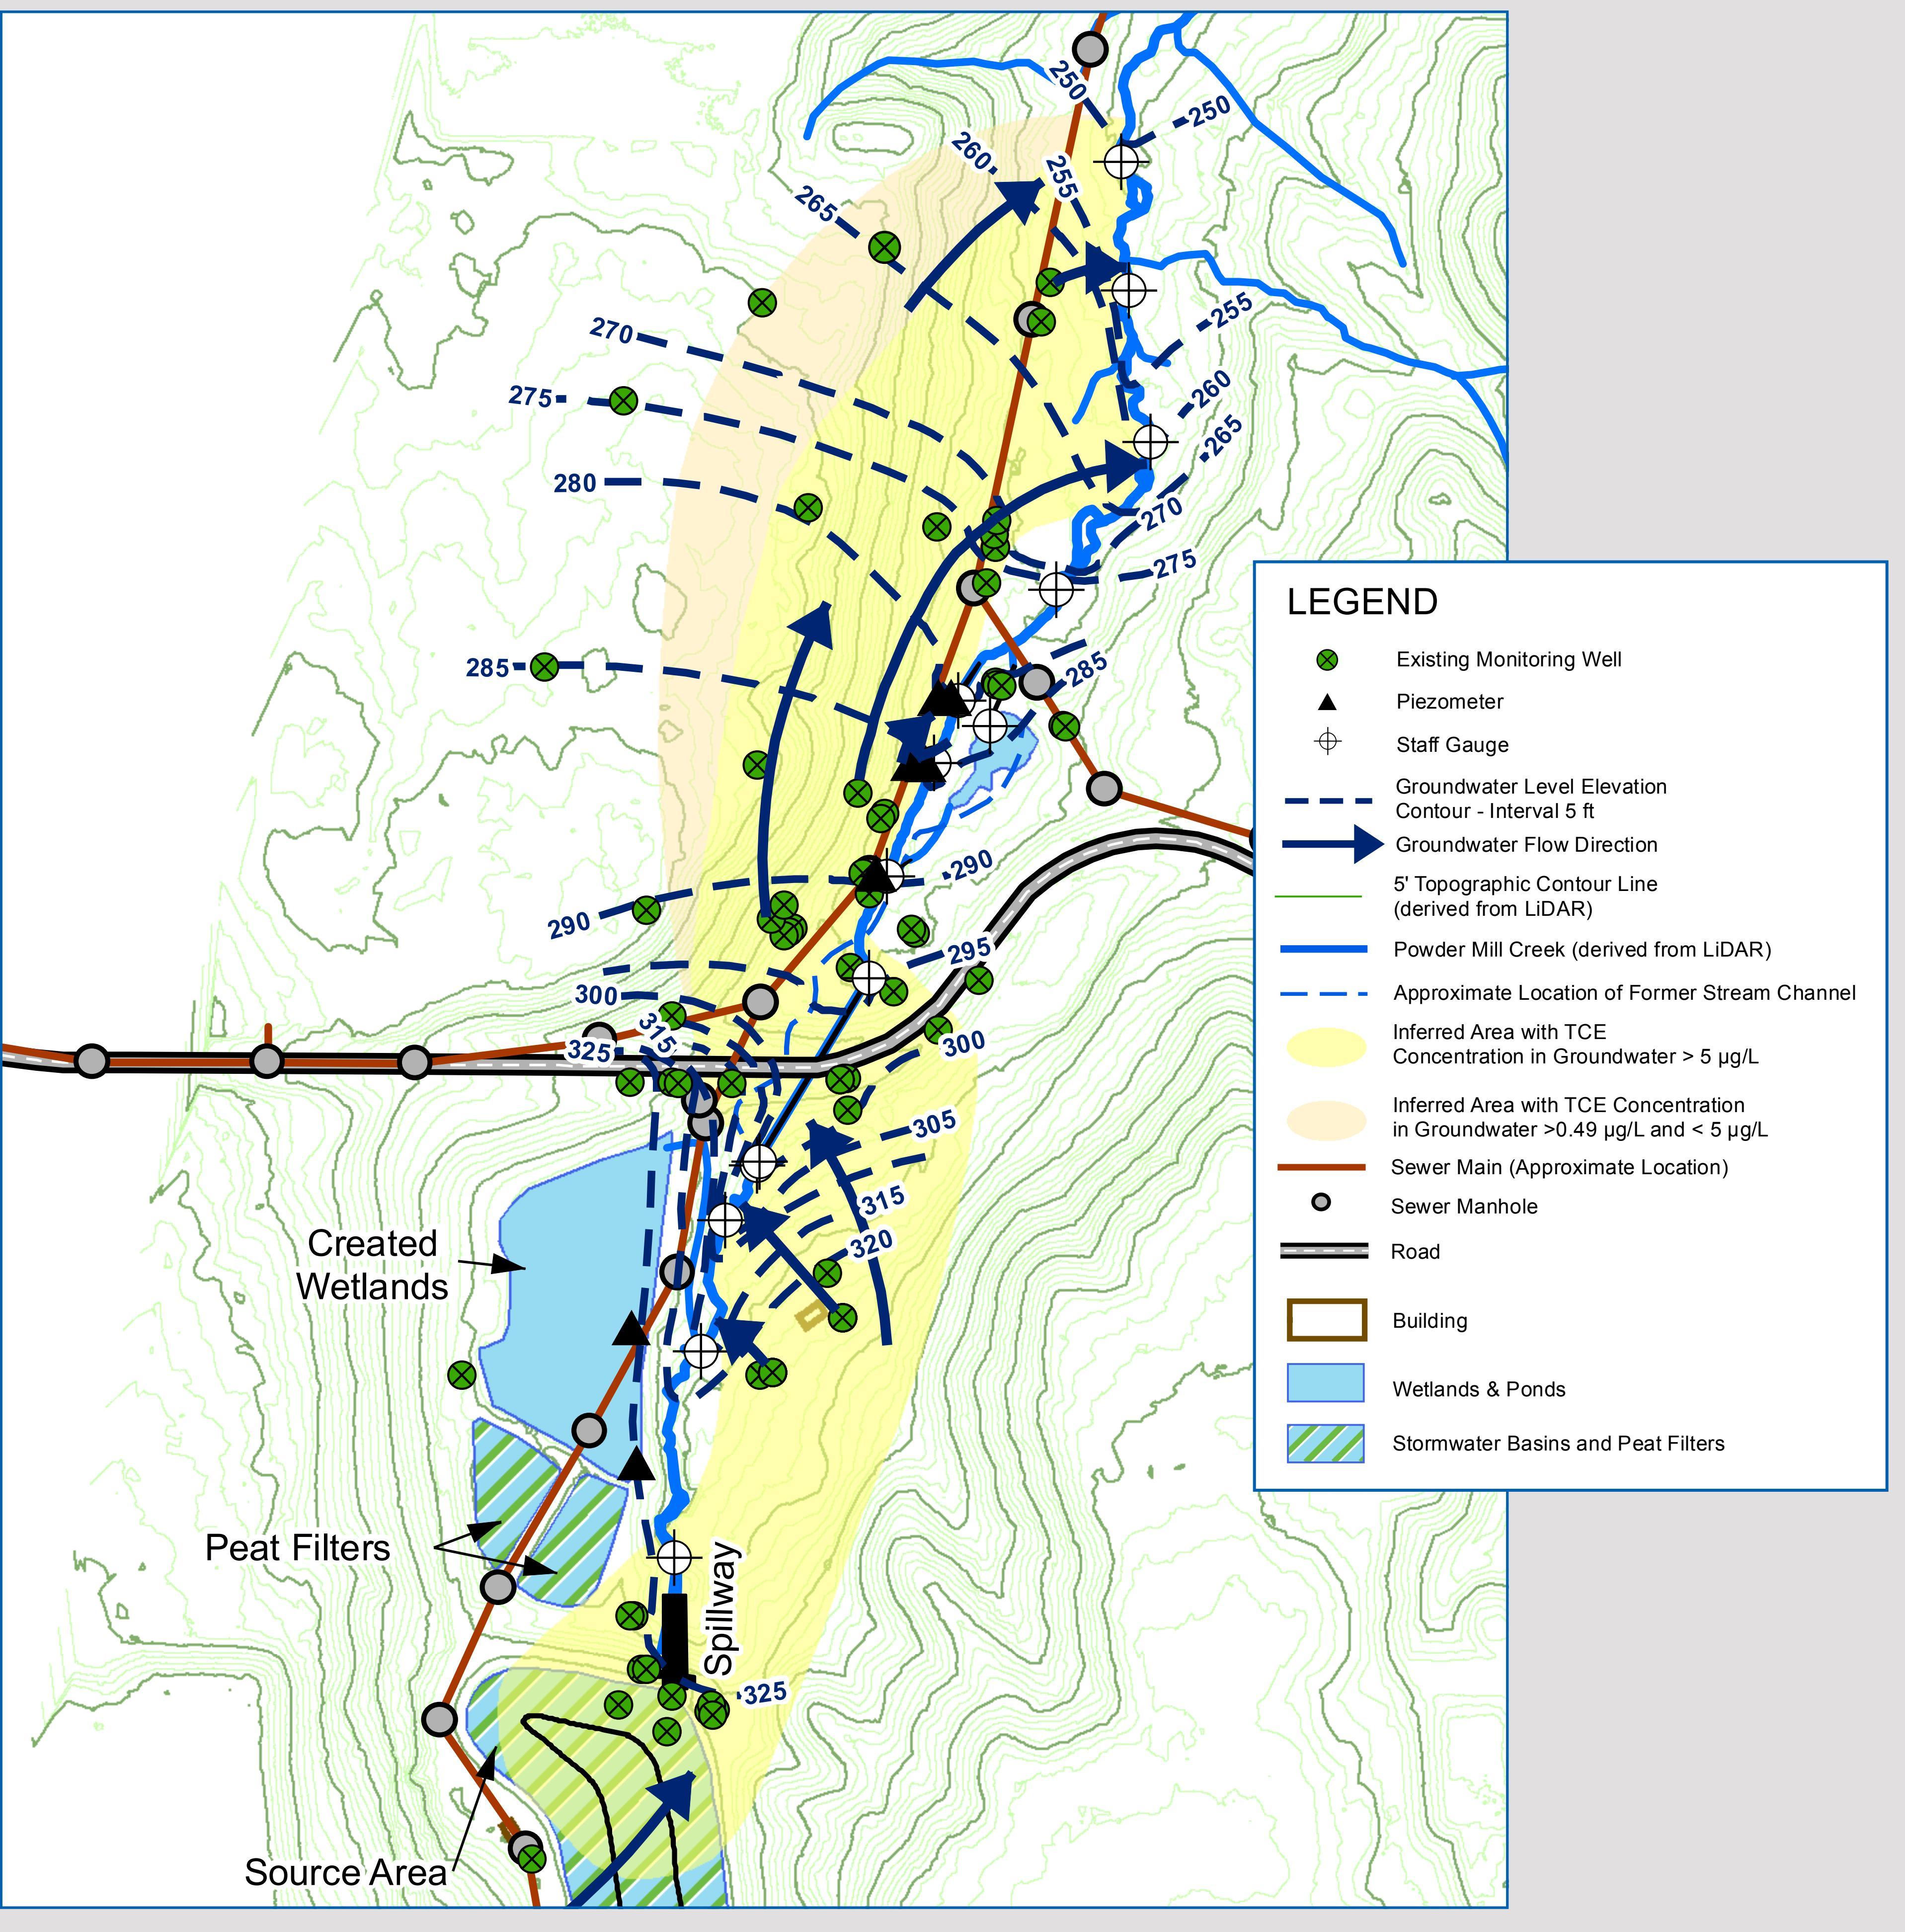
Groundwater Elevation Contours and Flow Direction – April 2010

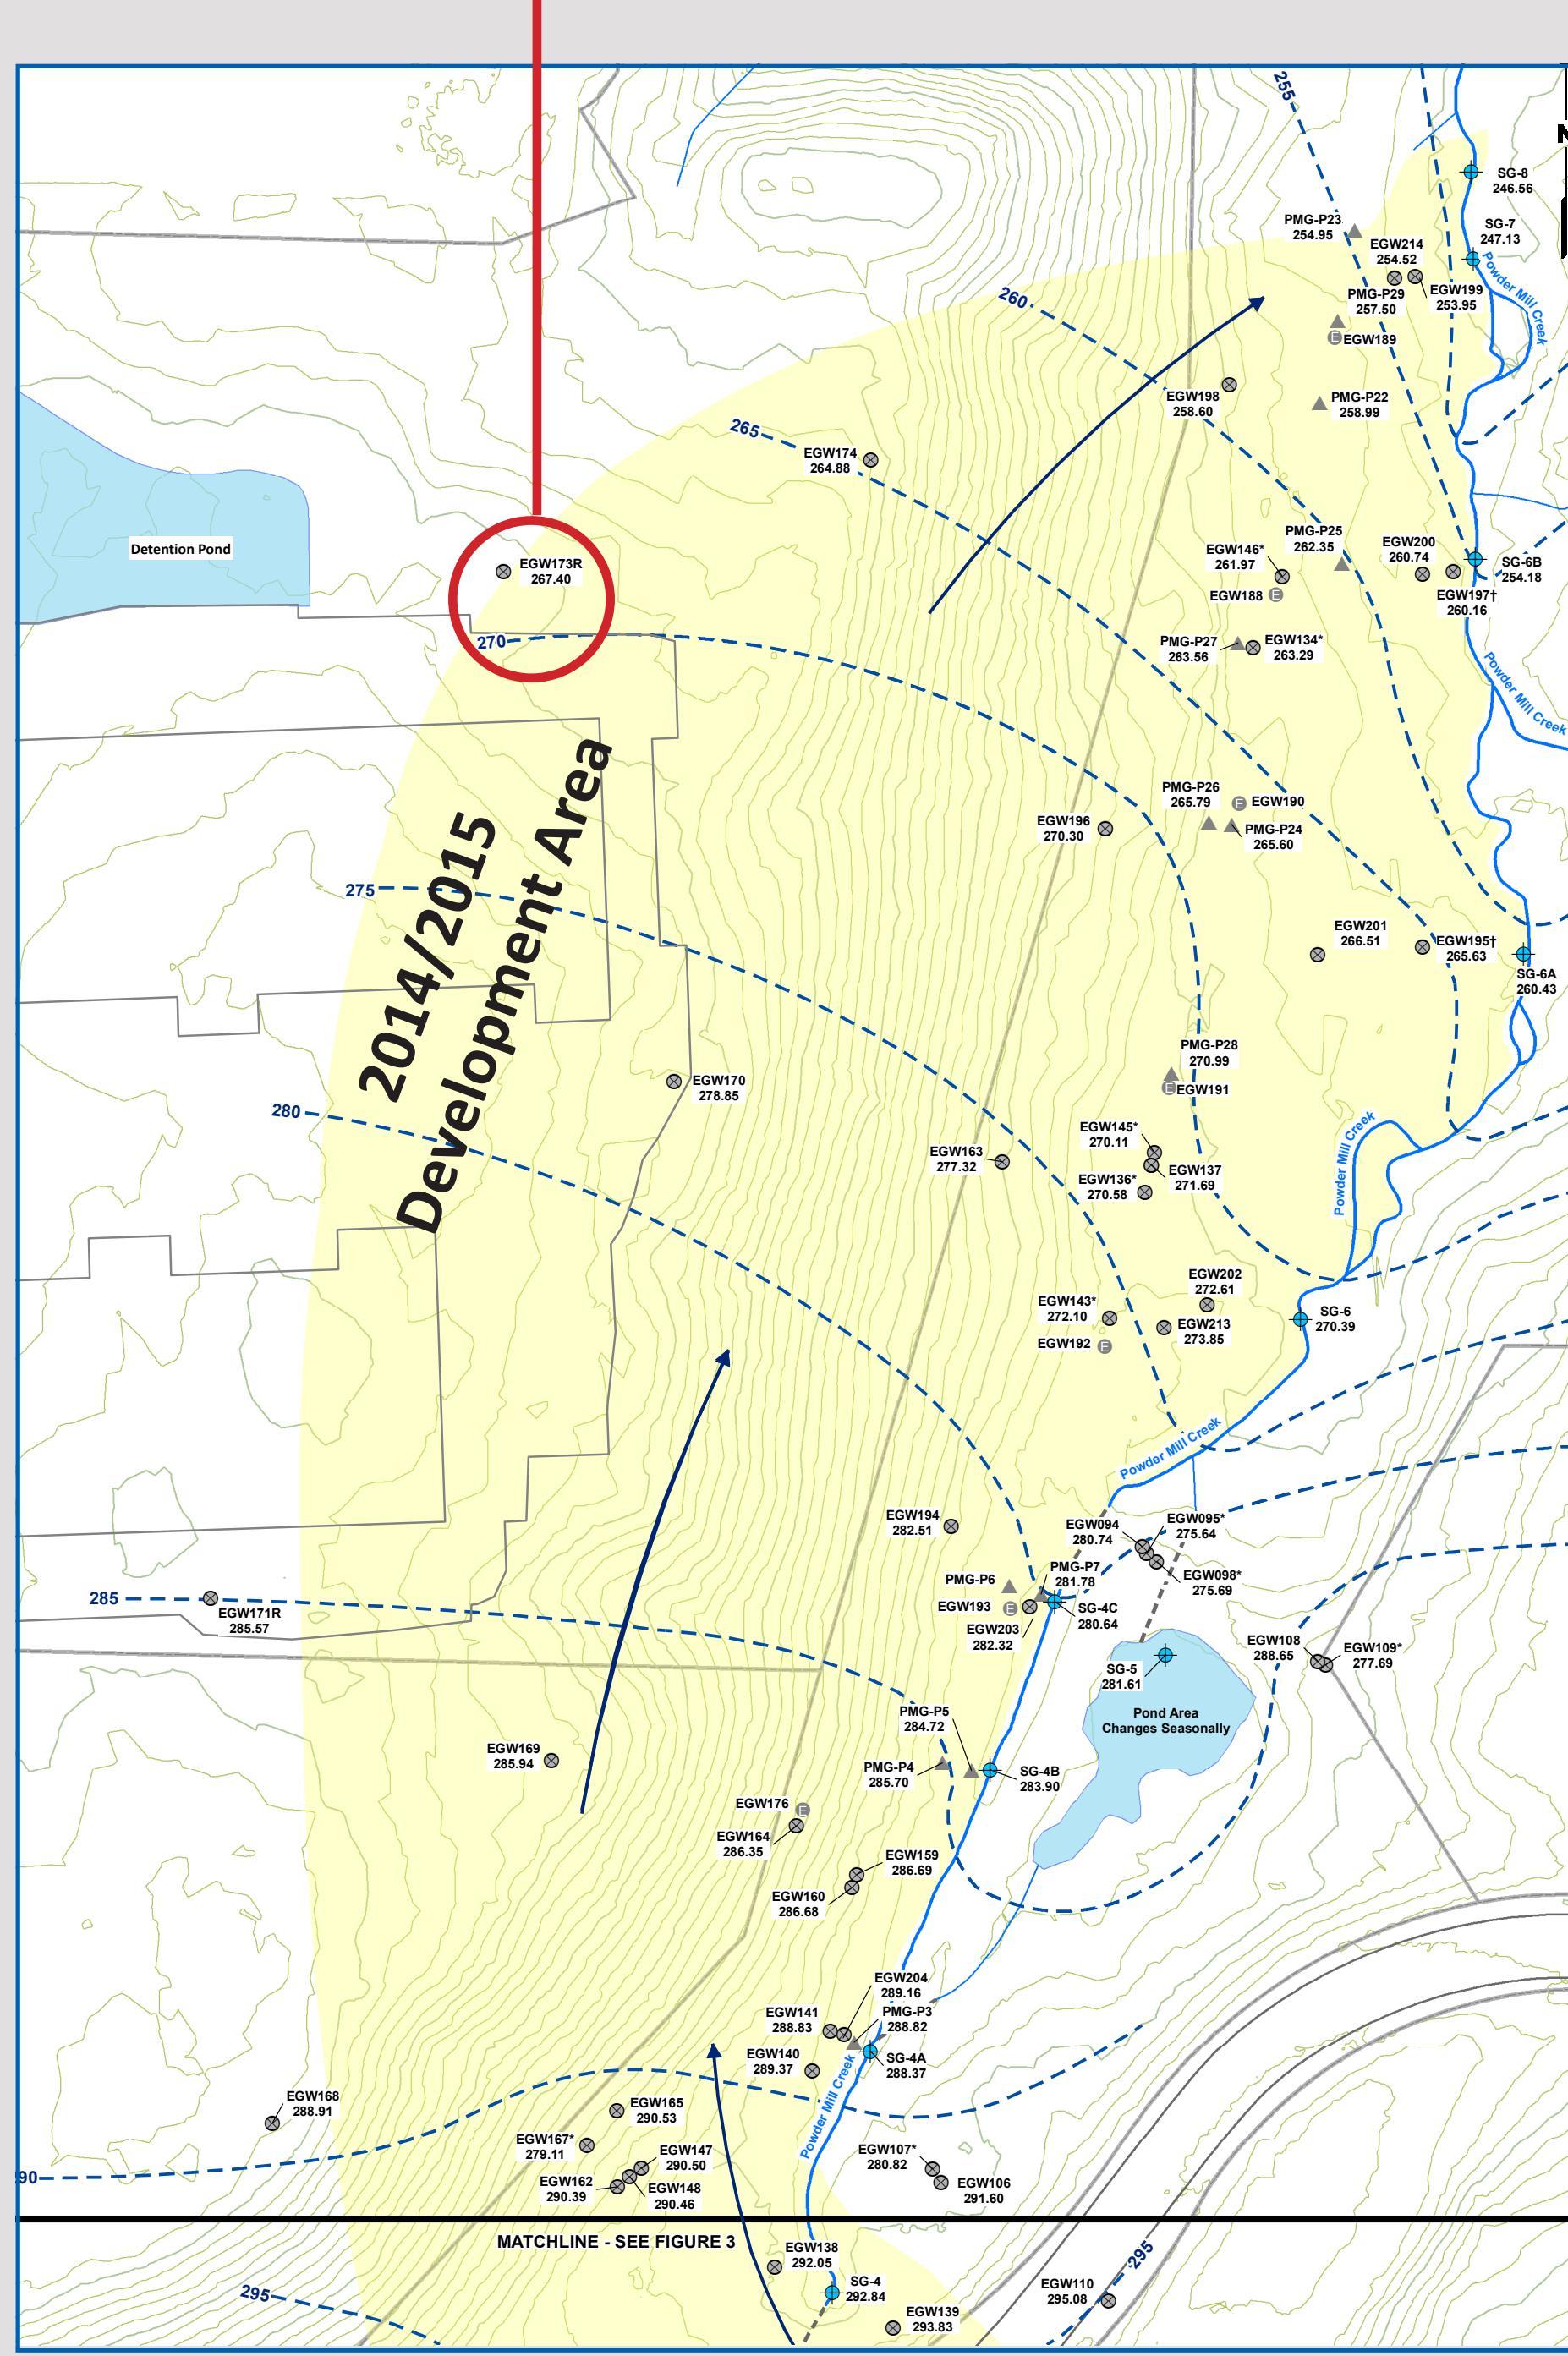
- In January 2016, monitoring of sentry wells along the leading (northwest) edge of the impacted area detected TCE for the first time.
- Groundwater contours identified a subtle shift in flow direction to the northnorthwest in this area.
- Indicated never-before-seen shift of the TCE-impacted area boundary to the northwest.
- In October 2017, monitoring of a new well along the western boundary identified an anomalous TCE detection where TCE has not been historically present.
- Another corresponding shift in groundwater contours/flow directions was also identified in this area.

Groundwater Contours – July 2015

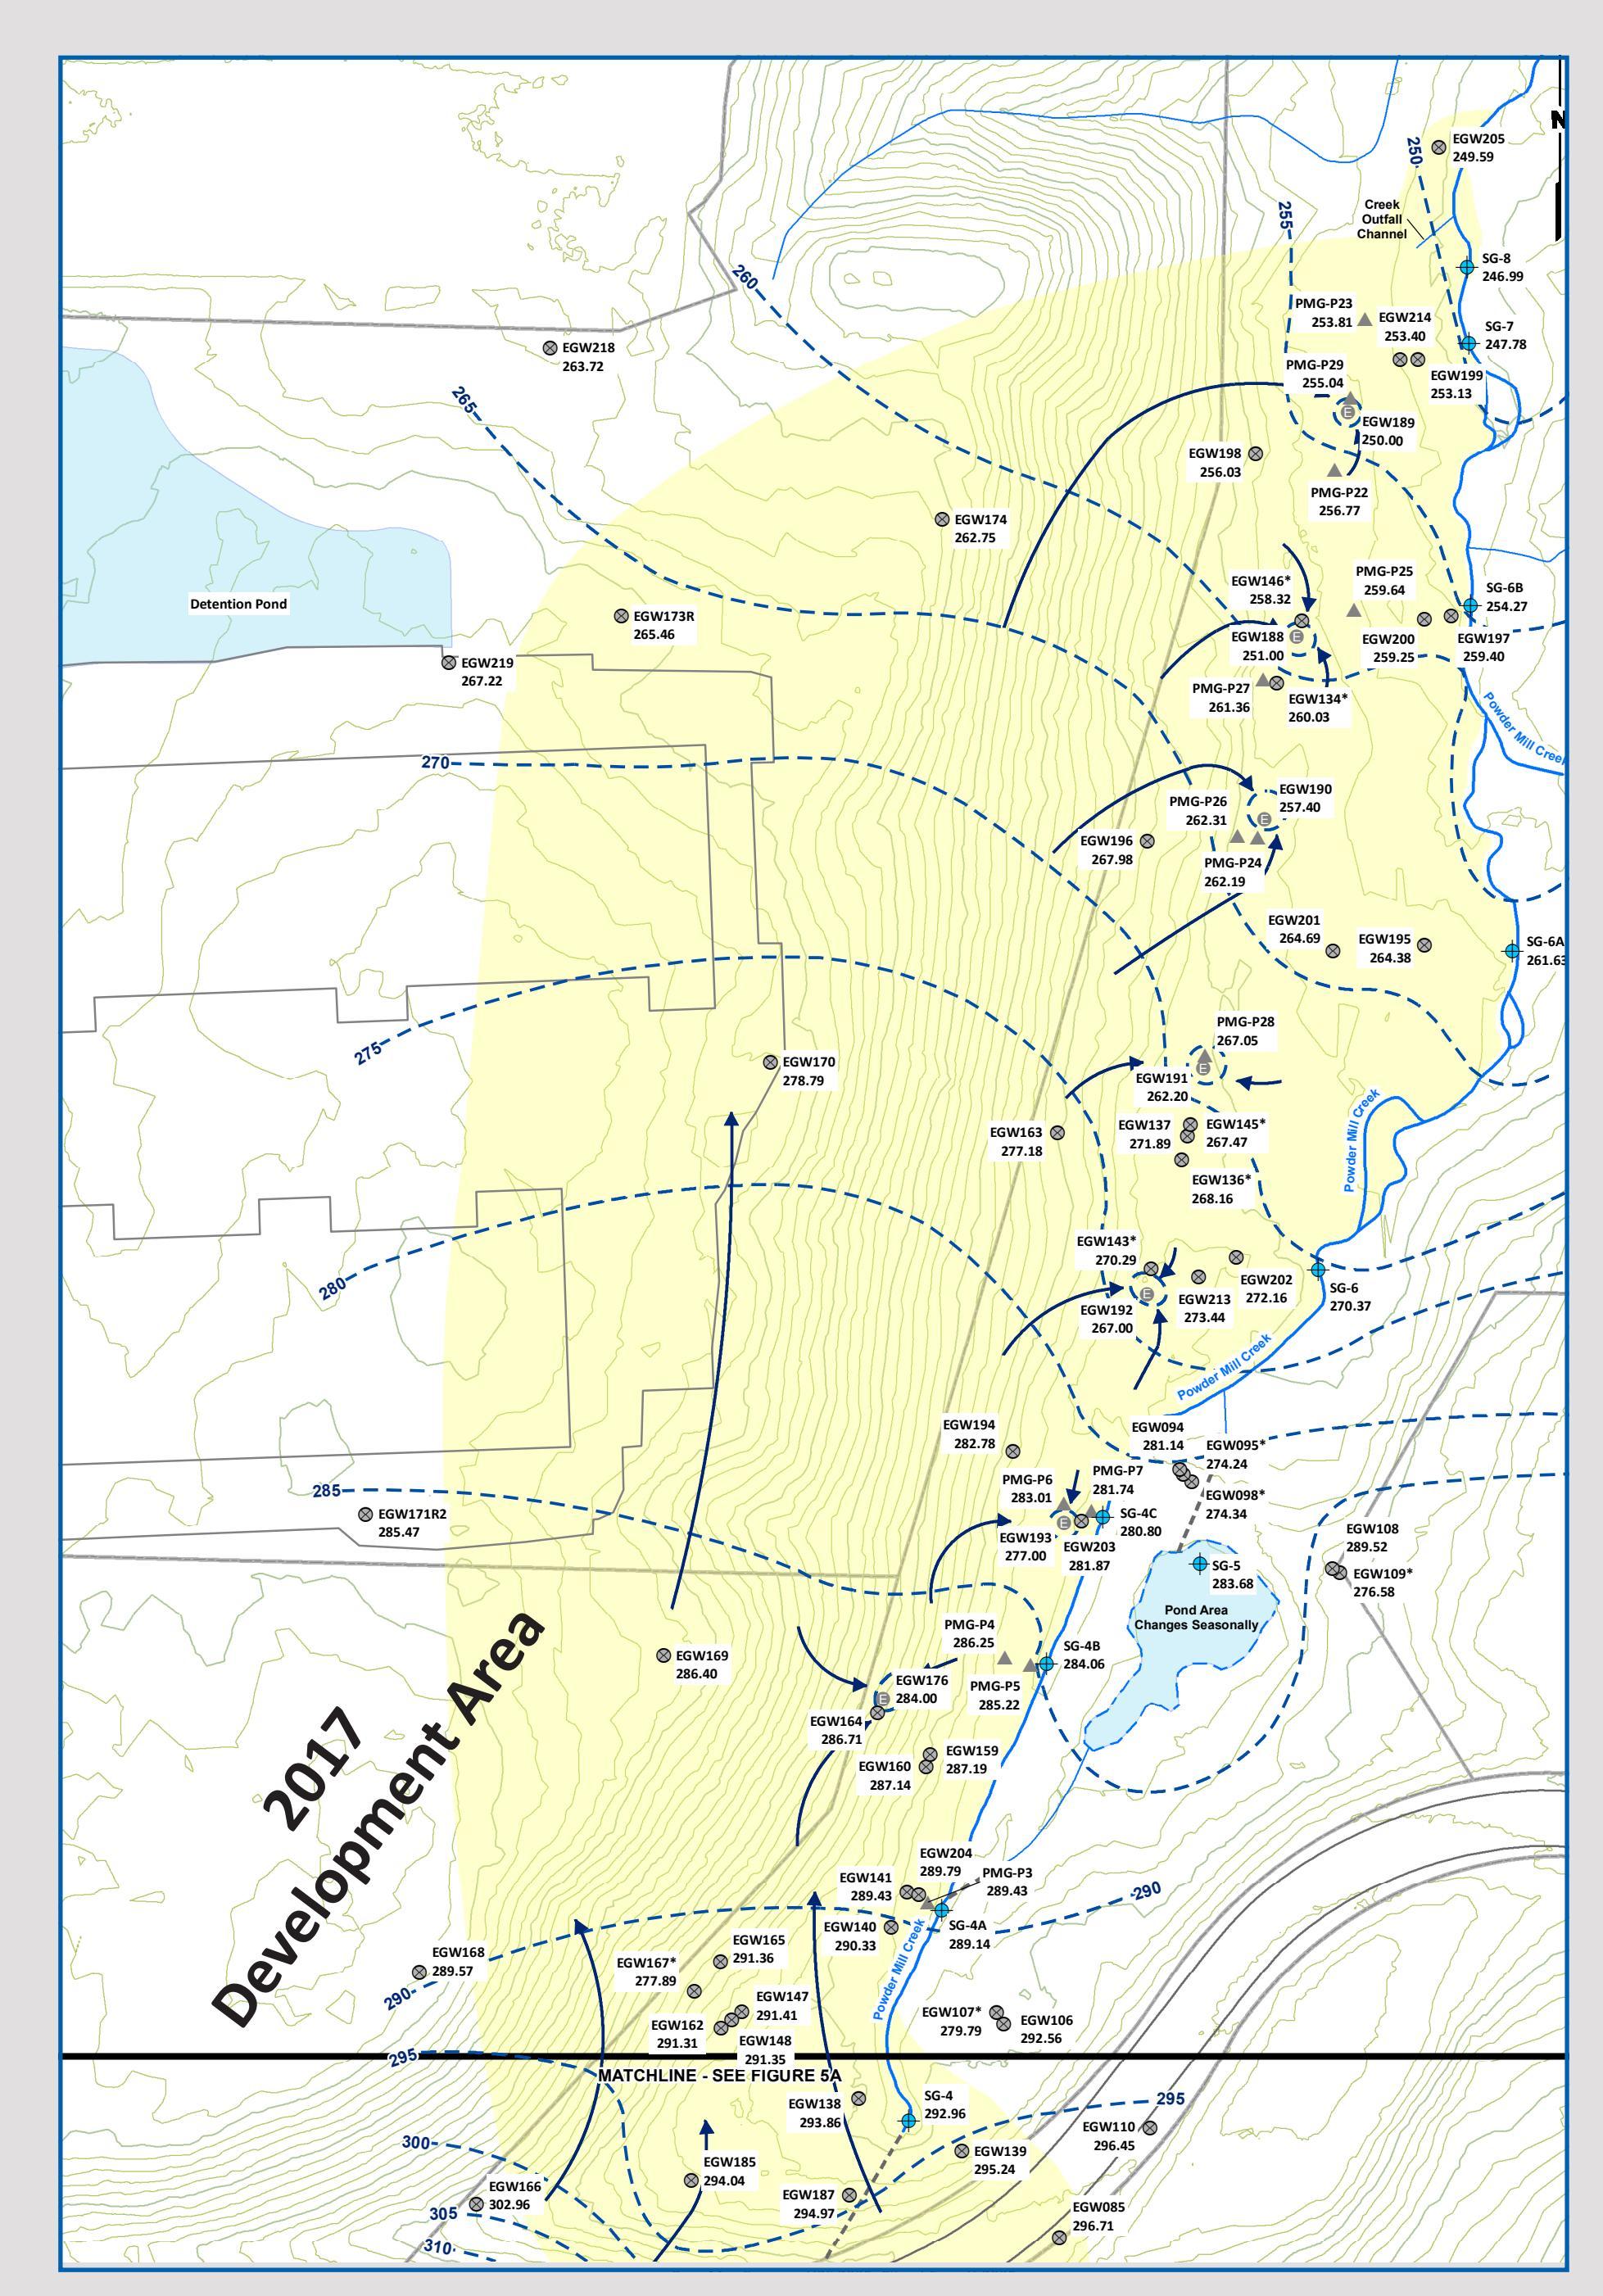
Groundwater Contours – January 2018

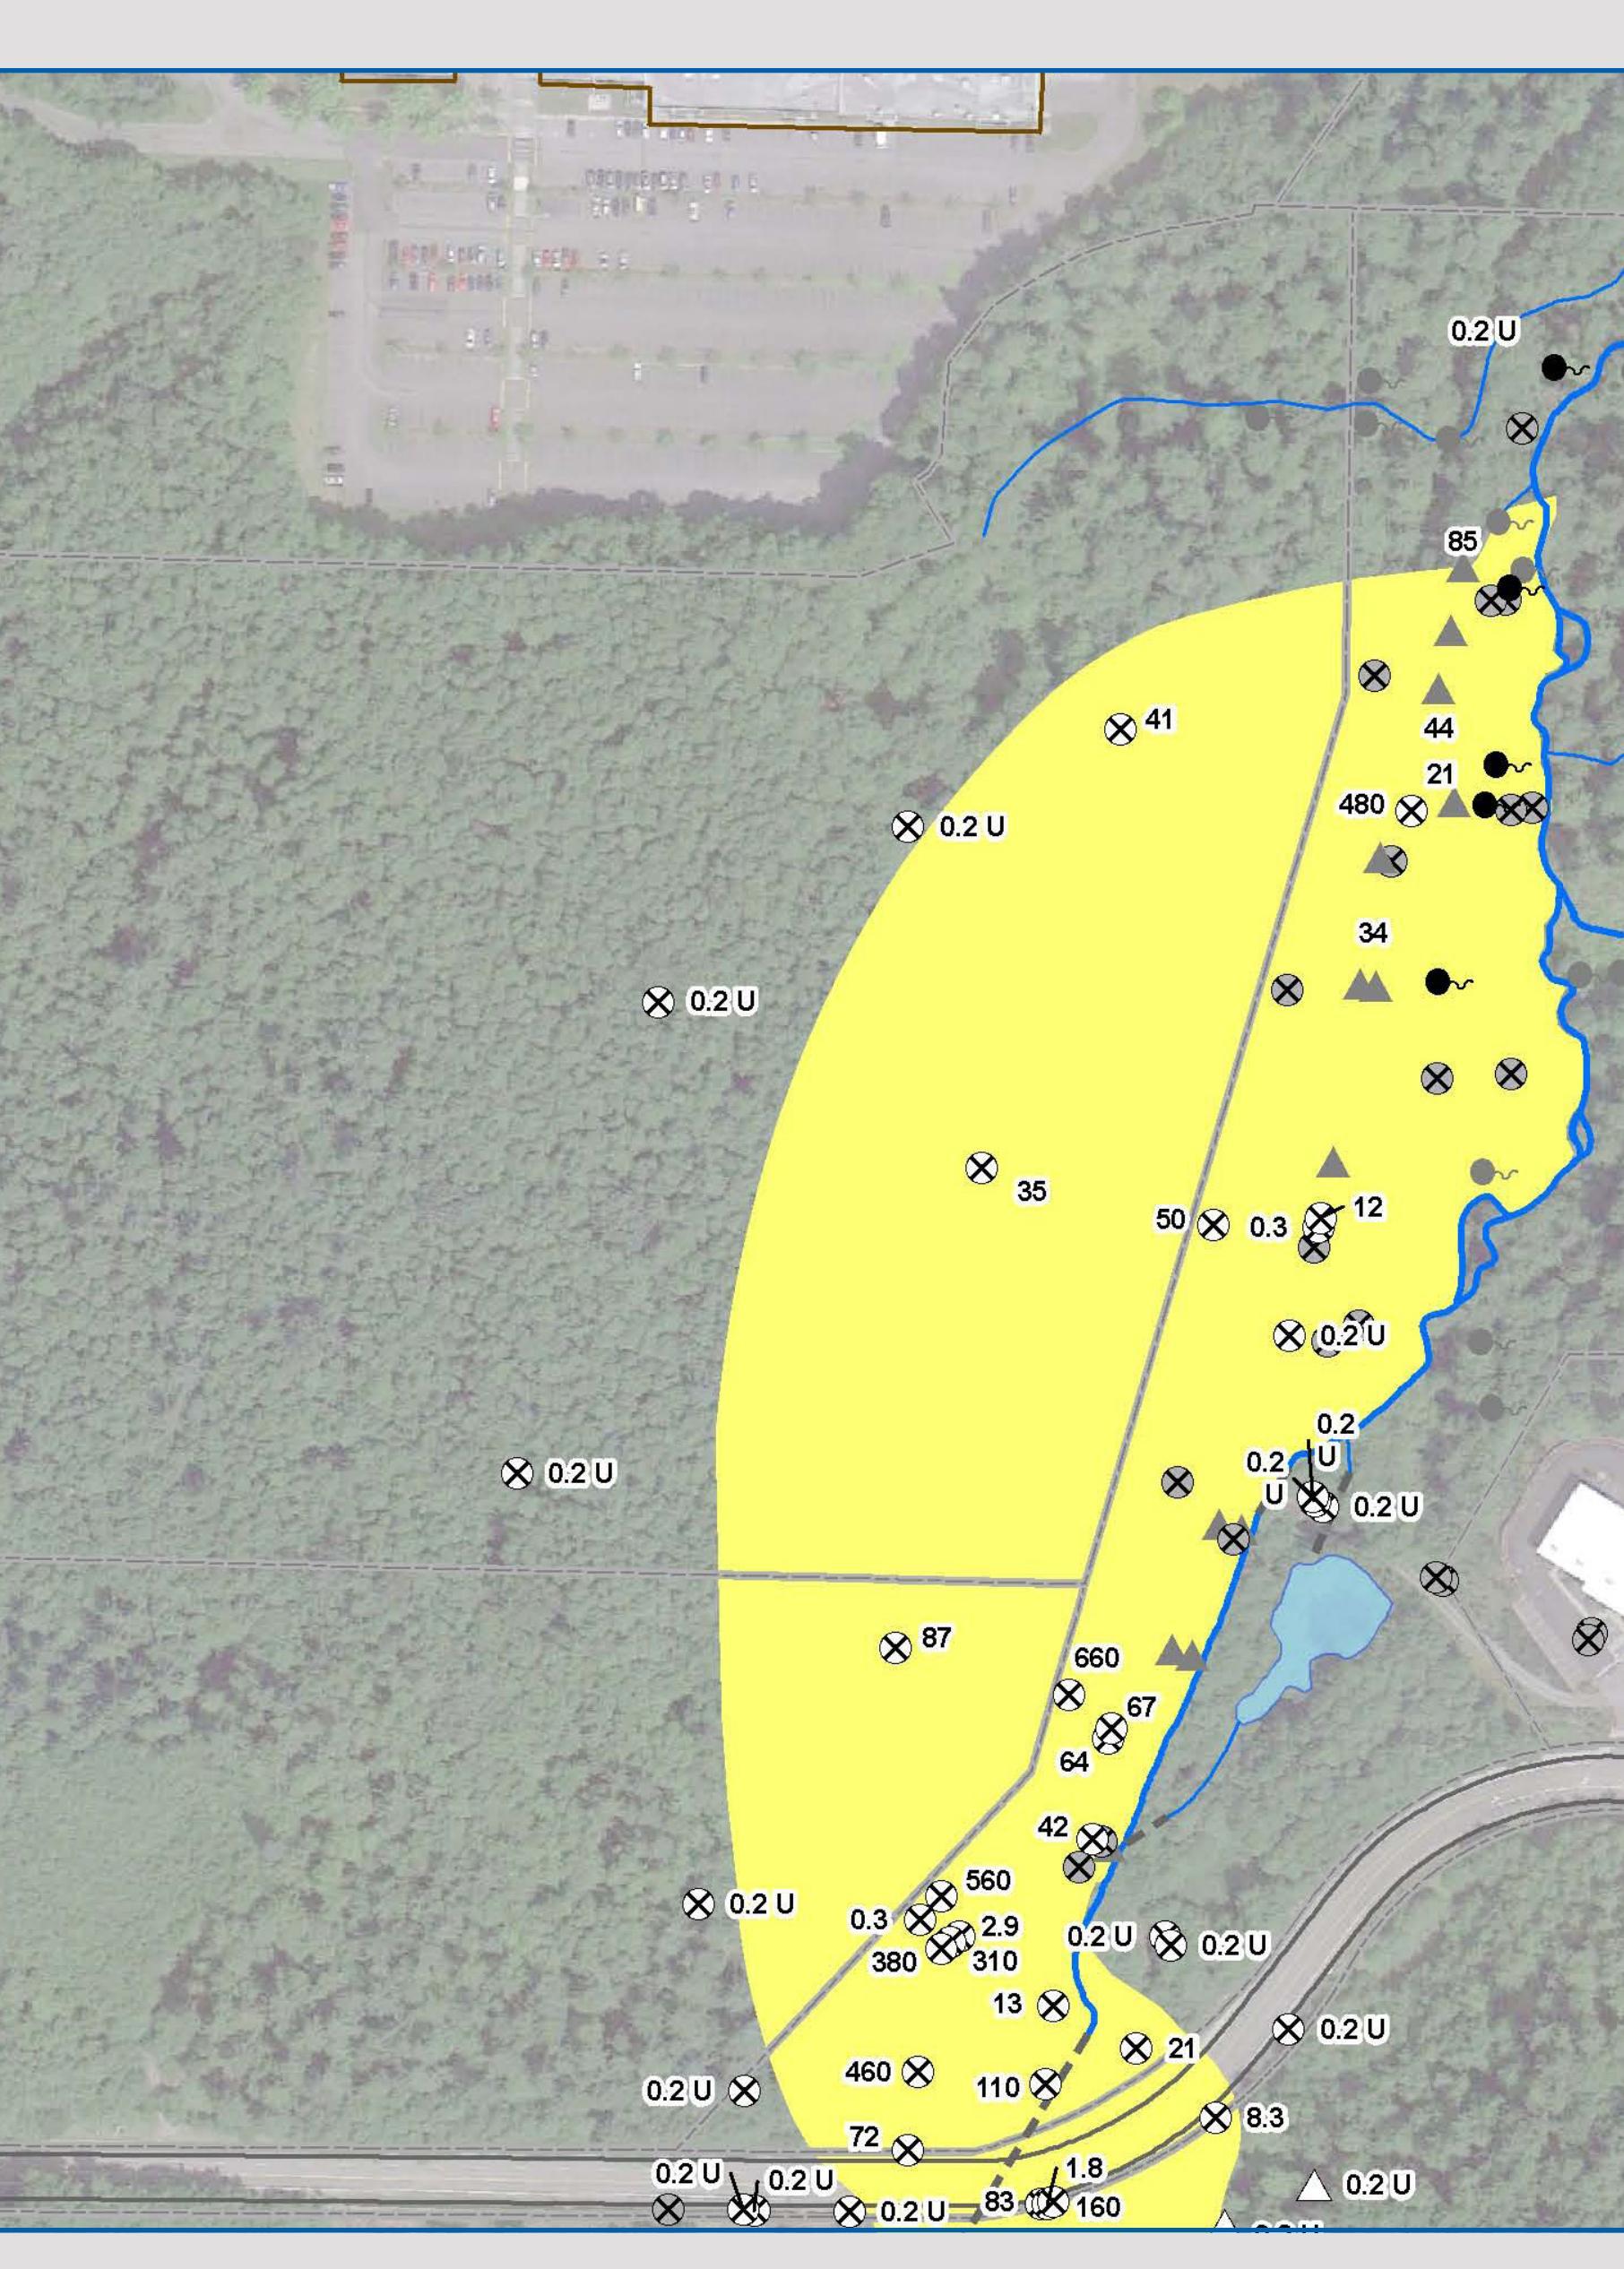
May 2013 Aerial Photo (October data)

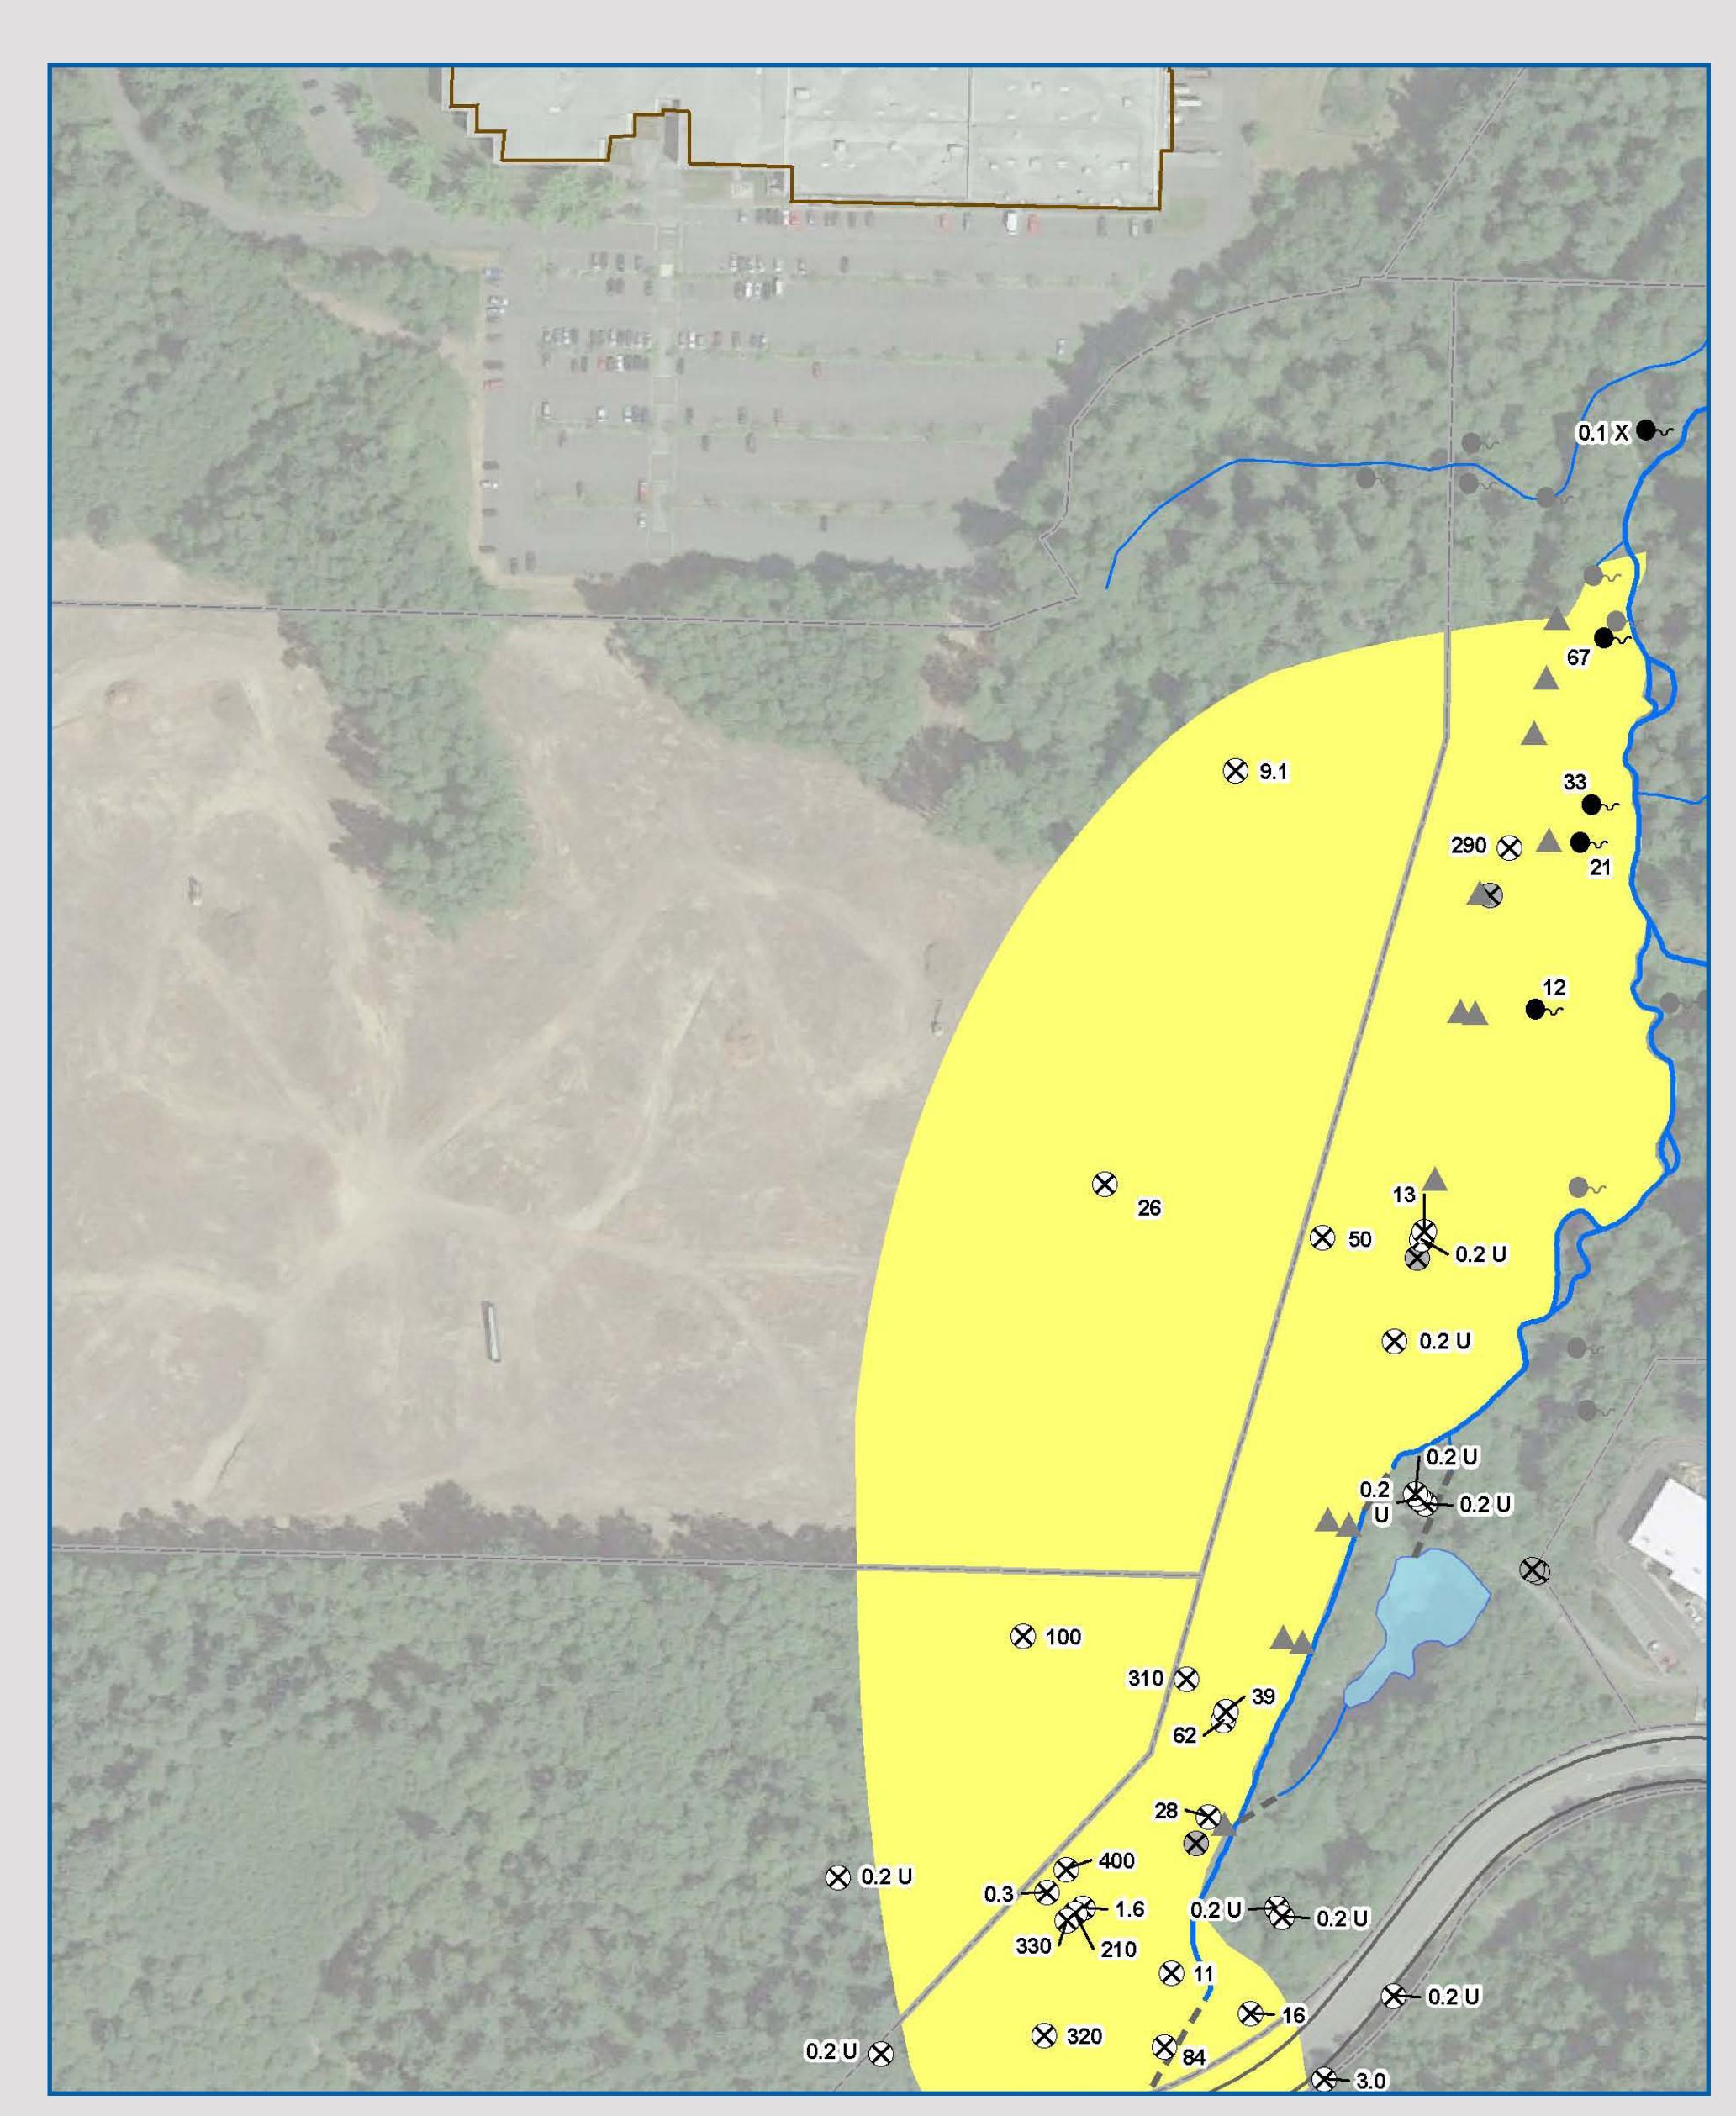
July 2014 Aerial Photo (October data)

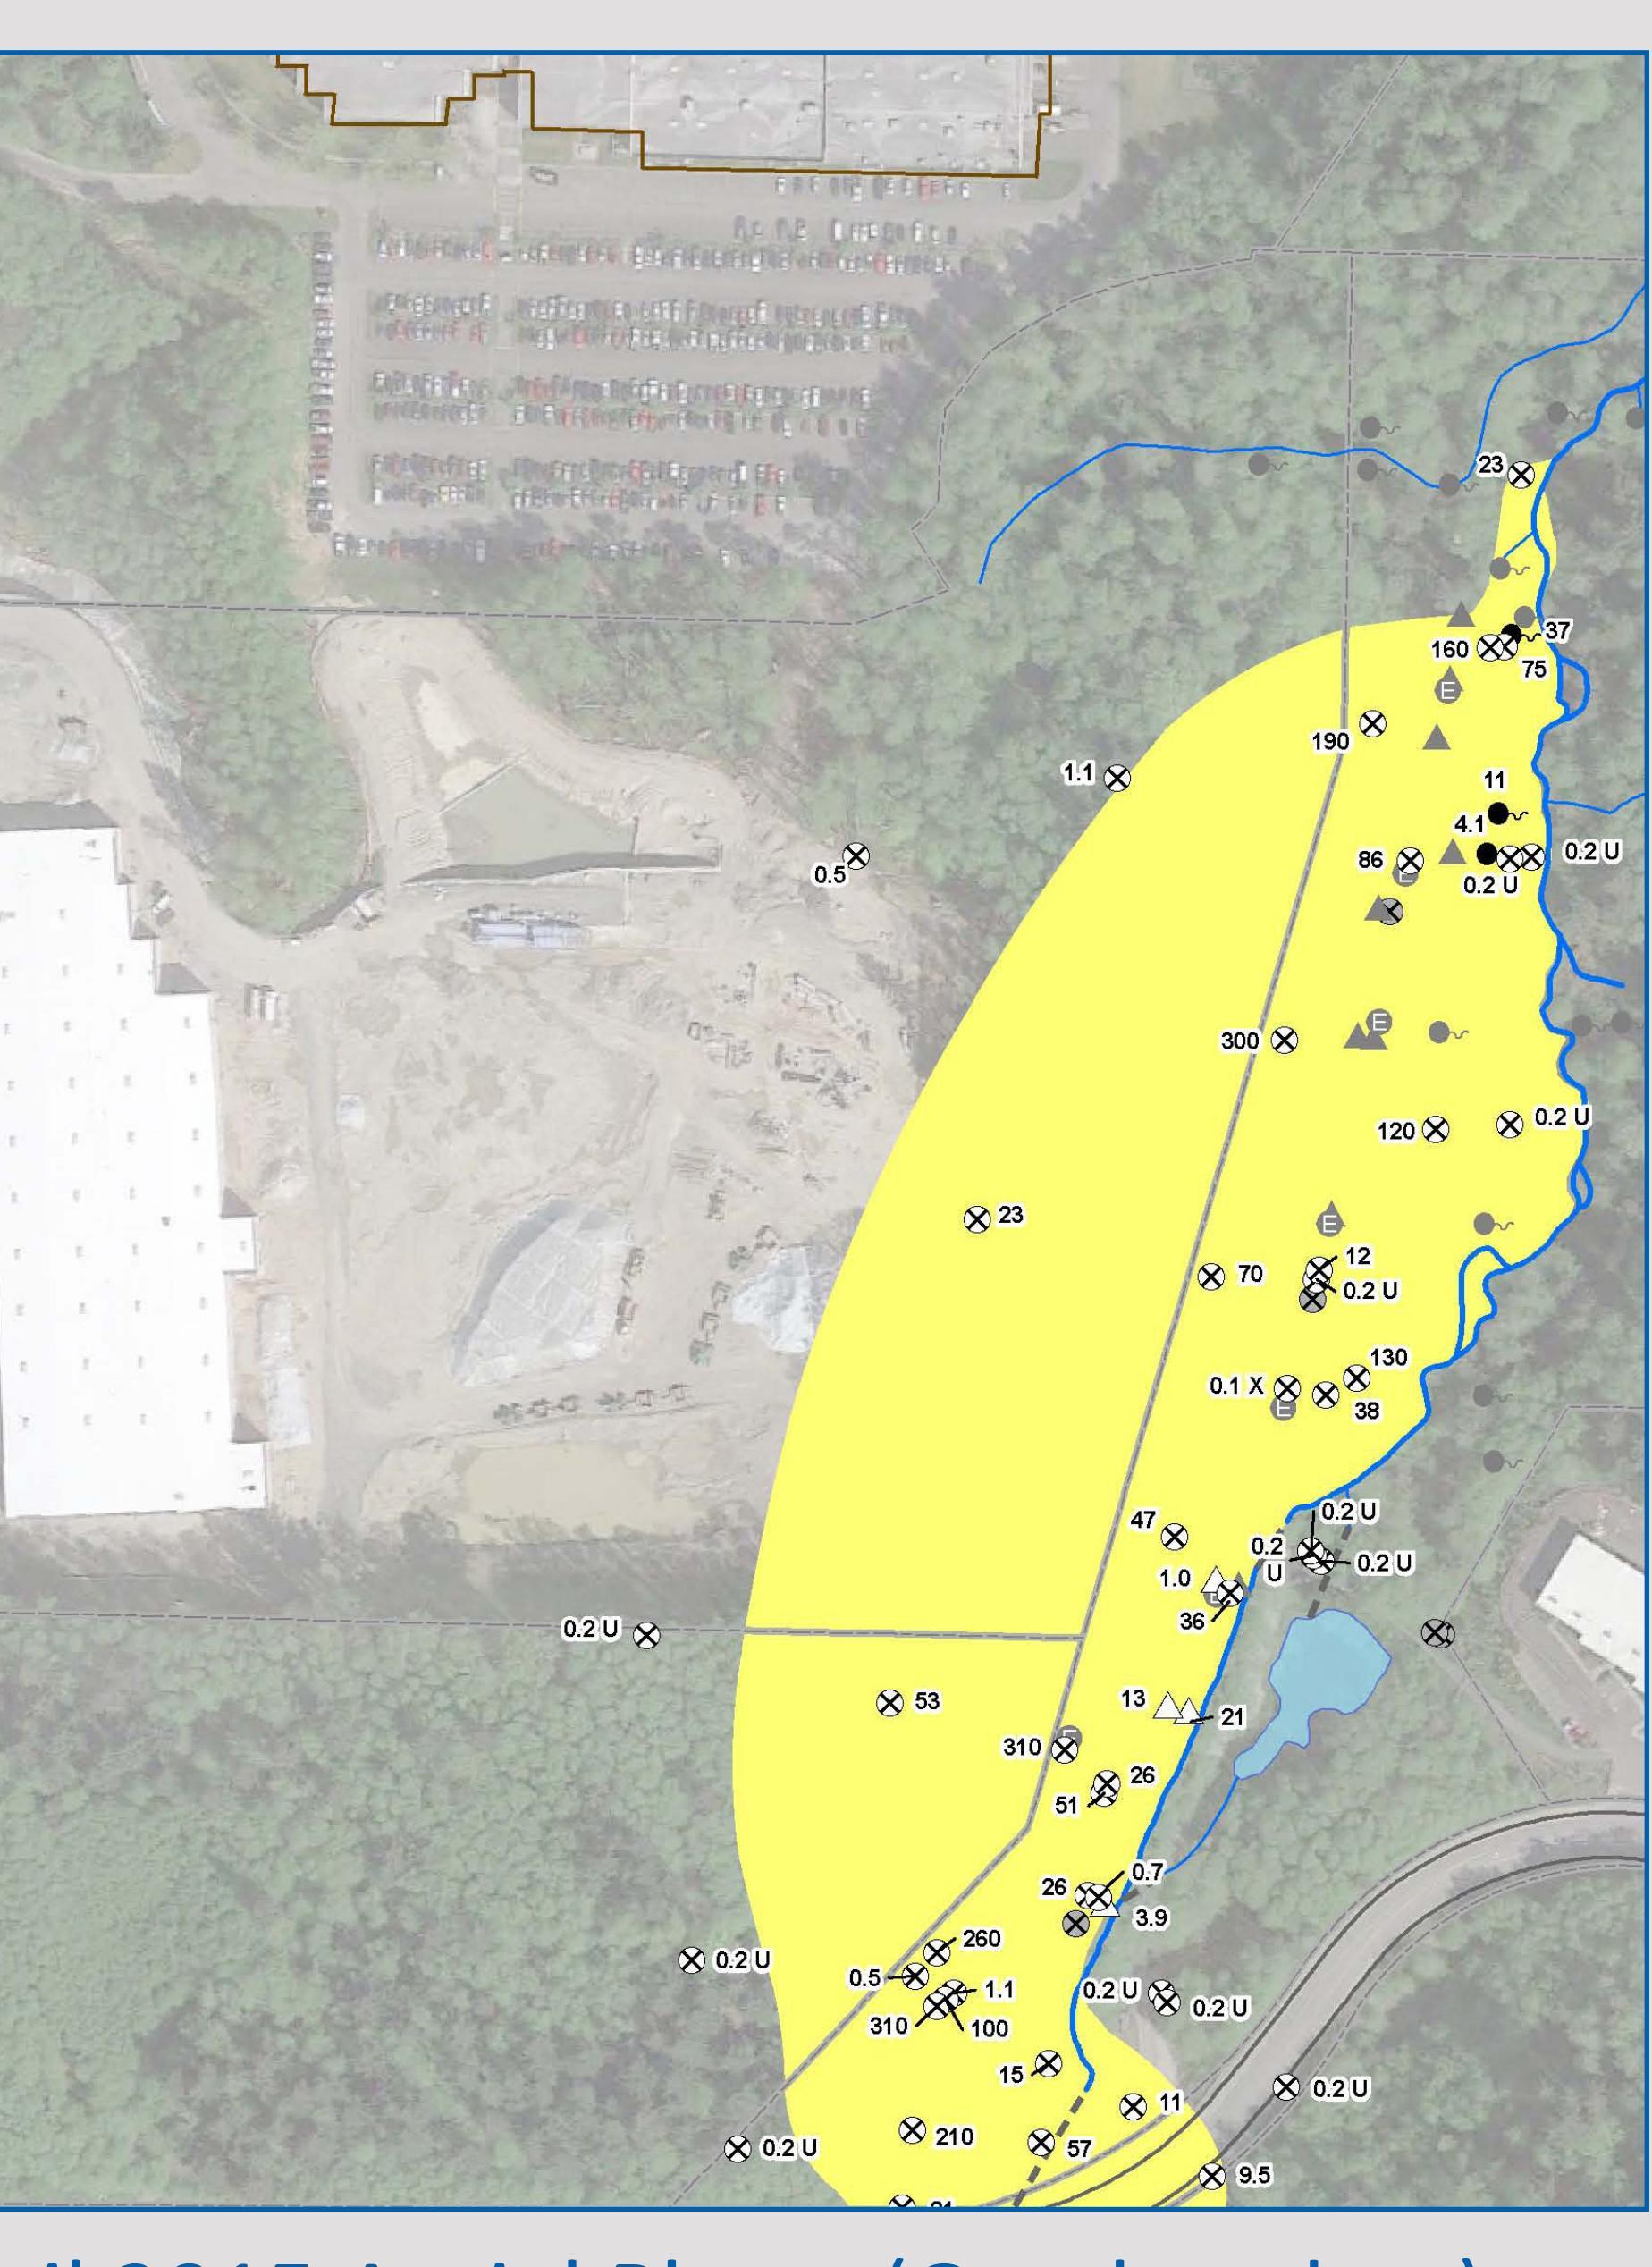
In mid-2014 to 2015 a large commercial development was constructed on the ridge located between the two streams:

- Approximately 25 acres of previously wooded land was developed and covered with impervious surfaces (buildings and parking lots).
- Stormwater was collected and routed to a detention/infiltration pond in the northeast corner of the development.

April 2015 Aerial Photo (October data)
