Effects of Land Development on TCE-Impacted Groundwater Boundaries

Piper Roelen, PE, Landau Associates, Edmonds, WA, USA Debbie Taege, The Boeing Company, Renton, WA, USA

Apparent Shift of Formerly Stable TCE-Impacted Area

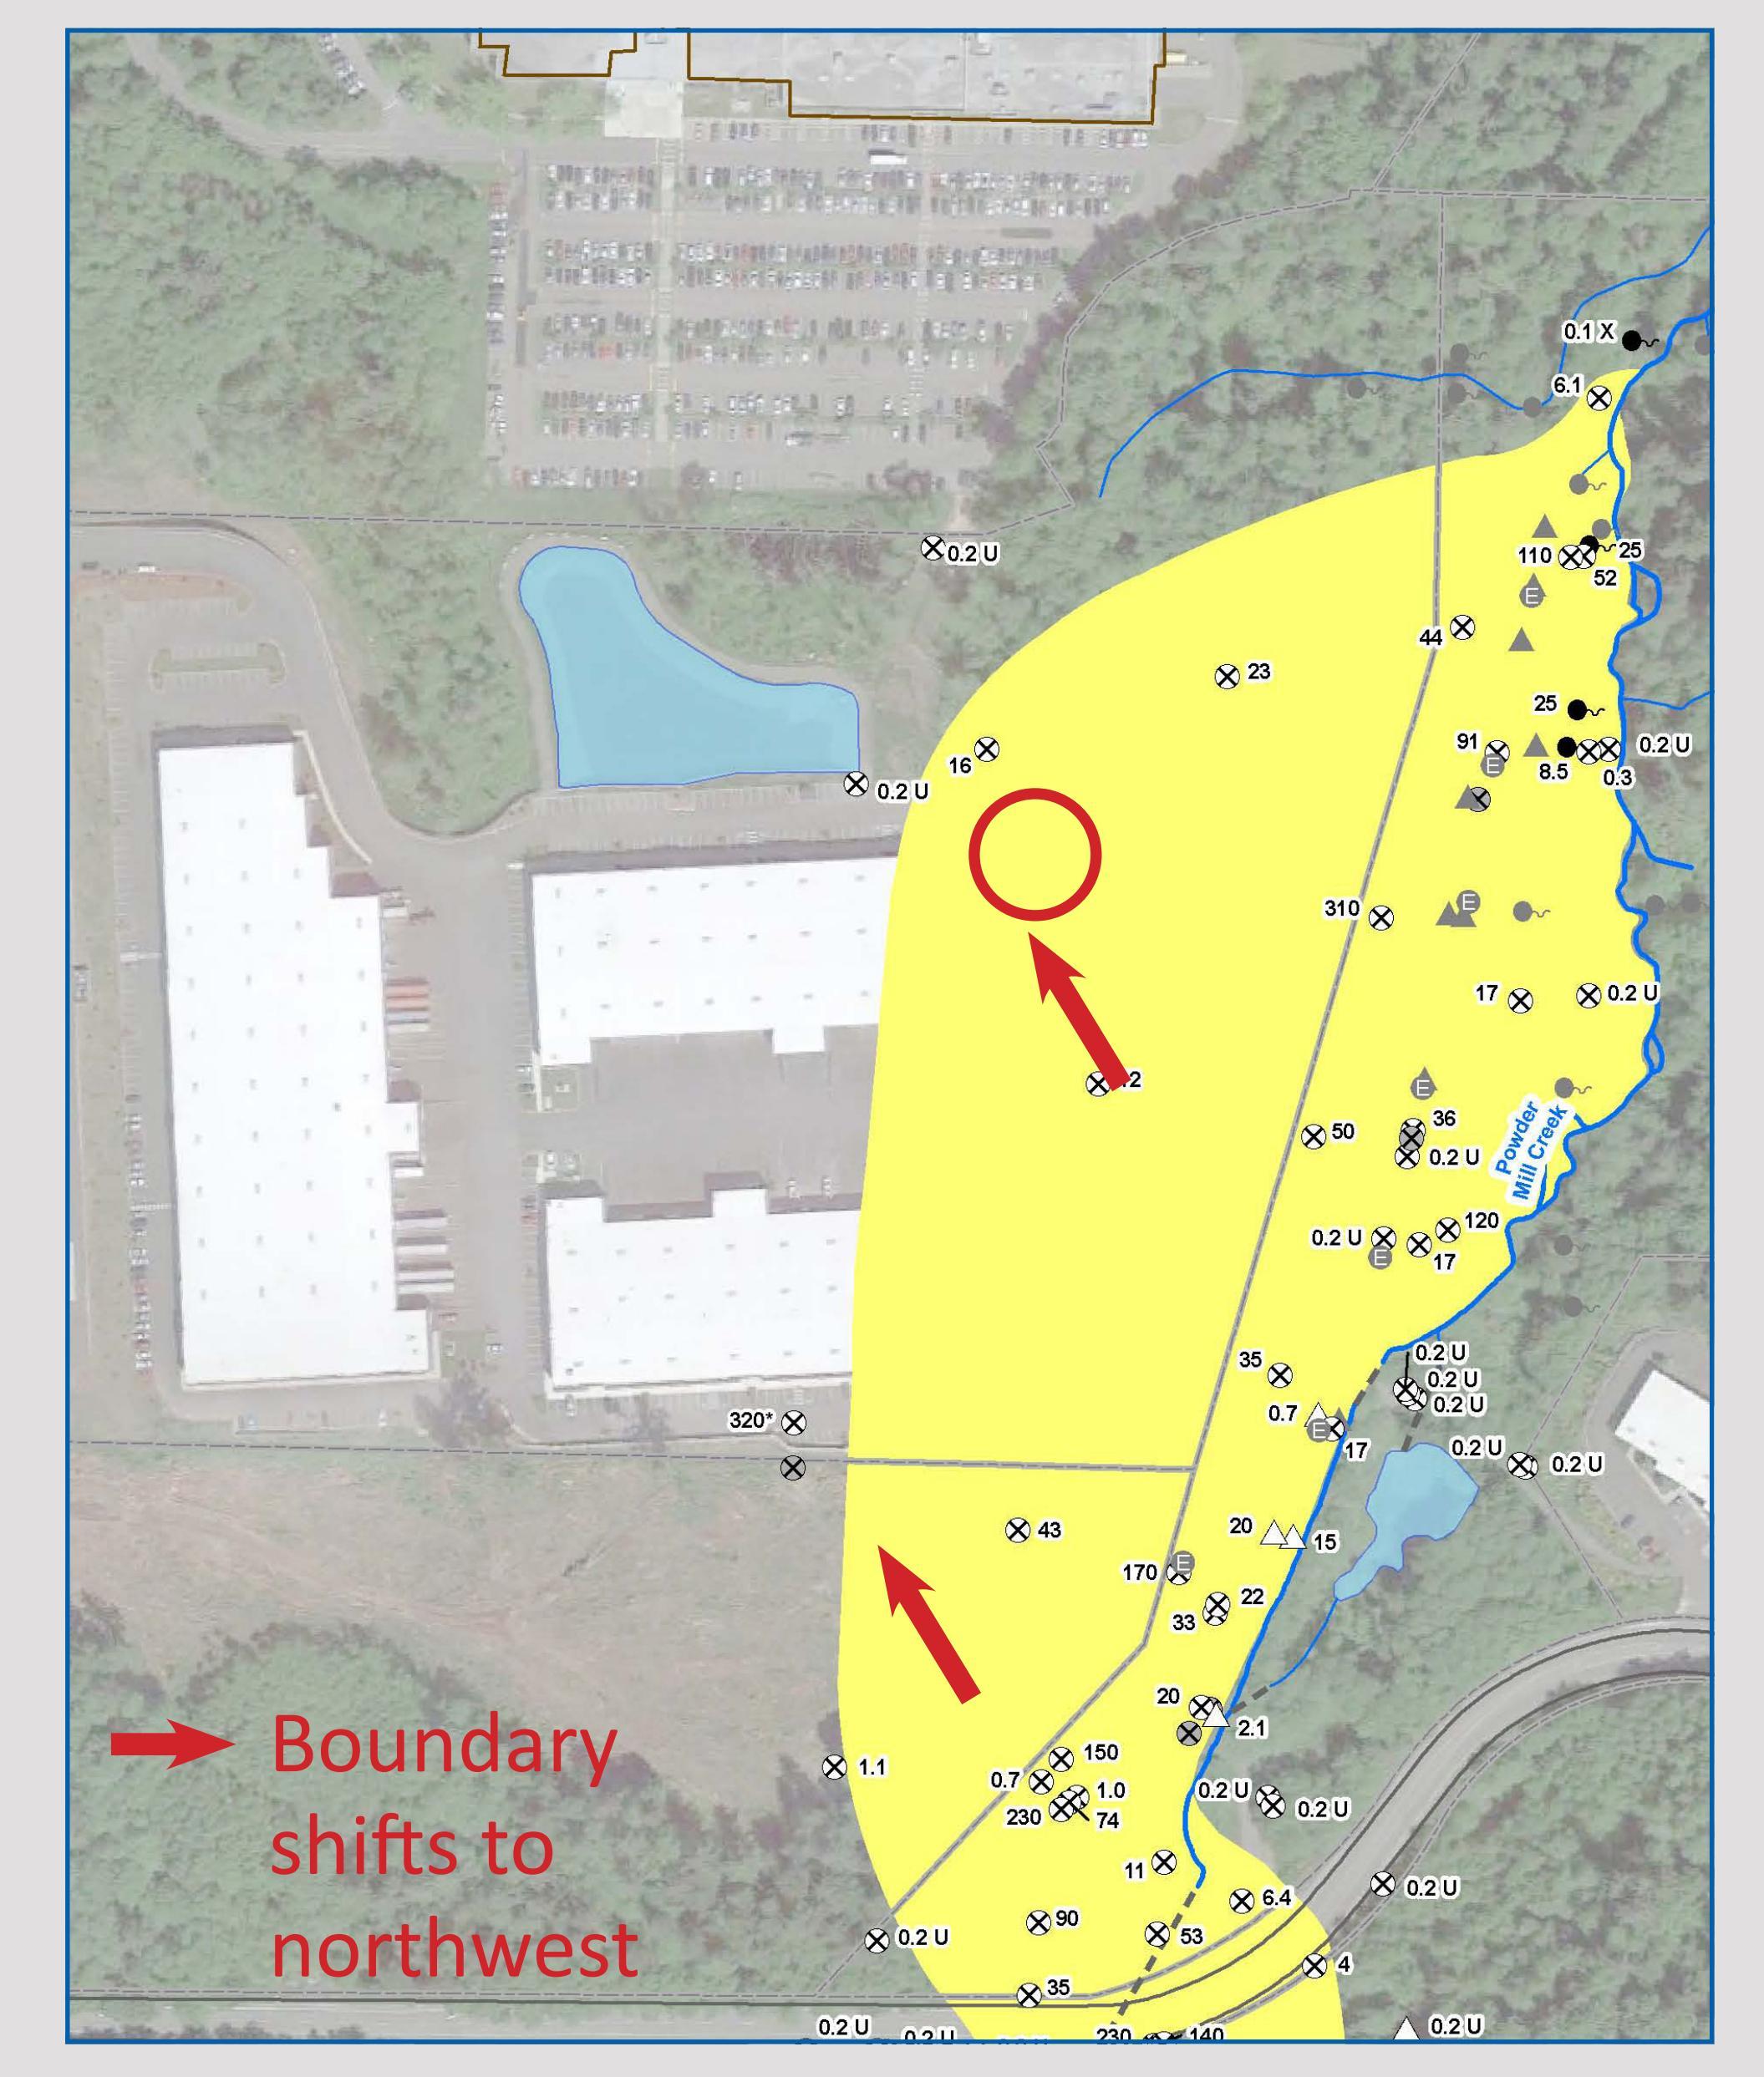
In 2017, construction of a second large commercial development began (still ongoing) to the south of the first:

- Approximately 11 acres of previously wooded land was developed and covered buildings and parking lots.
- Stormwater was collected and routed offsite via storm sewer.

May 2017 Aerial Photo (October data)

36 acres of land development may reduce groundwater recharge by up to 34.9M-gal/yr (equivalent to a 66 gpm extraction well)
