In-Stream Remediation of Coal-Tar-Impacted Sediments and Fractured Bedrock

Raymond D'Hollander, PE, P.Eng. | Heather Philip | Paul Roth

2019 Sediments Conference | Tenth International Conference on Remediation and Management of Contaminated Sediments | February 11-14, 2019 | New Orleans, Louisiana

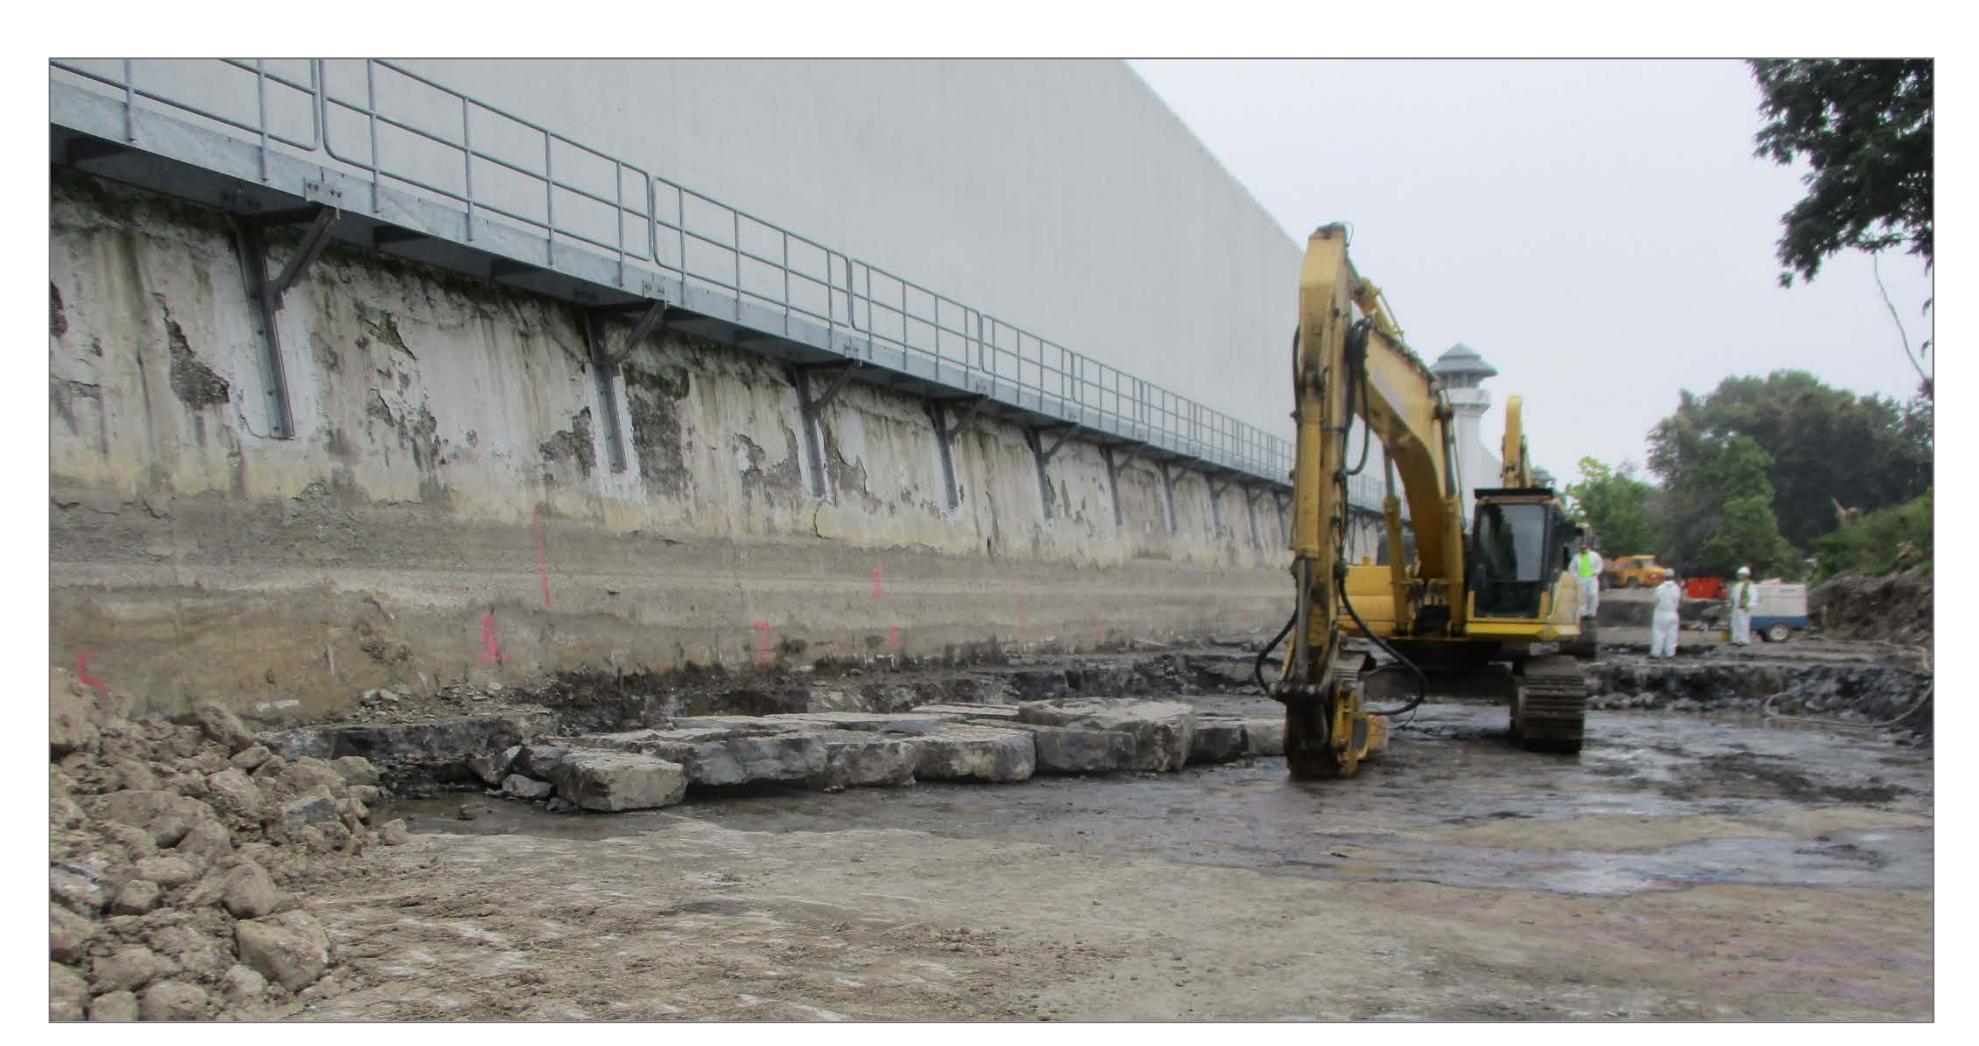
Sediments and fractured rock removed. Prison wall on left.

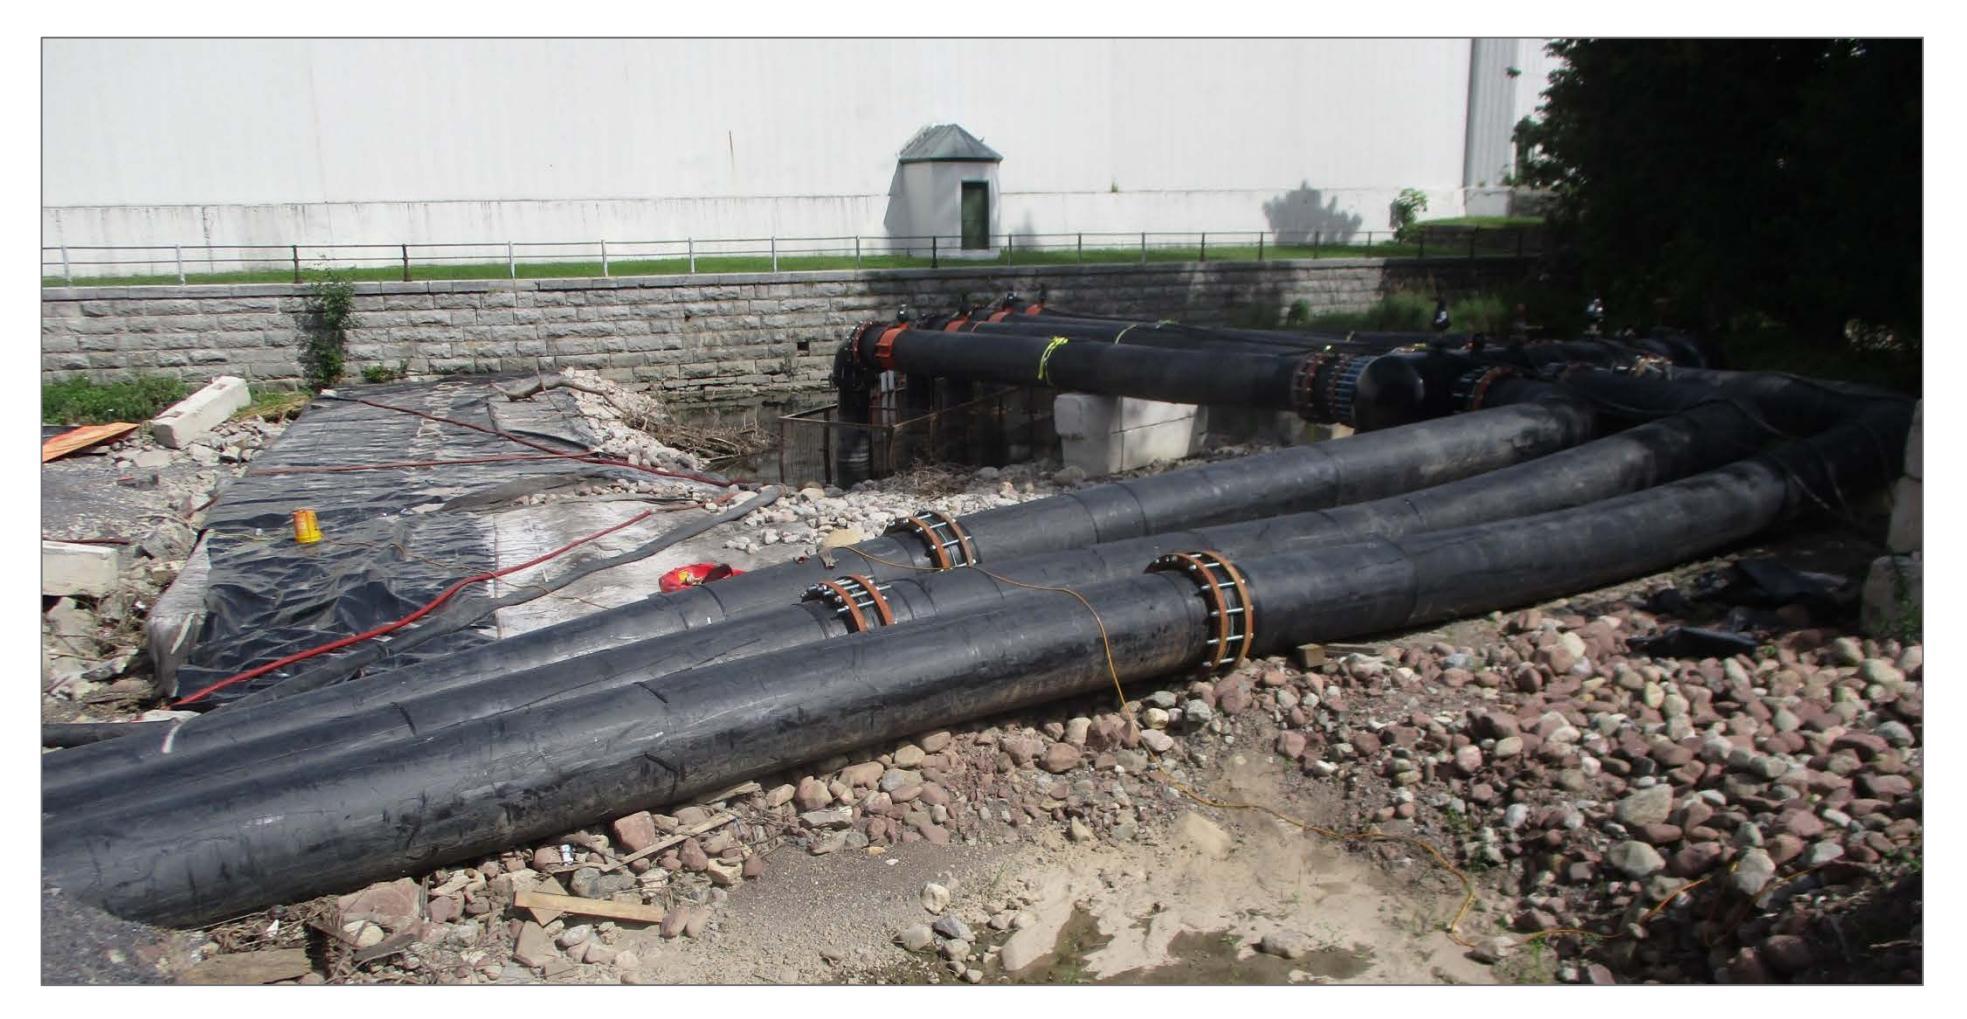
Temporary dam and pumped bypass diverted stream flow for "in-the-dry" remediation

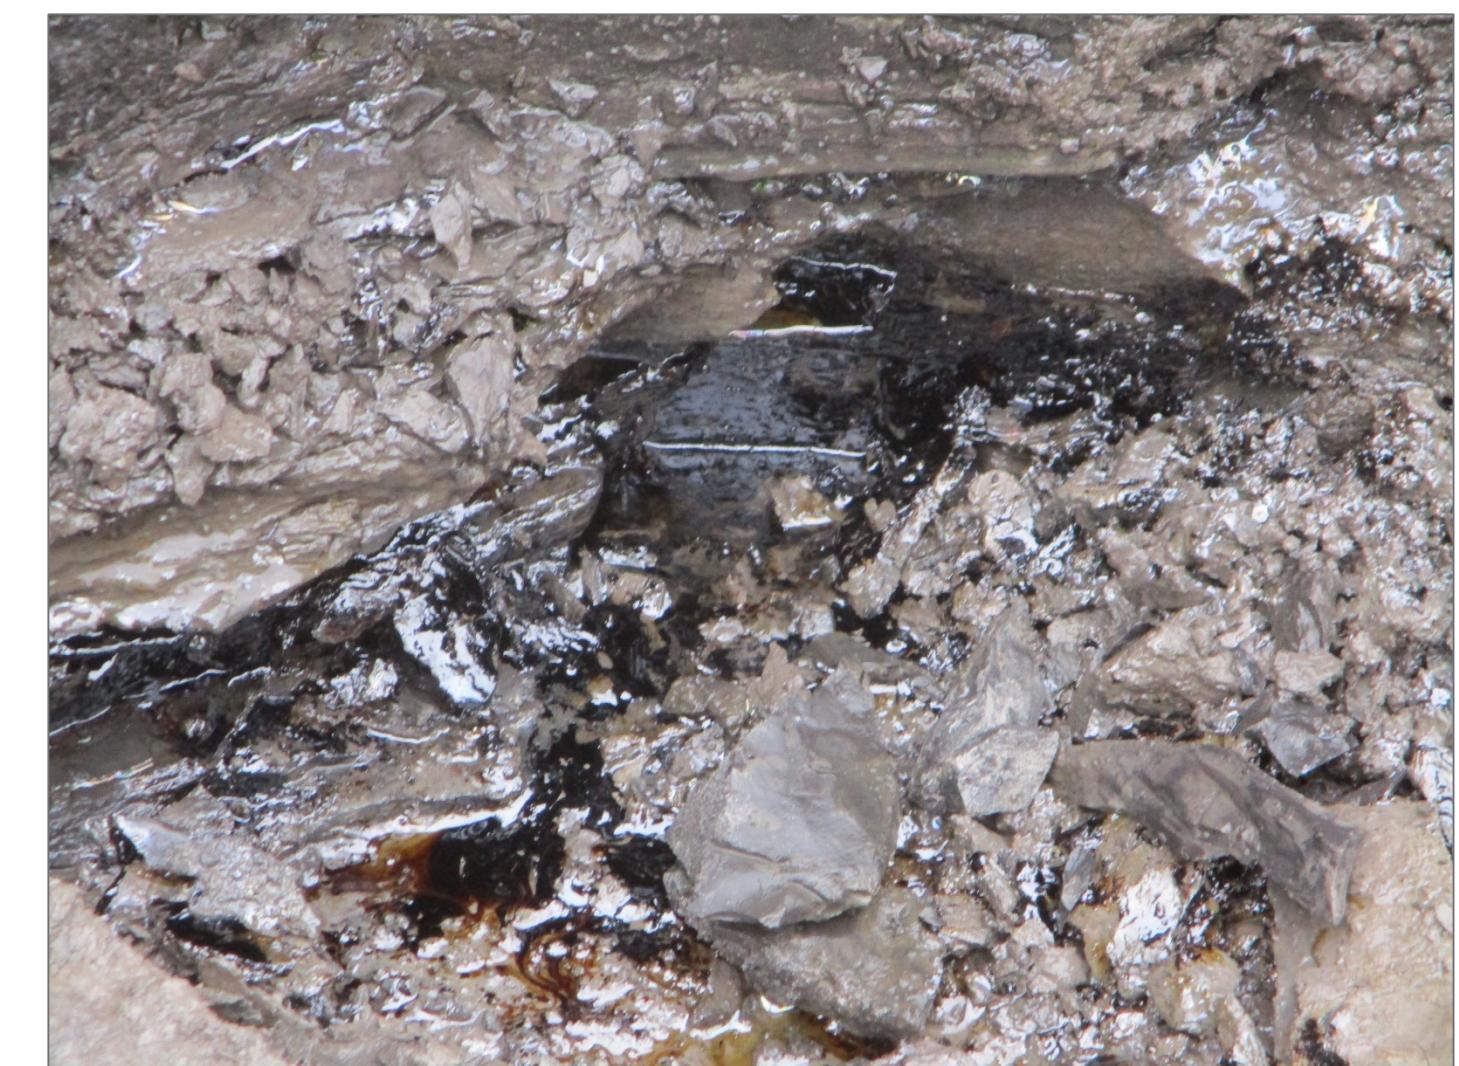
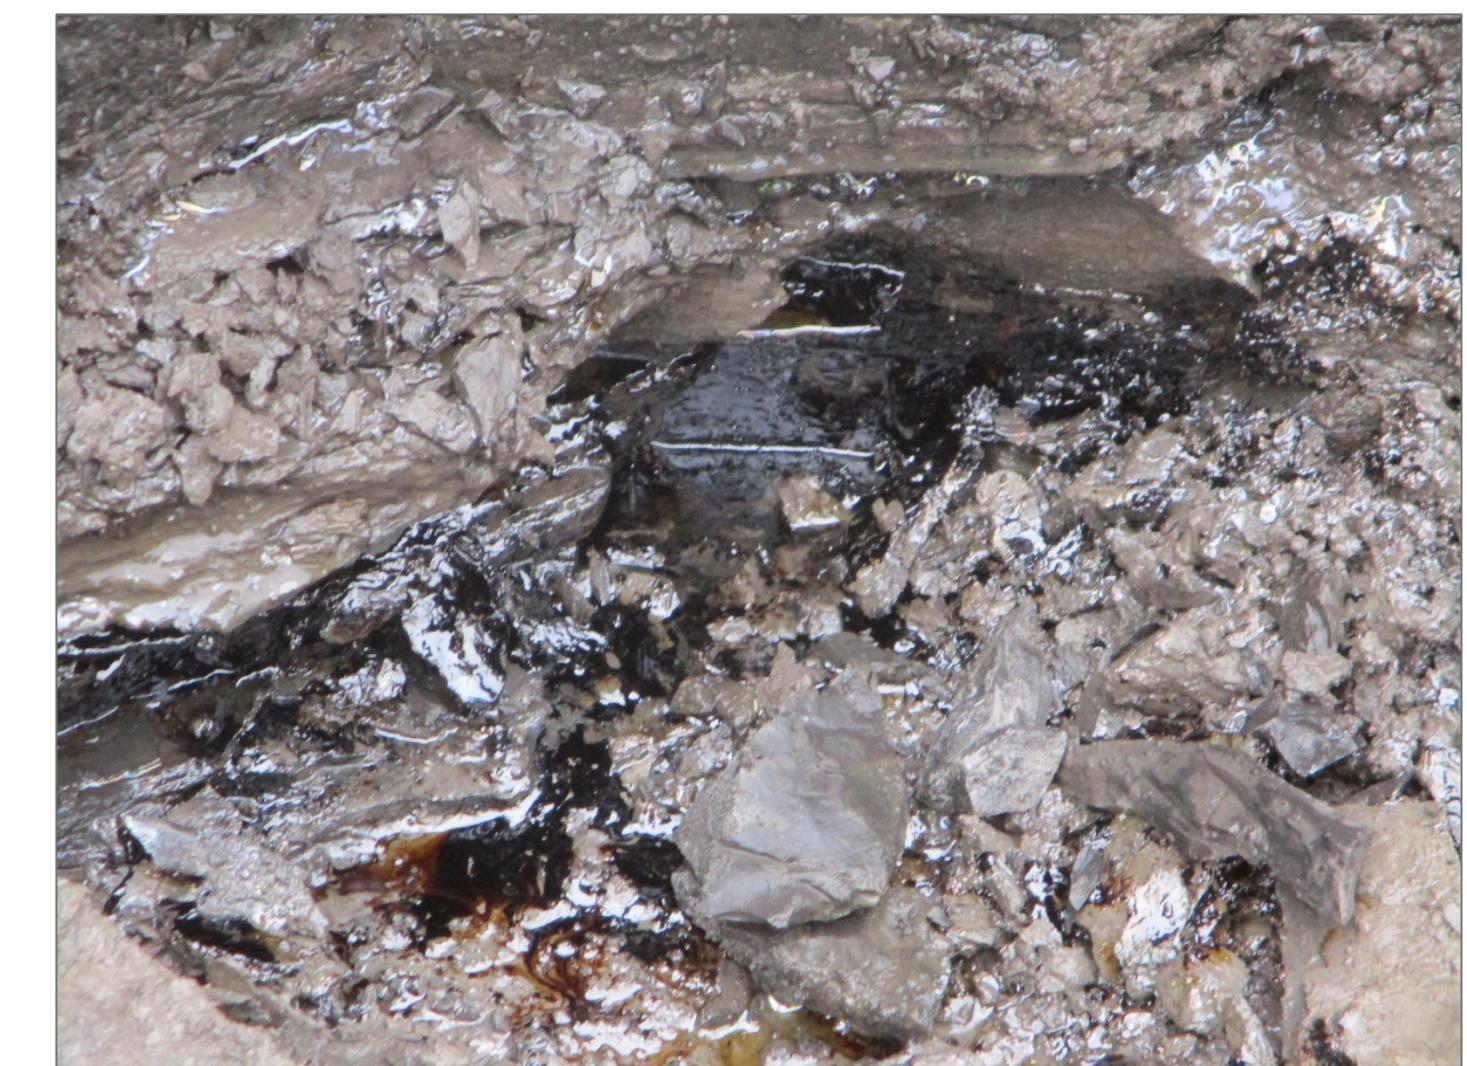
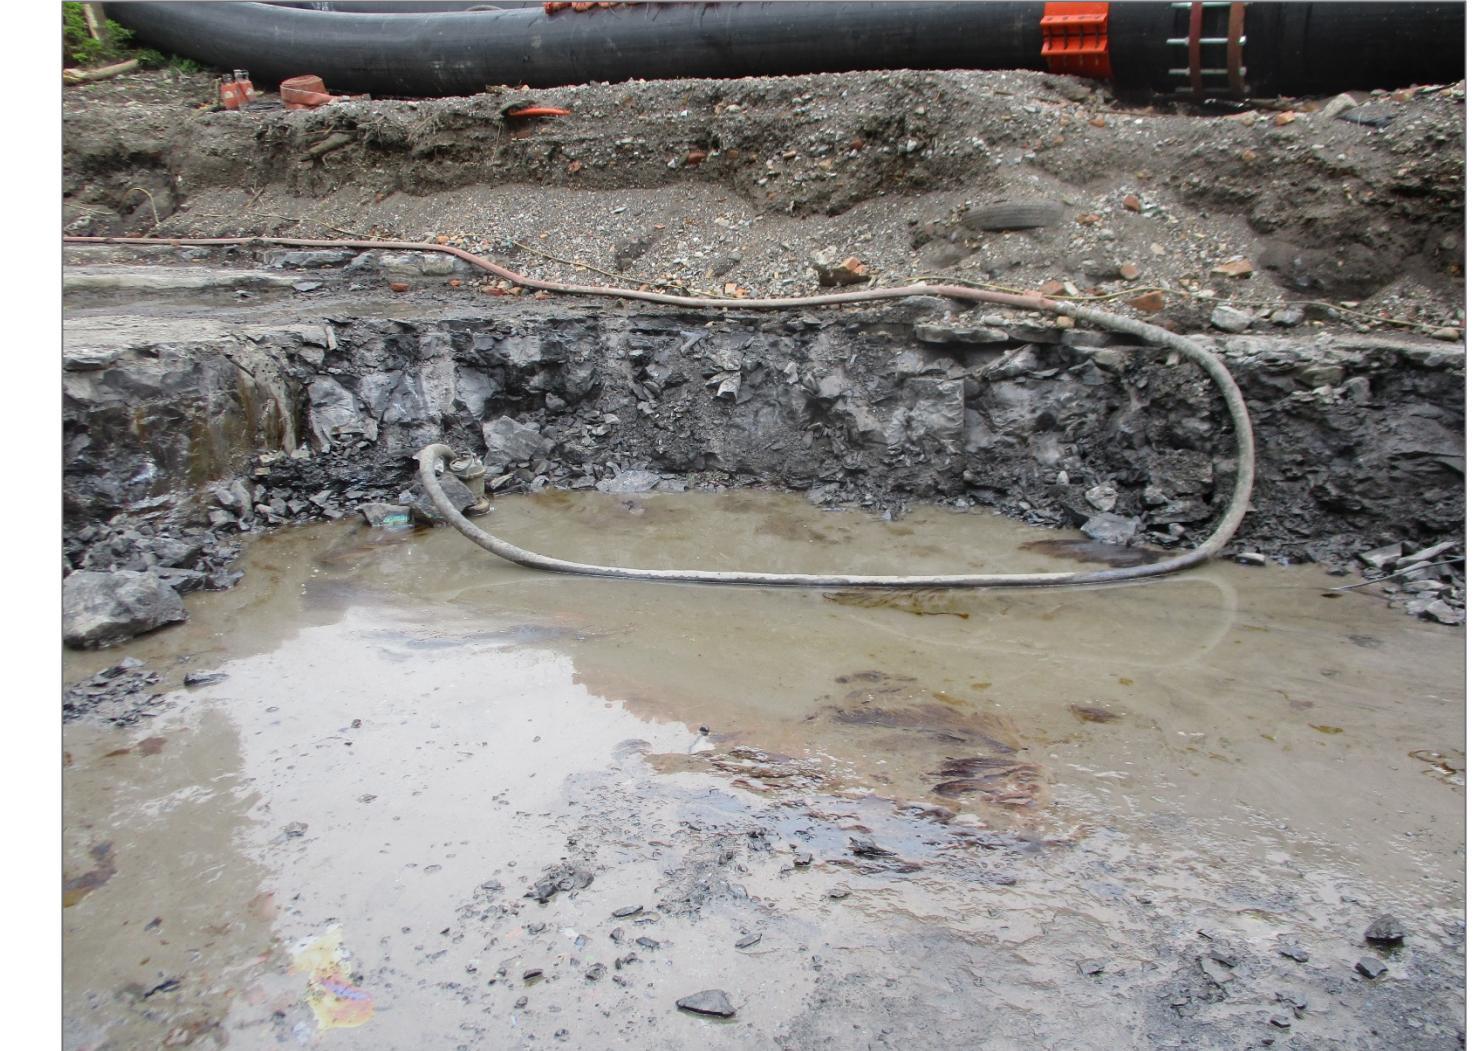
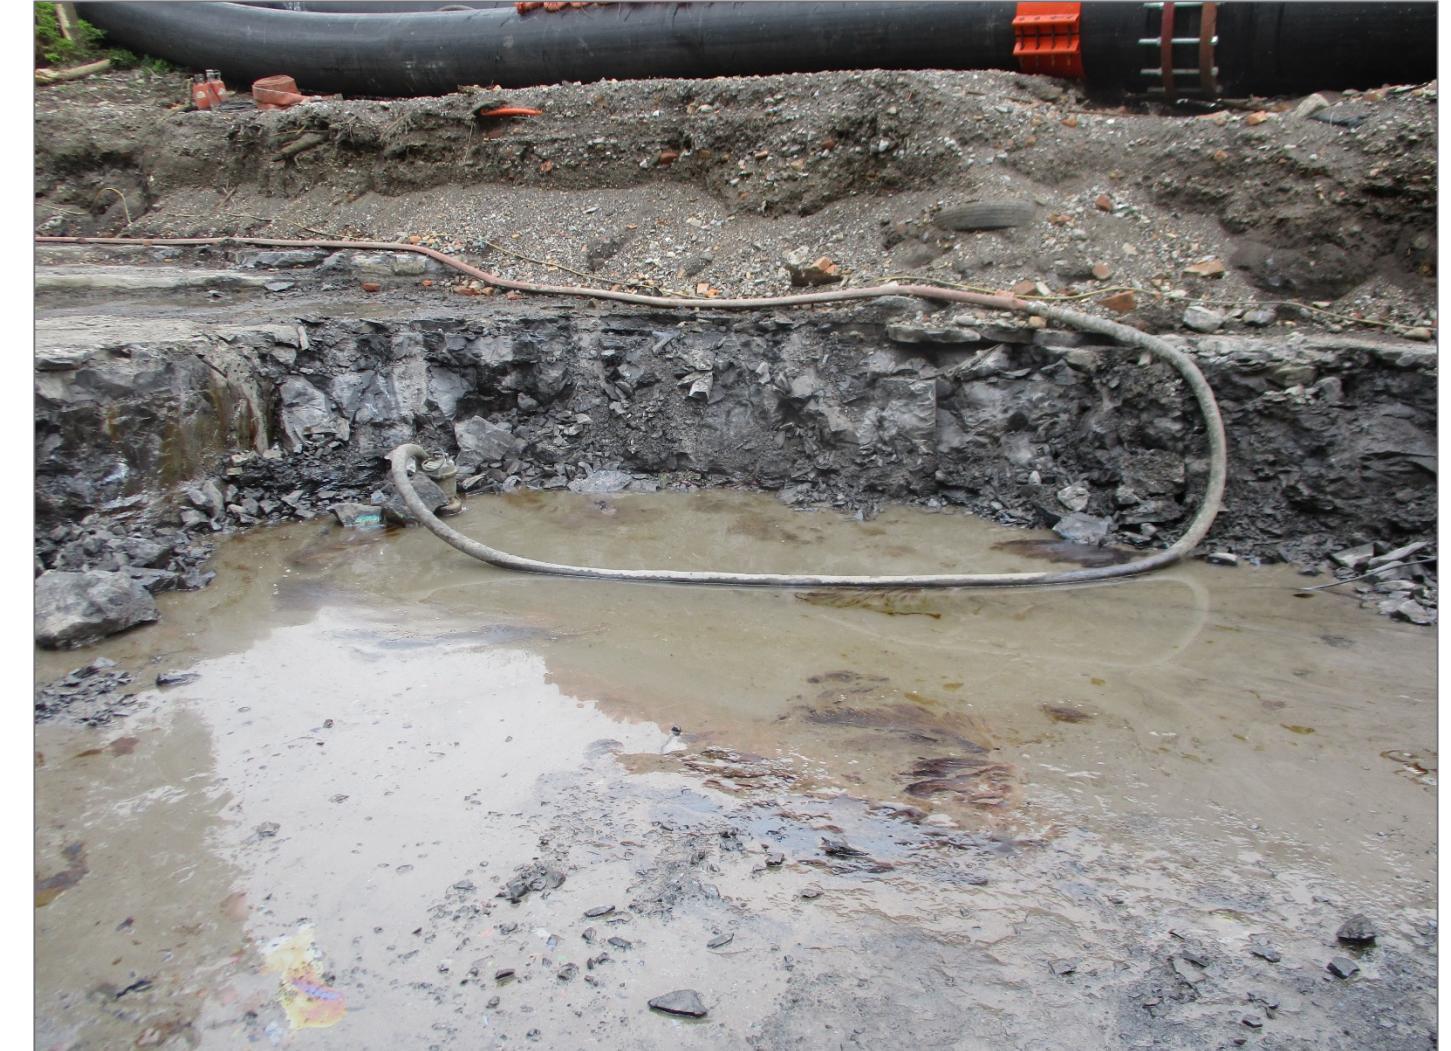
Coal tar NAPL discovered in fractured bedrock

Sediment removal exposed fractured bedrock with coal tar NAPL seeping from numerous fractures.

• Unexpected change of conditions requiring excavation modification

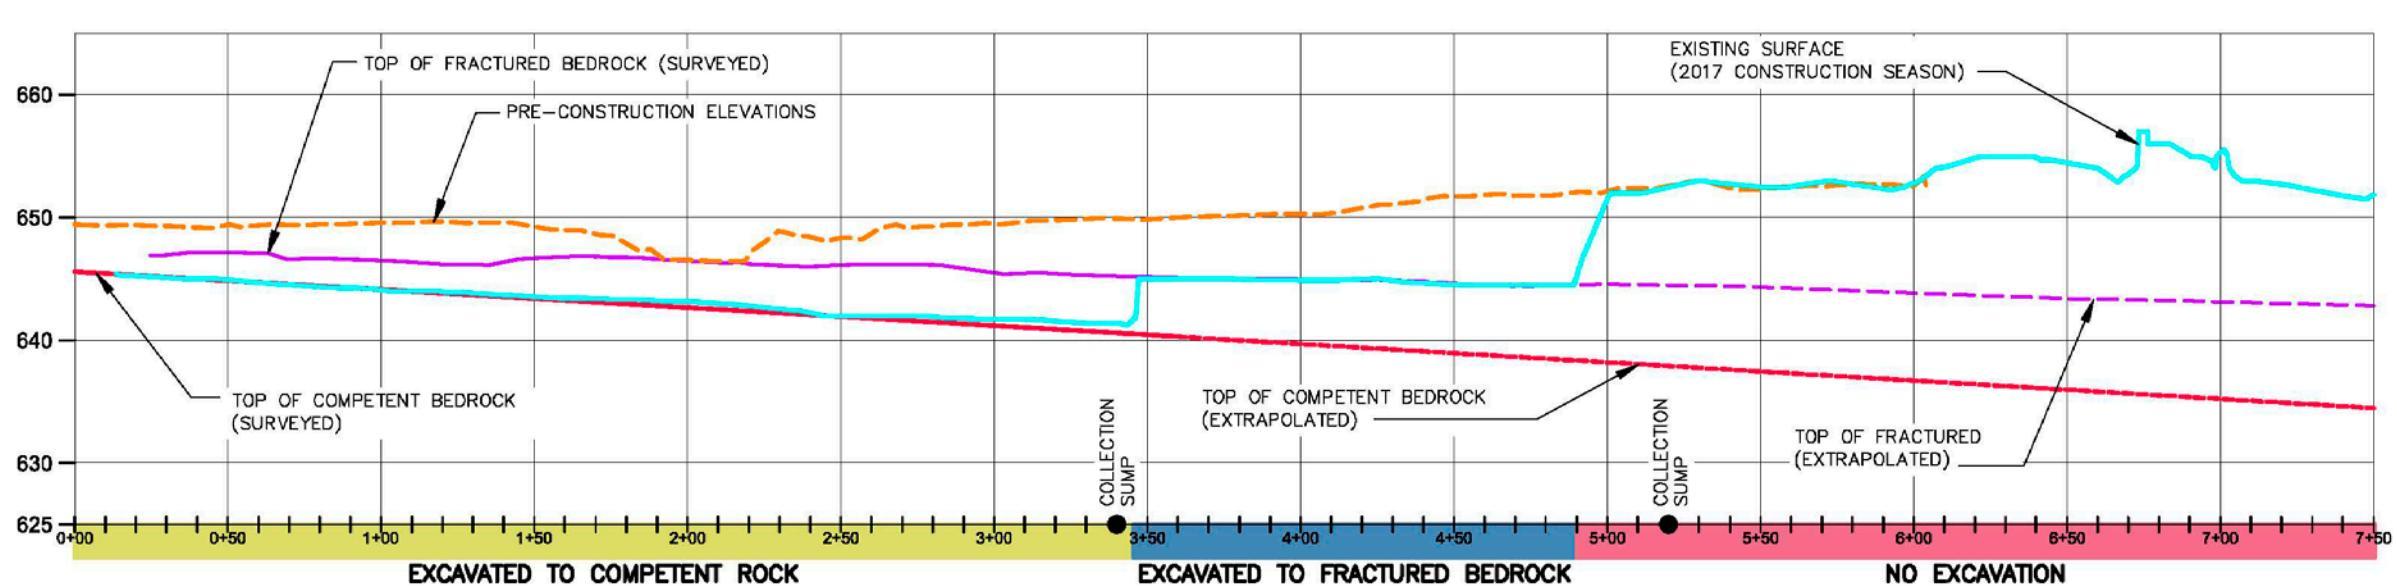
Competent bedrock slope

Fractured bedrock overlies competent bedrock with few fractures. • Natural barrier for coal tar NAPL flow

EXCAVATED TO COMPETENT ROCK

• Excavation terminated on top of competent bedrock layer
