## In Situ Sustainable CrVI Soil Remediation Implemented in Barranquilla, Colombia

2019 Bioremediation Symposium  
Baltimore, Maryland

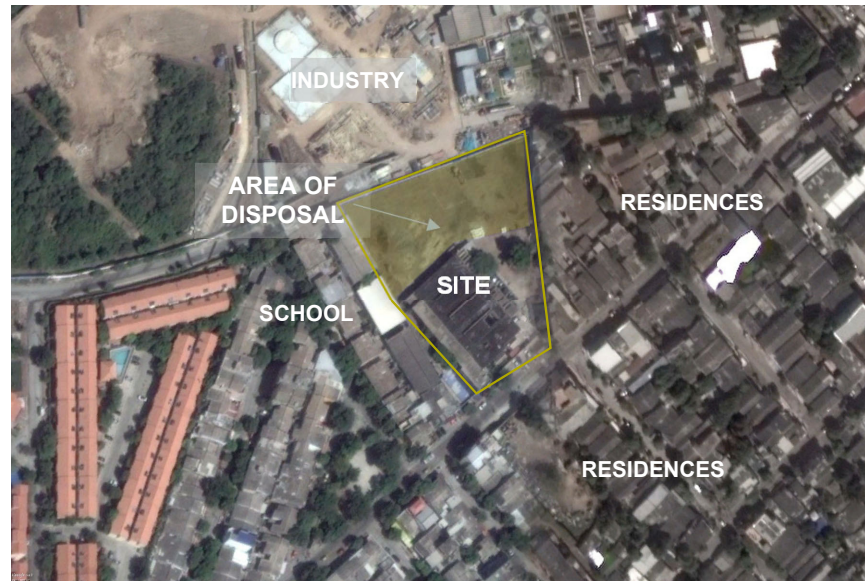
- Former plant located in mixed use area (industrial and residential) in the city of Barranquilla, Colombia.
- Operated as a bronze smelting plant with pipe and valve chrome and nickel plating.
- Plant operated from the 1960's to the early 2000's.
- Back lot was used as slag and residue disposal area.

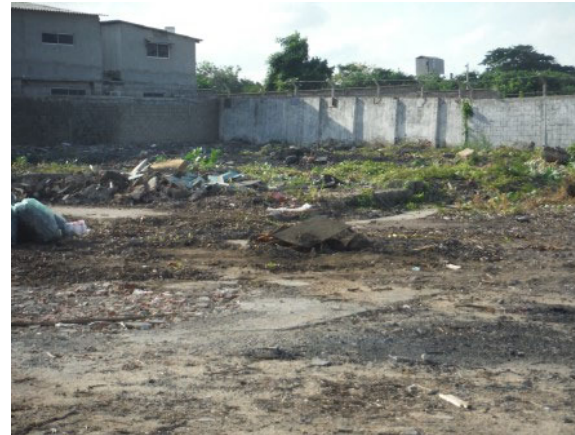
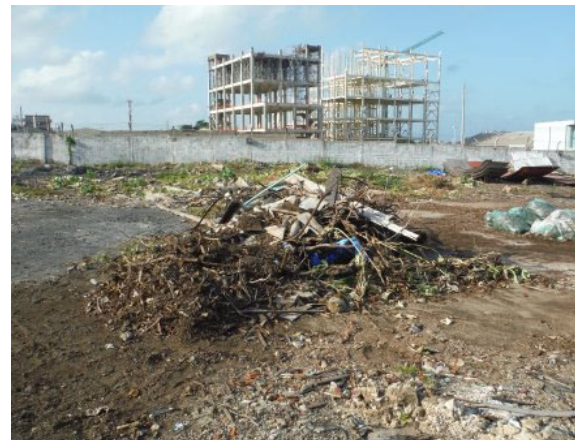
- Client completed a due diligence assessment in 2006. Assessment identified various heavy metal impacts in the soils of the former disposal area.
- Further investigations completed in 2013, including a Human Health Risk Assessment, identified Cr VI and lead as the main compounds of concern.

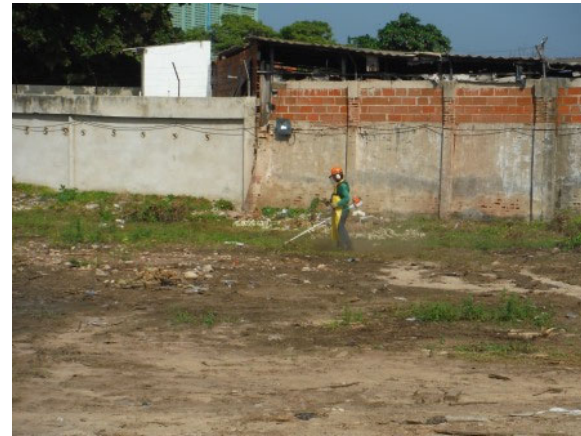
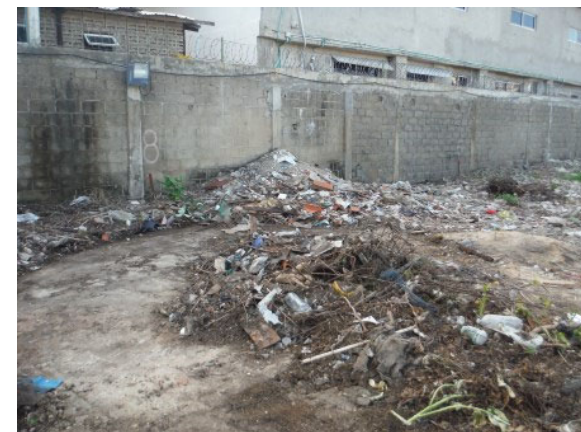
- Cr VI concentration in soil detected up to 229 mg/kg. Reference limit for direct contact: 97 mg/kg
- lead concentration in soil detected up to 9220 mg/kg. Reference limit for direct contact: 750 mg/kg
- Heavy metal impacts delineated to an area of 3,885 m<sup>2</sup> (96 acres) and to a depth of ~1.0m below the ground surface.

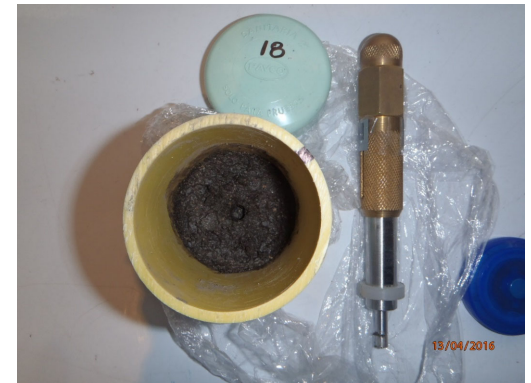
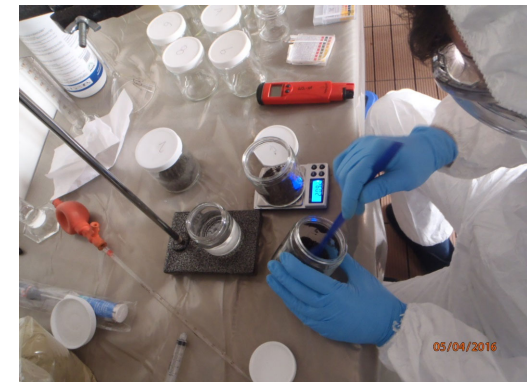
- Soil from the boreholes with the highest concentration of Cr VI and Pb was collected and was mixed with reagents in different proportions. Soil was collected from two boreholes. Reagents included Portland cement, fly ash, bentonite and calcium polysulfide solution (CPS) to reduce Cr VI to Cr III. 19 mixing aliquots were prepared, including one aliquot as control.
- After the preparation, aliquots were evaluated after one, seven, 15, 21 and 28 days for hardness and structural integrity using a portable penetrometer. All samples were submitted for laboratory analysis after 28 days. Cr VI and Pb concentrations were analyzed in SPLP test.

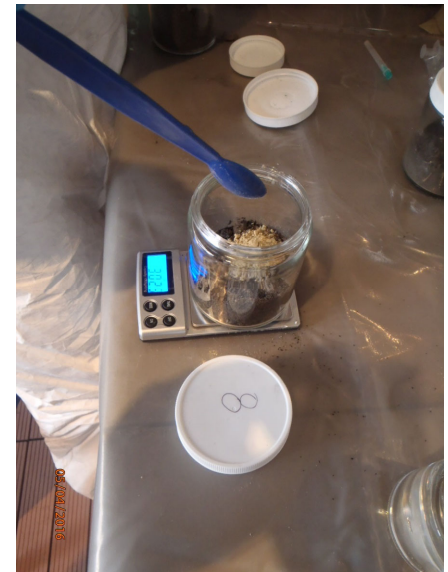
- Based on the results, a mixing of soil with 3% of cement with CPS at a rate of five times the stoichiometry was the recommended treatment approach.
- Given the variability of Pb and Cr VI concentrations and distribution at the Site, a confirmation test was conducted. The test included blending soil from each boreholes (equal parts), 3% of cement and five-times the stoichiometry of reductant. Mix was conducted in triplicate.
- Only by mixing the soil, with no addition of reagents, the concentrations of hexavalent chromium decreased by one order of magnitude. Lead concentrations remain in the same order of magnitude.
- The use of 3% cement and calcium polysulfide at 5 times stoichiometry stabilized lead and chromium in the soil. The SPLP concentrations for hexavalent chromium and lead were below the Method Detection Limits (MDL).

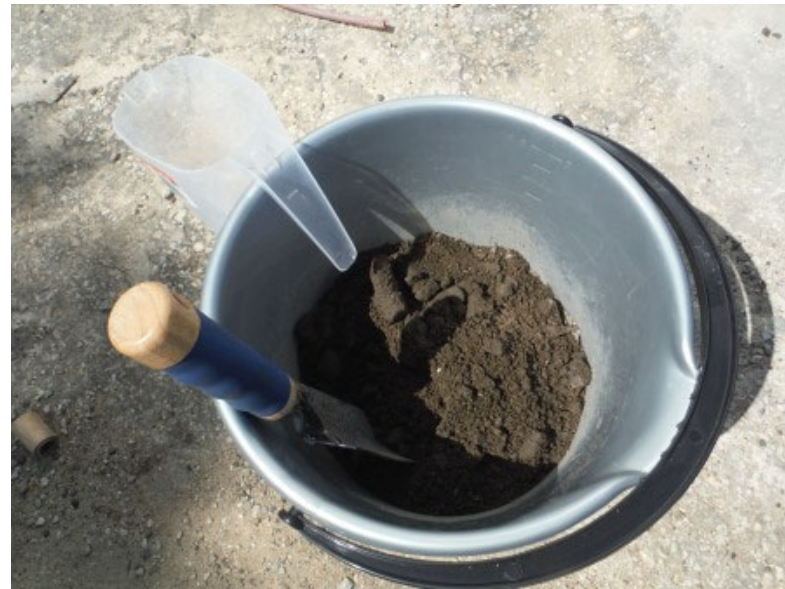
- Prior to implementing the full-scale mixing, a smaller scale “bucket test” was conducted to develop and optimize the mixing protocols and sequencing and was an adjustment from the original work plan.
- Protocol adjustment included mixing dry ingredients then adding wet solution followed by thorough mixing.

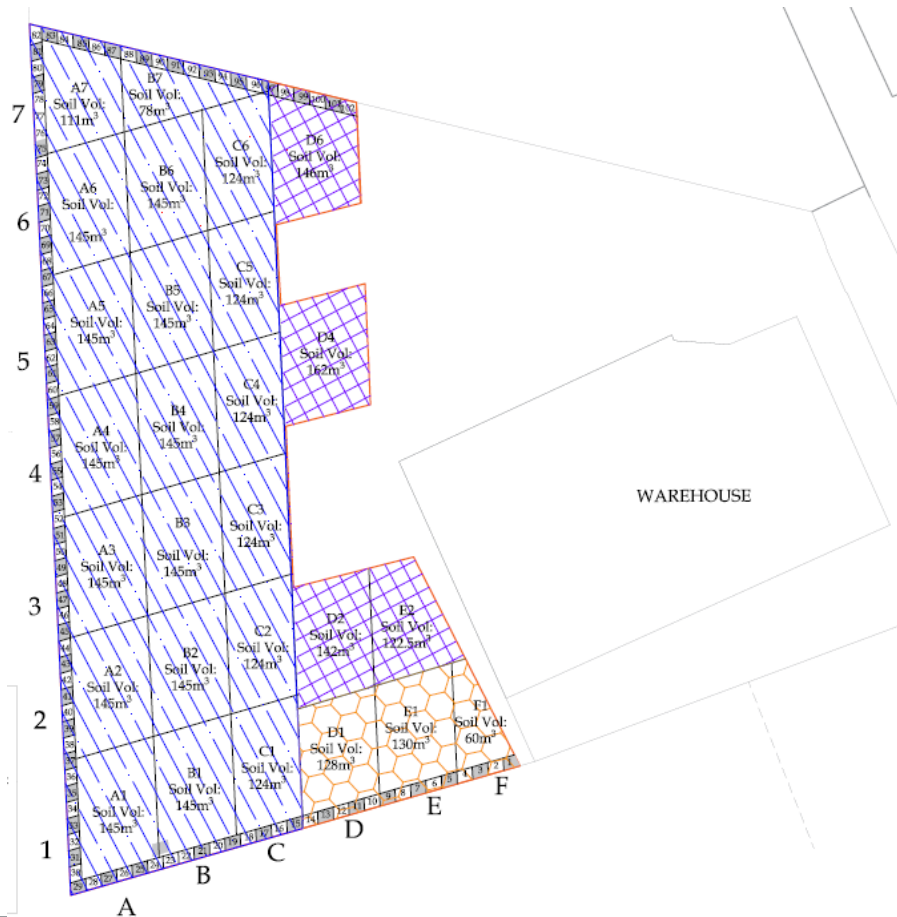
# Remediation approach

Area to be treated with cement down to a depth of 0.8 m
-

Area to be treated with cement and reductant down to a depth of 1.0 m
-

Area to be treated with cement down to a depth of 1.0 m

**Notes:**  
 Total area of treatment: 3884m<sup>2</sup>  
 Total volume of treatment: 3765 m<sup>3</sup>

- The remediation area was divided into three different treatment areas with a Cr VI load of 58 mg/kg, 62 mg/kg and 229 mg/kg. A different concentration of reductant agent (CPS) was applied to the soil, according to the Cr VI load, based on the conclusions of the treatability test.

- Remediation area was divided into perimeter and interior treatment cells, in order to protect the integrity of a perimeter wall. Soil from the perimeter cells were gathered into 24m<sup>3</sup> piles, in order to ease the mixing. Interior cells were subdivided into six 24 m<sup>3</sup>-subcells and mixed with no extraction of soil (*in situ* mixing).

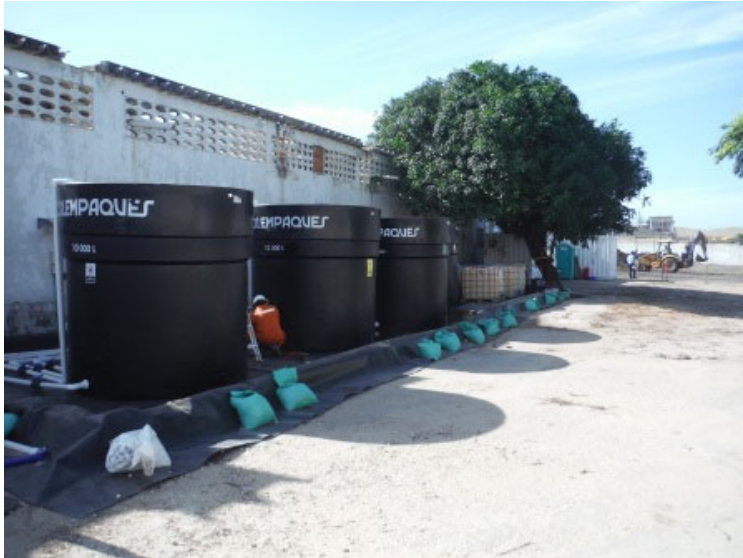
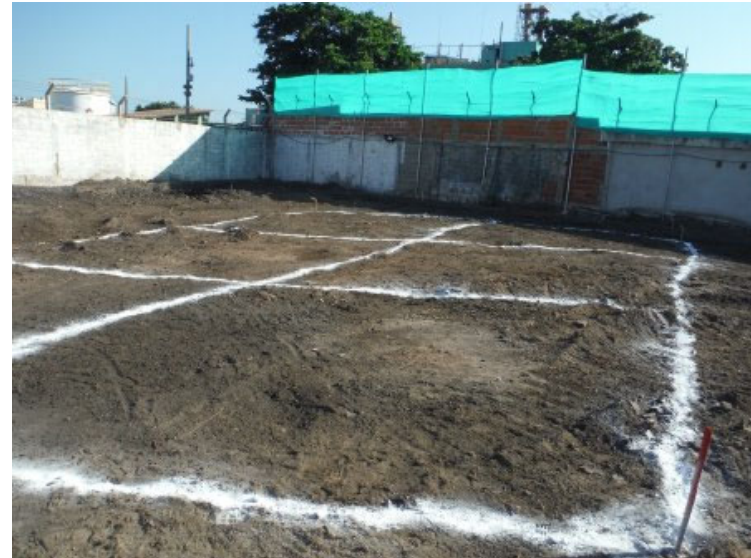
# Remediation Approach

- A mixing central station was built in order to complete the mixing of water and CPS.
- Mixing of soil and reagents was conducted mechanically using an excavator. Cement was first applied and mixed with soil, and the wet reagents were added and thoroughly mixed.

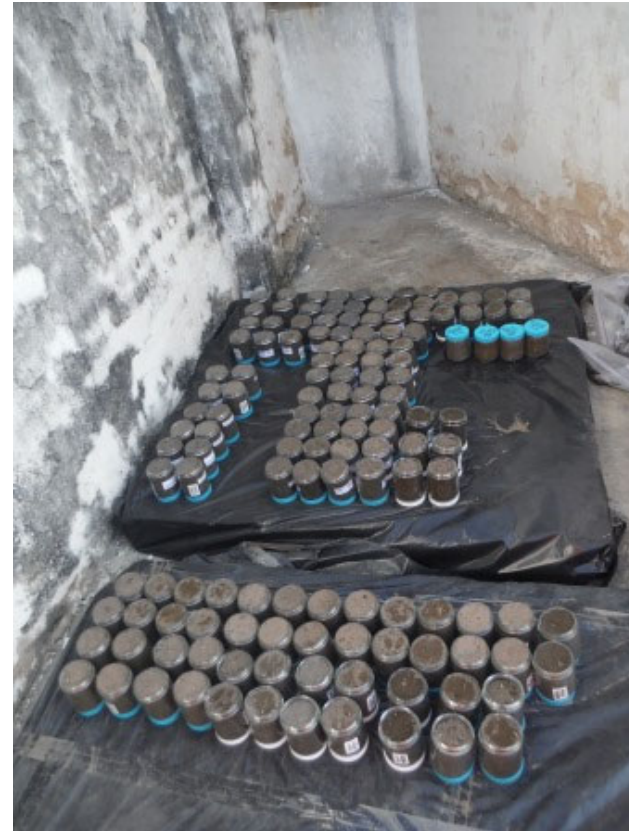
- Before the installation of the asphalt cap, 71 composite confirmatory samples, including 3 soil blank duplicates as quality assurance/quality control (QA/QC) were collected: 14 samples were collected from the perimeter cells and 54 samples were collected from the interior cells.
- Samples allowed to ‘set’ for 30 days prior to analysis to allow for chemical reduction process and stabilization.

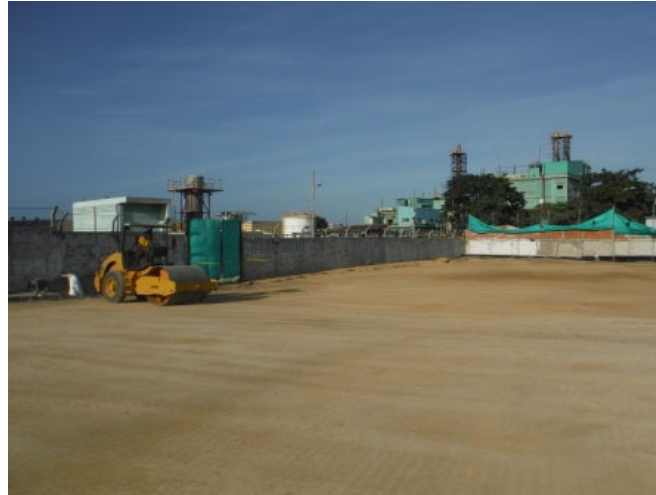
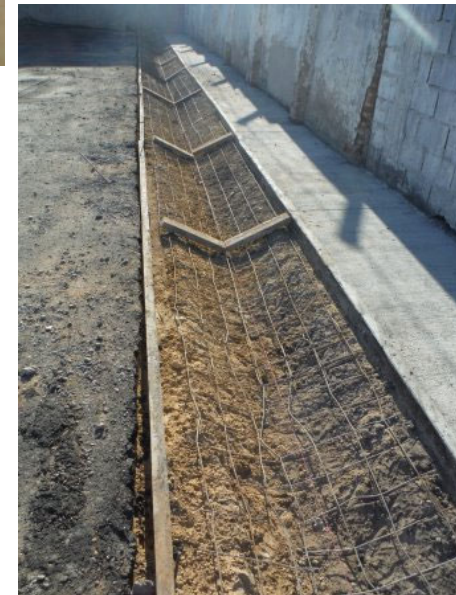
- A 30cm-thick cap with an extension of 4,806 m<sup>2</sup> was installed in order to eliminate the potential direct contact and inhalation exposure to treated soil;
- 143 linear meters of perimeter drainage channels was constructed in order to direct meteoric stormwater flow away from Site.

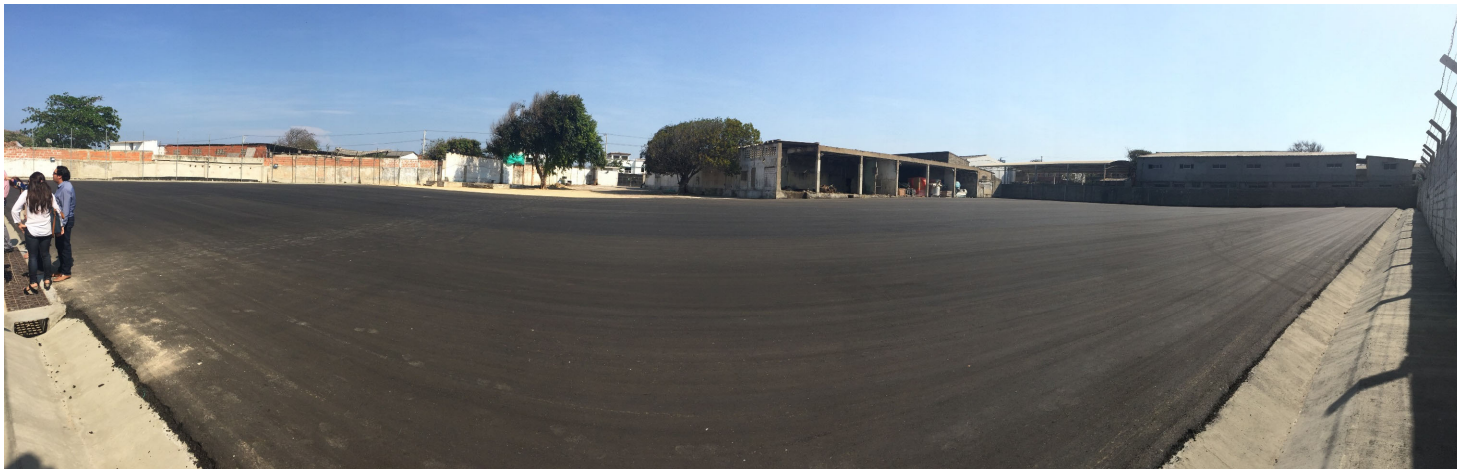
- Post-mixing soil data showed 96% reduction of CrVI
- The average pH of samples was 11.8 – Good indication of even distribution of cement
- No significant concentrations of Pb and ND for CrVI detected in the SPLP leachate analysis of the samples
- Meteoric water infiltration was mitigated via installation of the 30cm asphalt cap.
