Chlorinated Solvent Source Area Remediation: Combining Biotic and Abiotic

Enhanced Reduction Approaches

Outline

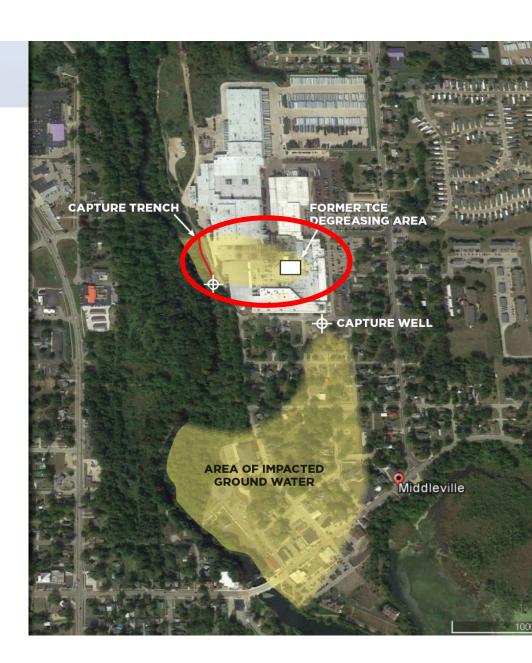
Existing Capture System

- 1999-Present
- Former TCE degreasing Area to be discussed in this presentation
- Concentrations downgradient of Capture system are low and meet site-specific GIS criteria

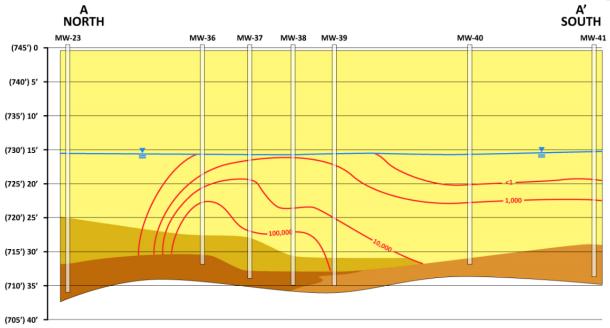
Hydrogeology

- Fine to medium sand: below the plant floor to approximately 28 feet bfl.
- Silty, fine to medium sand: thickness ranges from
 2-3 feet below the fine to medium sand.
- Dry, clay unit: under the silty, fine to medium sand.

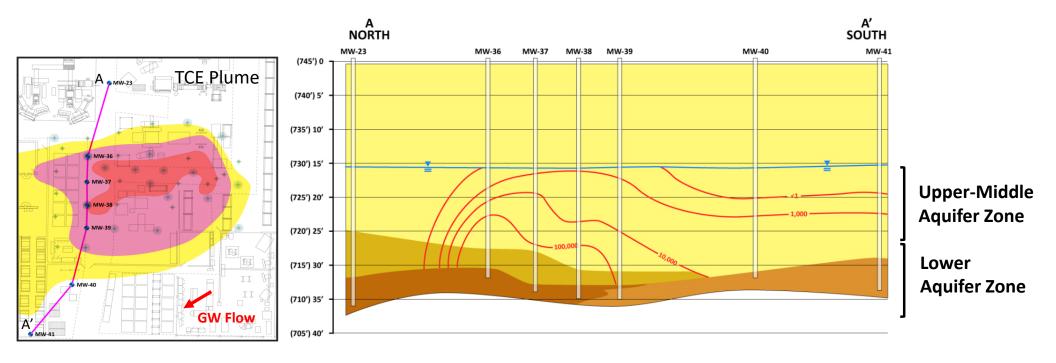
Hydrogeology

Groundwater flows to the Southwest and it is encountered at approximately 15 feet bfl

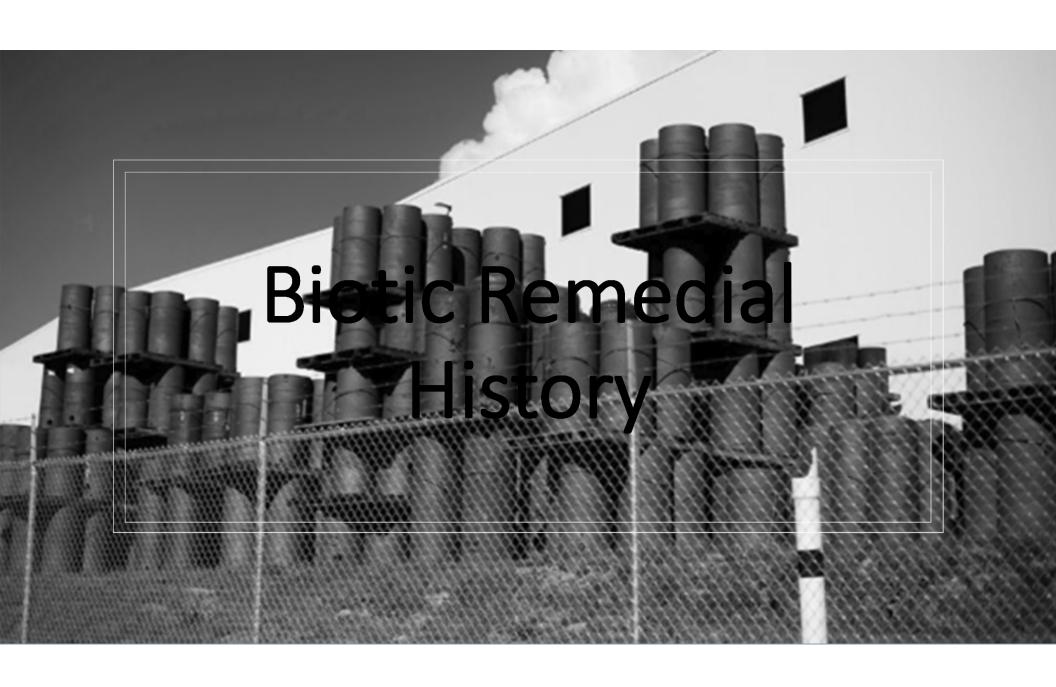
Most chlorinated volatile organic compound (CVOC) mass is in the lower aquifer zone

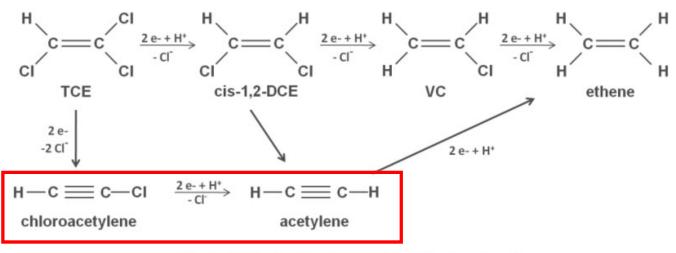
Biotic Pathway (Step-Wise Reductive Dechlorination)

Main Abiotic Pathway (β-Elimination)

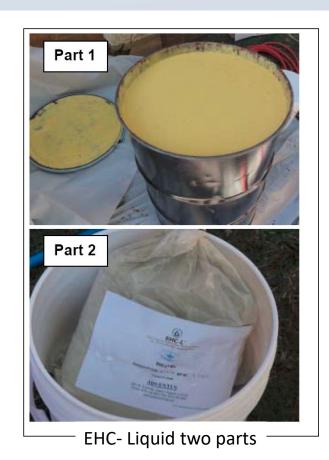
ELS 25% microemulsion

<u>Injection Mix:</u> lecithin, ferrous sulfate, and potable water solution, buffered with potassium bicarbonate

- **Lecithin**: organic carbon to support biodegradation and deepen the reducing environment
- **Ferrous sulfate**: form iron sulfide minerals to establish an abiotic reductive pathway

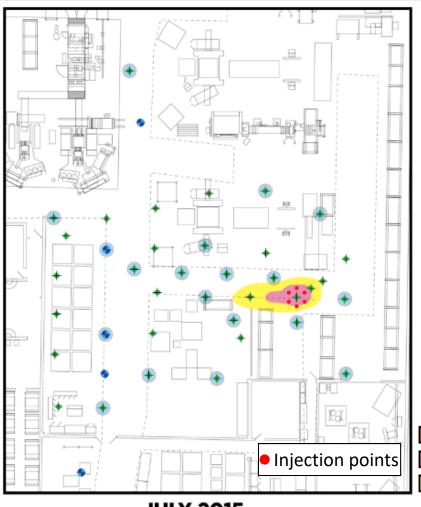
Abiotic Injection

- 226 gallons of the injection mixture was used
- 6 direct-push locations surrounding TW-17 (Hot Spot)

200,000 ug/L 50,000 ug/L 5,000 ug/L

JULY 2015

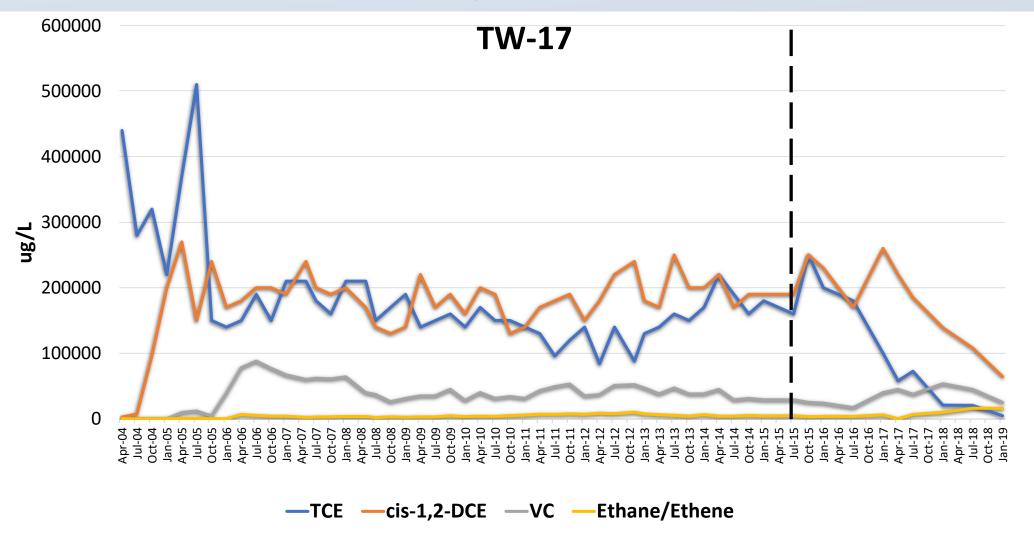
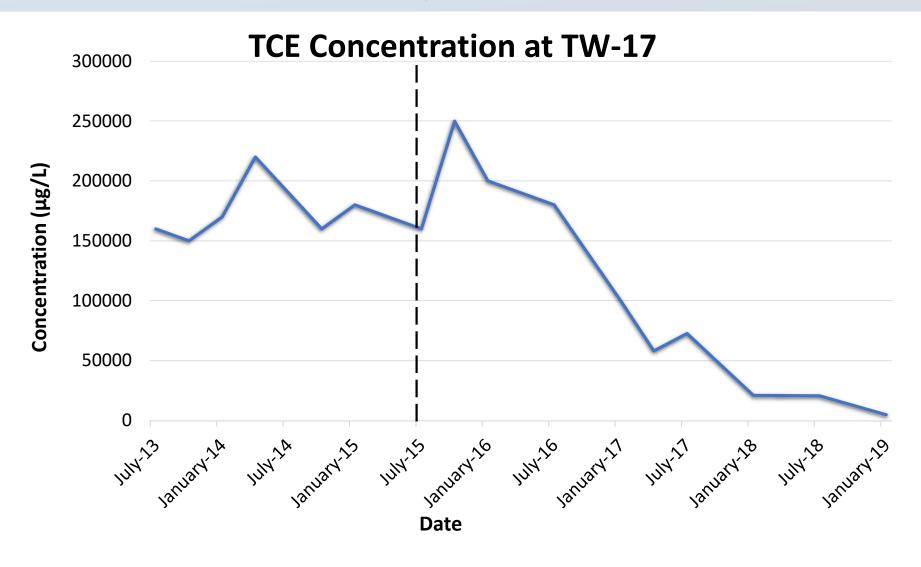
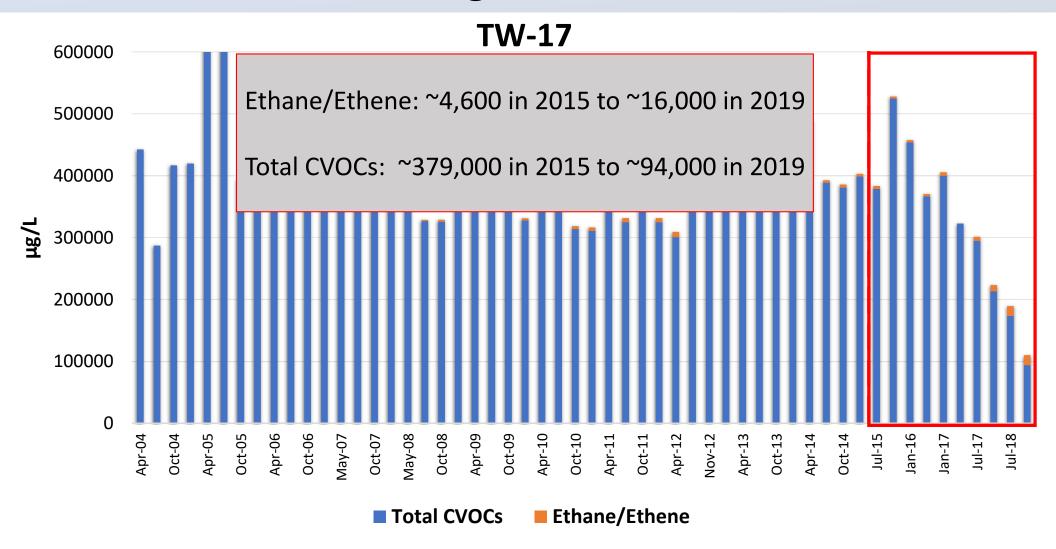
TW-17

ERD conditions over the years of the treatment

Collection	TOC	Alkalinity, Total	Chloride	N, Nitrate	Phosphorus, T.	Sulfate	Ferrous Iron	Diss. Oxygen	Eh	рН	Temperature
Date	(mg/L)	(mg/L)	(mg/L)	(mg/L)	(mg/L)	(mg/L)	(mg/L)	(mg/L)	(mV)	(s.u.)	(°C)
08/18/15								1.3	110	6.4	20.4
10/29/15	110					440		0.1	91	6.4	17.7
01/19/16	56					85		0.2	84	6.4	17.4
07/18/16	27	440	270	0.05 U	0.05 U	27		0.2	63	6.5	17.8
01/03/17	49					6.0		0.2	36	6.2	17.2
04/26/17	43						3.0	0.2	-98	6.2	17.8
07/18/17	27.4	370	263	0.05 U		16.1		0.2	140	6.4	17.3
01/23/18	42.7					10.5		0.2	170	6.3	17.0
04/18/18	73.8							0.3	140	6.2	16.7
07/18/18	84.5	344	303	0.05 U		11.5		0.1	100	6.5	17.0
10/18/18	49.2							0.3	110	6.3	16.0
01/28/19	47.6					12.1		0.2	120	6.3	17.6

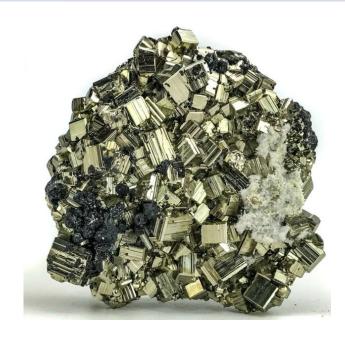
Biotic Pathway (Step-Wise Reductive Dechlorination)

Main Abiotic Pathway (β-Elimination)

- Acetylene was first measured and detected in 2017, but concentrations were low thereafter very labile or too late?
- Magnetic Susceptibility and X-Ray Diffraction analyses in 2018: Iron sulfides and oxides (Magnetite, Mackinawite, Pyrite and Green Rust) were not detected/different than background – looking in the wrong place?

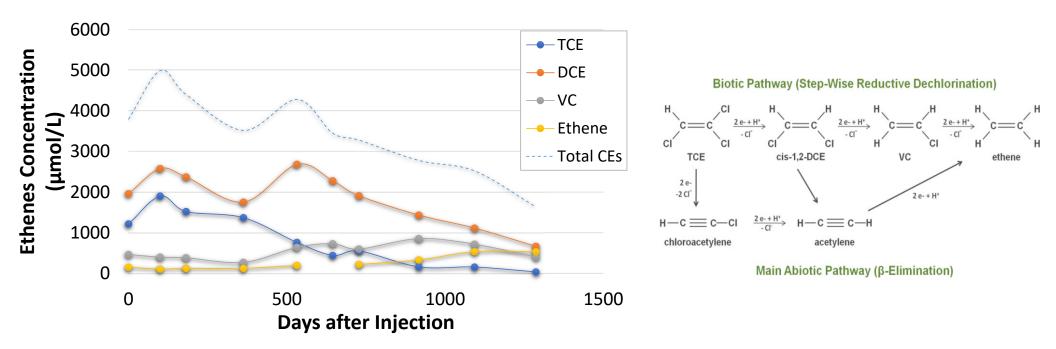
Proof of Abiotic Pathway?

- TCE → cDCE : primarily biological;
- cDCE → VC : Some VC is produced but not the stoichiometric equivalent of DCE reduced. Some other
 process (assumed to be abiotic degradation*) is occurring.

*dilution and dispersion or rapid degradation of the VC

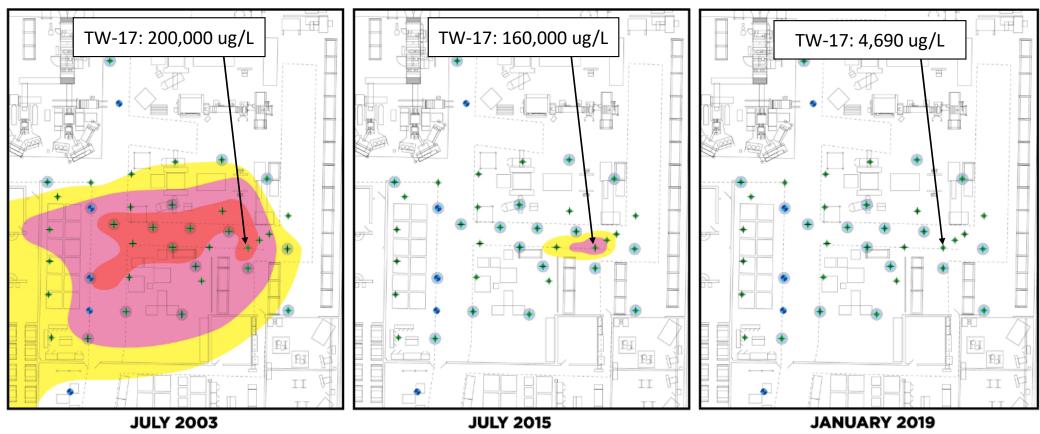
PRESS ROOM - TCE

SOURCE AREA REMEDIATION

- Abiotic injections from July 2015 addressed the stagnant high concentration of TCE at the Source Area.
- Detection of acetylene in 2017 and current detections of cDCE and VC, indicate that both abiotic and biotic reductive pathways were/are relevant for TCE degradation in the Hot Spot Source Area.
- Reduction of TCE in the Hot Spot Source Area (160,000 to 4,500 μg/L)
 has occurred since 2015 with no significant alteration of pH.
