# Enhanced In-Situ Bioremediation and Solar-Irrigated Phytoremediation to Treat a High Salinity PCE Plume

Jim Leu, Dan Griffiths, Linda McGlochlin, Michael Schulman, and Kevin Garon

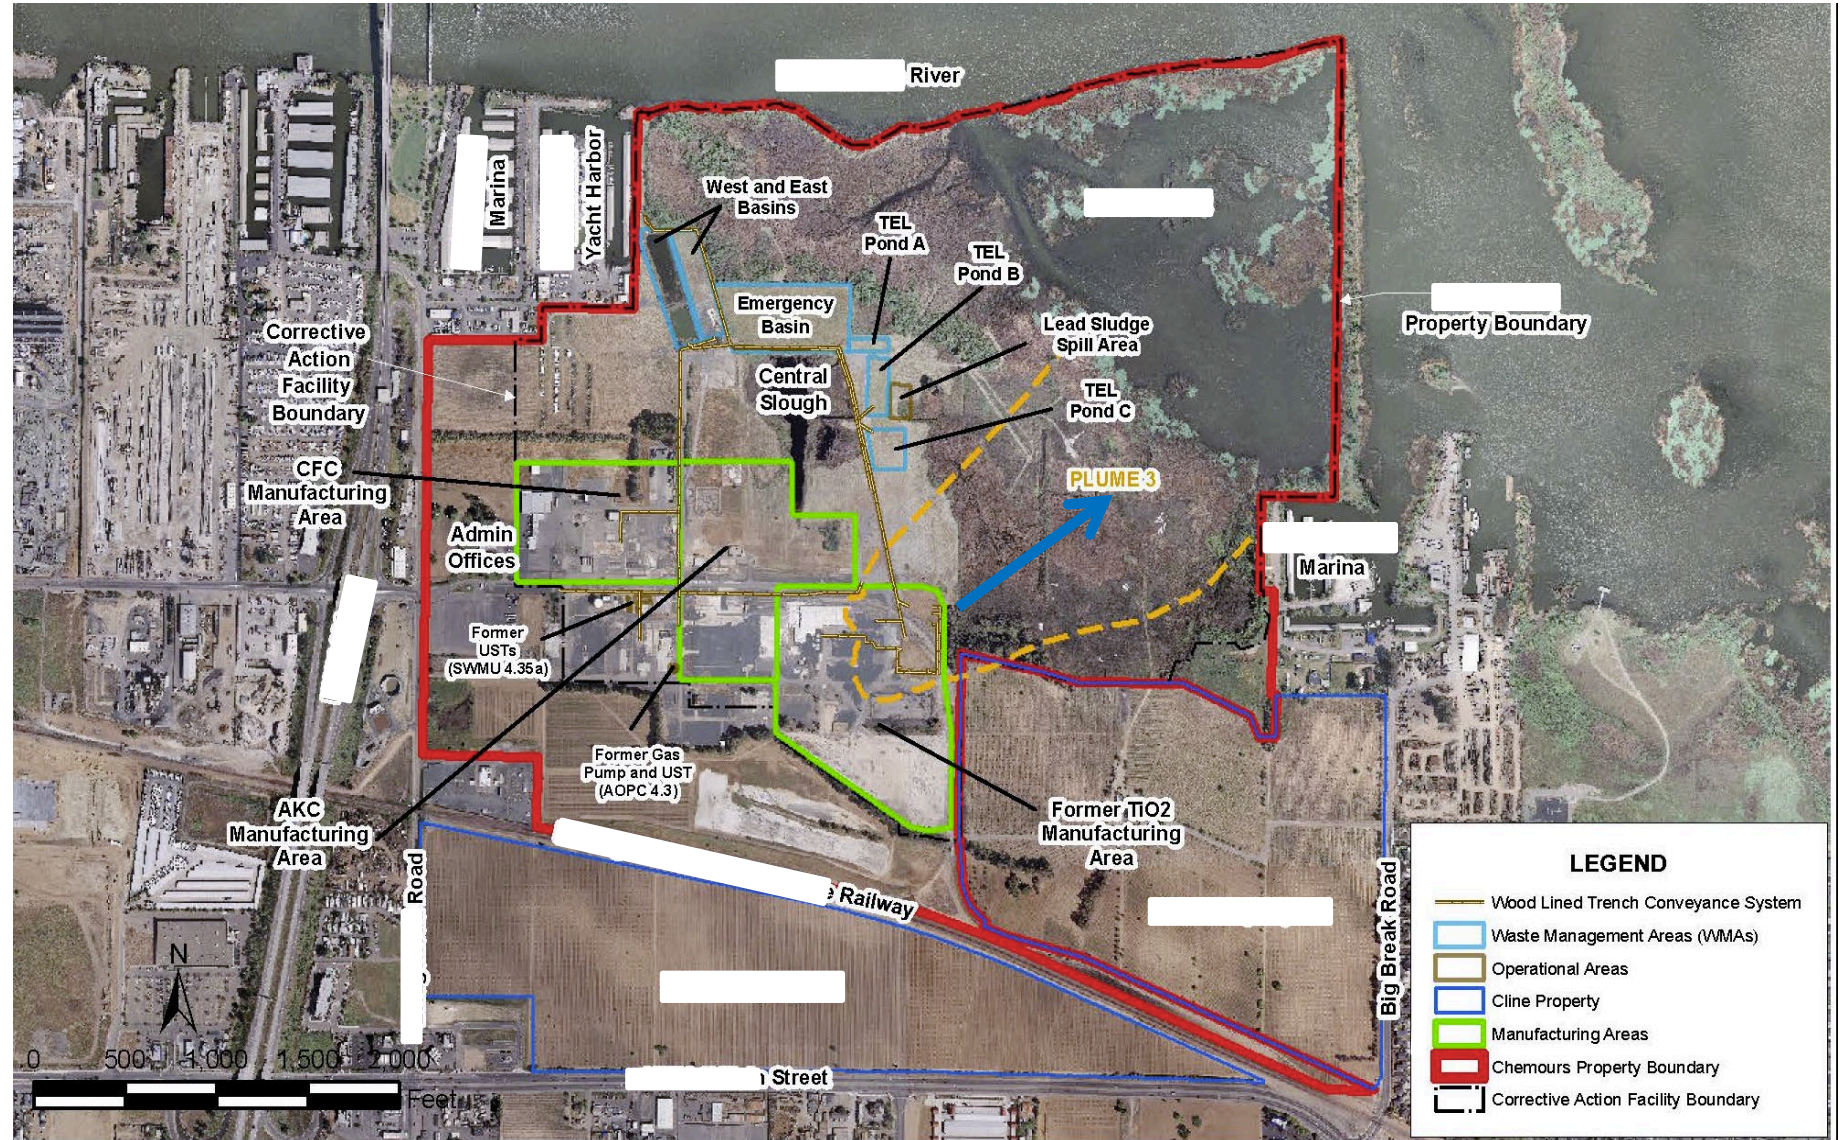
# Site Map

- Shallow Water Table
  - 8 - 12 ft bgs
- High TDS
  - 1,000 - 2,000 mg/L
  - Salty
- Tidal Effect
- Main COCs
  - CFCs
  - $\text{CCl}_4$
  - Organo-lead
  - 1,2-DCA
  - PCE

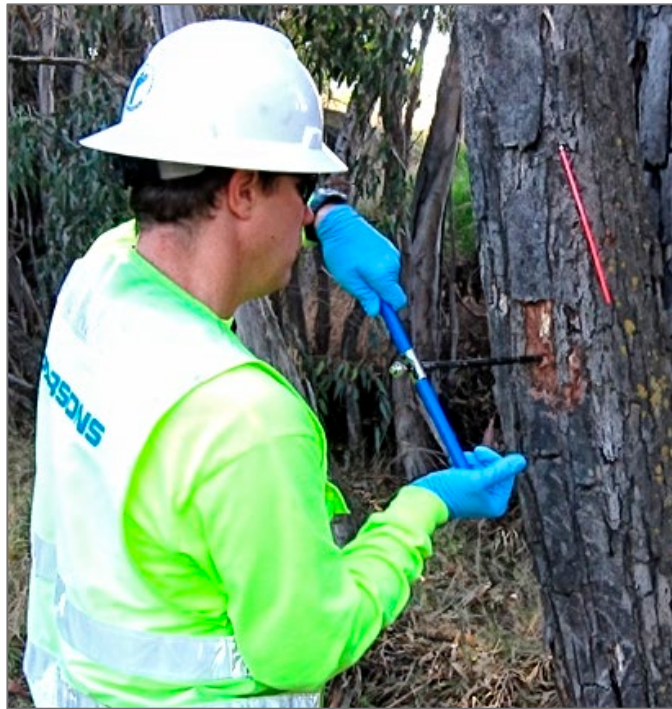
- Collected 36 eucalyptus and willow tree tissue samples
- Data indicated PCE uptake occurs in eucalyptus trees, but willow uptake may require further study

*Tree core sample collection*

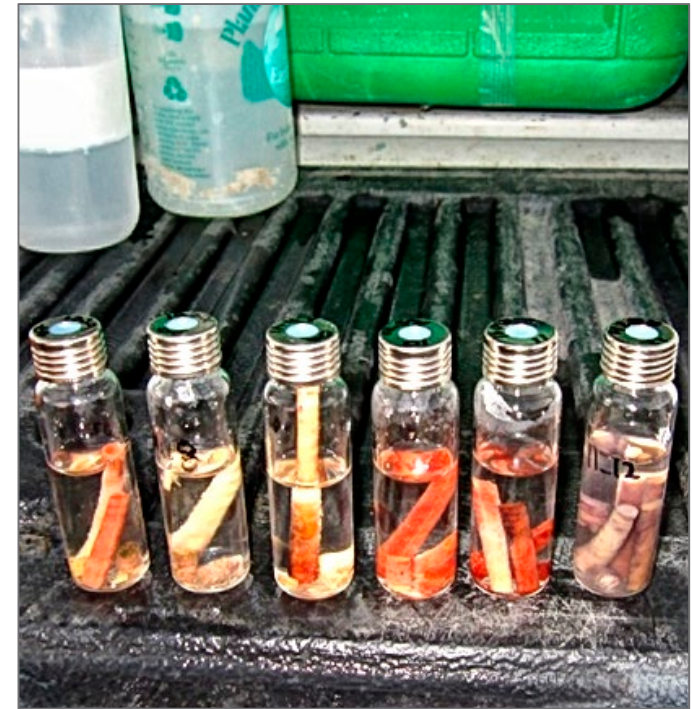
*Wood analyzed for VOCs*

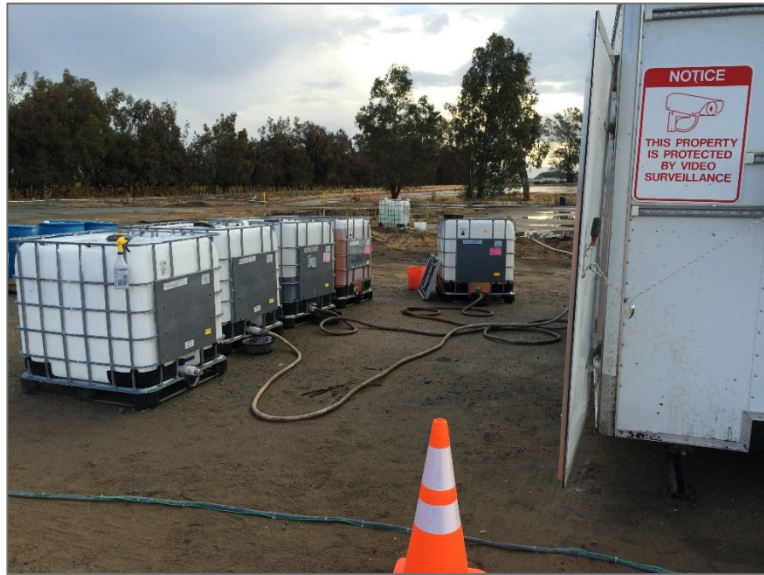
*Totes of Substrate*

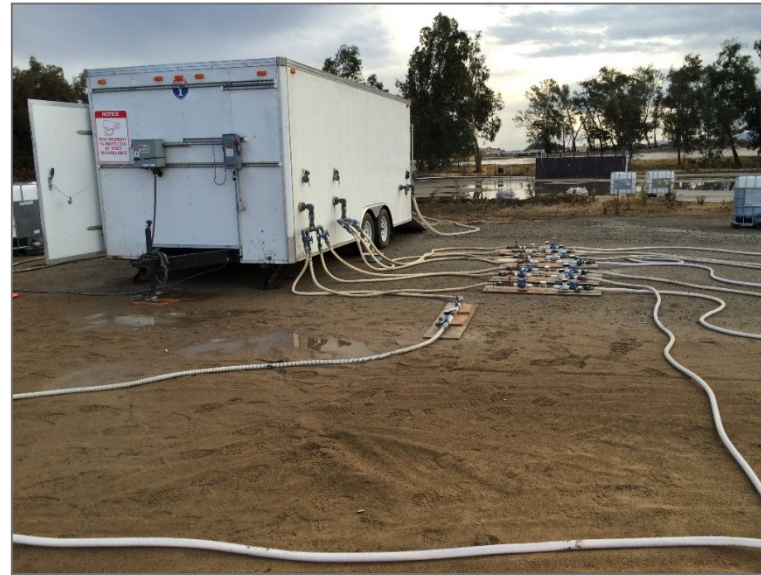
*Injection Trailer and Manifold*

- Slower than expected injection rates resulted in minor substrate spoilage and lower injection efficiency
  - Shallow groundwater level
  - Less permeable
- Expand manifold to maintain minimal (~4 gpm) injection rate required for injection pump to maintain prime.
- High pressure direct injection

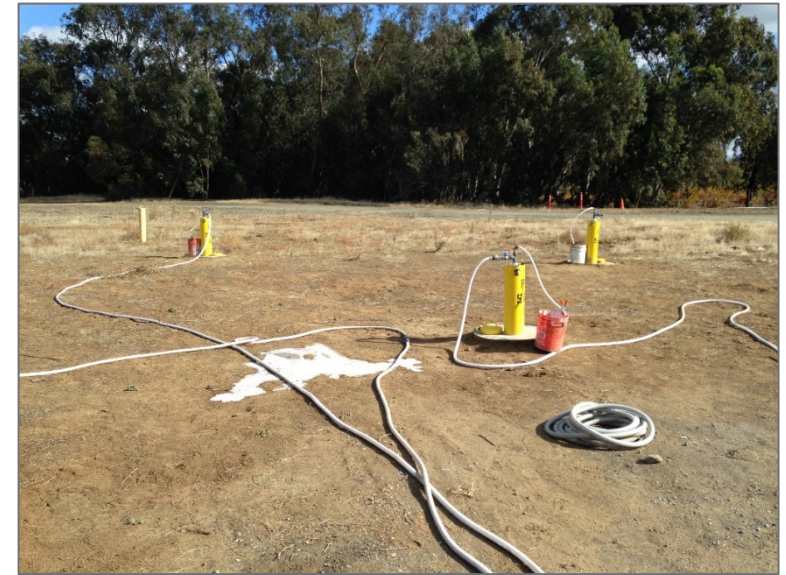
*Well Injection*

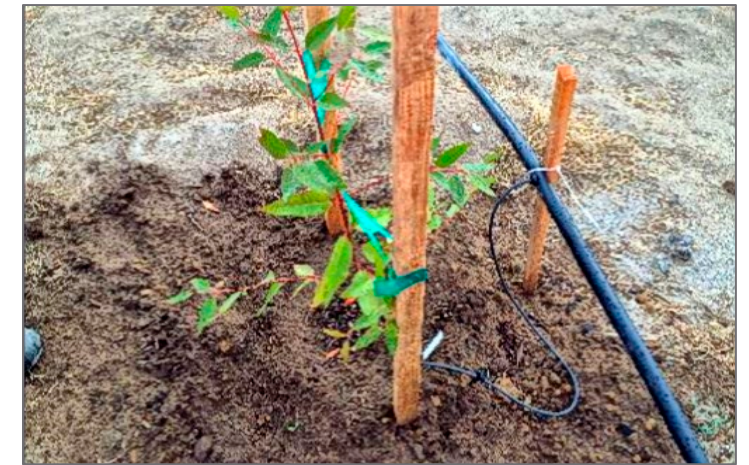
Planting Spec

- Grid – 15ft x 15ft
- Depth – 10 ft Upland  
3 ft for Wetland
- Diameter – 1.5 ft
- Import Soil with 10% Municipal Compost

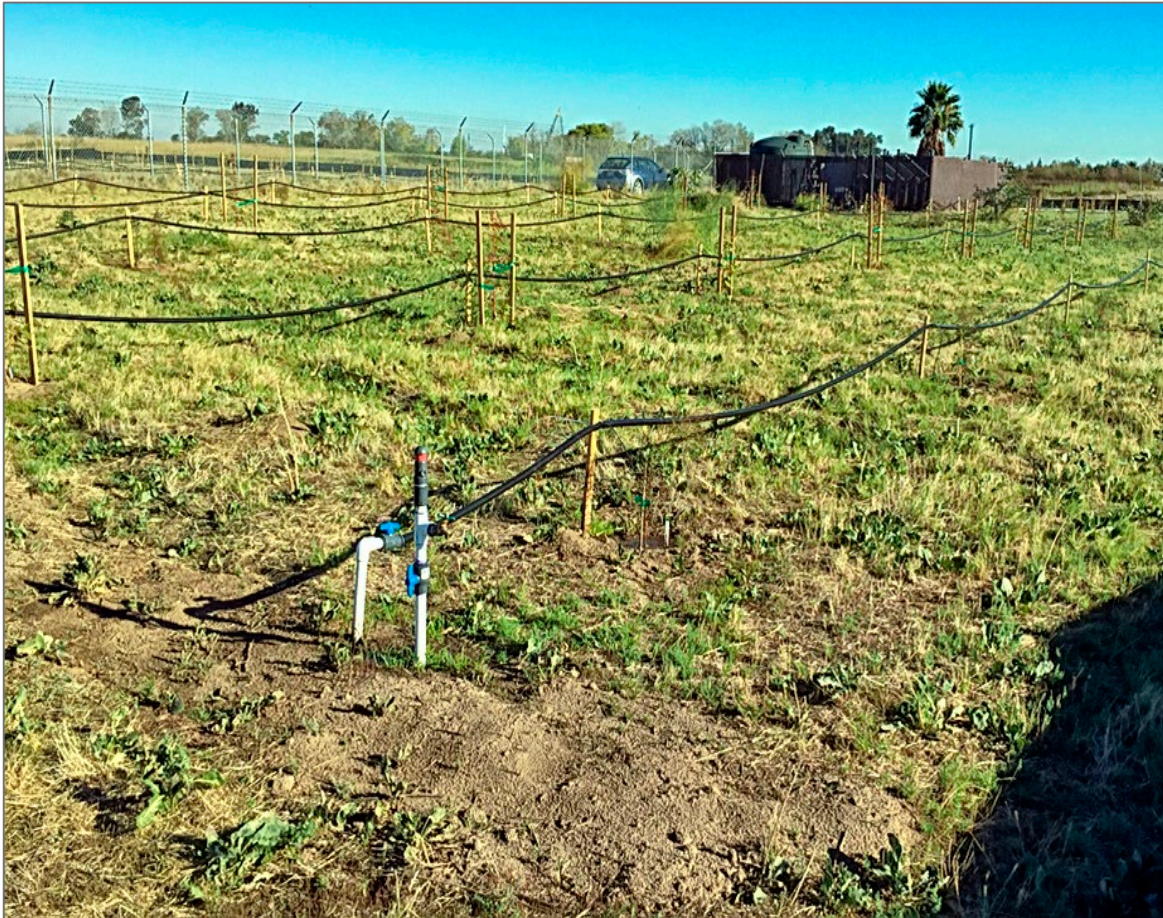
*Wetland Irrigation Station and Drip Emitters*

- Upland Irrigation Station
  - 1,100 gal storage tank – MW-32 groundwater
  - Power submersible pump in MW-32 and transfer pump to irrigation network
- Wetland Irrigation Station
  - 2,600 gal storage tank – import water due to salty GW
  - Power transfer pump to irrigation network

- Hand watering required weekly before full-scale implementation
- More effort involved in weeding and mowing than anticipated
- Salinity of one onsite well was high - elected to truck in water
- Salt tolerant eucalyptus trees – E. Robusta and E. Occidentalis
- Solar panel attracts vandalism
- Irrigation stops after two years of operation
- High tree survival rate

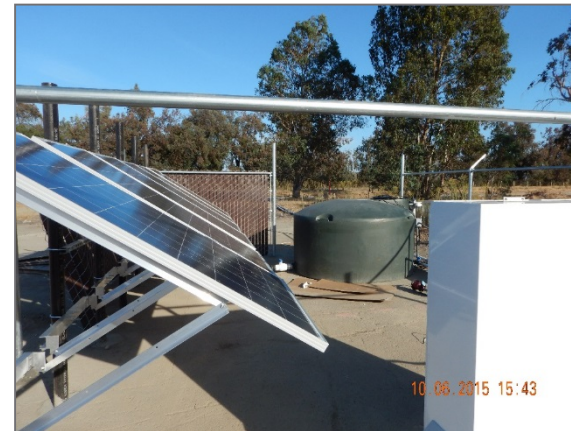
*Upland Irrigation Station Setup*
