THREE DECADES OF REMEDIATION AT THE CDOT MTL:

A MODEL FOR ADAPTIVE MANAGEMENT

May 2019

Craig E. Divine, Kim L. Heinze, Jesse L. Manley, Treck Hohman, Kelli Preston (Arcadis) Scott D. Andrews (EMS) Theresa Santangelo-Dreiling (Colorado Department of Transportation)

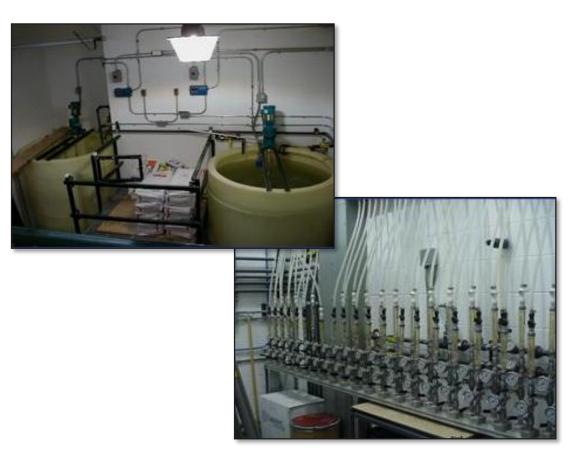
Aerobic Biodegradation (AB) System (2001-2008)

- 2001: Start-up
- Large-scale injection system
 - 82 hydrofractured injection wells, 3 treatment buildings
 - Dissolved methane and oxygen
 - Tracers (Br, SF₆)
- System operation
 - Continuous injections initially
 - Switched to pulsed injections
 - 0.1 to 0.5 gpm per well

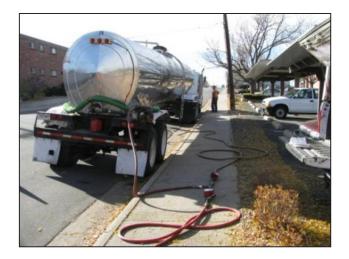
Off-site Anaerobic ERD Pilot Testing (2005-2008)

- 1. Is large-scale system redox conversion possible within a reasonable timeframe?
- 2. Can remedial timeframes be achieved under and anaerobic ERD approach?
- 3. Are full-scale lifecycle costs less?
- Only 3-4 month "lag time" to convert to anaerobic conditions compared to other nearby sites in same geologic unit
- > Full dechlorination achieved at all wells, apparent half-lives ~80% shorter
- Estimated lifecycle cost savings \$3-5M

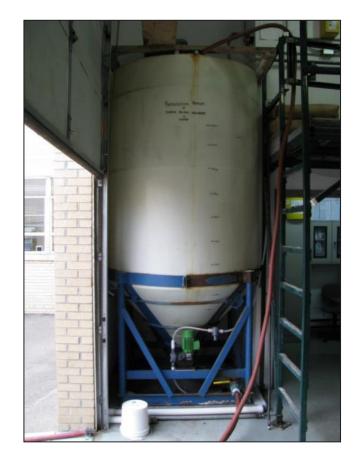
Full-Scale Off-Site ERD System (2008-2013)

- Full-scale conversion utilizing existing infrastructure
- Upgrades to automate injections at 78 wells
- Injection volumes: 1,000 to 4,000 gal/well 2-4 times/year
- Dosage ranges between 1 and 3% molasses
- 80% less annual injection volume

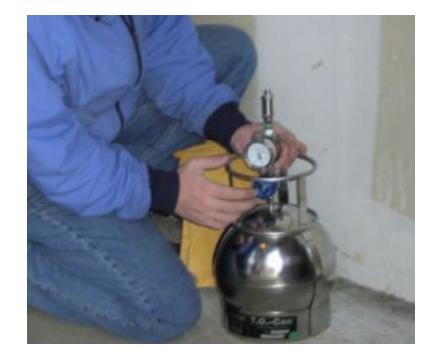
Residential Indoor Air Program

- 1995: Vapor Intrusion concerns (1,1-DCE and TCE)
- 1997: Interim action plan implemented
 - Temporary relocation of 12 residents
 - Indoor Air Mitigation Systems in 14 apartment buildings, 12 townhomes, and 21 single-family homes
- Quarterly monitoring at up to 135 residences
- 2005-2007: Initial Round of System shutdowns
 - Confirmatory sampling conducted post-system shutdown
- 2012-2013: Final round of system shutdowns
 - All off-site locations well below IA goals
- 2014: No Further Action (NFA) for Off-site Indoor Air Program
