Battele International Symposium on Bioremediation and Sustainable Environmental Technologies April 15-18, 2019 | Baltimore, Maryland

# Drone-Based Vegetation Mapping Supporting Plant-Assisted Bioremediation at a Fuel Pipeline Spill in Sagebrush Steppe, South-Central Idaho

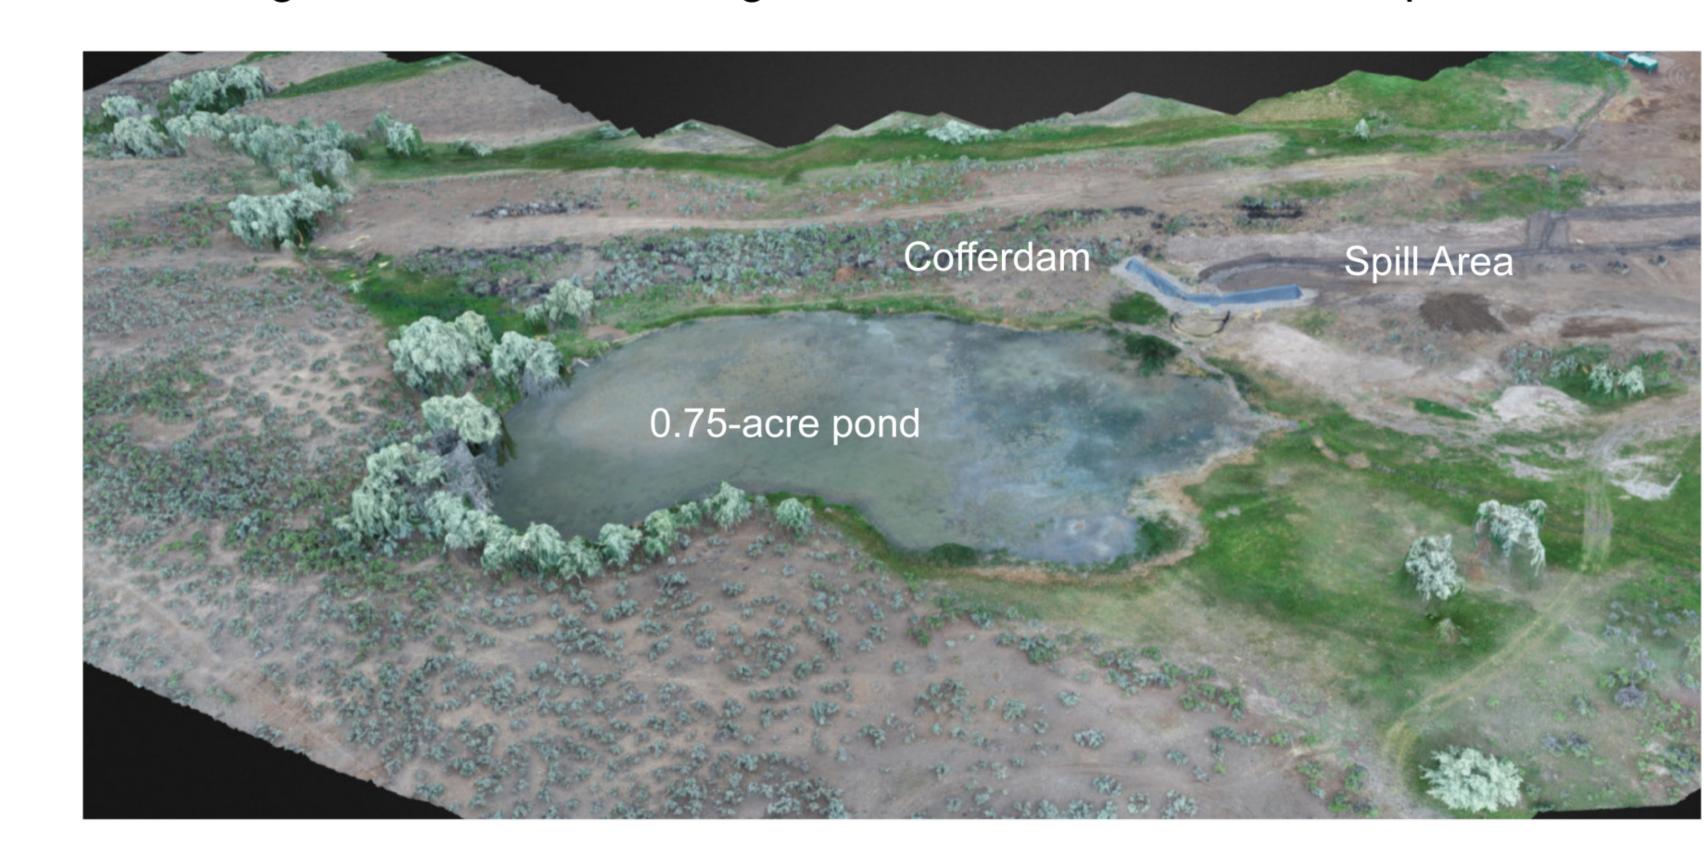
Drone flight aerial-mosaic image of Site. Post-response. May 30, 2018.

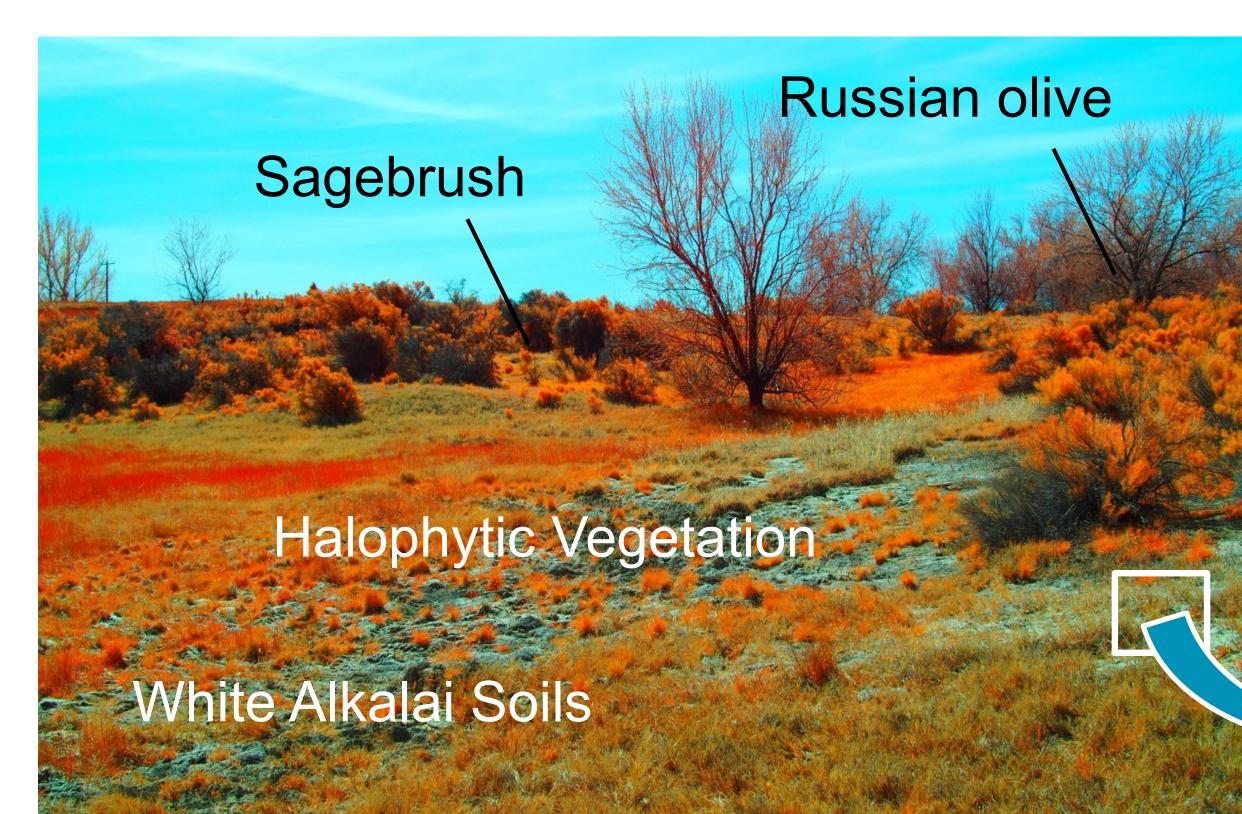
Ground-based image of sagebrush steppe habitat (Area A) using digital near infrared Normalized Difference Vegetative Index

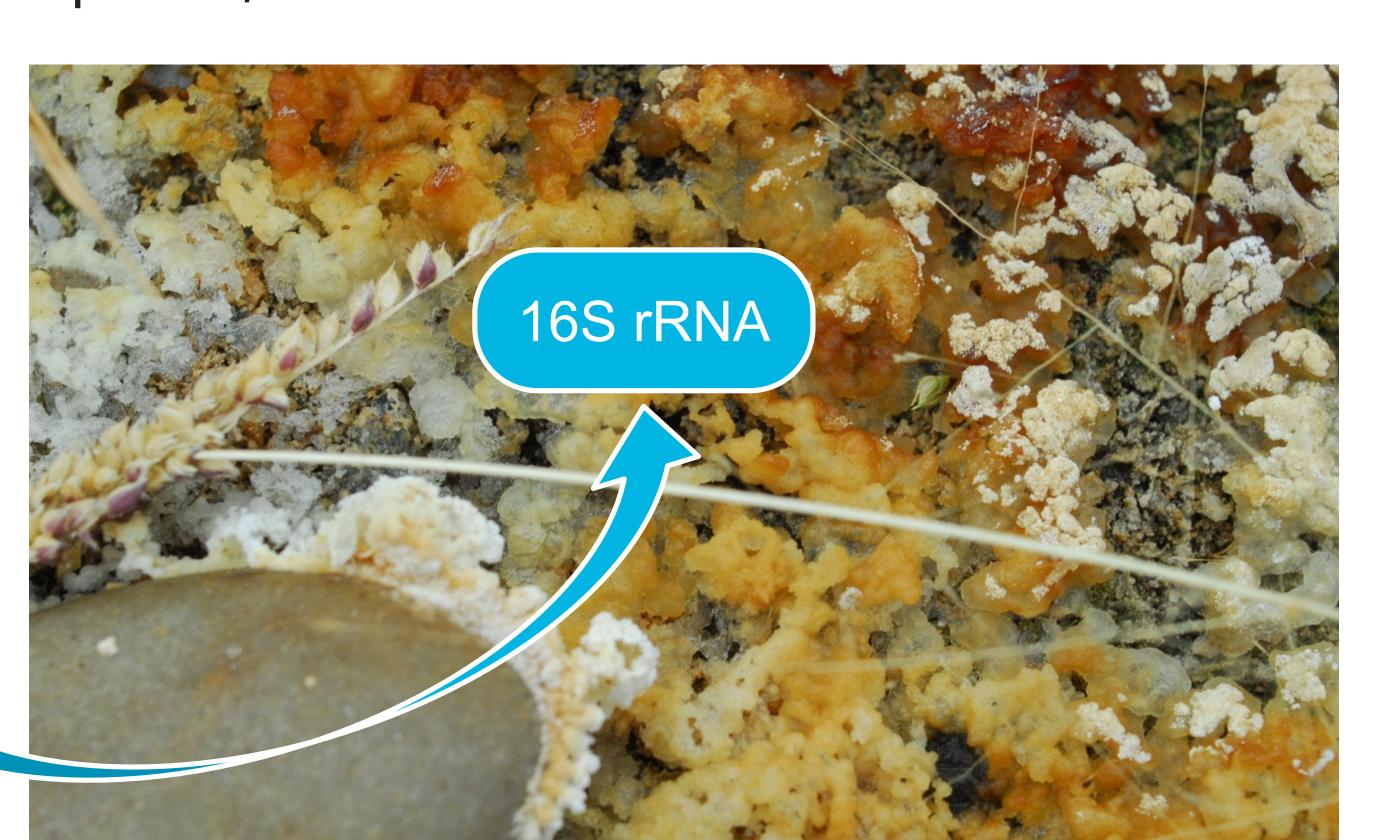
Salt-rich soil supports halophytic vegetation. 16s rRNA profiling of soil indicated presence of haloalkaline bacteria, including Cytophagia (yellow-(NVDI). The red tufts are salt-grass (*Distichlis*). brown-red colonies) and *Halomonadaceae*.

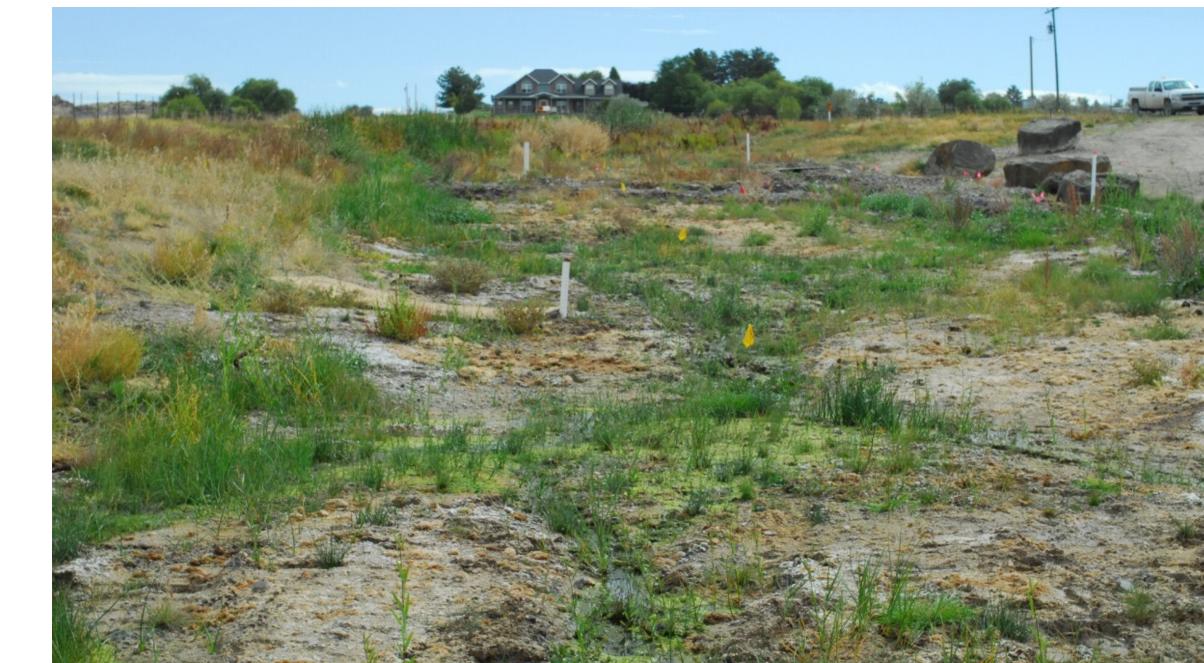
Petroleum spill area along drainage swale. Looking east. Seeded with specified plant mix. October 2018.

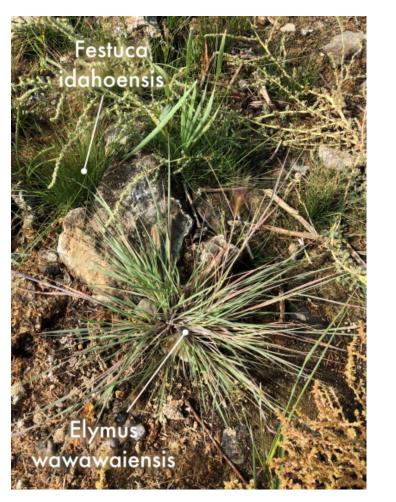
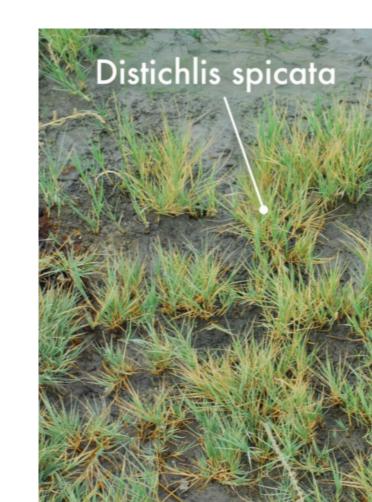
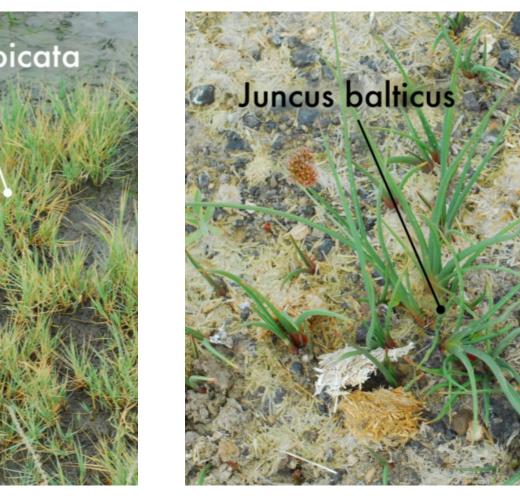
In-stream and ground mix grasses and rushes post-germination. October 2018.
