# VaporSafe™ Continuous Air Monitoring for a Sustainable Solution to the Vapor Intrusion Pathway at a Non-Residential Facility

Darby Litz, TRC

April 18, 2019

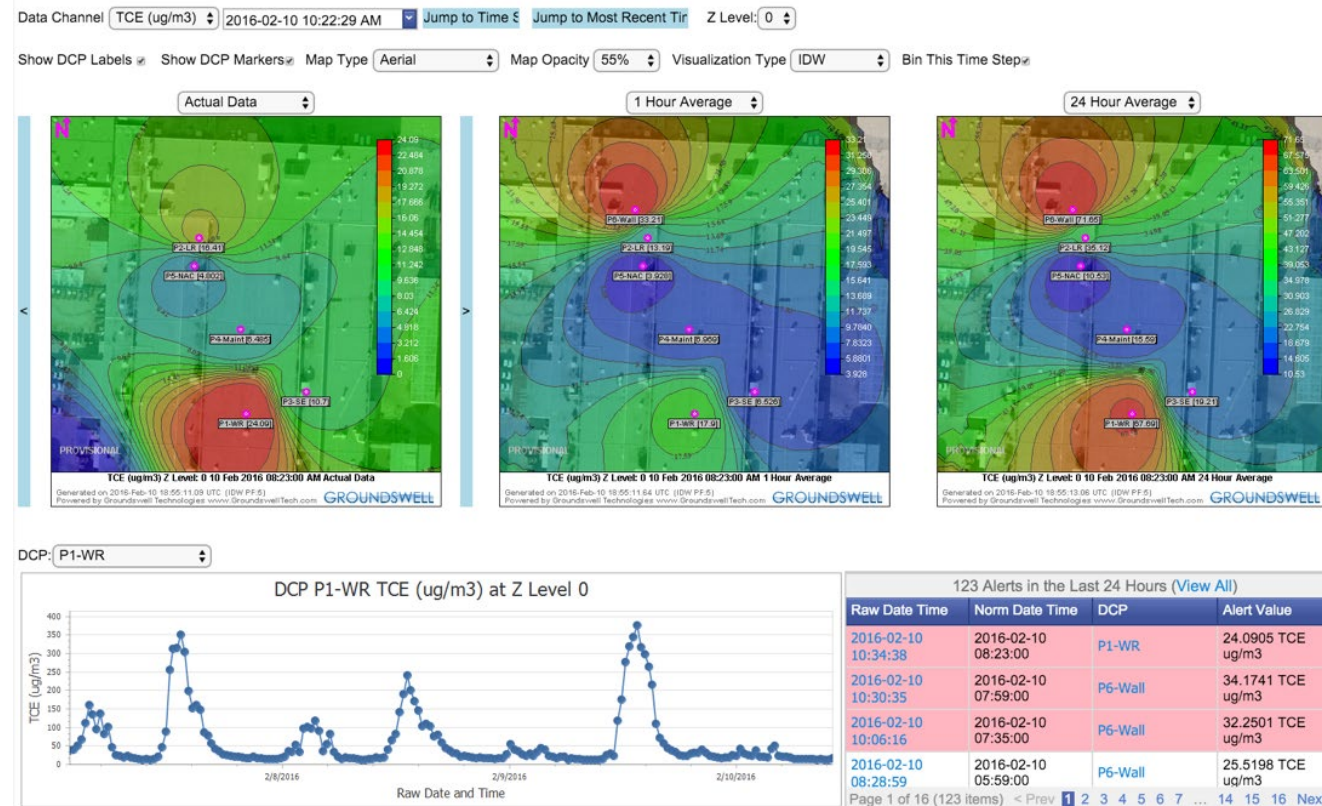
- Fully Quantitative EPA Method TO-14
- Can Reach Ultra-Low Levels (<1 ug/m<sup>3</sup>) for TCE, PCE, Vinyl Chloride & others
- <10 min Analysis Time for TCE & PCE
- Multiple Sample Locations (16 to 30)
- Very Stable - holds calibration for months
- Discrete Sampling Mode
- QA/QC: calibrated with validated gas standard
- Real-Time Data – Web-Based Dashboard

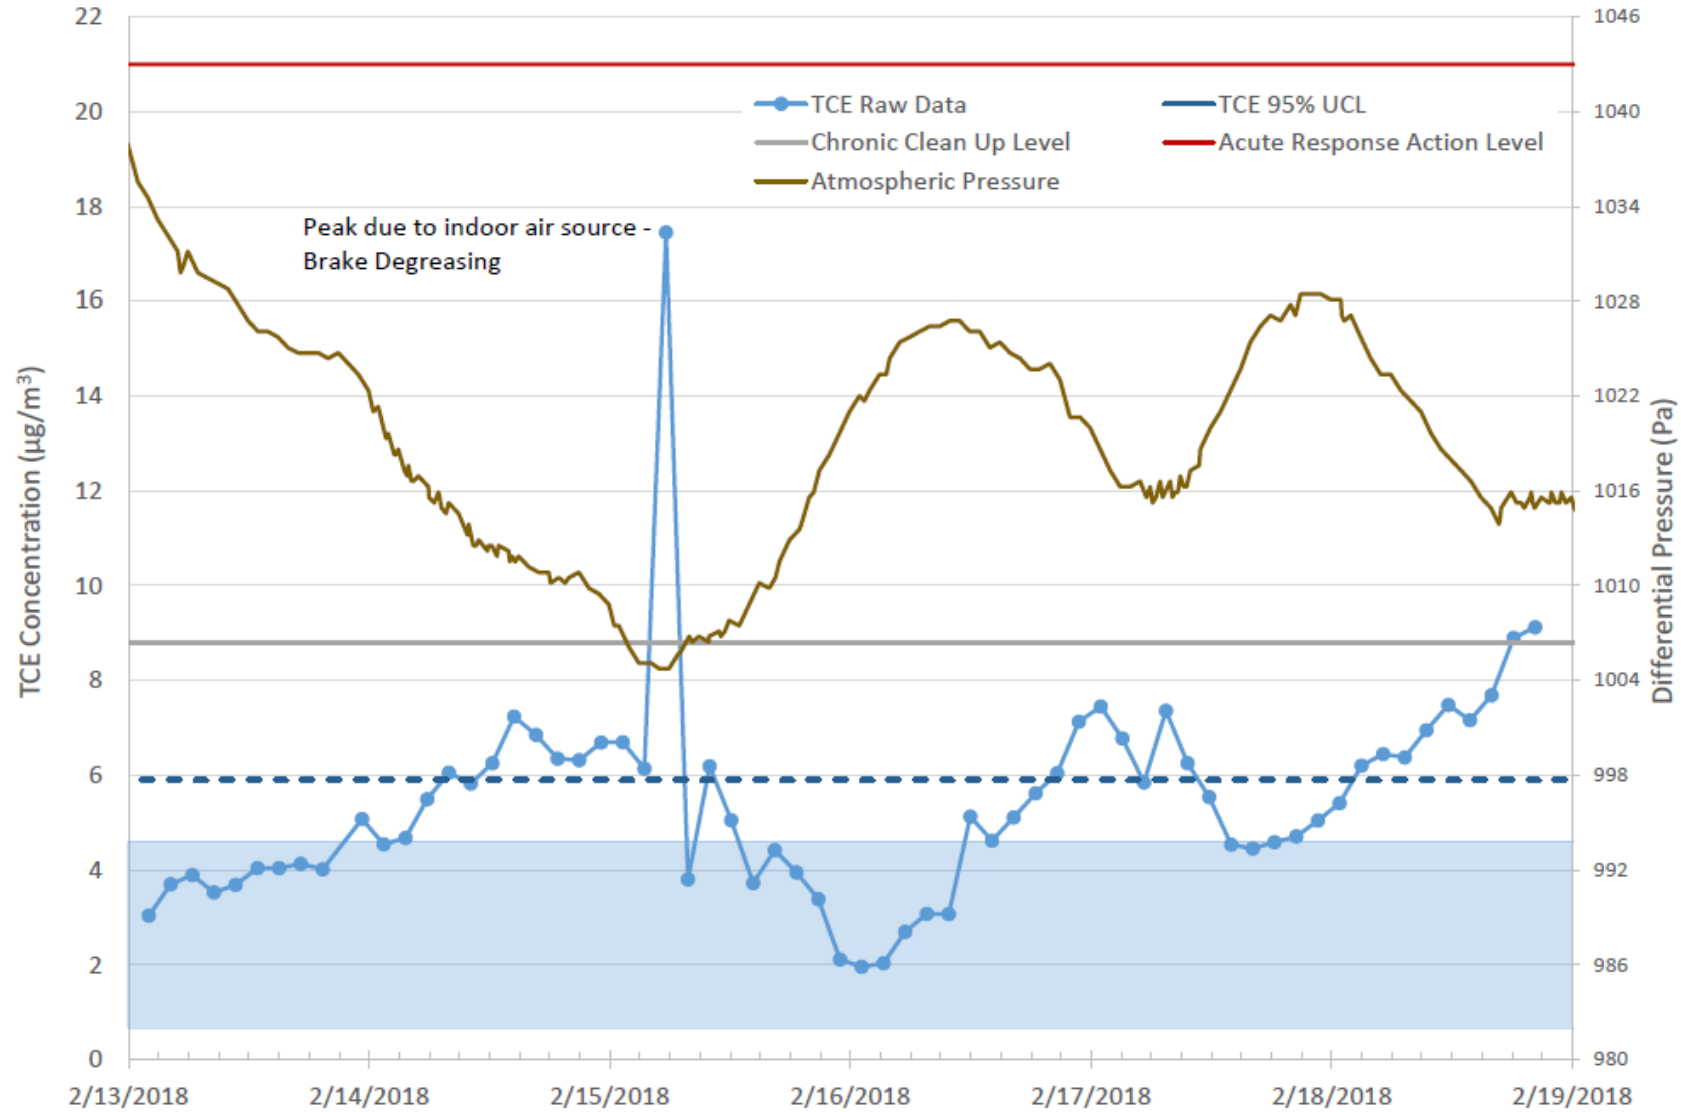
Chart 10: IA-01

IA-01: Automotive Maintenance Area

Note: Shaded region indicates post-SSV system installation TCE concentration range at CA-AIR-08 (June 2016 - February 2017)

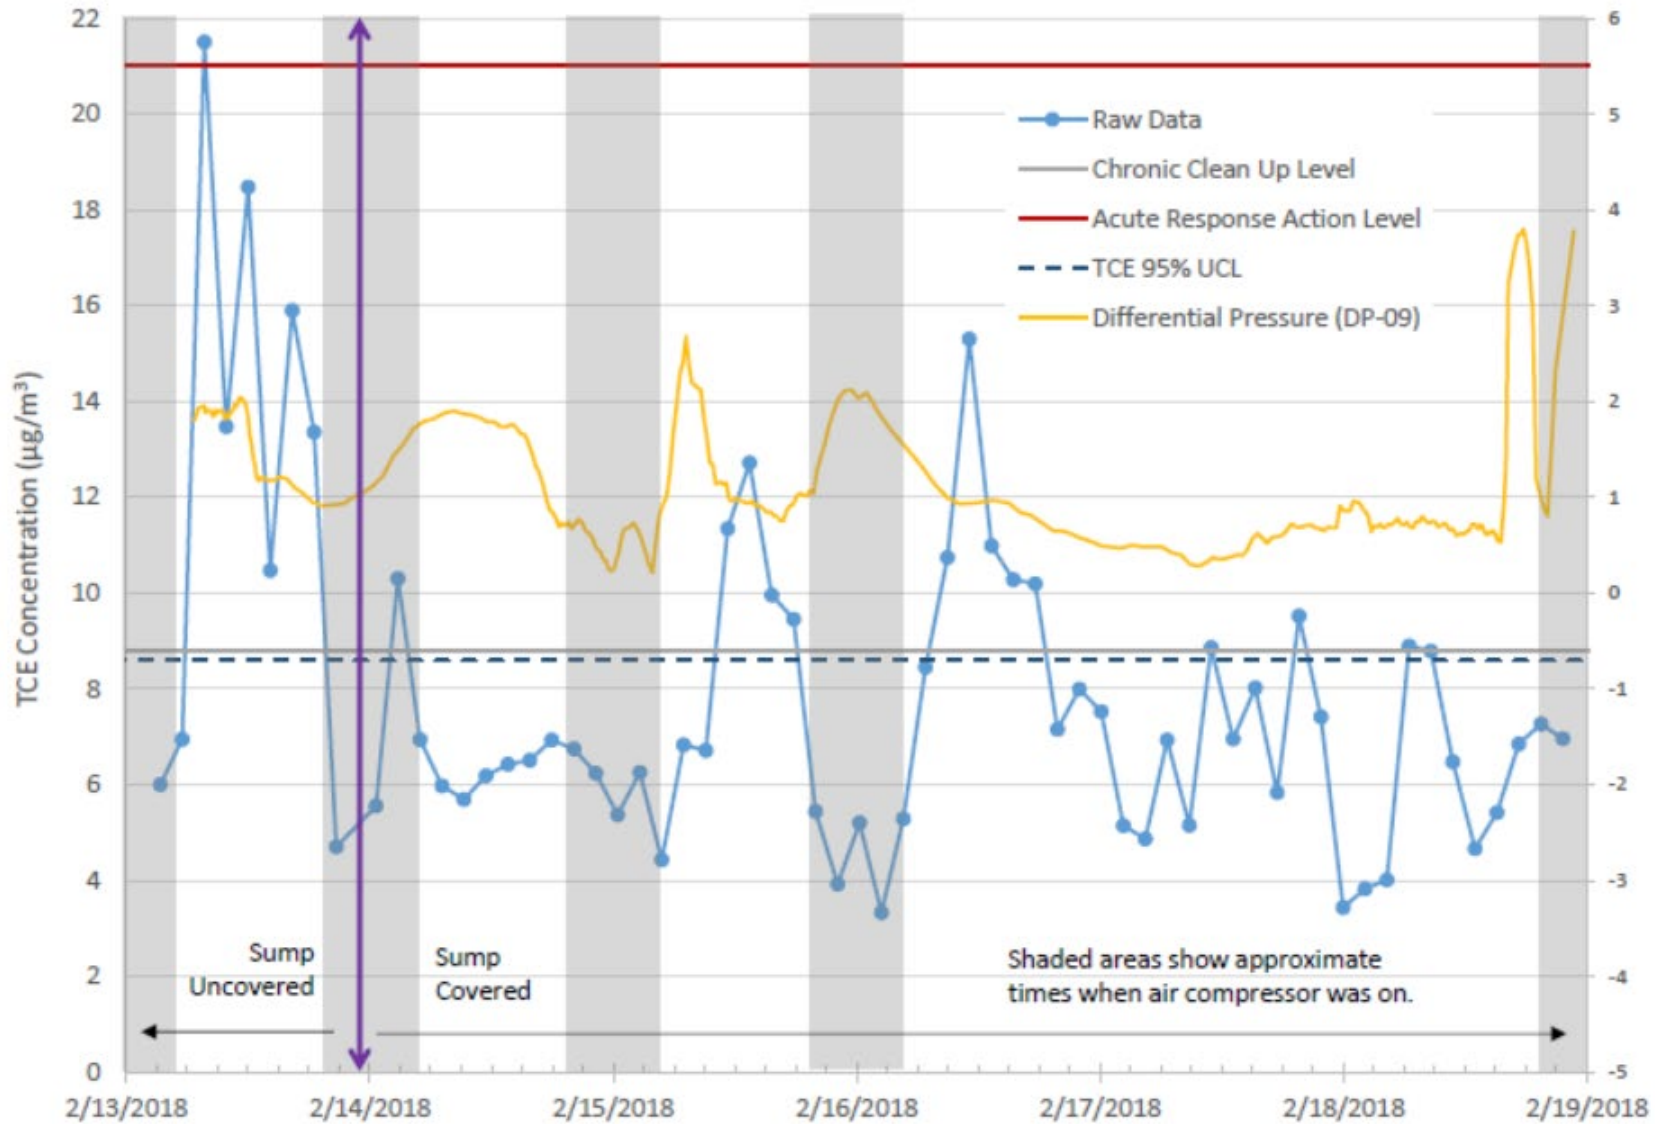
Chart 9: IA-09

IA-09: Air Compressor Room

- To further address concerns with short-term TCE exposure in the unoccupied factory area, recommended:
  - Further preferential pathway mitigation: seal sump near IA-09
  - SSV system improvements: install active fans

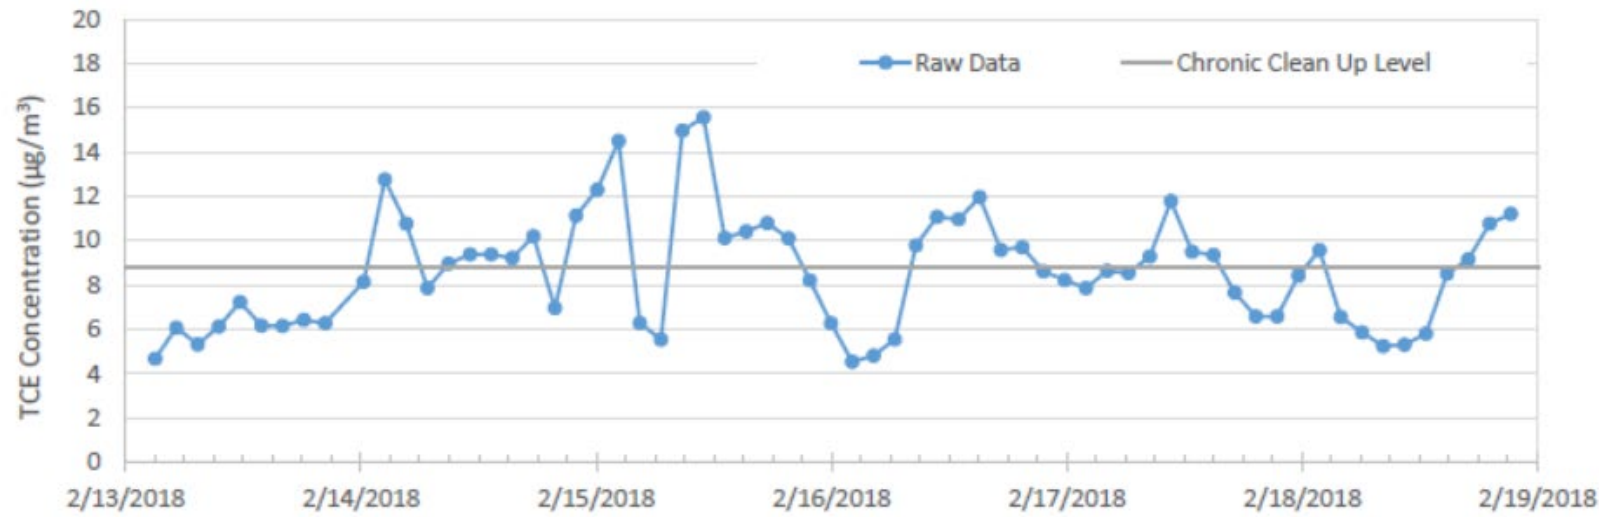
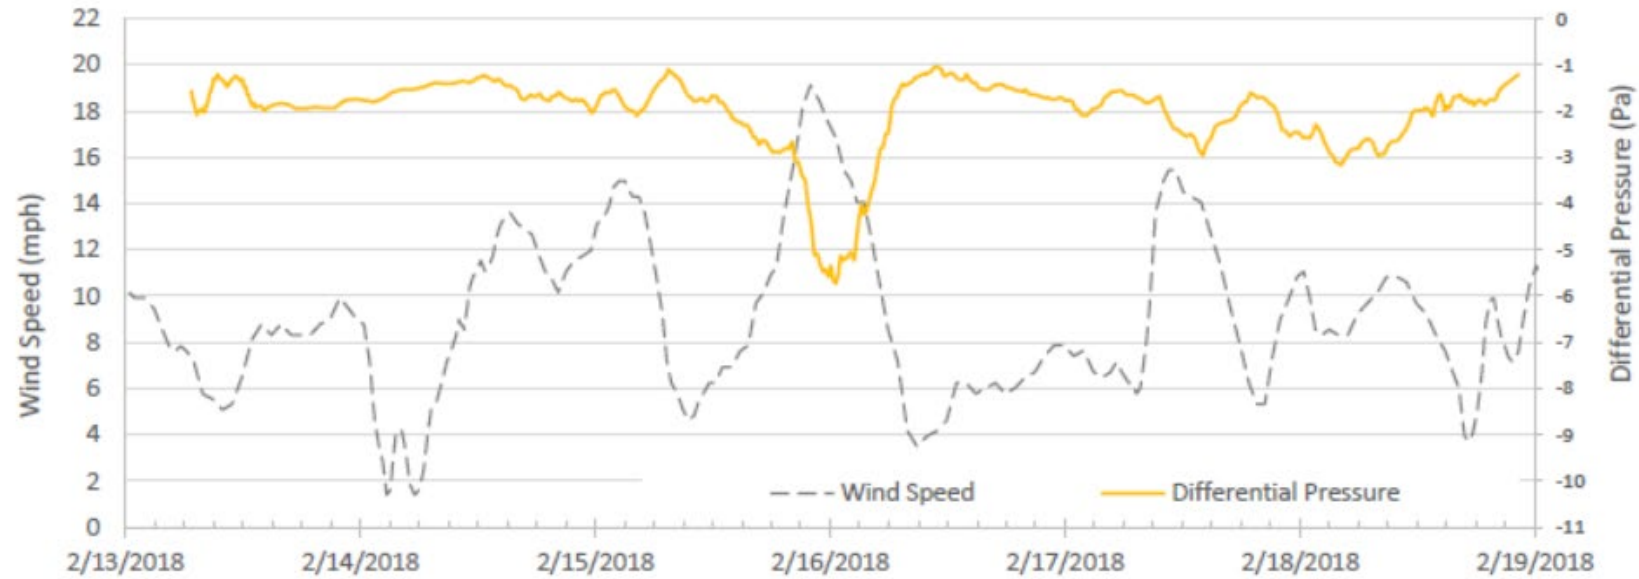
Chart 11: IA-07

IA-07: Former Plating Area

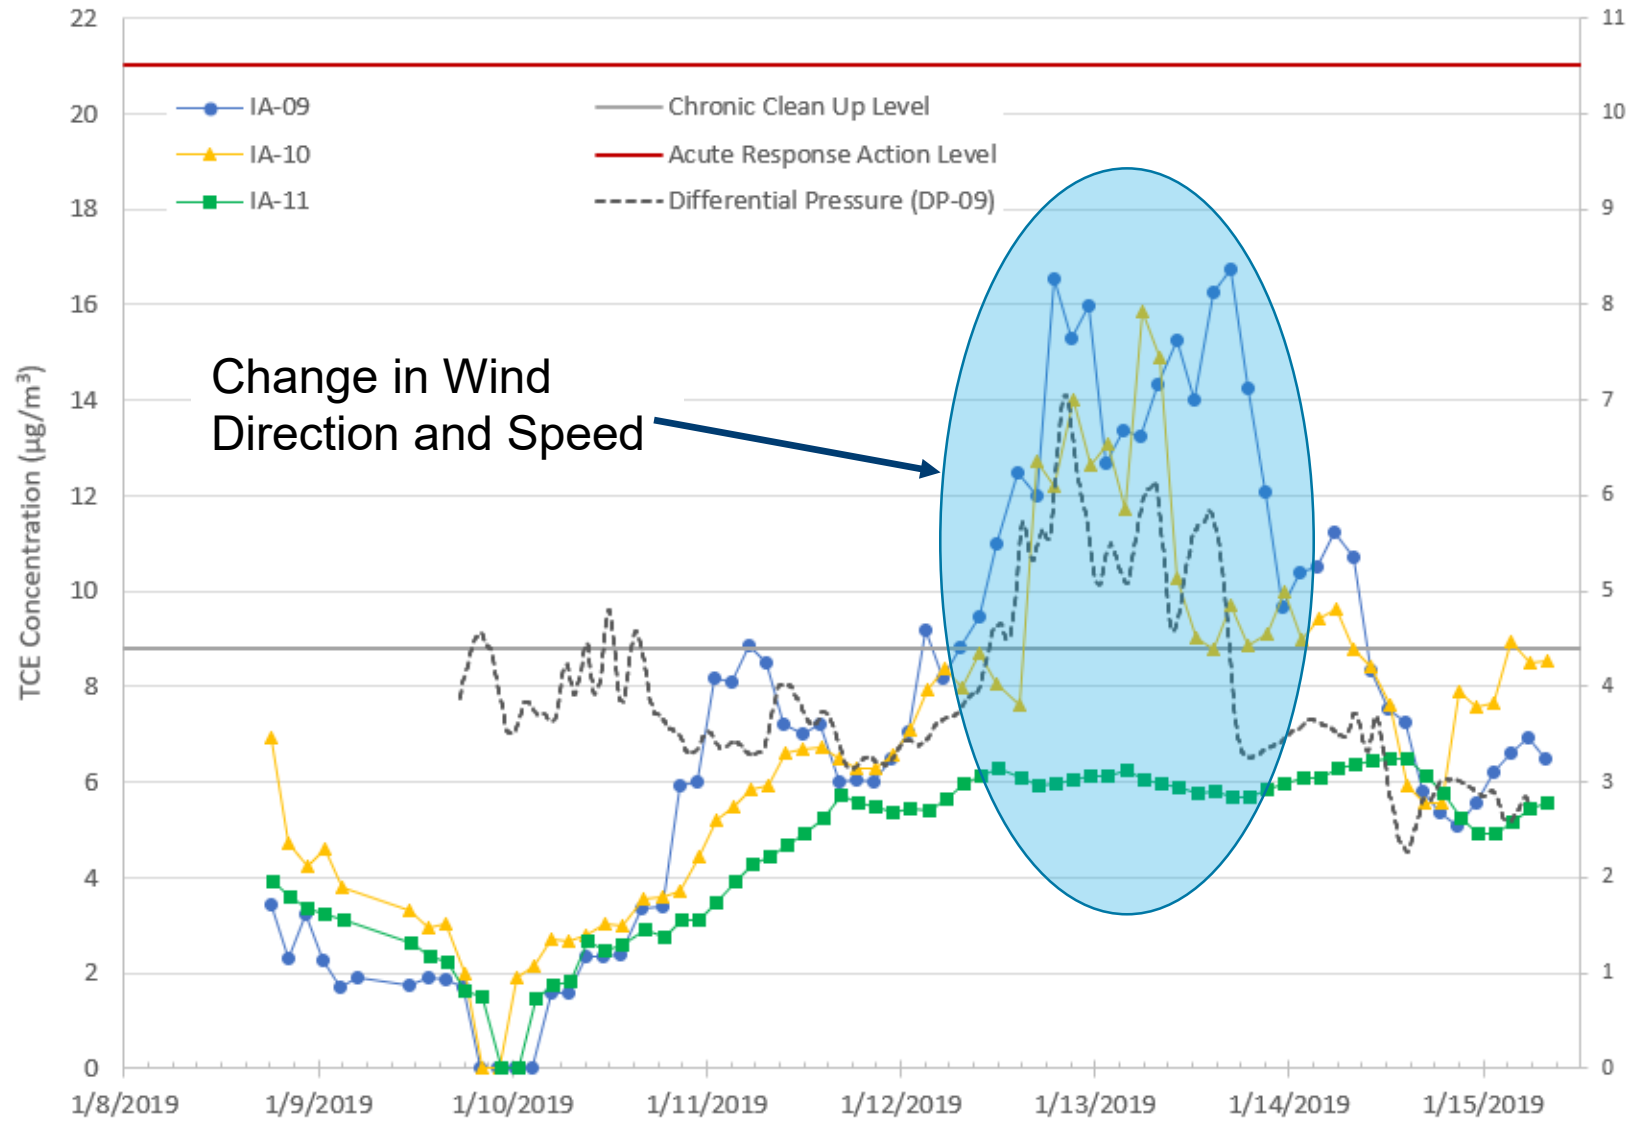
### Interior Rooms - 2019

IA-07: Former Plating Area/SSV Area

IA-10: Compressor Room/Sump Area

Date	24-hr EPC (ug/m3)	Date	24-hr EPC (ug/m3)
2/14/2018	9.6	1/8/2019	5.4
2/15/2018	12	1/9/2019	5.1
2/16/2018	9.7	1/10/2019	4.6
2/17/2018	10	1/11/2019	7.1
2/18/2018	8.2	1/12/2019	8.2
		1/13/2019	8.2
		1/14/2019	8.5
		1/15/2019	7.6
<b>All Data</b>	<b>9.2</b>	<b>All Data</b>	<b>6.9</b>

Date	24-hr EPC (ug/m3)	Date	24-hr EPC (ug/m3)
2/14/2018	12	1/8/2019	4.0
2/15/2018	7.6	1/9/2019	2.7
2/16/2018	10	1/10/2019	3.7
2/17/2018	8.9	1/11/2019	7.8
2/18/2018	7.8	1/12/2019	13
		1/13/2019	15
		1/14/2019	9.3
		1/15/2019	6.9
<b>All Data</b>	<b>8.6</b>	<b>All Data</b>	<b>8.3</b>

Passive Sub-Slab System

Active Sub-Slab System

Sump Covered

Sump Sealed
