Must See TV: A Post-Treatment Study Like None Other

Bill Brab, CPG, PG
Senior Geologist
AST Environmental, Inc.

Proof of Concept Project

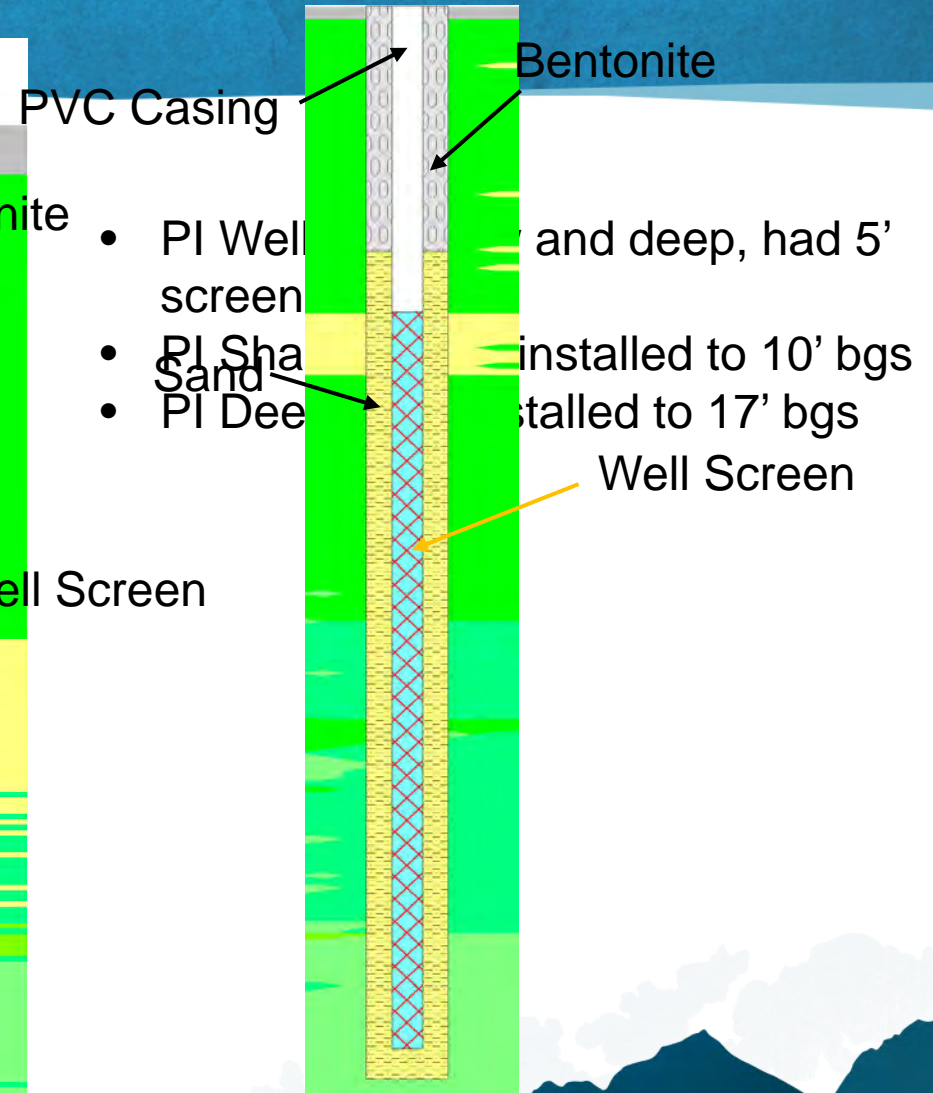
Well Construction

- For this project, any monitoring (MW) or sentinel (SW) well that was impacted by BOS 200® injectate was replaced.
- 2" Monitoring Wells (MW) had 10' screens with wells installed to 18' bgs
- 2" Sentry Wells (SW) had 10' screens with wells installed to 19' bgs
- Existing well was over-drilled to completely remove casing and screen materials and clean but the sand pack.
- New bore hole was slightly larger than the original but did not extend below the original depth.
- The replacement well was constructed with the same screen and riser lengths.
- New sand pack and bentonite seal also matched the original construction.
- The replacement well is a intended clone of the original.
- The clone wells were developed and sampled using accepted procedures.

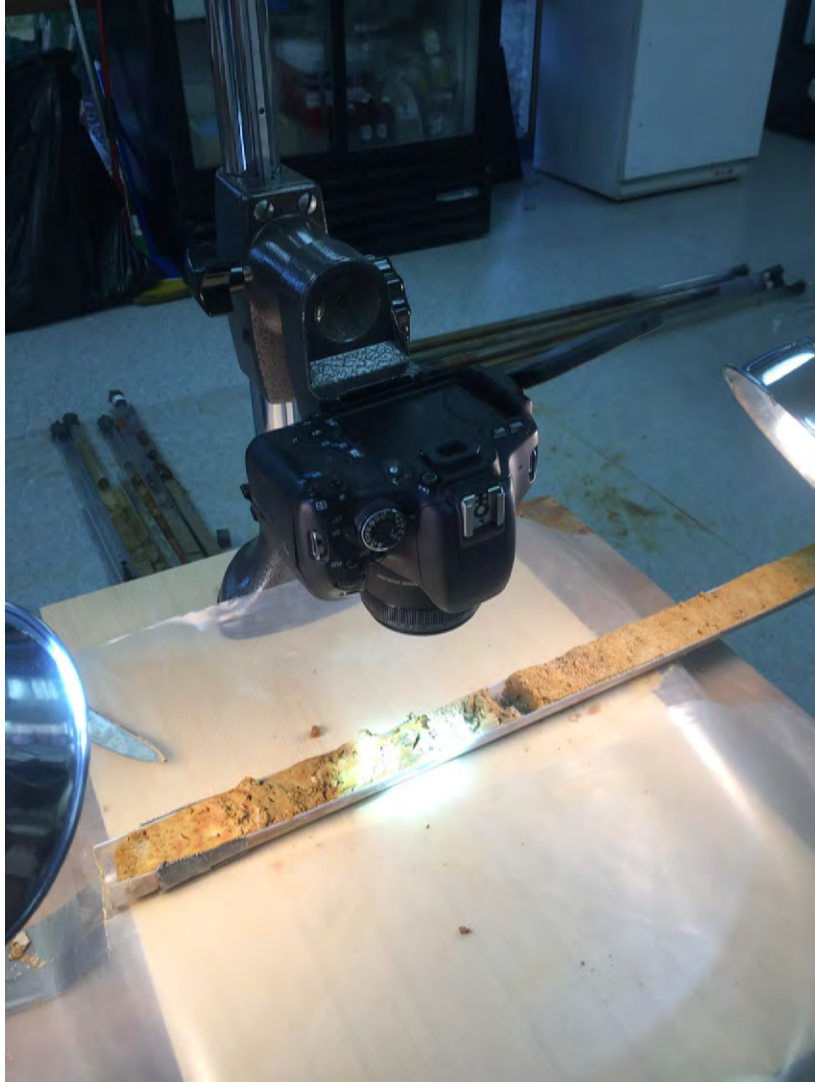
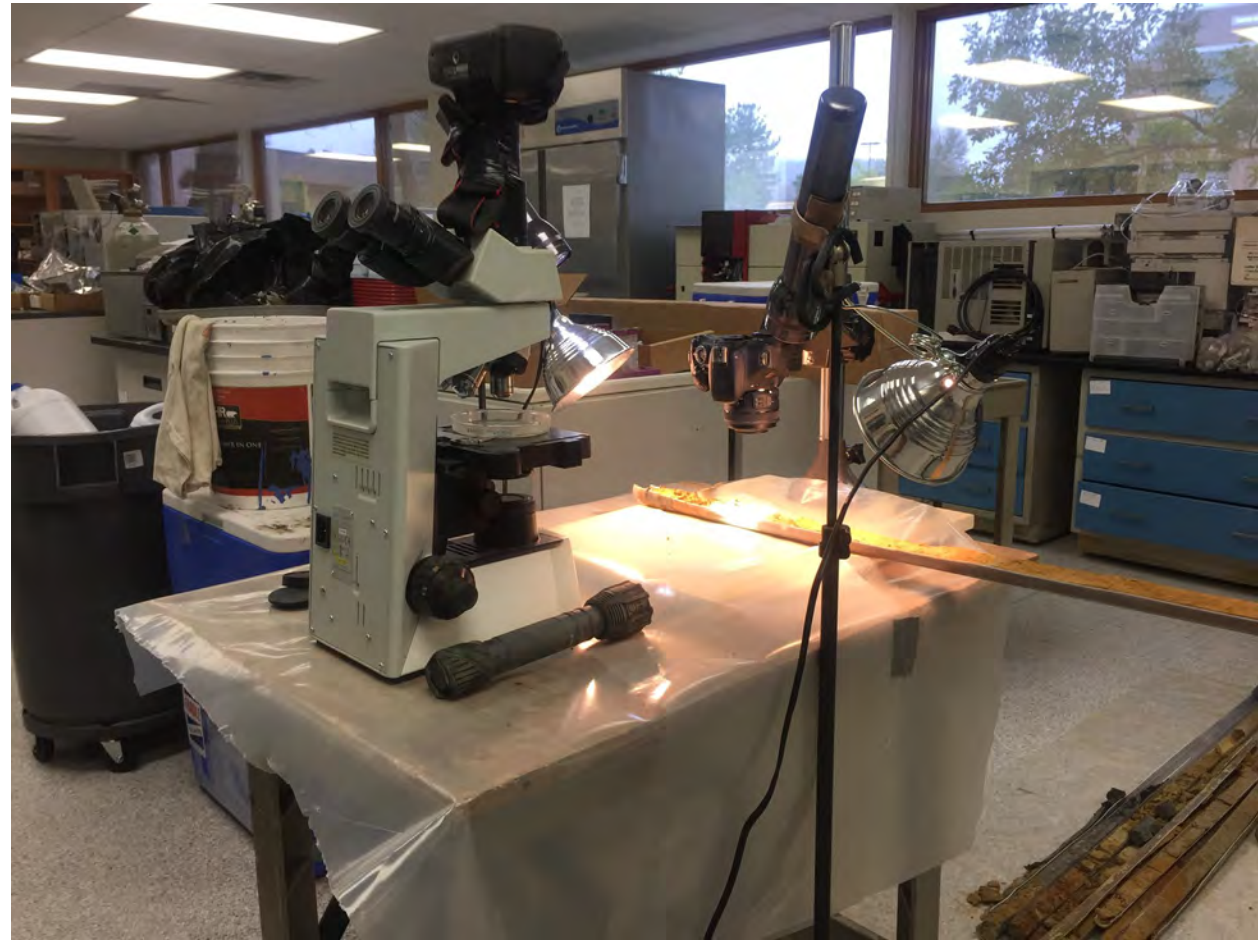
Camera and Microscope Setup

- Open Liner
- Cut and Split Long Axis (Top to Bottom)
- Cut Slices Short Axis (X-Sect)
- Light w/ no Magnification
- Light with Magnification
- Laboratory Analytical Fingerprint

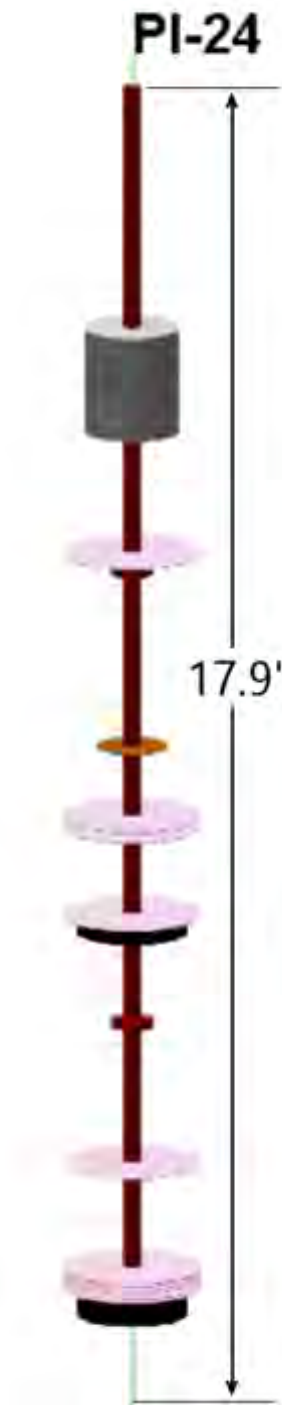
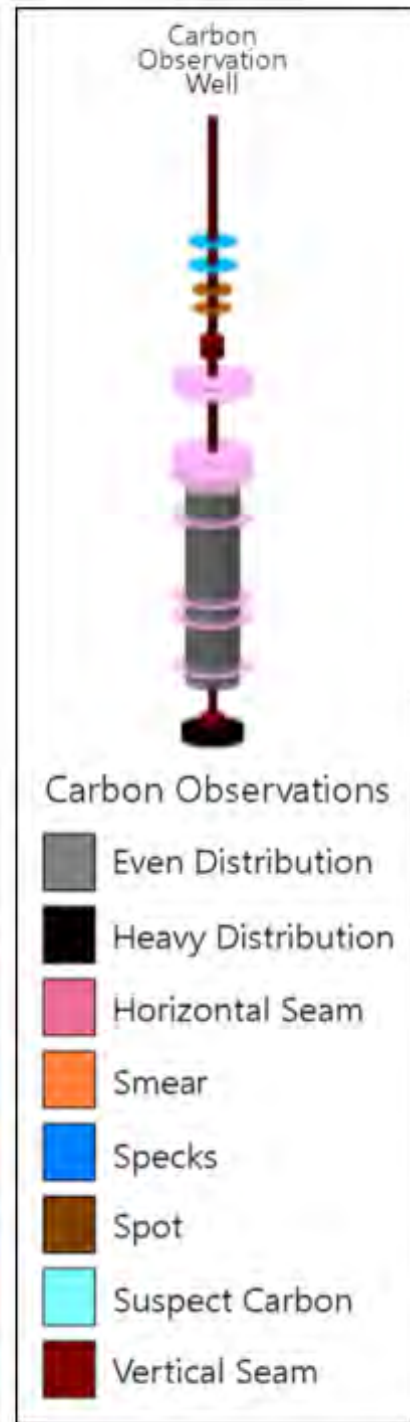
Observed Carbon Types

- Suspect Carbon
- Specks
- Spots
- Smears
- Even Distribution
- Heavy Distribution
- Vertical Seams
- Horizontal Seams

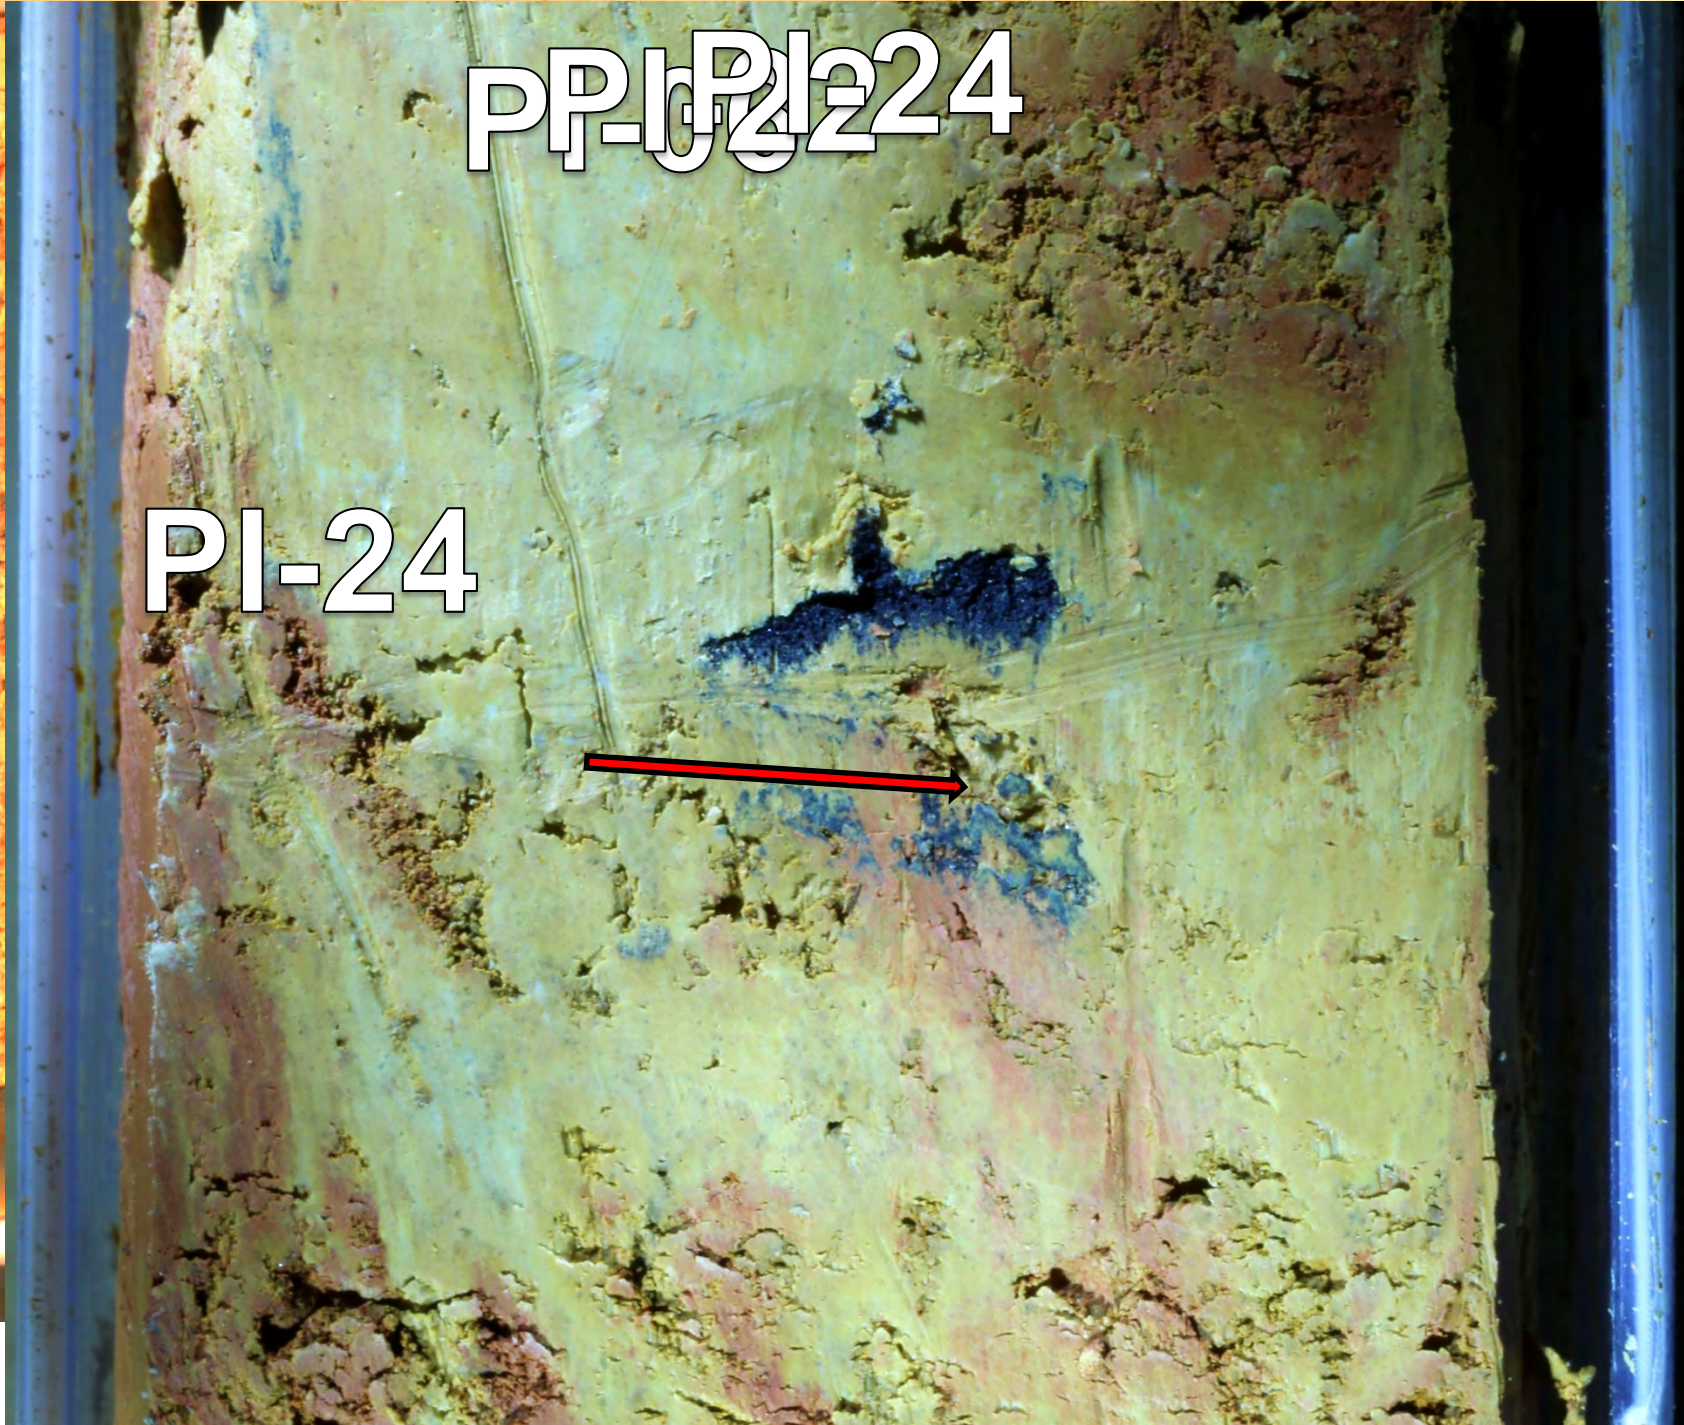
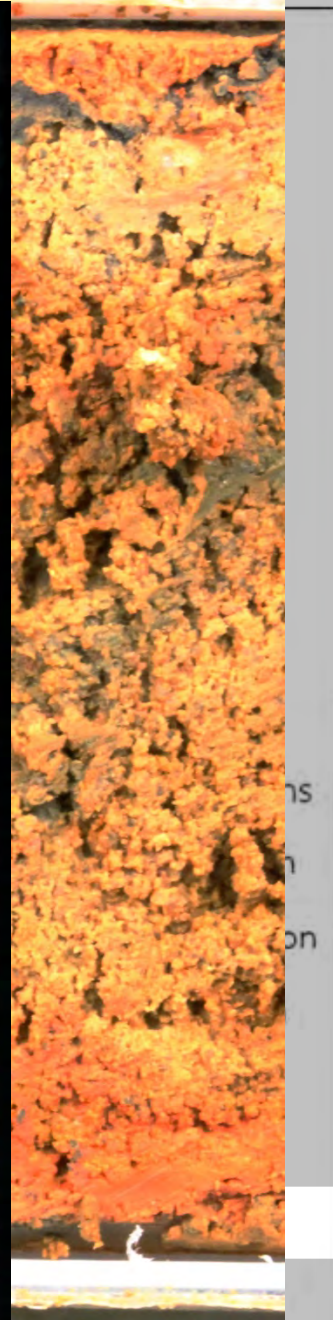
PI-08

Vertical Seam

20X Magnification

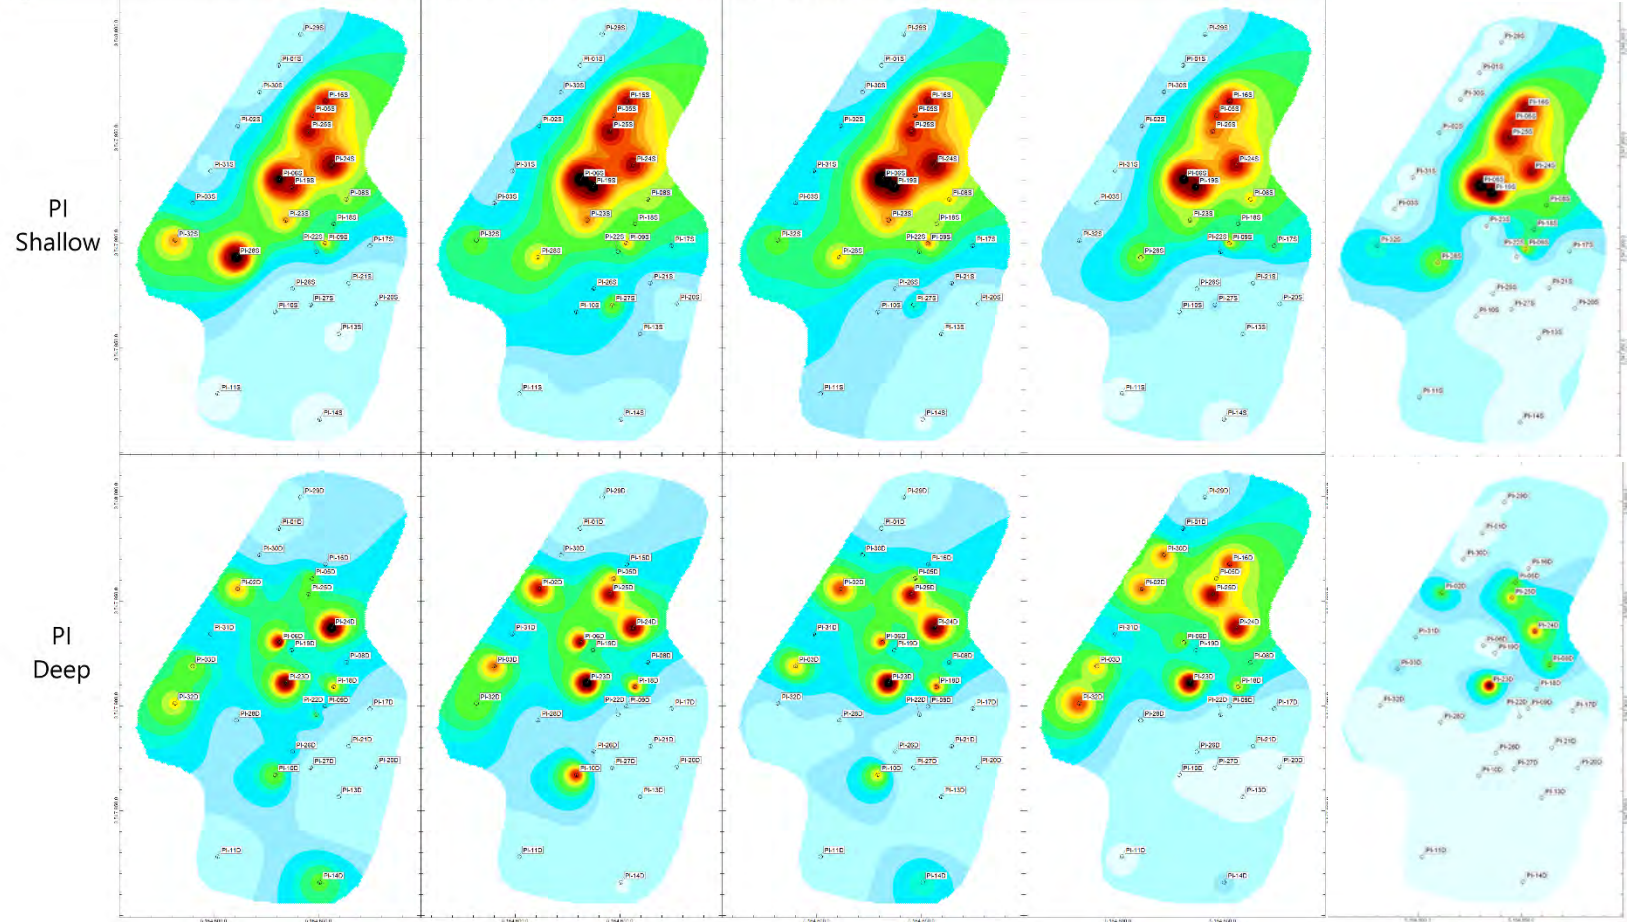
Benzene Levels

Top Row:
 MW-1,2,3,4,5,6,7,8,9,10,11,13,14,15 &
 SW-1,2,3,4

Middle Row:
 PI-1,2,3,5,6,8,9,10,11,13,14,15,16-32 Shallow

Bottom Row:
 PI-1,2,3,5,6,8,9,10,11,13,14,16-32 Deep

All Horizontal Units = Feet
