# Tetra Tech & EPA Region 5

May 24, 2016

# Project Introduction – Site Location

# Site History

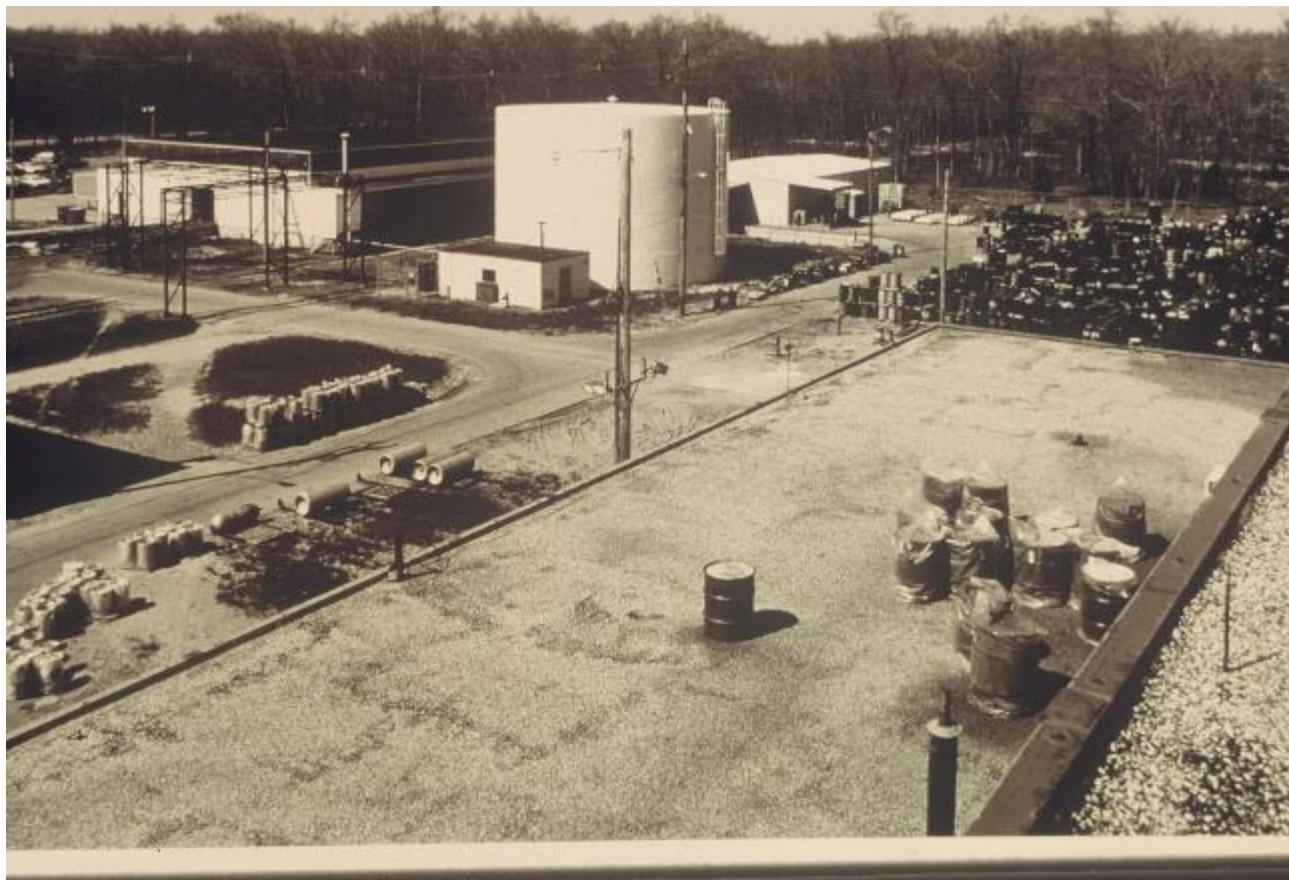
# Site History

Waste by-products from the chemical manufacturing processes were placed in unlined lagoons or stored in drums on the property.

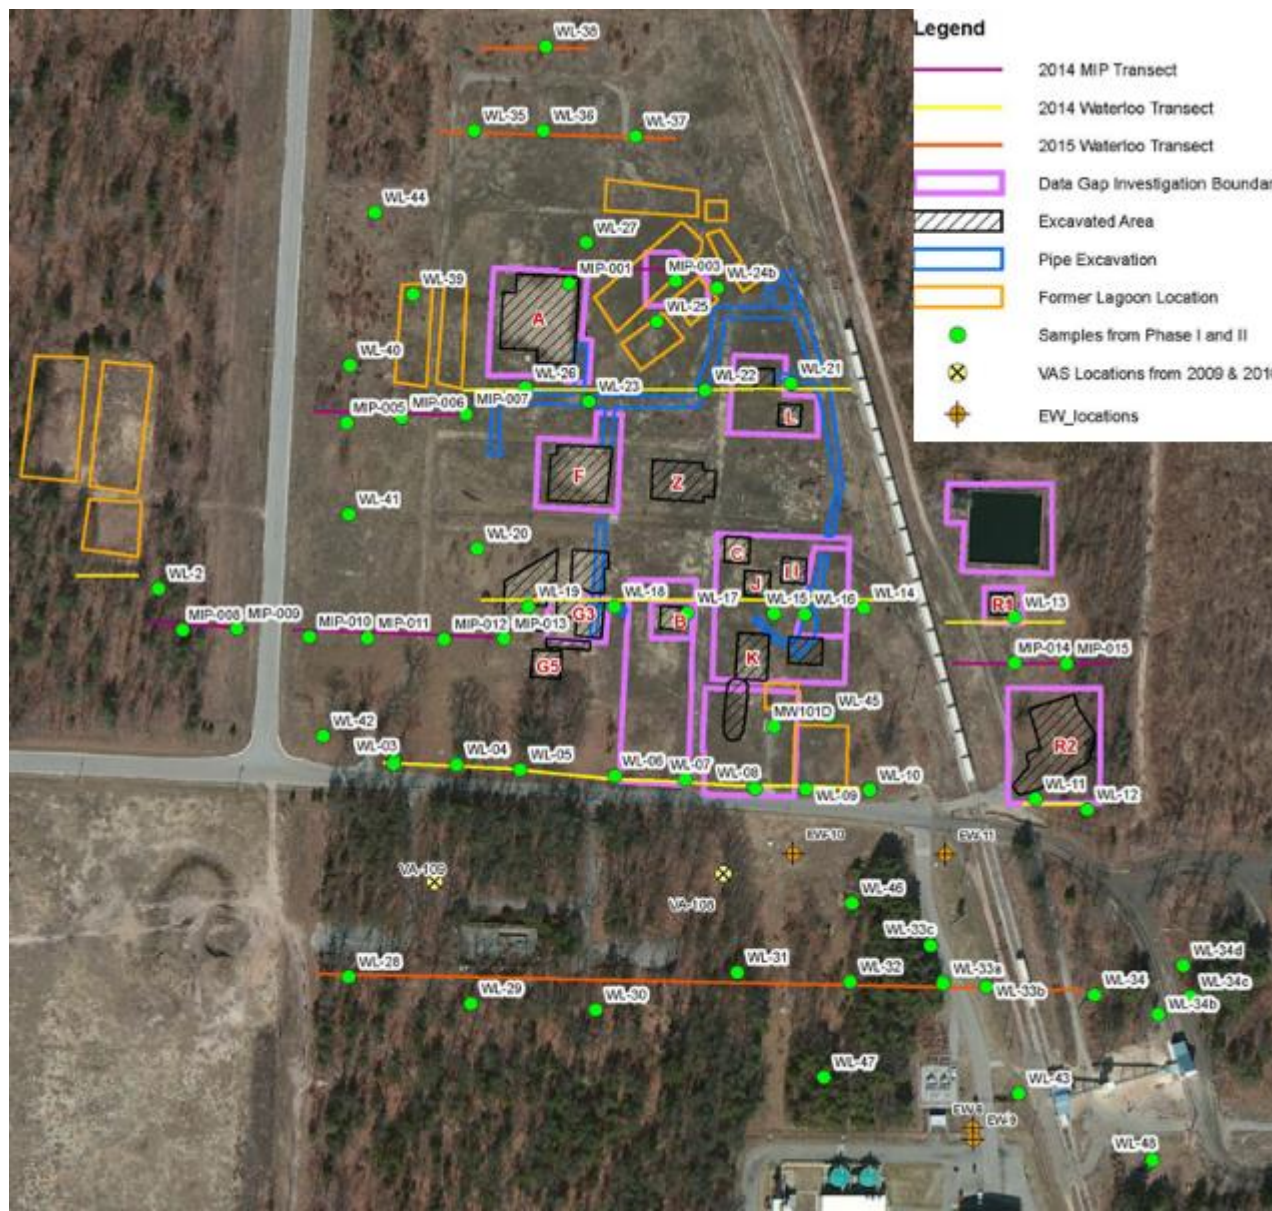
# Phase I and II Investigation Summary

- Conducted MIP at 13 locations to primarily set edges of Waterloo transects
- Conducted Waterloo profiling at 52 locations collecting over 1,000 groundwater samples and generating 52 continuous Index of Hydraulic Conductivity (relative IK) geologic logs
- Analyzed all groundwater samples with an on-site mobile laboratory

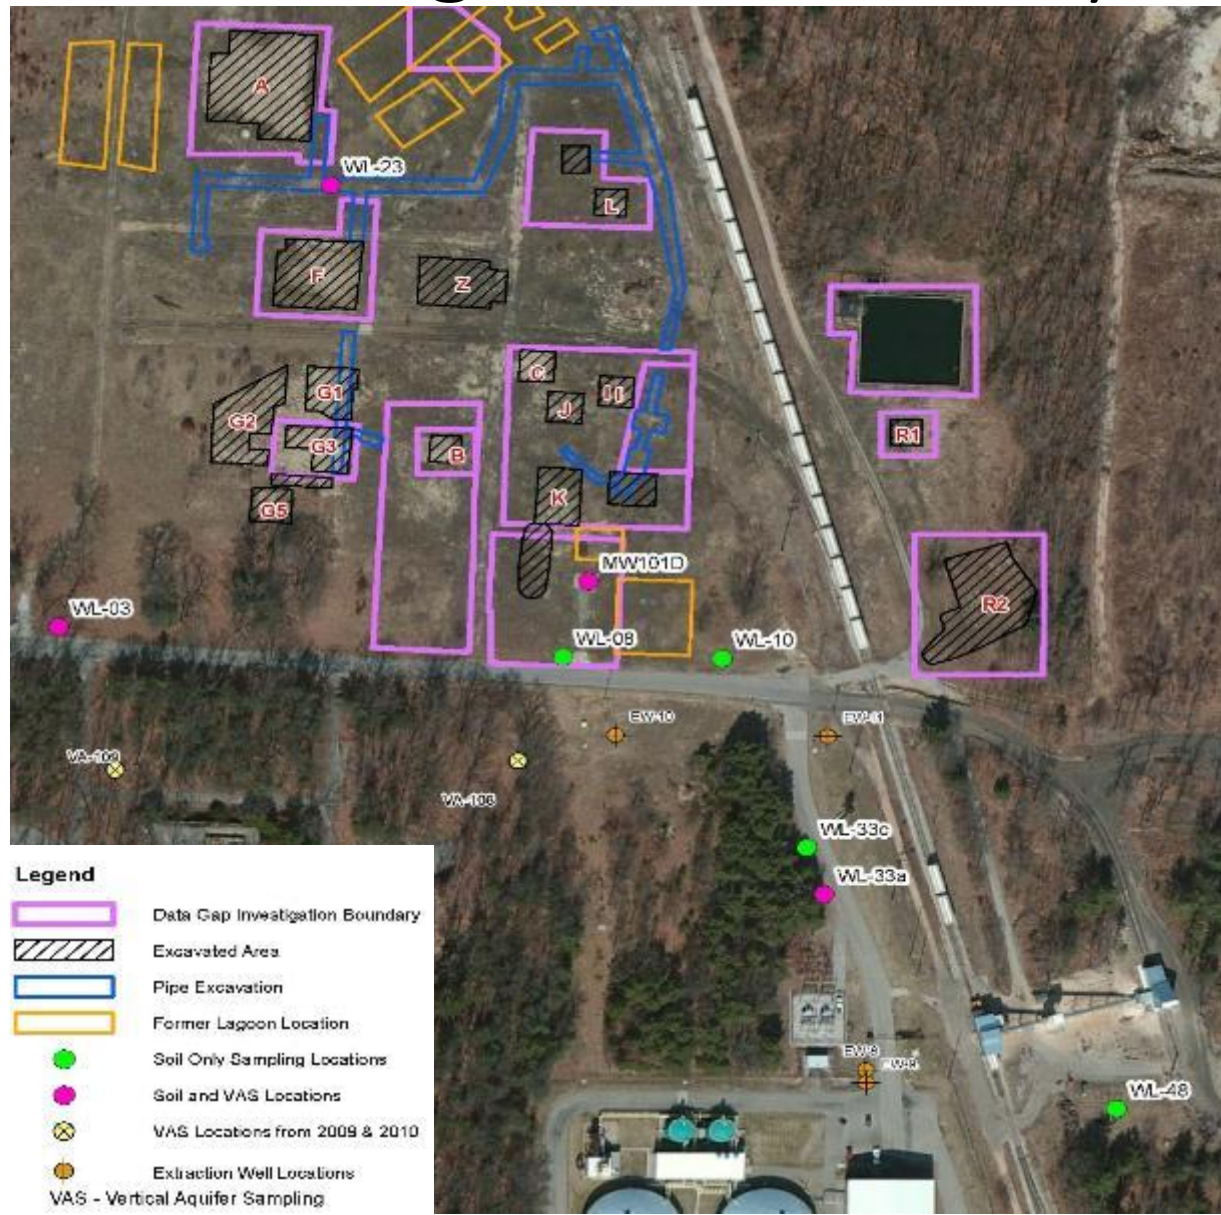
# Phase III Investigation Summary

- Paired up with 4 Waterloo boring locations to conduct deeper VAS using sonic drilling and packer sampling to collect soil and groundwater samples from discrete depths
- Collected soil samples at discrete depths at 4 additional Waterloo boring locations
- Conducted field screening for NAPL using visual observations, PID, and field test kits (Oil-in-Soil shake tests)

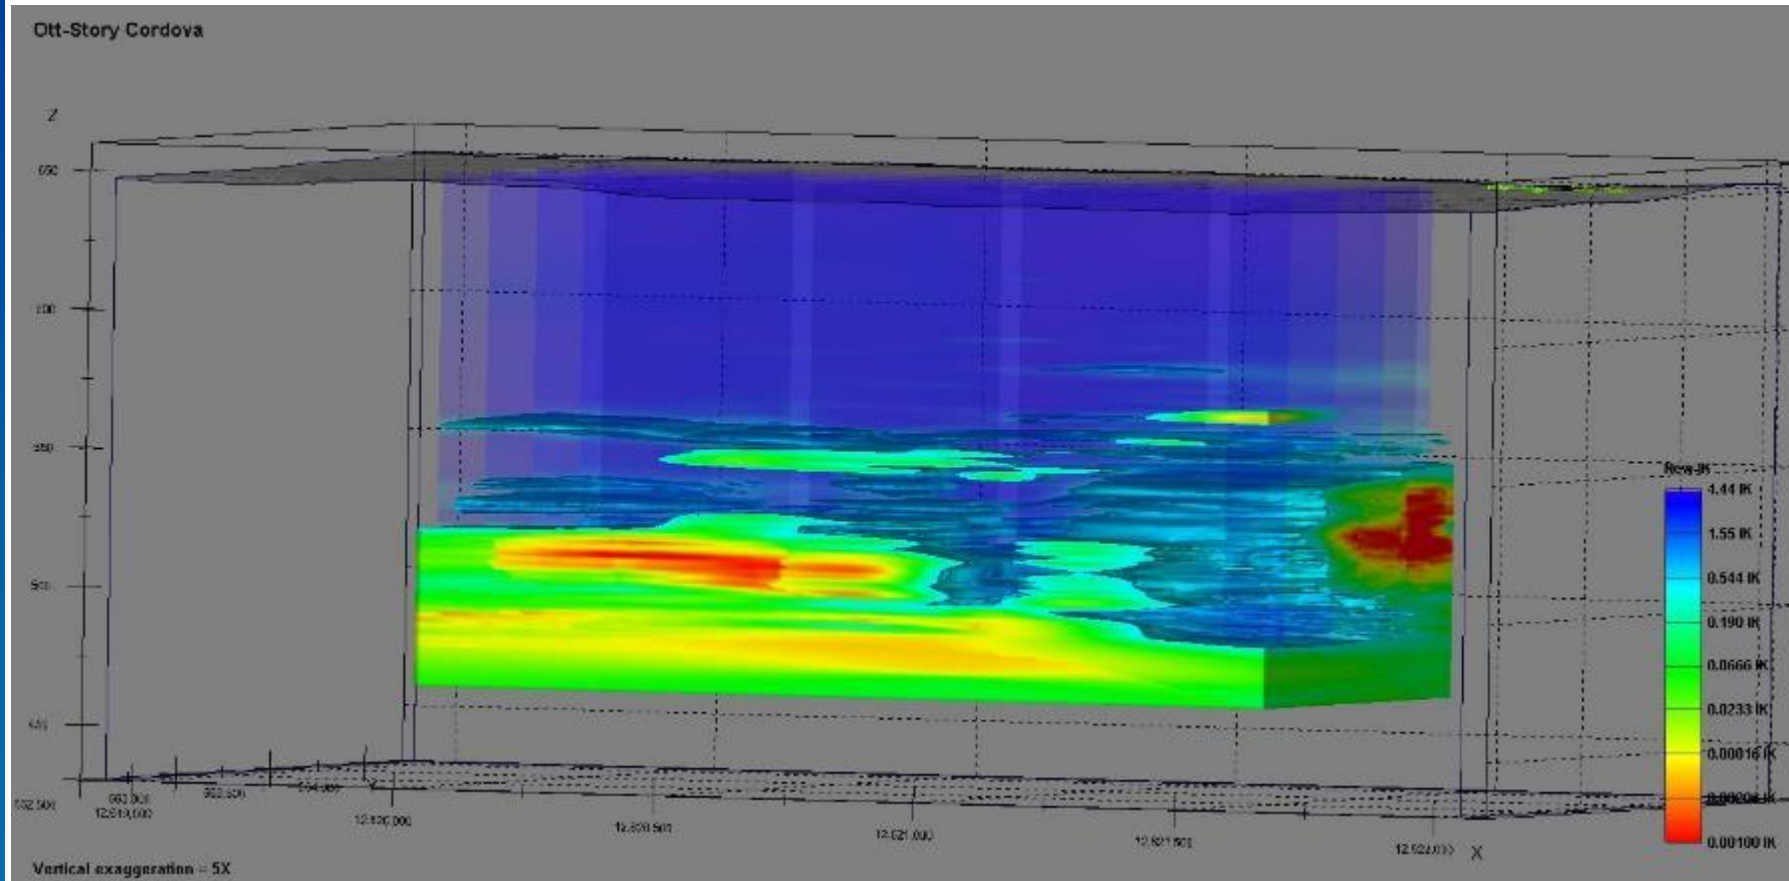
## Site Geology Results

- Multiple contaminants are present
- Lateral and vertical extent varies by compound
- Contaminant pattern is indicative of multiple releases in many areas
- Higher dissolved-phase groundwater concentrations were generally detected just above low hydraulic conductivity (clay) zones
- Contamination does not appear to extend vertically below the lower clay

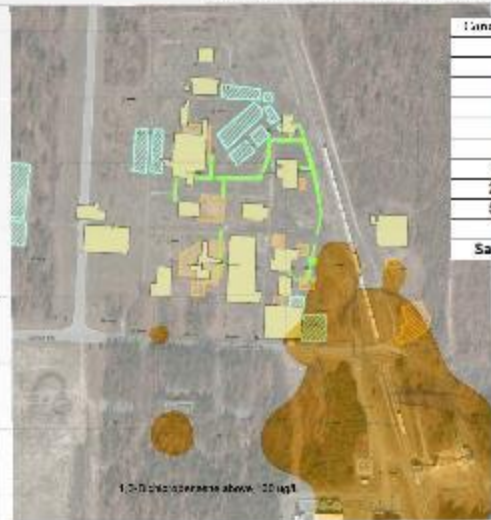
1,2-Dichlorobenzene Above 100 µg/L

Concentration Range (µg/L)	1,2-Dichlorobenzene
0 - 49	228
50 - 99	168
100 - 249	65
250 - 499	29
500 - 999	33
1,000 - 24,999	10
25,000 - 49,999	0
50,000 - 99,999	0
>100,000	0
Sample population	1004

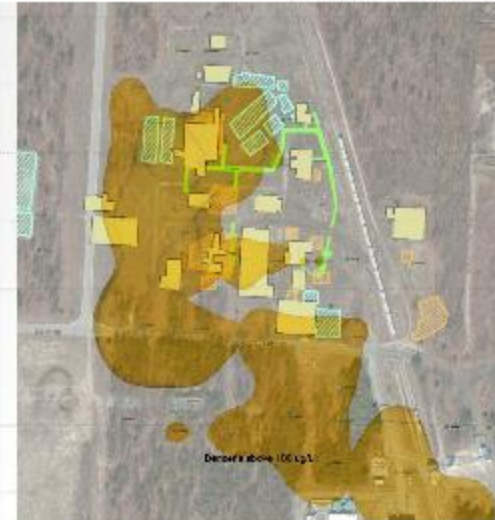
Benzene Above 100 µg/L

Concentration Range (µg/L)	Benzene
0 - 5	275
5 - 49	168
50 - 99	53
100 - 249	58
250 - 499	25
500 - 999	17
1,000 - 24,999	5
25,000 - 49,999	0
50,000 - 99,999	0
>100,000	0
Sample population	1004

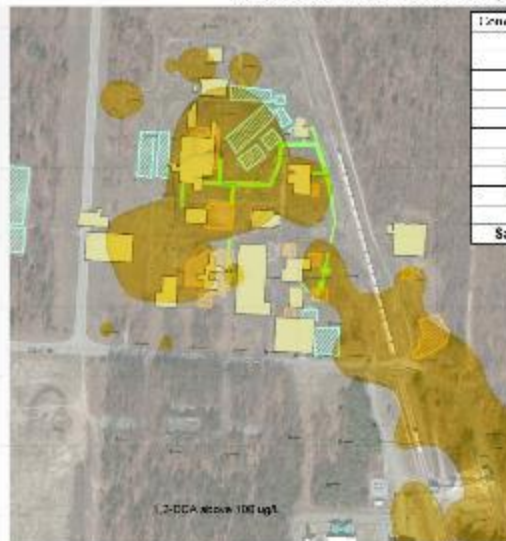
1,2-Dichloroethane Above 100 µg/L

Concentration Range (µg/L)	1,2-Dichloroethane
0 - 5	173
5 - 49	138
50 - 99	34
100 - 249	23
250 - 749	19
750 - 999	4
1,000 - 24,999	17
25,000 - 49,999	0
50,000 - 99,999	0
>100,000	0
Sample population	1004

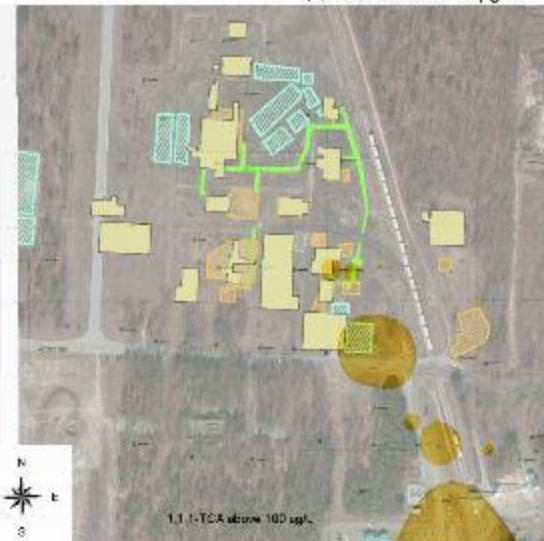
1,1,1-TCA Above 100 µg/L

Concentration Range (µg/L)	1,1,1-Trichloroethane
0 - 5	42
5 - 49	20
50 - 99	3
100 - 249	4
250 - 749	4
750 - 999	1
1,000 - 24,999	9
25,000 - 49,999	0
50,000 - 99,999	0
>100,000	0
Sample population	1004
