Phytoremediation of 1,4-Dioxane Contaminated Aquifers: Case Studies & Lessons Learned

Ron Gestler, E. Gatliff, P. Thomas and J. Linton Geosyntec Consultants

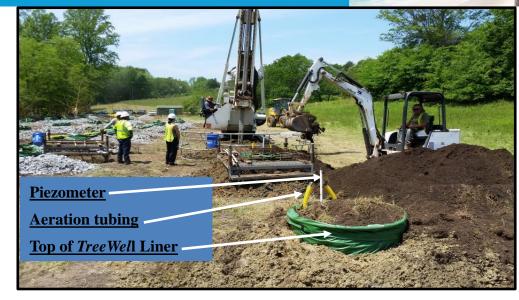
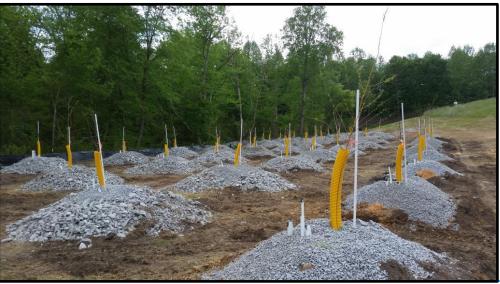
System Installation

- Borehole advanced to the horizon of interest
- Safety platform set
- Liner and aeration tubing are added
- Borehole is backfilled with topsoil and selected amendments
- Plant and above-ground completion

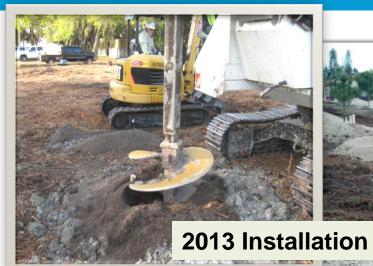
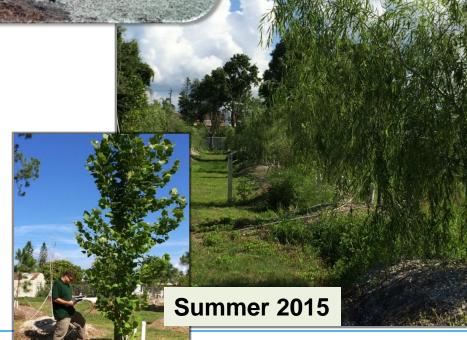
Case Study 1: System Installation

- 154 Units Installed
- 48" Borehole Drilled to 15' bgs
- Set liner system to top of impacted zone
- Plantings set 20 feet on center
- Native trees:
 - Slash Pine (Pinus elliottii)
 - Sycamore (*Platanus occidentalis*)
 - Willow (Salix caroliniana)
 - Pond Cypress (Taxodium ascendens)

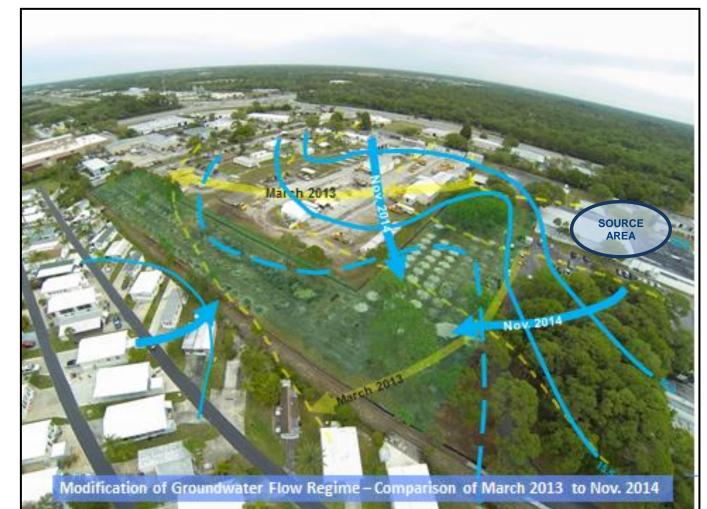
Case Study 1: Impact on Groundwater Flow

- <u>Yellow</u> indicates initial GW flow at time of Phyto System installation (away from source area towards site boundary)
- Blue indicates GW flow <u>18 months</u> <u>after</u> Phyto System installed (gradient reversal/hydraulic control; flow towards the Phyto System)
- Results have been very consistently positive:
 - Groundwater flow had been historically to the west-northwest
 - Some changes in flow were seen in the first season
 - By the end of the second season, groundwater flow had reversed

Demonstration of hydraulic capture enabled shutdown of the existing pump and treat system. The system has since been dismantled and removed.

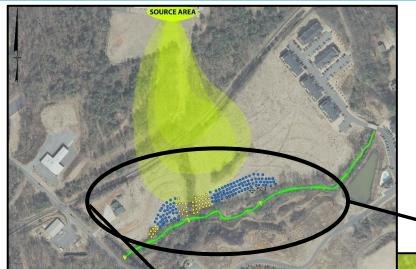
FOCUSED FEASIBILITY STUDY

- Rebound study
- Aquifer performance testing
- Vertical Profile Sampling
- Groundwater modeling to determine capture requirements
- Results indicated phytoremediation would be effective

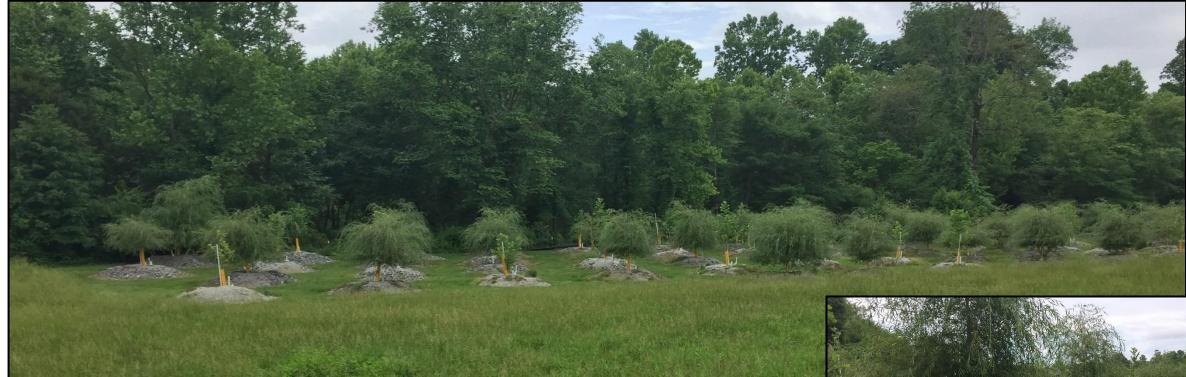
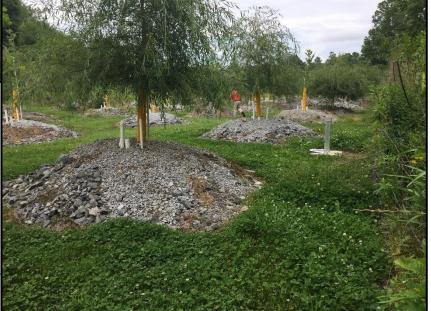
Case Study 2: System Progress

- Vigorous plant growth in all three species
- Roots now relying on groundwater for irrigation needs
- In general, all plants have more than doubled in size
