Demonstrating Contaminant Biodegradation in Conjunction with Colloidal Activated Carbon Remediation Technologies

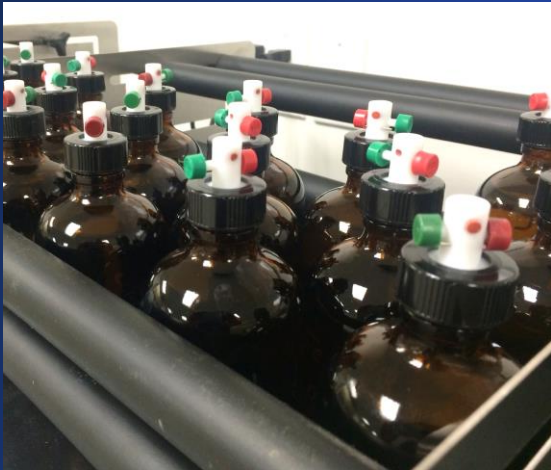
Test 1: PCE Microcosm study

- Monitor degradation based on contaminant mass

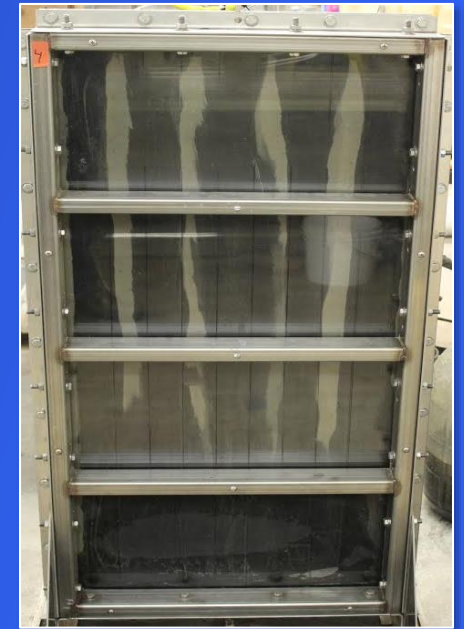
Test 2: Simulated back diffusion tank study

- MBTs
- Lines of evidence

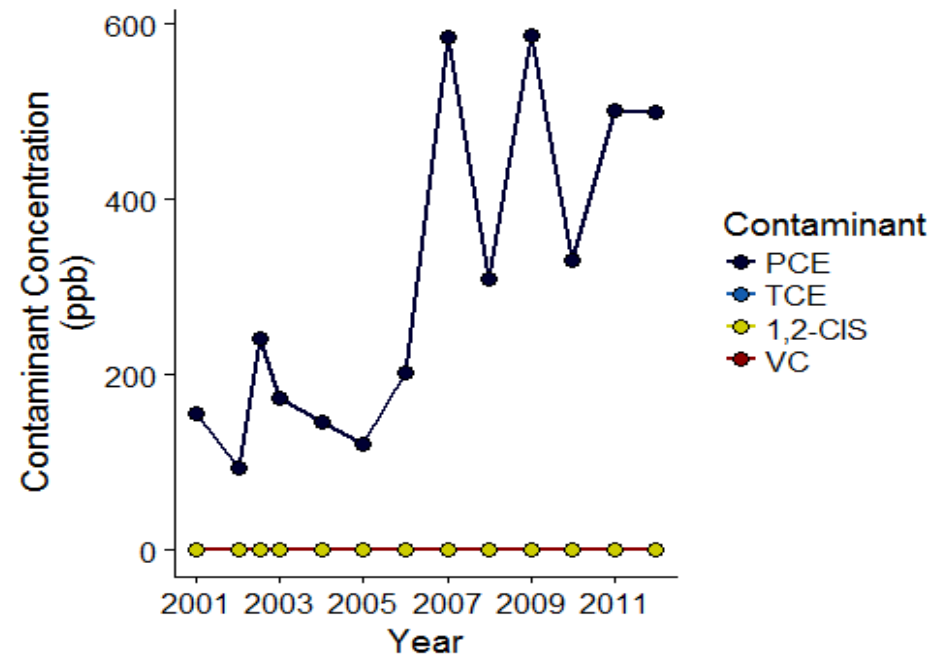
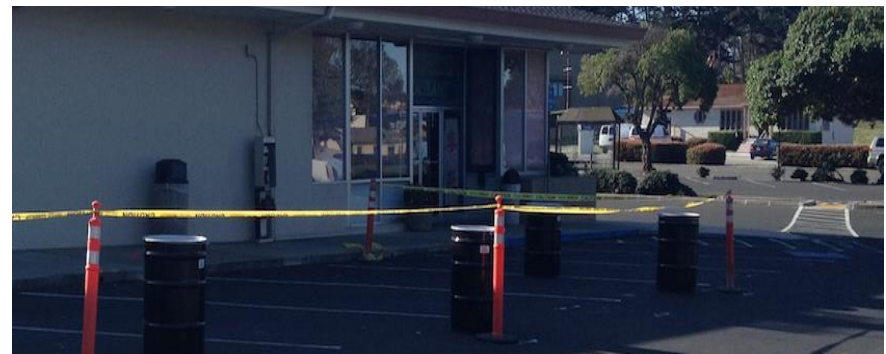
Case Study 1 - Introduction

- No Daughter Products (since 2001)
- No Detected Dehalogenating Bacteria
- No Attenuation
- Sandy Aquifer
 - 10 m/yr GW Flow

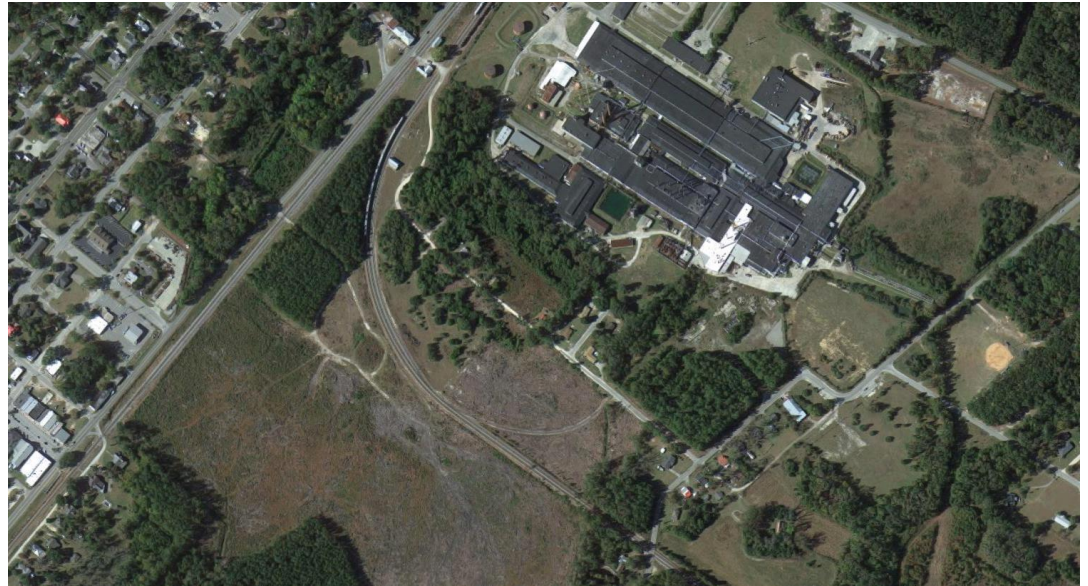
Case Study 2 - Introduction

- Former Manufacturing Facility (began in 1950s)
- Degreaser
- Coastal Plain Sediments
- Groundwater Flow of ~ 9 m/yr
