Eva L. Davis U.S. Environmental Protection Agency, Ada, OK, USA

Background

Defining the Target Treatment Area for Thermal Remediation

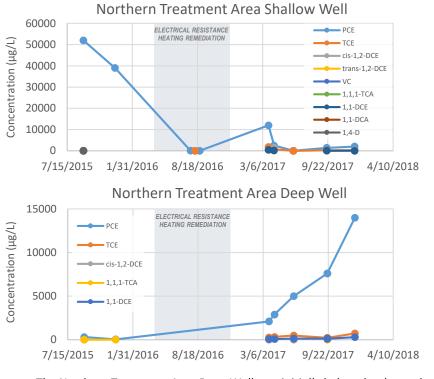
PCE-Contaminated Site Remediated using ERH

At another Superfund site, one source zone (mainly PCE) was successfully remediated using Electrical Resistance Heating (ERH) as can be seen in the source zone well that continues to show concentrations that are not indicative of DNAPL presence. However, other source zones to the north and south have re-contaminated sections of the thermal treatment area.

The Northern Treatment Area Deep Well was initially below the thermal treatment area, as it did not contain significant PCE concentrations. The actual location of the source zone creating the plume seen in the graph is not known.

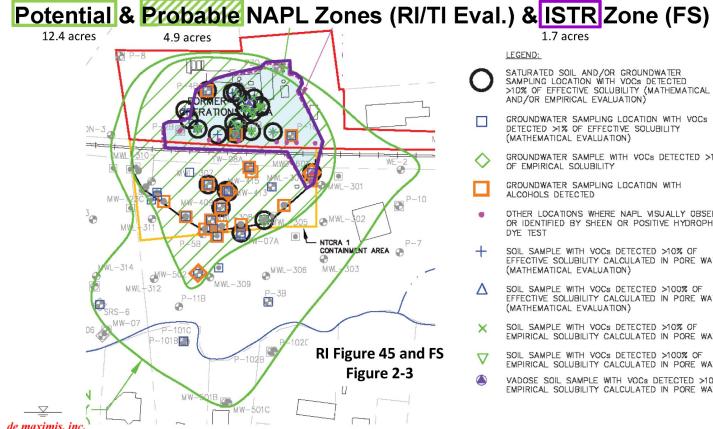
Overburden NAPL Zone Delineation

What type of data should be used to define NAPL area? For this Superfund site, a potential NAPL area was delineated based on groundwater results where VOCs were detected at > 1% of their effective solubility. The probable NAPL area was delineated based on the detection of alcohols in groundwater. Alcohols were believed to be degradation products of the VOCs that were only detectable close to NAPL, as they were then biodegraded themselves. The thermal treatment zone was delineated based on where NAPL was observed in soil cores, with substantial help from oil red dyes.

- Prepared by testing standard samples with site soil and known NAPL saturation (1% to 30%)
- Visual screening with shake tests, pan "smear" tests using Oil Red O
- Direct-push cores on ~20' centers
- Logged residual and pooled NAPL

Was this definition of the thermal treatment area adequate?

Yes – This graph of influent concentrations to the P&T system shows that when in situ thermal treatment (ISTR) ended, the influent concentrations decreased substantially, and continued to decrease overall. Two years after thermal treatment ended, chlorinated VOCs are no longer found in the influent, and petroleum hydrocarbon VOCs have decreased to less than 10 kg/year. This is a good indication that essentially all the NAPL was successfully removed from the source zone. The criteria of visible NAPL (aided by Oil Red O dye, see below) was used successfully to delineate the NAPL-contaminated area.

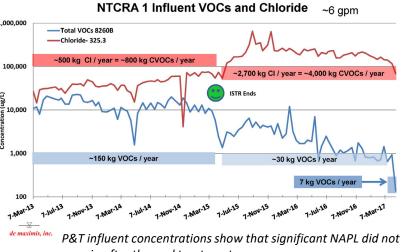
- GROUNDWATER SAMPLING LOCATION WITH VOCS DETECTED >1% OF EFFECTIVE SOLUBILITY MATHEMATICAL EVALUATION)
- GROUNDWATER SAMPLE WITH VOCs DETECTED >1% OF EMPIRICAL SOLUBILITY
- GROUNDWATER SAMPLING LOCATION WITH ALCOHOLS DETECTED
- OTHER LOCATIONS WHERE NAPL VISUALLY OBSERVED OR IDENTIFIED BY SHEEN OR POSITIVE HYDROPHOBIC
- SOIL SAMPLE WITH VOCS DETECTED >10% OF EFFECTIVE SOLUBILITY CALCULATED IN PORE WATER MATHEMATICAL EVALUATION)
- SOIL SAMPLE WITH VOCS DETECTED >100% OF EFFECTIVE SOLUBILITY CALCULATED IN PORE WATER MATHEMATICAL EVALUATION)
- SOIL SAMPLE WITH VOCS DETECTED >10% OF EMPIRICAL SOLUBILITY CALCULATED IN PORE WATER
- SOIL SAMPLE WITH VOCS DETECTED >100% OF EMPIRICAL SOLUBILITY CALCULATED IN PORE WATER
- VADOSE SOIL SAMPLE WITH VOCS DETECTED >100% OF EMPIRICAL SOLUBILITY CALCULATED IN PORE WATER

remain after thermal treatment

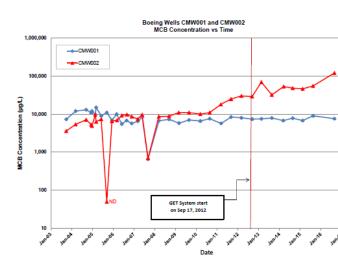
DNAPL can migrate for a long time & travel long distances

It's not uncommon for NAPLs to continue migrating. Recent characterization data of NAPL extent is required to ensure that essentially all of the NAPL contaminated area is within the thermal treatment area. One option is to install borings/wells as the system is being designed. Another option is to complete the characterization after the system is designed and as the system is being constructed. This option has resulted in significant increases in the treatment area, requiring significant redesign, particularly of energy requirements. These options have an advantage in that spacings between borings/wells for remediation are often closer than boring spacings used for characterization.

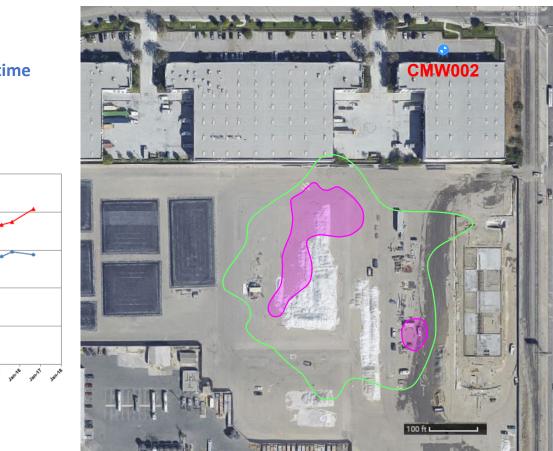
Despite belief that NAPL and plume were not migrating, they were!

2.5 million pounds recovered by SEE Estimated that as much remains in the ground

I'm commonly told that NAPLs in the subsurface are not migrating, thus they do not pose a risk. I now have definite proof of continued NAPL migration at two different sites. At the former Williams Air Force Base, at the time that the steam enhanced extraction (SEE) system was planned, it was believed that the jet fuel at depth was largely contained within the light blue area shown (with the exception of well W-37 to the southeast). However, as the system was installed, LNAPL was found to extend to the edges of the light blue area, which changed the design of the SEE system from outside-in steam injection to inside-out (perimeter wells were extraction wells). Subsequent borings determined that the LNAPL had spread considerably beyond where initially characterized to be, as shown in the dark blue. To the east the extent of LNAPL at this depth is still not fully defined. More than 2 million pounds of jet fuel were recovered by SEE, however, it is estimated that a similar amount remains in the subsurface surrounding the areas that were treated.

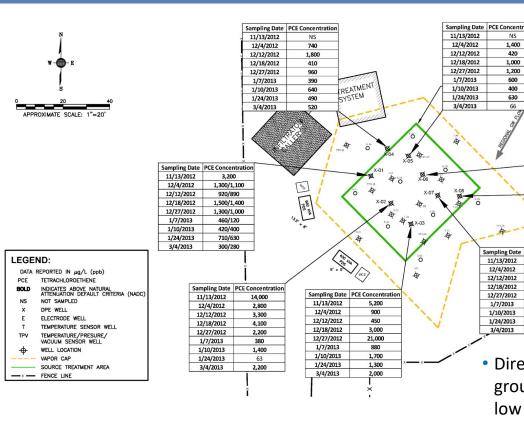
Average digiTAM Temperature by Depth

during 180 days of treatment!

1 ½ years after treatment, groundwater concentrations increasing in some wells.

- caused by:
- soils
- treatment area
- temperature not achieved at depth

Increasing groundwater concentrations likely caused by contaminant remaining below

Depth of electrodes limited by refusal – target
