Lessons Learned During DNAPL Source Zone Remediation

Erik Gustafson, PG, CHMM

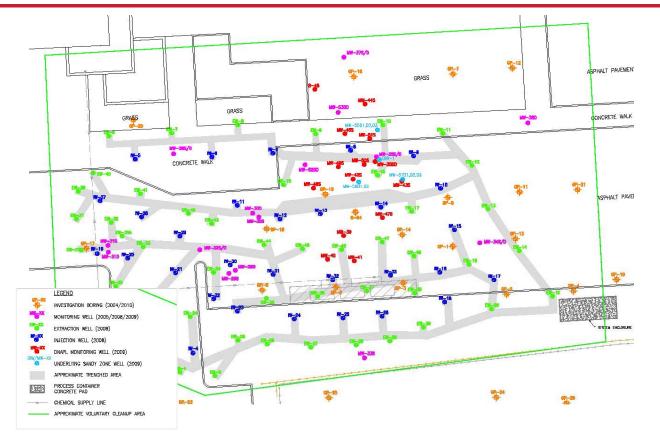
Biostimulation System (started Nov 2008)

Biosystem includes:

- 48 extraction wells
- 33 injections wells
- Total recirculation flow rate: ~1.5 GPM
- 18 monitoring wells

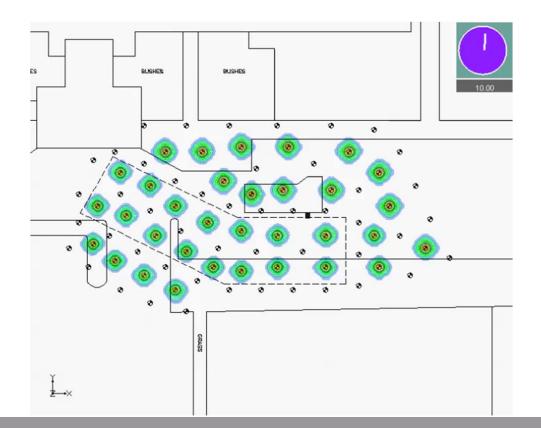
Challenge #2 – Lactate Distribution

- Modeling estimated adequate distribution of lactate after ~70 days
- Full containment of DNAPL/highly impacted groundwater

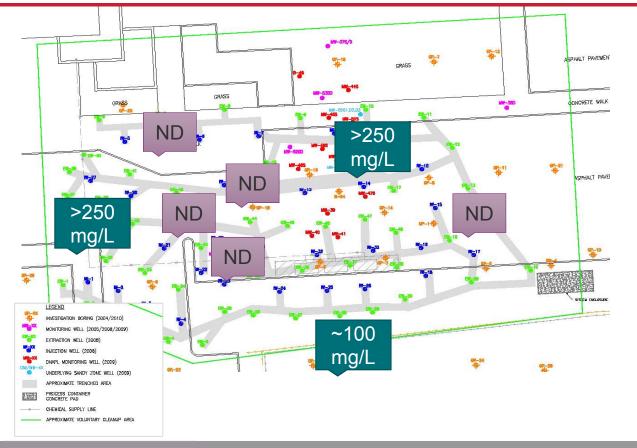
Challenge #2 – Lactate Distribution (~7 years)

Many MWs remain ND for electron donor (VFAs) after many years of operation

Contributing cause = geology complexity

- Preferential flow between injection and extraction wells bypassing MWs
- Consumption of electron donor higher than expected

Solution = utilize flexibility in the system to target areas

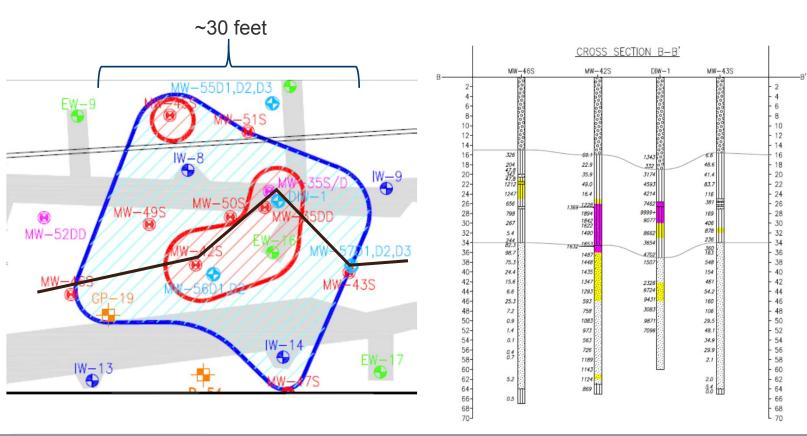
Supplemental RI (2009)

DNAPL investigation tools:

- Soil borings (8)
- Well install (17)
- Visual inspection
- Well pumping
- Lab analysis
- PID readings
- UV screening of soils

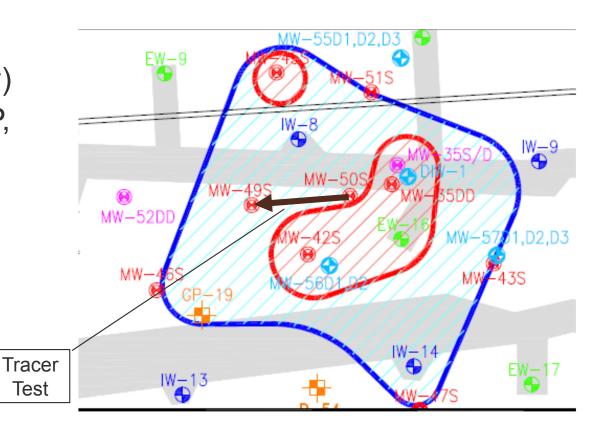
Co-Solvent Flushing Development

- Hydraulic conductivity testing (2.07x10⁻¹ ft/day)
- Tracer testing (7.7% EP, confirmed connectivity)
- Well field modeling
- Co-solvent bench scale testing (ethanol vs. methanol)
- Evaluation of DNAPL migration

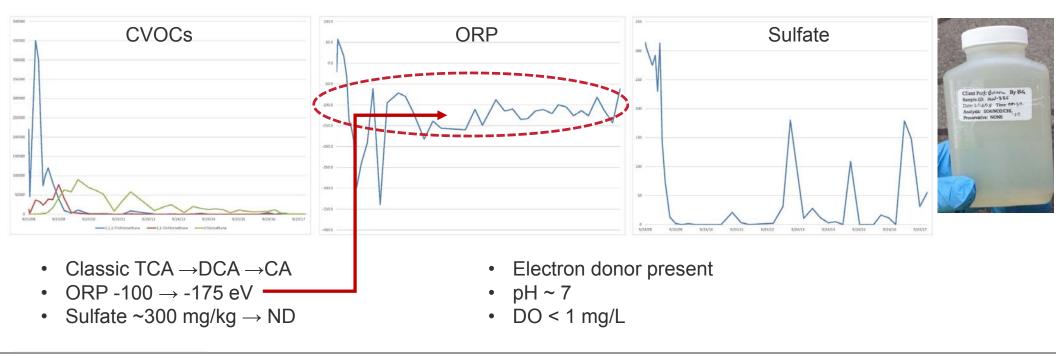
MW-33S

Challenge #4 – Evaluating Biological Activity

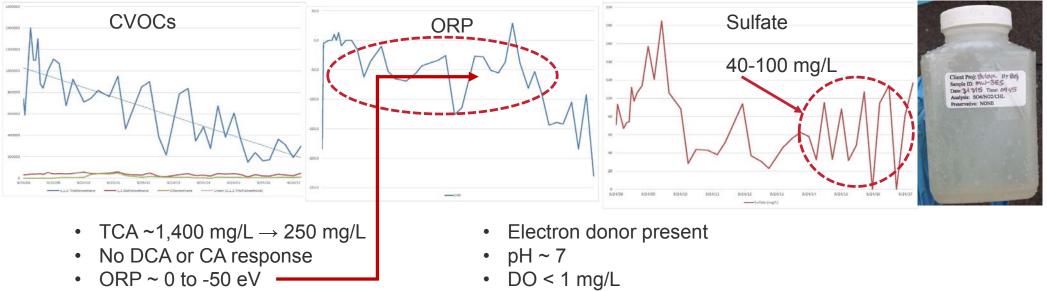
MW-35S

Sulfate remains elevated

- Free hydrogen present
