Sustained-Release Oxidants: Use of Remox SR+ Cylinders in Treatment for Chlorinated Solvents in Groundwater

Battelle – April 12, 2018

D. Grant Walsom, B.A.Sc., P.Eng., QP
Partner
XCG Consulting Limited

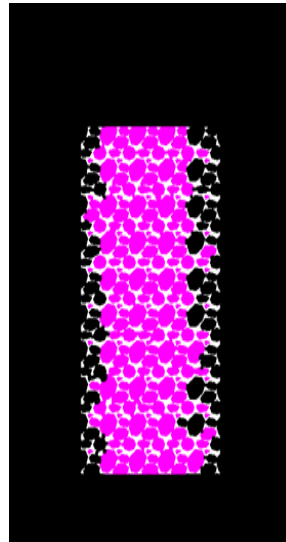
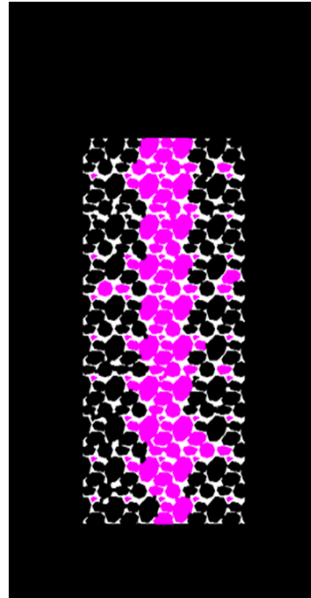
Oxidant Release from Wax

- This is why we see an initial spike of permanganate in early time...
- And a significantly slower and lower release of permanganate at later times

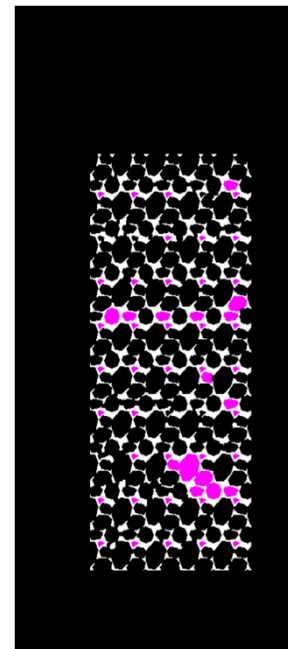
- Newly created void spaces expose permanganate solids for dissolution and diffusion
- Process occurs radially from the exterior of the cylinder to the inner core

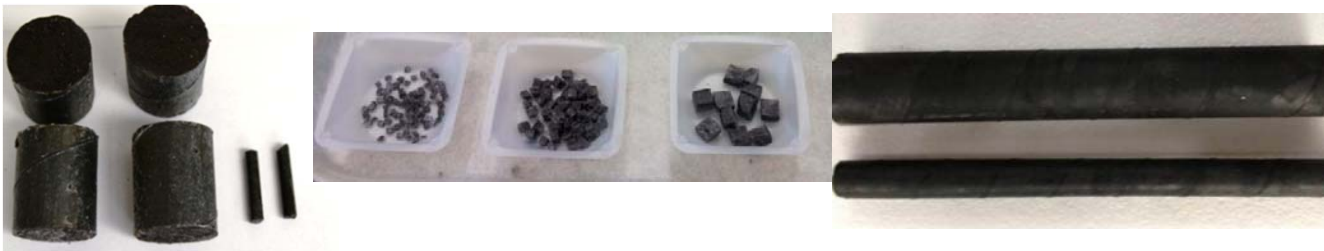
SR+ Technology - Versatility in Applications

- Cylindrical shape: 2.5" diameter x 18" long
- Application Possibilities:
 - Passive treatment- direct push, existing wells
 - Combined remedies/treatment train approaches
 - Stepped-implementation strategy
 - Minimizes above-ground infrastructure
 - Mitigate impacts of rebound, matrix diffusion, daylighting

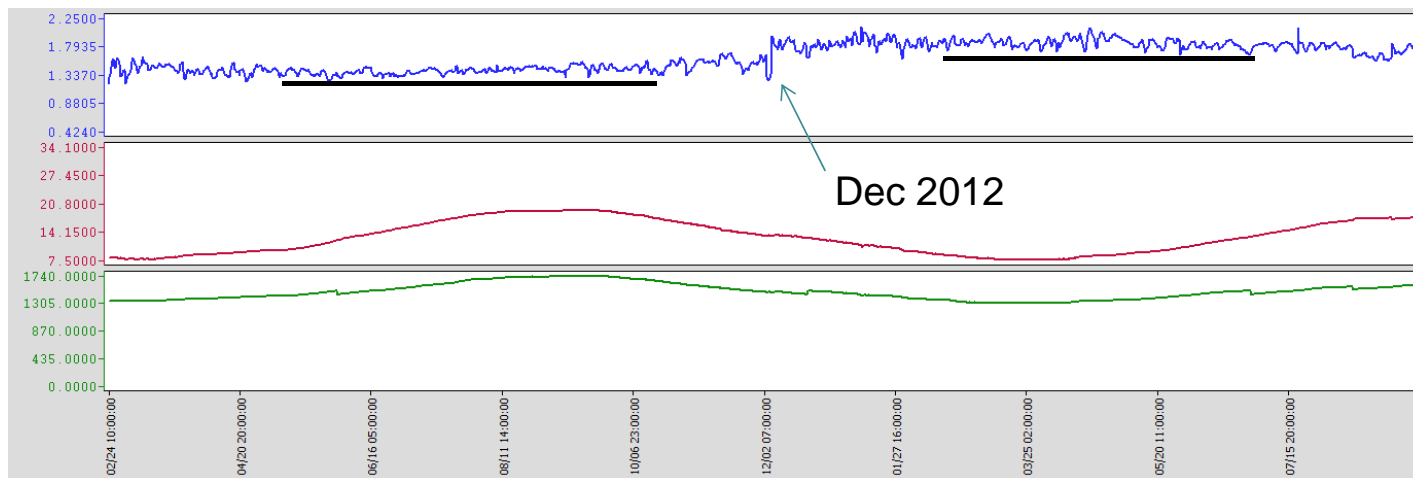
- Location MW20B – observed an almost immediate increase in electrical conductivity (distance ~ 5m)

- Hydraulic conductivity is low ... 1.27×10^{-5} m/s

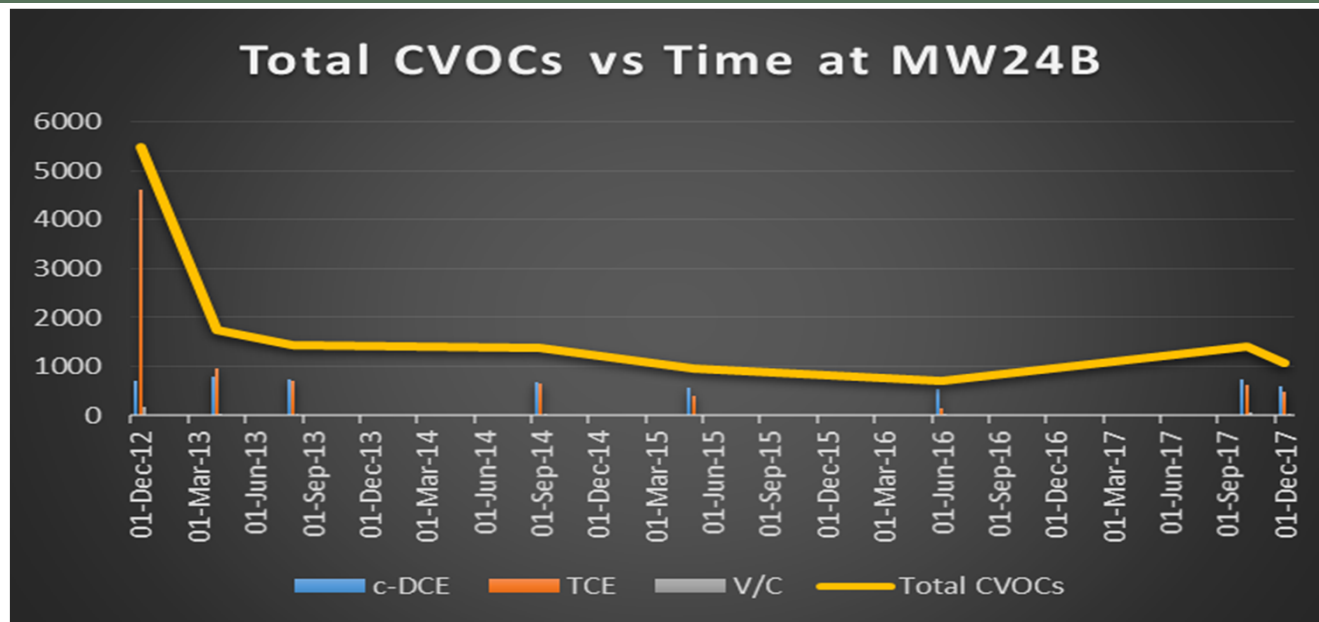
MW24B installed at 5.5 metres below ground surface, located approximately 1.5 metres from barrier

From 2013, TCE concentration decreased until 2016.

Replenished Cylinders in Barrier in Nov. 2017.

MW24B	06-Dec-12	15-Apr-13	12-Aug-13	09-Sep-14	14-May-15	22-Jun-16	17-Oct-17	22-Dec-17
c-DCE	710	790	720	690	560	540	720	590
TCE	4600	950	700	660	400	150	630	480
V/C	170	5.6	19	19	0	5.2	69	0.5

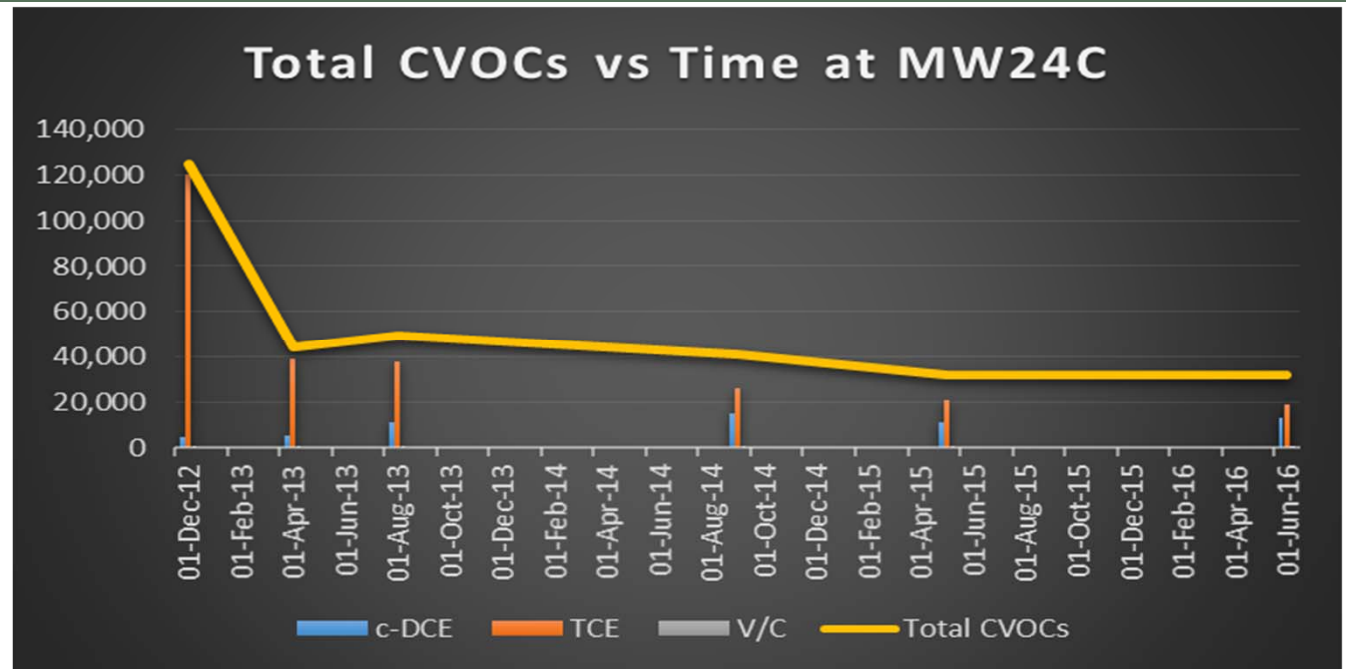
MW24C installed at 10 metres below ground surface, located approximately 1.5 metres from barrier

Since 2013, TCE concentrations continue to decrease

MW24C	06-Dec-12	15-Apr-13	12-Aug-13	09-Sep-14	14-May-15	22-Jun-16
c-DCE	4,400	5,100	11,000	15,000	11,000	13,000
TCE	120,000	39,000	38,000	26,000	21,000	19,000
V/C	260	9.2	270	150	10	16

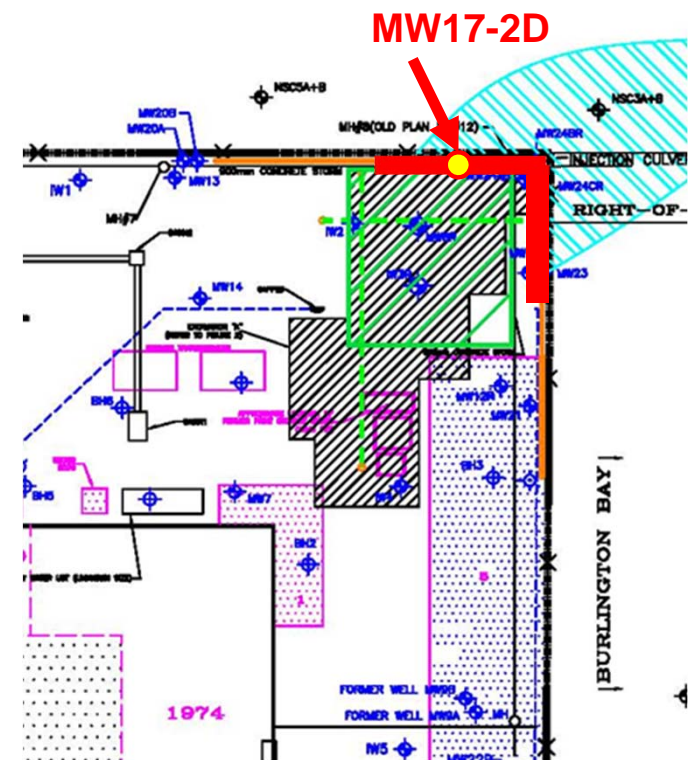
- Initial Barrier calculated active for 4 - 5 yrs
 - Client and site owner pleased with results
- Replenished Barrier in Nov 2017
 - RemOx SR+
 - Smaller **barrier** designed due to improvements in groundwater quality in fringes of plume (depth of 5 metres)
 - 228 cylinders in 57 direct-push boreholes over 5 days

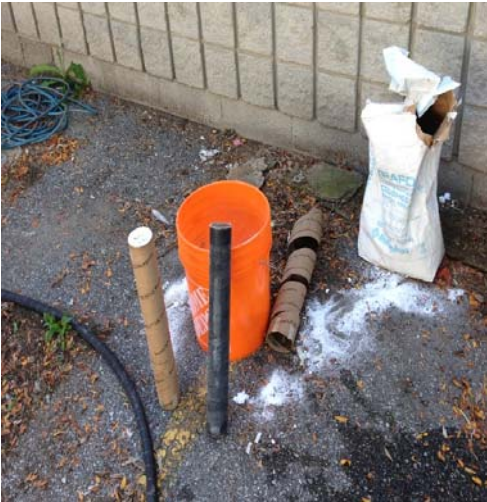
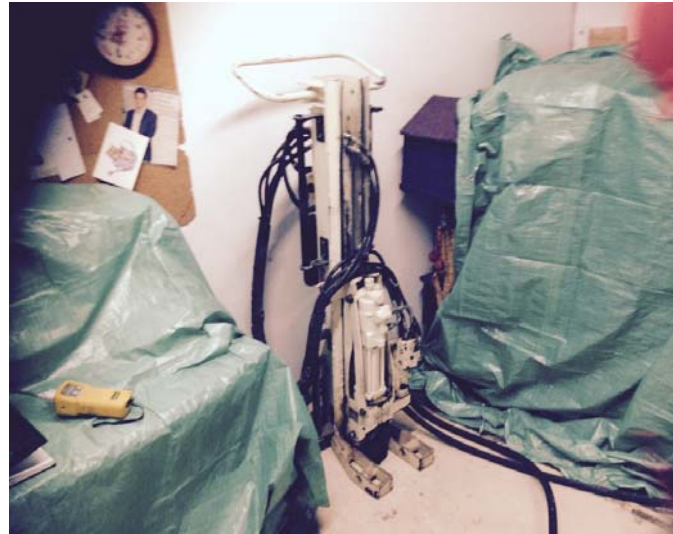
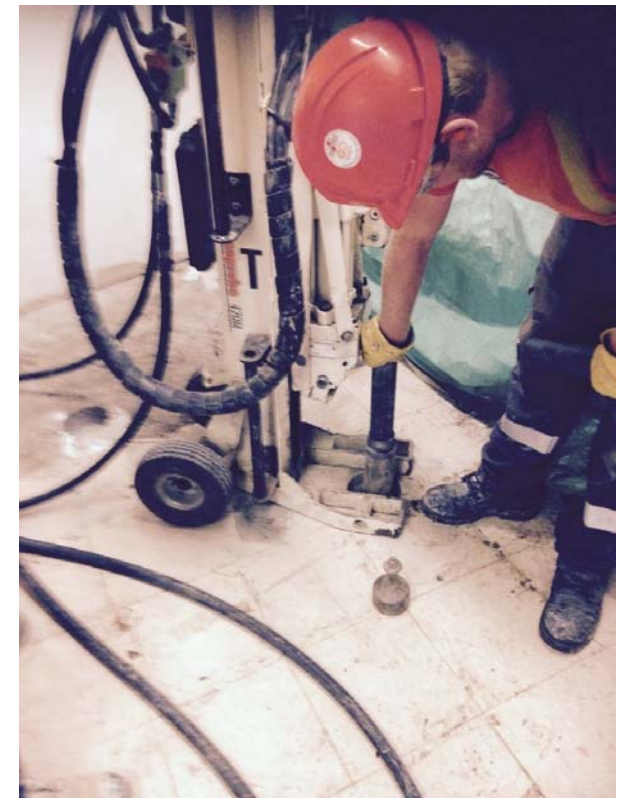
- Placement of Remox SR+ cylinders in Boreholes

5 boreholes with 2 cylinders each; depth of 2.5 m

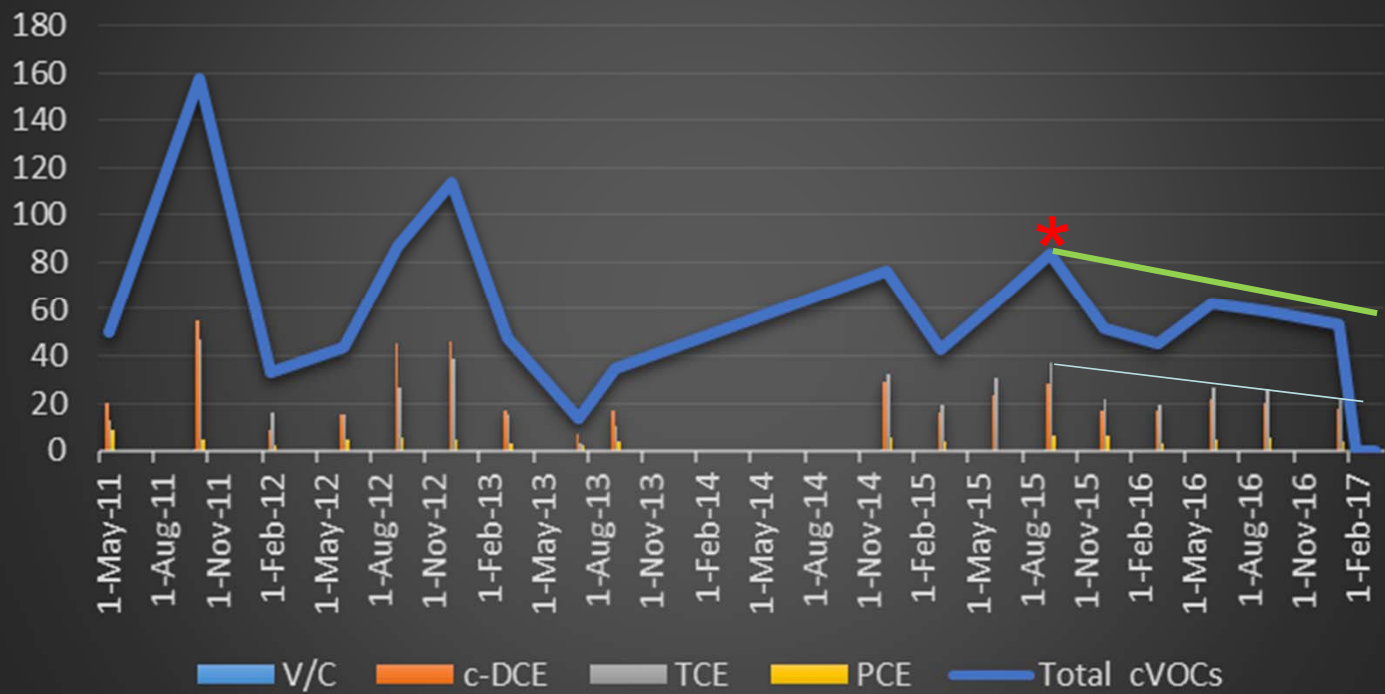
Total cVOCs vs. Time at MW4

- TCE before Installation
 - **37 µg/L**
- Within 6 months
 - **19 µg/L**

MOECC
Table 3 Standard
for TCE
is 17 µg/L
