Performance of Combined Bioremediation and ZVI Emplacement Remedy for Chlorinated Solvent Source Area Treatment

Bountiful/Woods Cross Operable Unit 1 Superfund Site

Eleventh International Conference on Remediation of Chlorinated and Recalcitrant Compounds
April 8-12, 2018 | Palm Springs, California

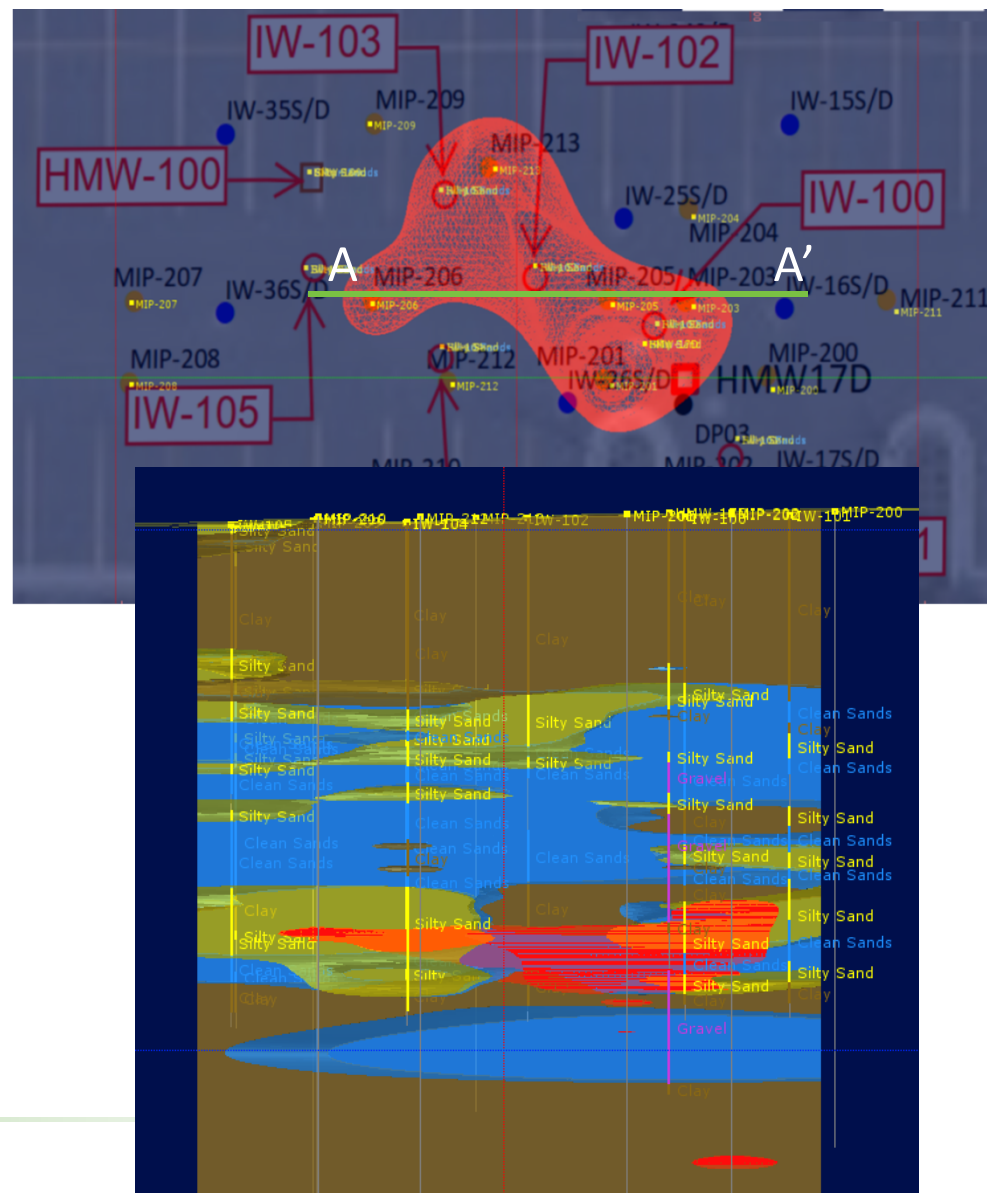
Source Area Characterization

- MIP/EC logging
- Leapfrog® 3D to visualize high-concentration source mass and lithology
- VOC mass was present in low-K layers and in interbedded silty sands
 - Depth intervals between 35 and 70 feet
- Depth-discrete GW samples confirmed up to 7,000 µg/L VOCs in deeper (60-75 ft) interval

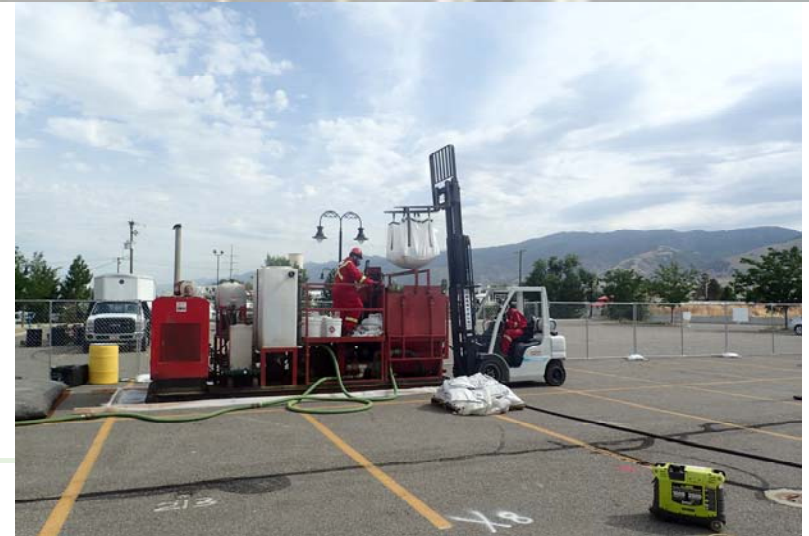
Permeability Enhancement Approach

- Create a dense network of relatively small fractures
- Eight boreholes, each with between 3 and 6 fractures
- Each fracture contained:
 - 140 gallons of slurry
 - 550 pounds of iron (C.E.R.E.S. micro-scale iron)
 - 550 pounds of 20/40 silica sand proppant
- Total of 39 fractures emplaced

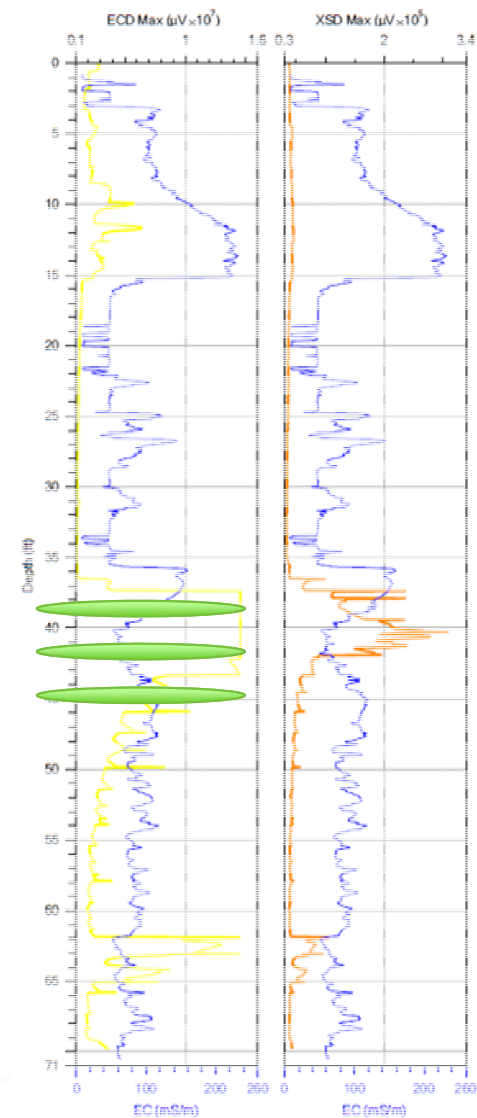
Permeability Enhancement and ZVI Emplacement

- Depths for fracture initiation determined based on MIP logs and 3D visualization
- Planned to follow up with biorecirculation through fracture network

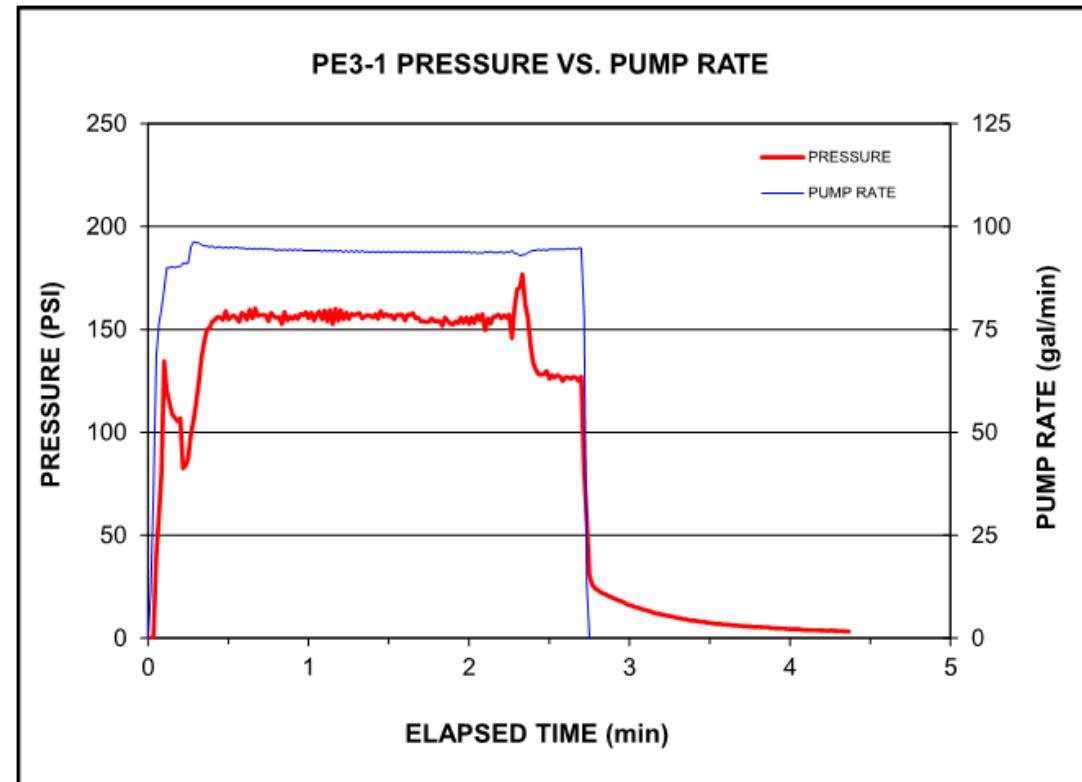
Permeability Enhancement Implementation – Pressures and Flow

- Fracture initiation pressures ranged from 80 – 240 psi
- Propagation pressures ranging from 105-220 psi
- Pump rate 80-110 gpm

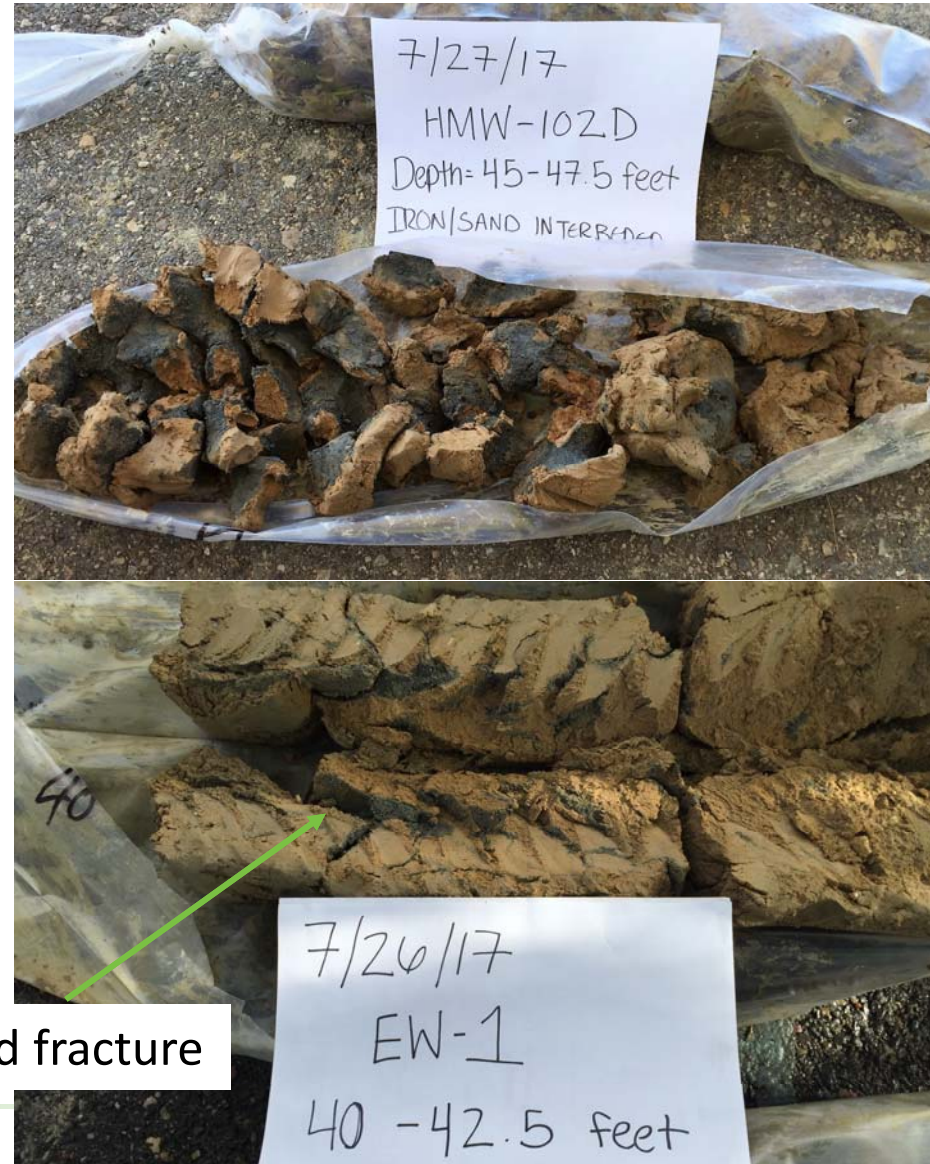
Sand and iron filled fracture

- Iron presence in boreholes within target treatment area
 - Boreholes 5-12 feet away from fracture initiation points
 - Fractures with sand proppant observed
 - Leak-off of iron into sand lenses

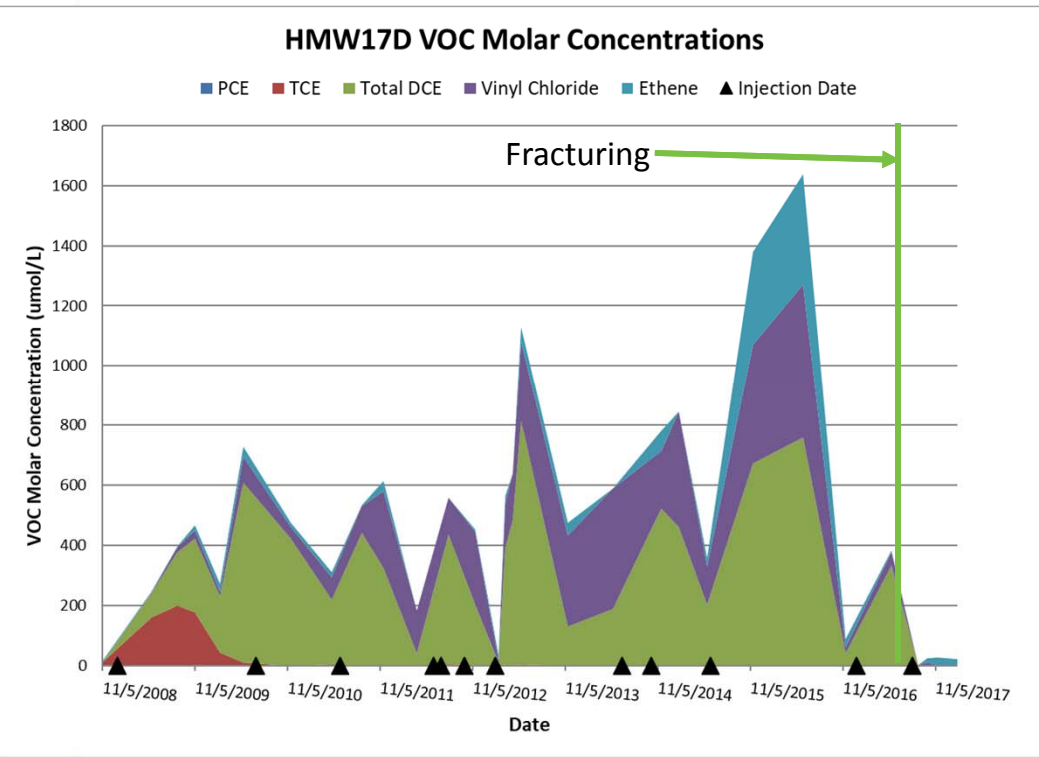
HMW-17D Area – Molar VOC Concentrations

■ Complete Data Set

■ Post-Fracturing
