## Shoreline Remediation of Petroleum Hydrocarbons Using an Oleophilic Bio Barrier for Sheen Control

Battelle Conference

Jeff Gentry, P.E. Jacobs  
Scott Martin, P.G. Kinder Morgan  
Keith Sheets, Jacobs  
Dr. Tom Sale, Colorado State University  
April 2018

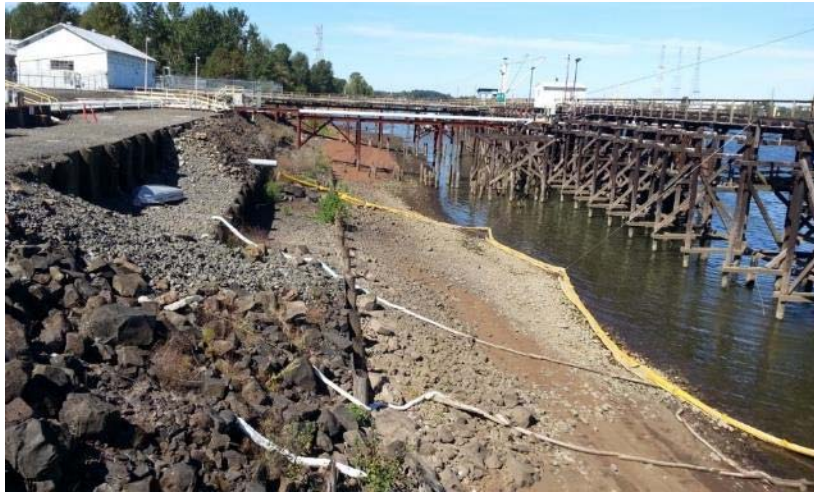
**Low Water**

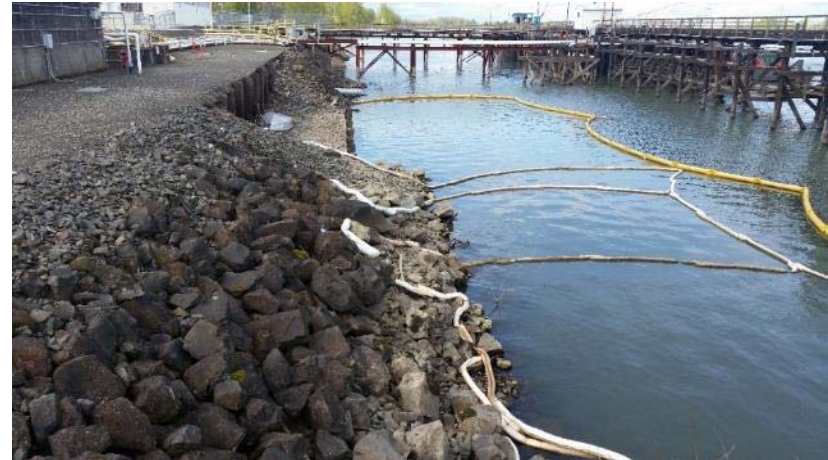
**High Water**

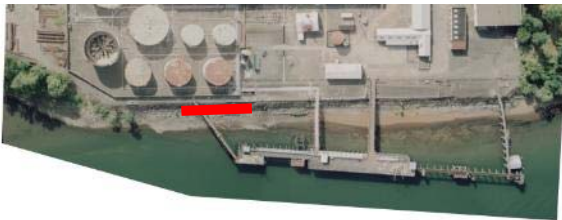
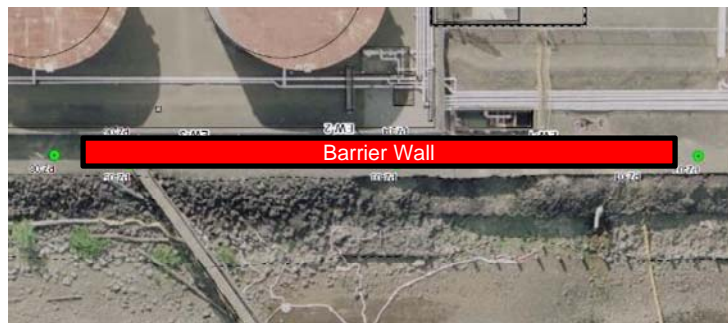
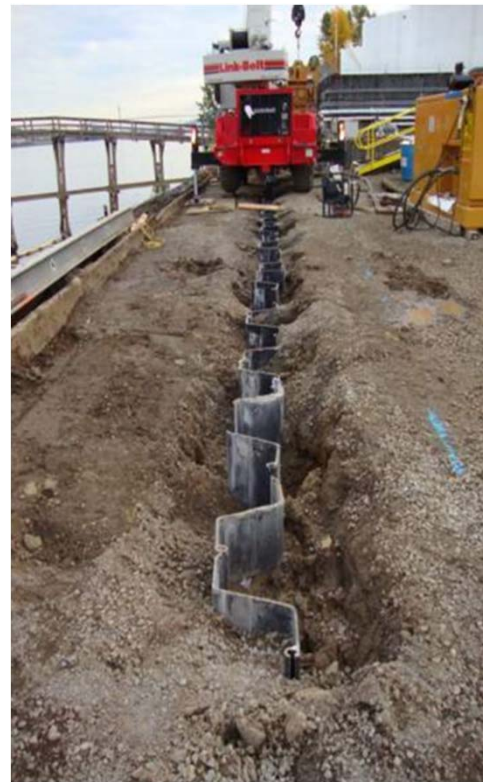
- Barrier wall installed to block NAPL flow path to the river
- Fiberglass sheet piles with Viton seals
- Bottom penetrated silt underlying silt layer
- Sheets not meeting target depth were grouted to the silt layer

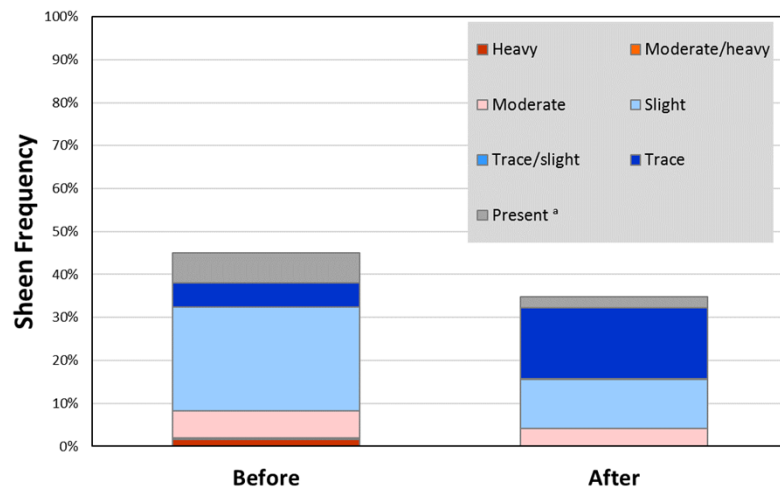
- Heavy sheens no longer observed, trace sheens still present

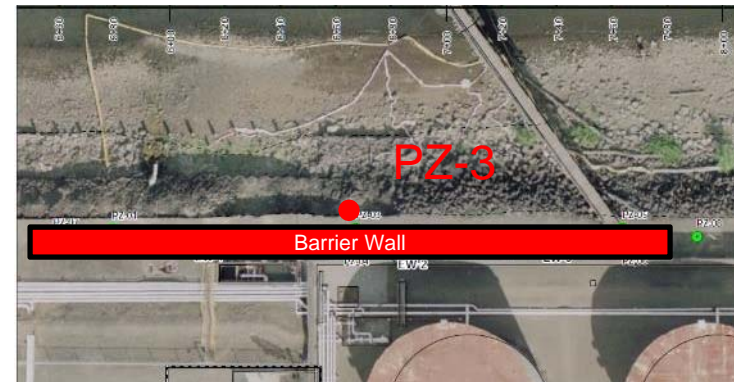
- Downgradient piezometer have LNAPL accumulations, what does that data tell us

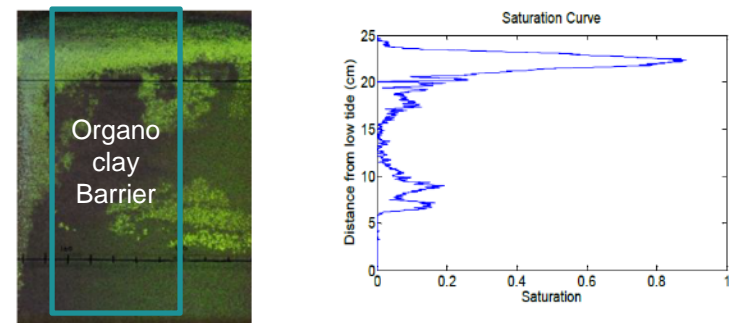
Figure 25. First organoclay barrier experiment at failure, showing preferential flow and the corresponding saturation curve obtained from transformation of the digital image to LNAPL saturation.

- ROD prescribed organoclay caps for NAPL control
- CSU Research demonstrated organoclay barriers could experience early breakthrough at water table
  - Organoclay lowers water table and creates a trough where LNAPL can accumulate
  - LNAPL can imbibe across the air water interface

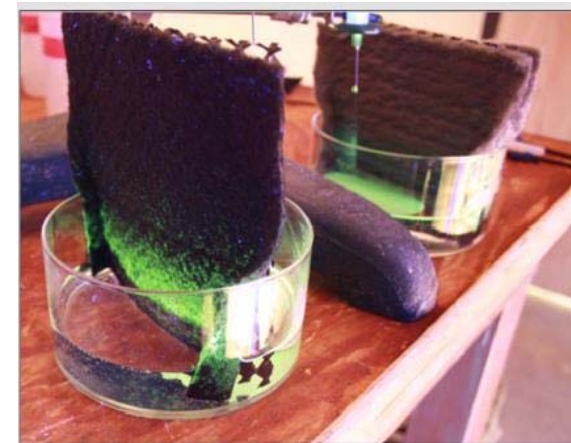
Polymer geocomposite wicking hydrocarbons

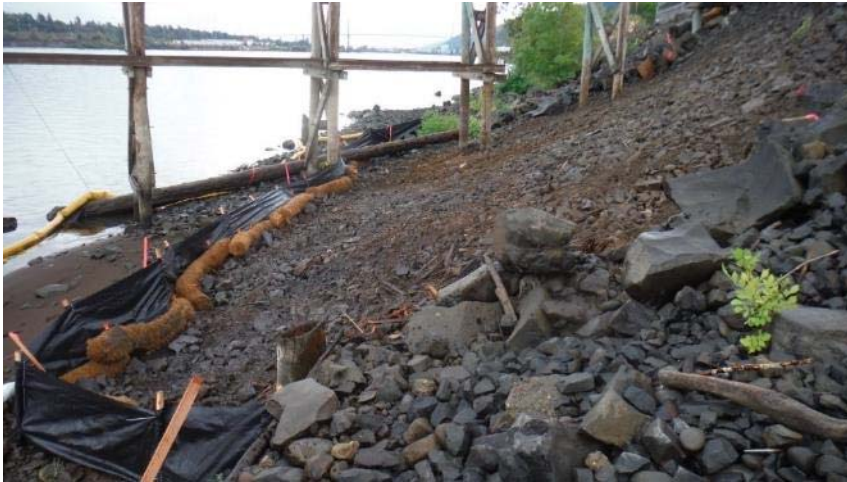
Remove existing rip rap.  
Level slope with granular fill

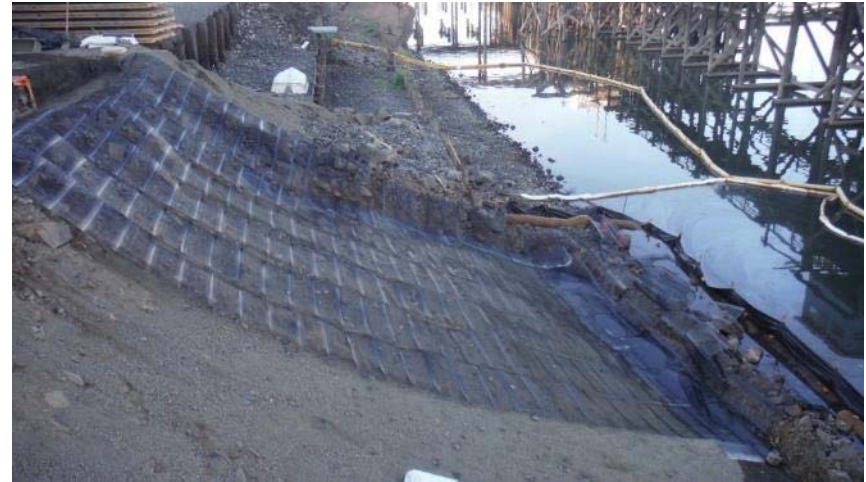
Install geogrid in anchor trench

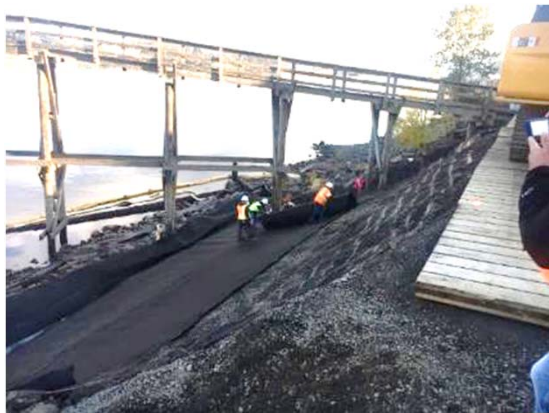
Grade geogrid level  
layer crowned in middle

Install Oleophilic Bio  
Barrier with overlaps

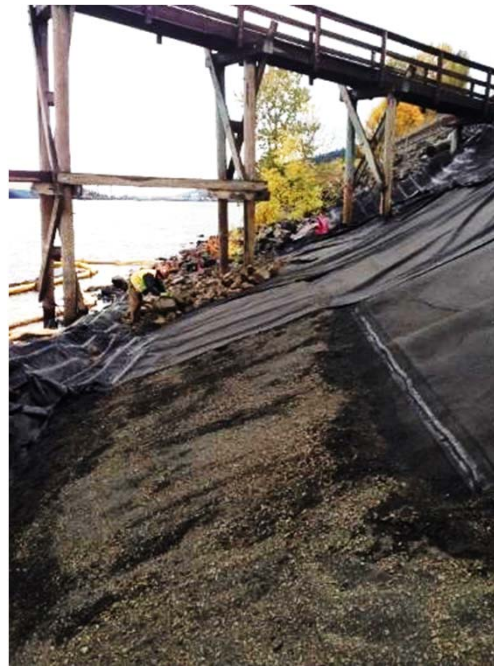
Place carbon –  
granular fill mixture

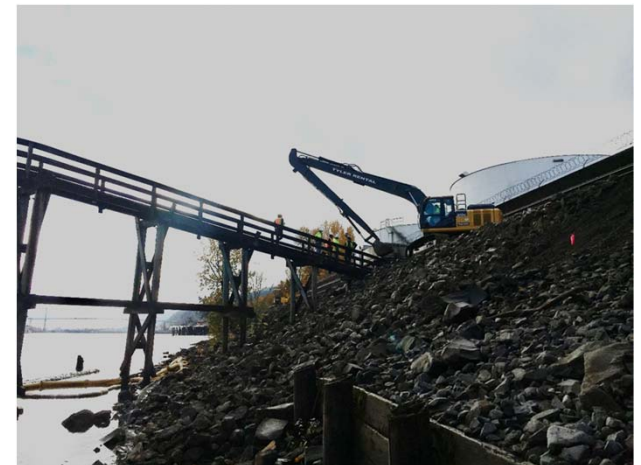
Place reused and new  
rip rap
