Evaluating LNAPL Mobility and Transmissivity: A Route to Closure

Sharon Drummond

April 11, 2018

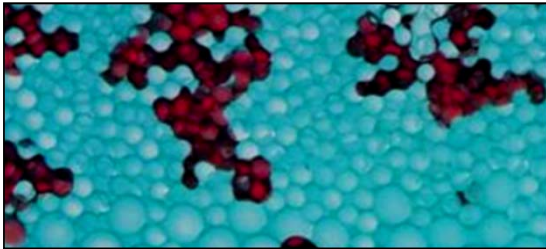
Residual LNAPL

- Small, disconnected droplets and ganglia
- Immobile
- Does not flow into well

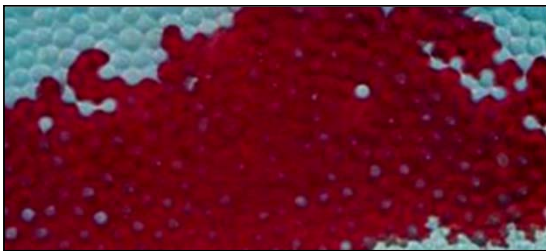
Mobile LNAPL

- Any saturation exceeding residual
- Connected pore spaces
- Does not migrate unless significant driving force

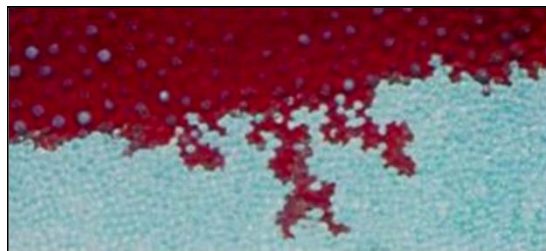
Migrating LNAPL

- An LNAPL body that is observed to spread or expand laterally or vertically or otherwise result in an increased volume of the LNAPL extent

Experimental photos (after Schwille, 1988)

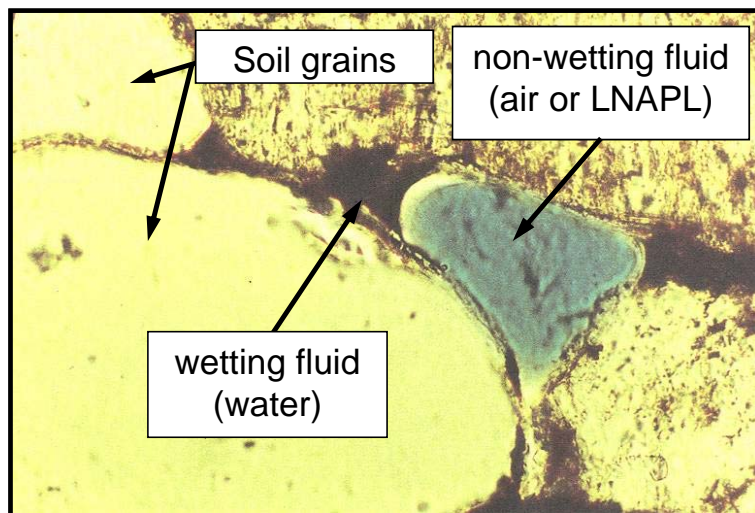
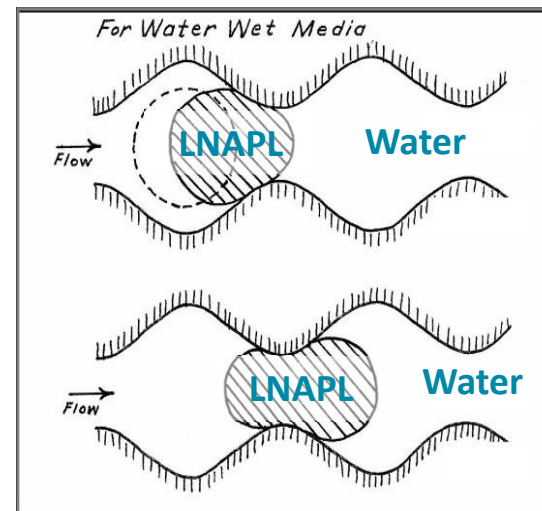
Pore Entry Pressure

- LNAPL will only move into water-wet pores when the entry pressure (resistance) is overcome

Pressure gradient is too low (immobile)

Pressure is sufficient (mobile)

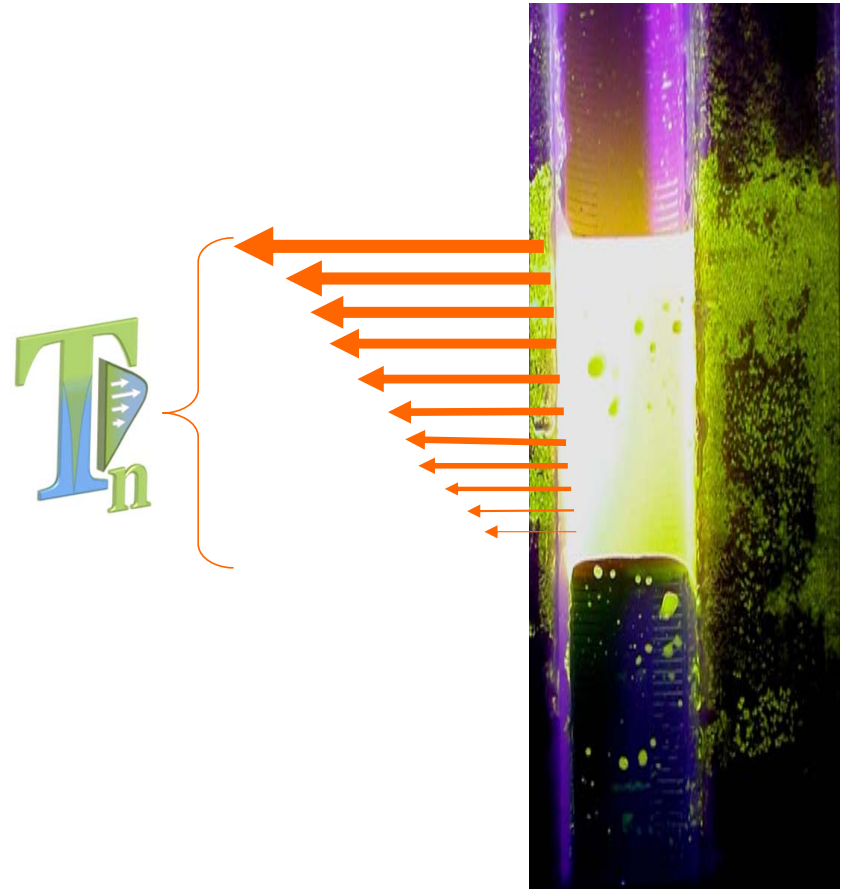
Transmissivity as an Indicator of Mobility and Recoverability

- Incorporates site-specific factors
 - LNAPL physical properties
 - Soil properties
- Proportional to LNAPL saturation
- Proportional to LNAPL mobility/recoverability
- In-well LNAPL thickness is not representative of these factors

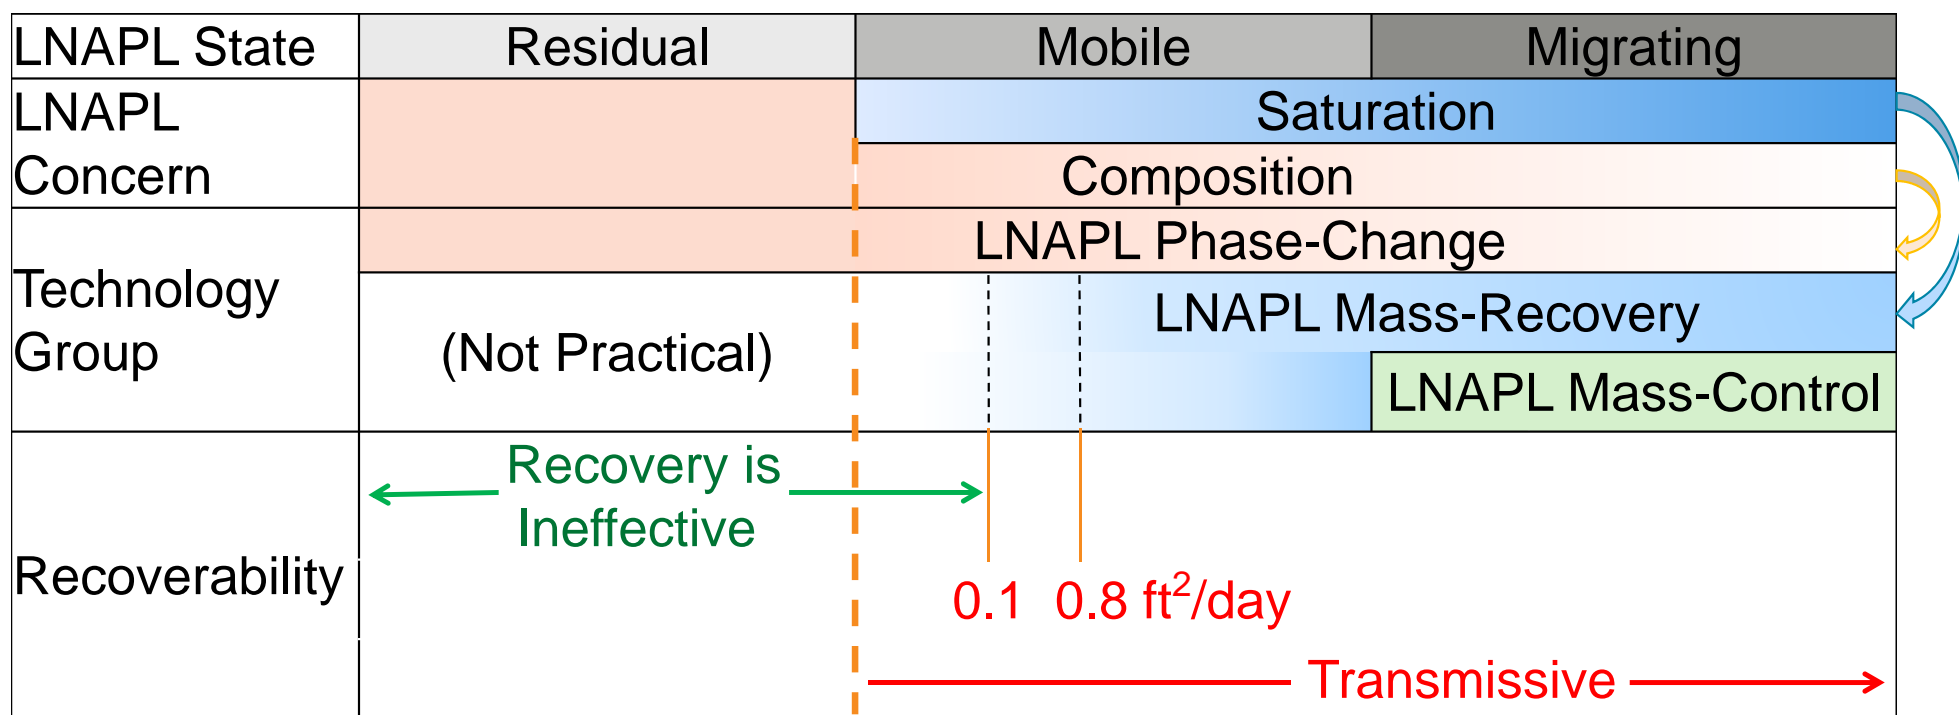
Relation of LNAPL Saturation and Composition to Technology Selection

ITRC Practicable Recovery Limit : 0.1 – 0.8 ft²/day

Source: ITRC LNAPL Update, 2018

The Interstate Technology and Regulatory Council (ITRC) states that LNAPL recovery via physical methods is not practical at transmissivity values less than 0.1 to 0.8 ft²/day.

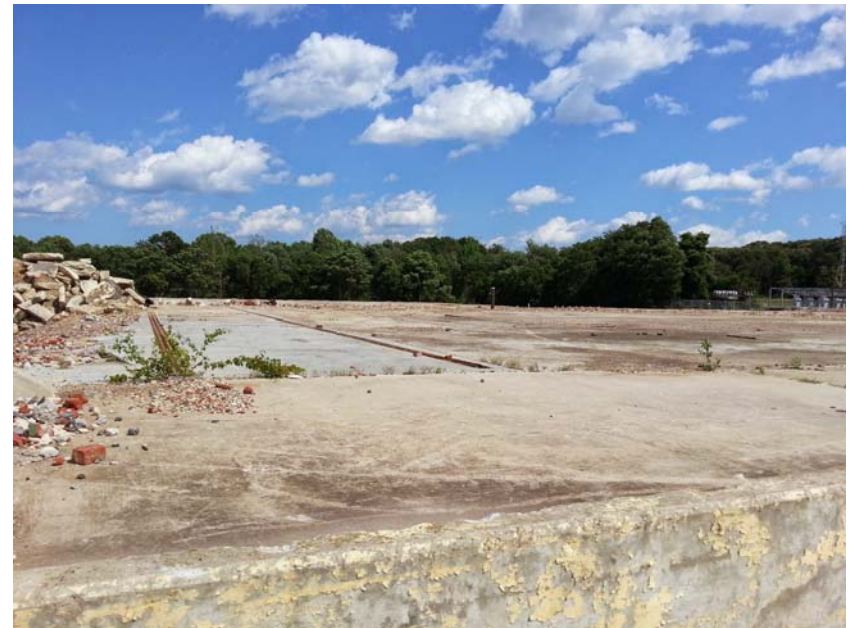
- Former manufacturing facility
- Maryland Coastal Plain
- LNAPL initially encountered during 1995 during UST abandonment
 - No. 2 fuel oil and gasoline
 - Former USTs (gasoline and diesel)
 - Former AST product lines (No. 2 fuel oil)

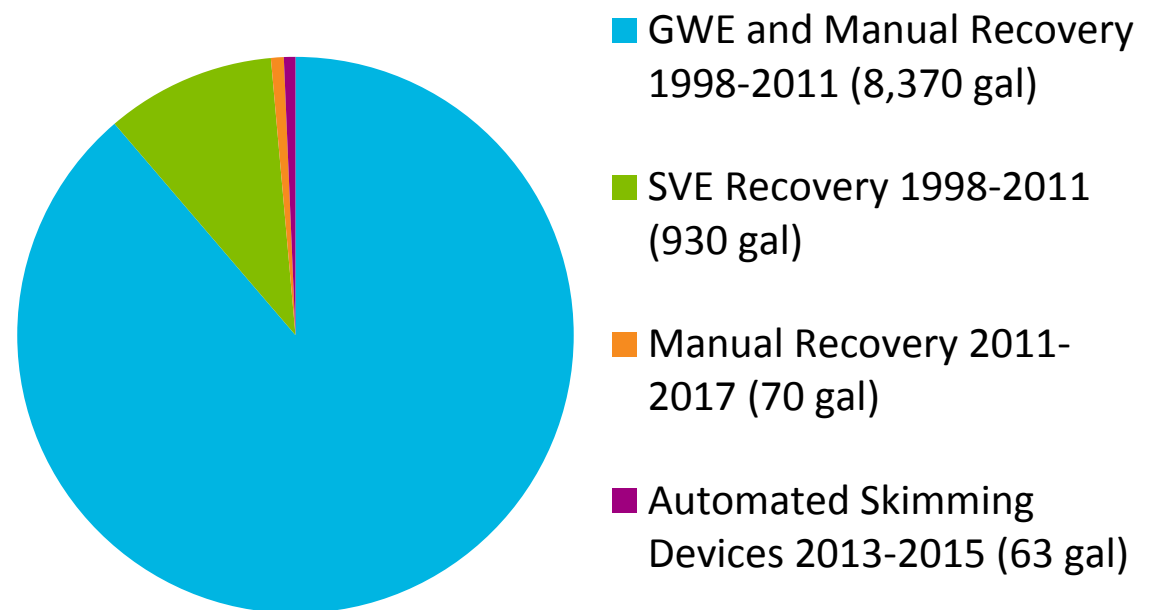
Total LNAPL Recovered

- Asymptotic recovery for all remedial phases
- LNAPL only migrated approx. 240 feet downgradient of the suspected source since release prior to 1995
- No LNAPL observed in the farthest downgradient wells

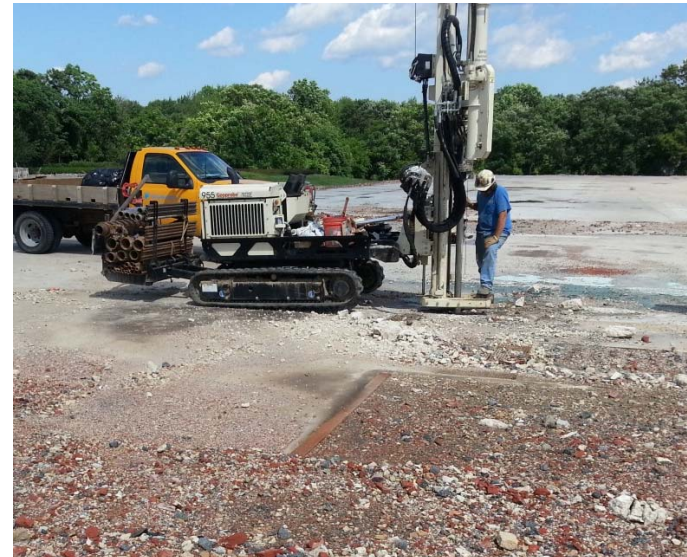
Designation: E2856 – 13

Standard Guide for
Estimation of LNAPL Transmissivity¹

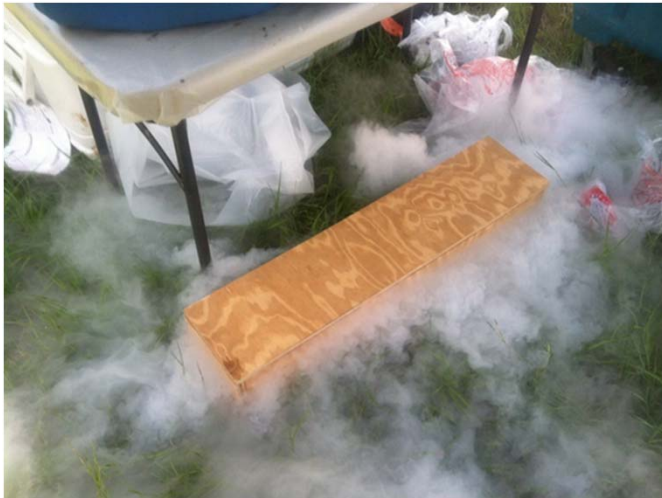
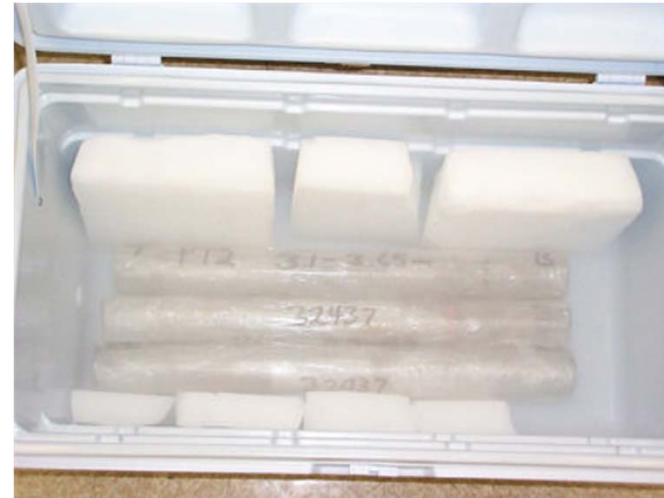
Soil Sampling

- Soil borings were advanced at eight locations to collect samples for TPH, and oil and grease analysis
- One undisturbed soil core was collected and immediately frozen with liquid nitrogen to preserve pore structures and fluid saturation

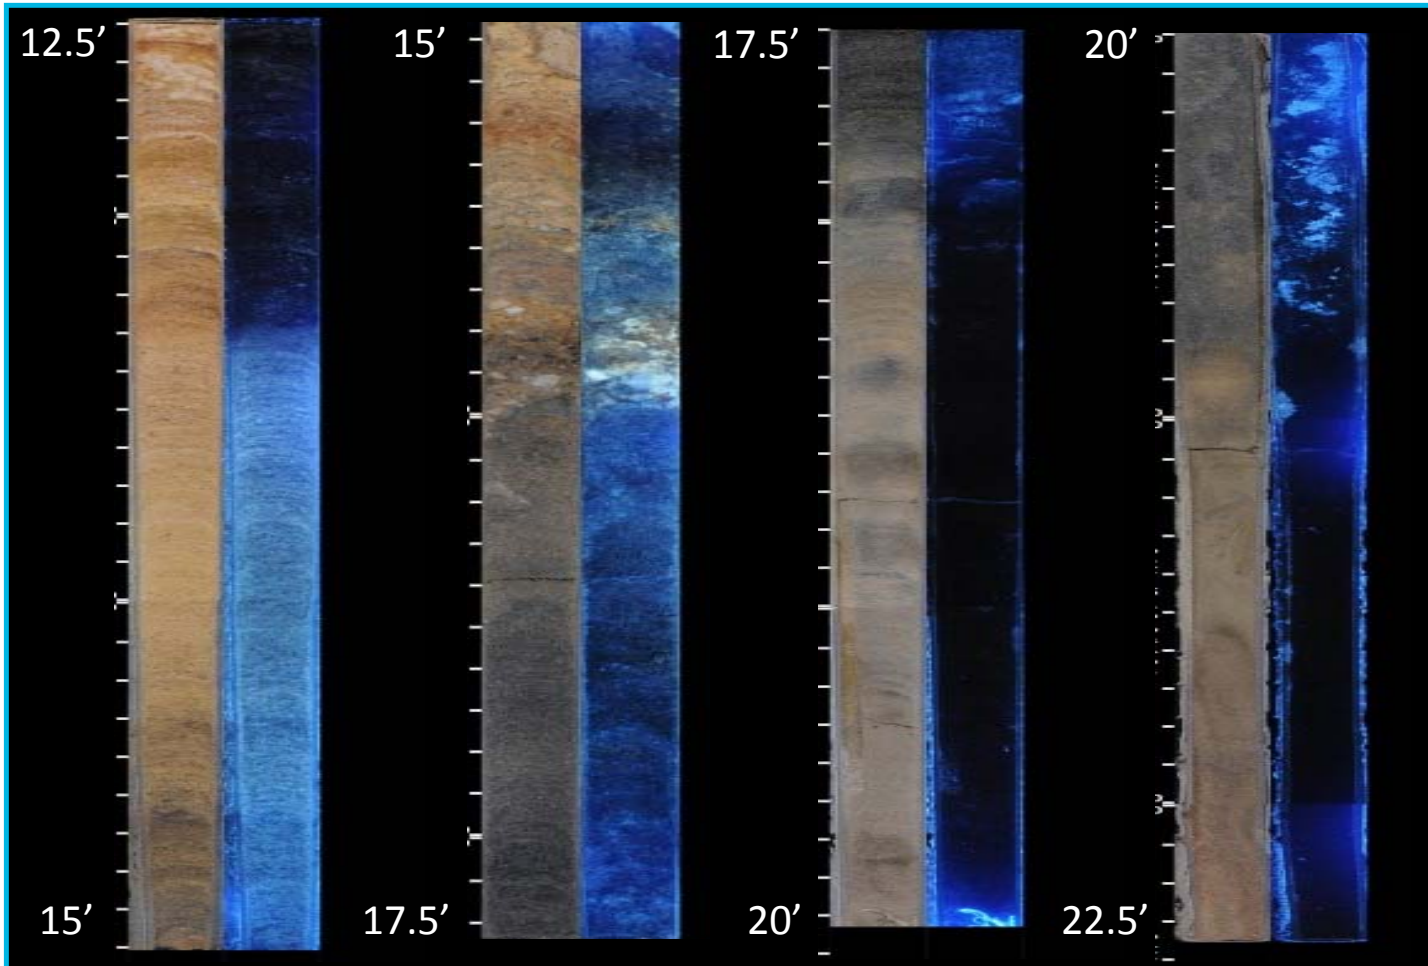
LNAPL Core Photography

Selected Analyses:

- Pore Fluid Saturation
- Grain Size
- Mobility
- Capillary Pressure

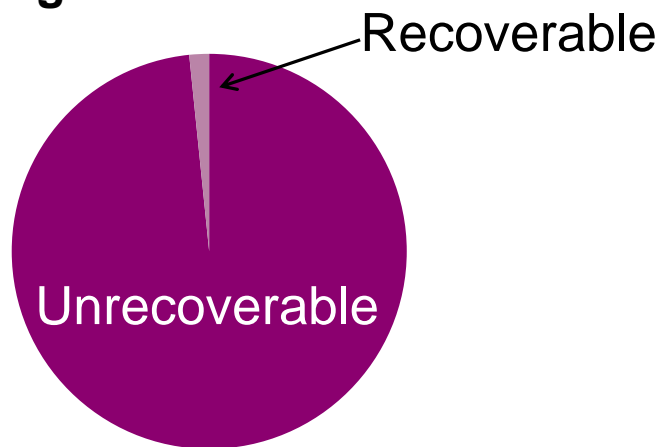
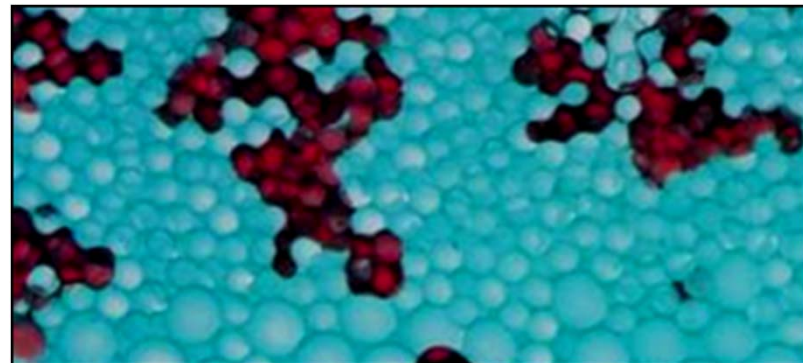
Mobile Fraction of LNAPL

- Four samples from the undisturbed core were centrifuged at 1000xG
- LNAPL saturation was measured before and after centrifuging
- Results indicate that more than 98% of the LNAPL remained within the soil

The majority of remaining LNAPL is residual.

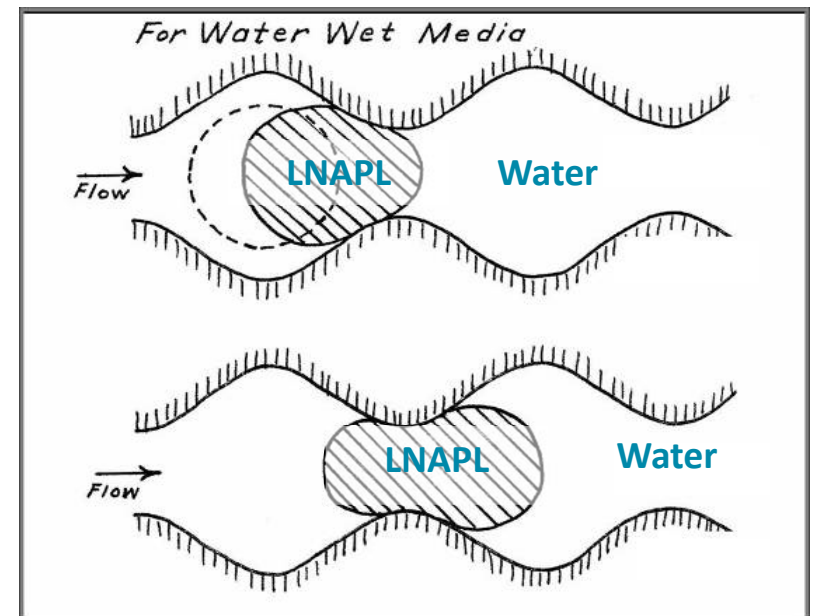
Capillary Properties

- LNAPL will only move into water-wet pores when entry pressure (resistance) is overcome
- LNAPL entry pressure head was estimated using the capillary properties of the soil
 - Thickness of over 1.9 feet is required for LNAPL to migrate

The potential for LNAPL migration is very limited.
