# **LNAPL RECOVERY AND REMEDY TRANSITIONS**

**A CASE STUDY AT A RAILYARD FUELING FACILITY**

**JEREMY COUGHLIN AND LEEANN THOMAS, CP  
ANDY PENNINGTON AND DAWN GABARDI, ARCADIS**

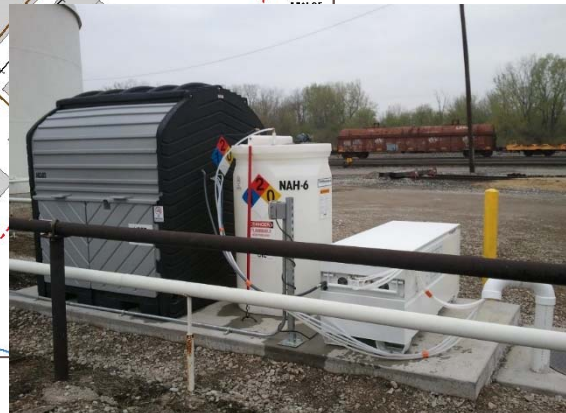
- Skimmer system installed 2011, with recovery rates tracked by well
- Vacuum enhancement in 2013 - blower connected to subsurface piping/wellheads
- No significant increase in LNAPL recovery, but significant benefit via bioventing (tracking CO<sub>2</sub> effluent)

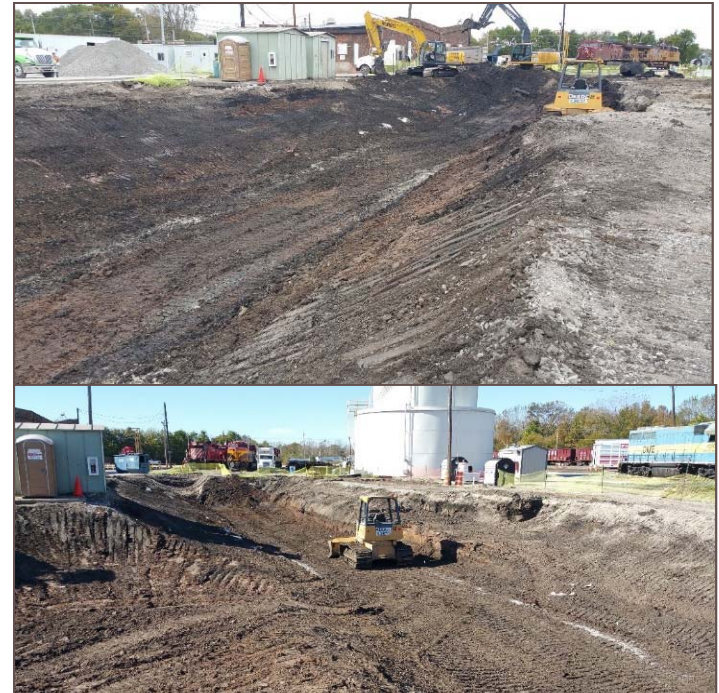
- Upgrades in 2015 removed buried piping and ~ 6,600 tons of impacted soil
- Excavation to 10 feet in main fueling area, 5 feet along buried piping runs
- Removed ~ 58,000 lbs (8,000 gals) diesel petroleum hydrocarbons

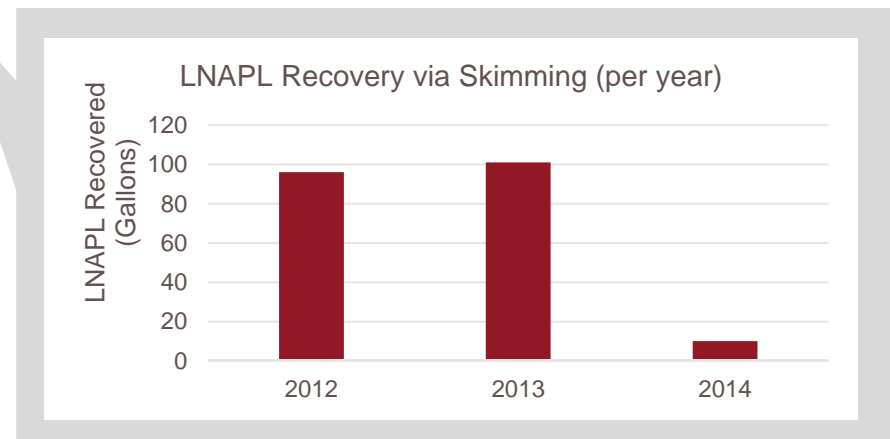
Recovery/Removal Method	Total Volume (gallons)	Years Active
Manual/periodic removal	250	2010 - present
High-vacuum extraction	1,550	2011 – 2012
Skimming	206	2012 – 2014
Bioventing/vacuum-enhanced biodegradation	1,800	2013 – present
Excavation/Soil Removal in Fueling Area	8,220	2015

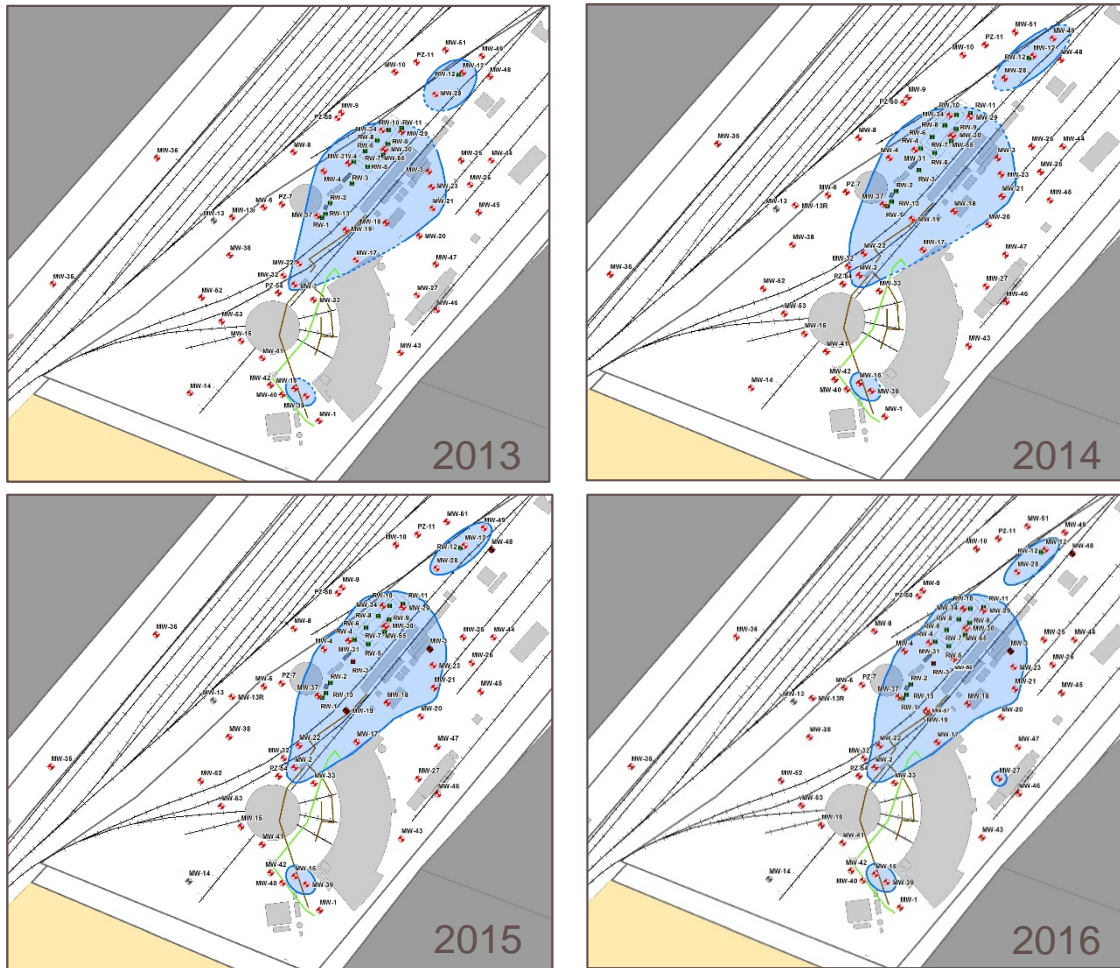
# LNAPL FOOTPRINT OVER TIME

- LNAPL footprint consistent year-over-year
- LNAPL is not expanding or migrating

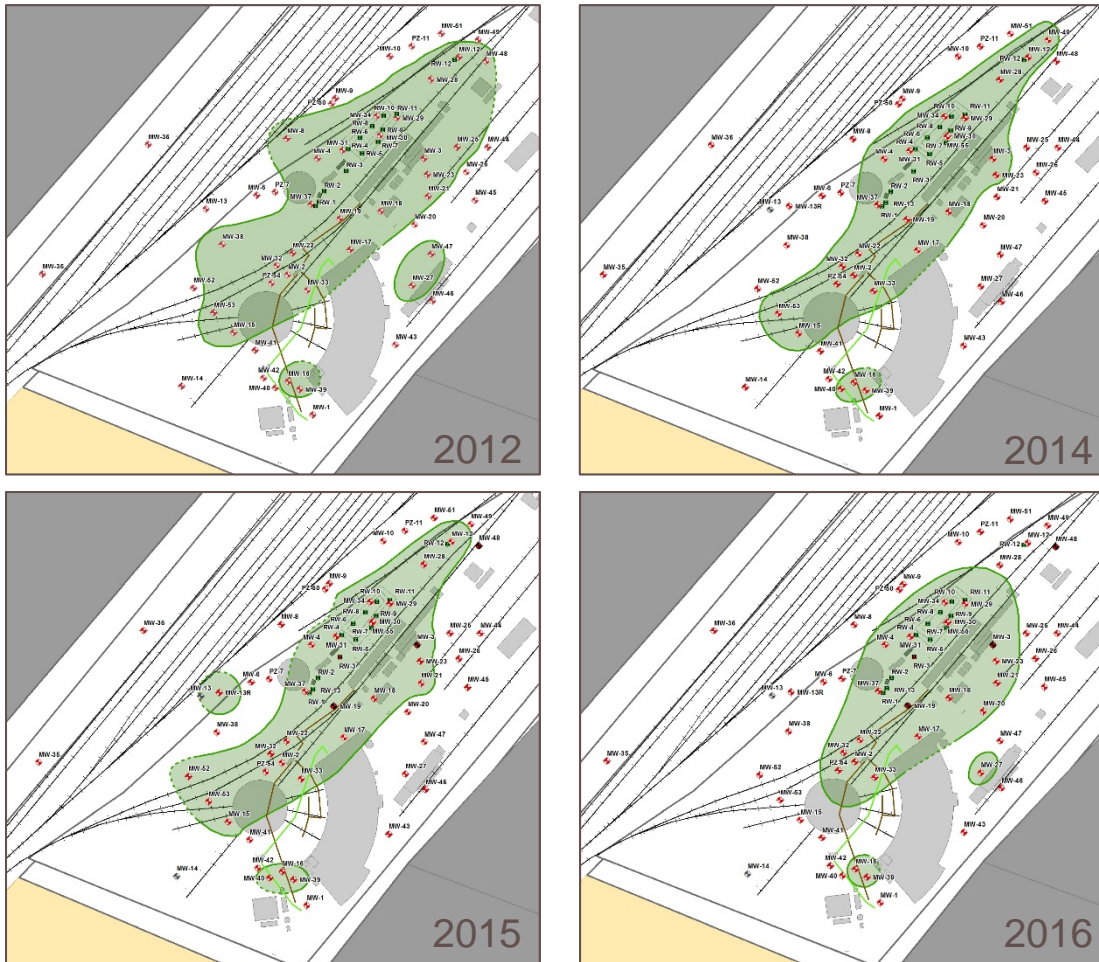
# DISSOLVED-PHASE FOOTPRINT OVER TIME

- Consistent TEHc footprint in groundwater, centered around LNAPL-impacted areas, consistent with residual LNAPL footprint
- Down-gradient wells (along western edge of site) consistently below criteria
- Localized geochemistry changes
- No consistent VOC issues

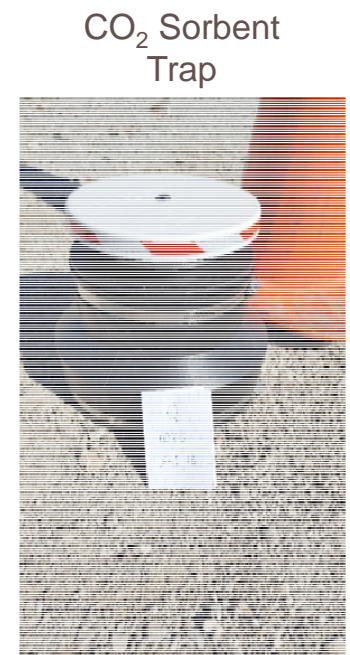
CO<sub>2</sub> Sorbent Trap

- Carbon dioxide flux out of the ground surface correlates to natural LNAPL degradation
- Measured CO<sub>2</sub> flux at 30 locations with a flux chamber and 8 locations with time-averaged sorbent traps
- Conducted after Fueling Area excavation
