Comparison of Laser Induced Fluorescence Profiles Following a Decade of LNAPL Recovery

Peter Stumpf, PE

Shailendra Ganna, PE (Shell), Joseph Lentini (Shell), Cynthia Shen, PE (AECOM), Ram Kannappan, PhD, PE (AECOM)
April 11, 2018

2018 Chlorinated Conference | April 8-12 | Palm Springs, CA

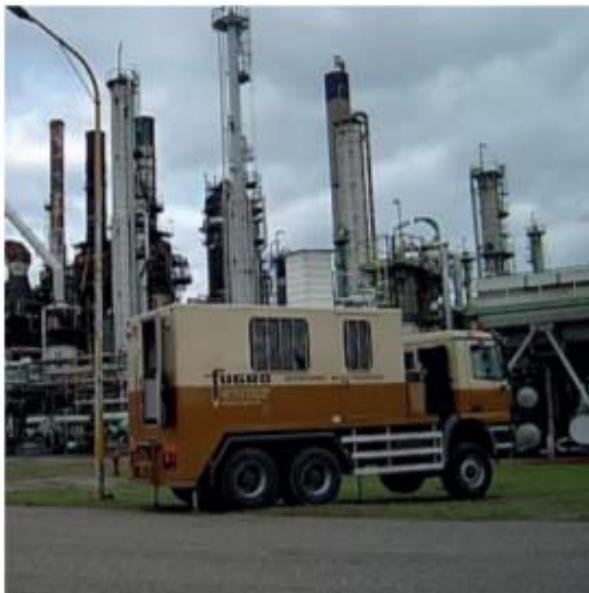
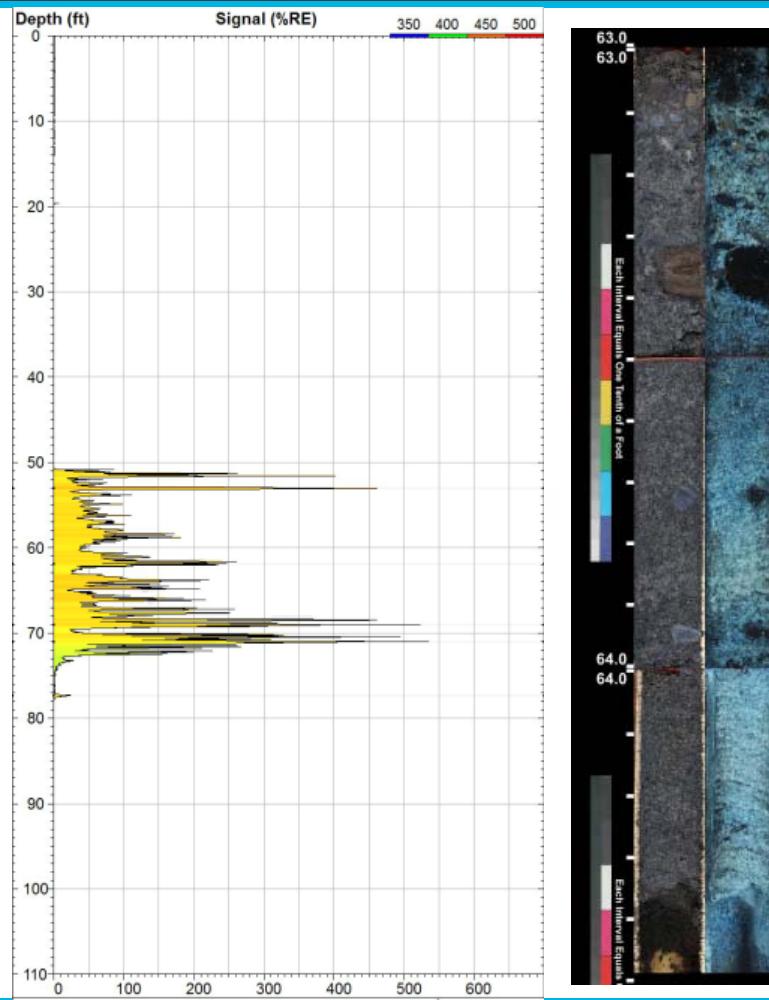
Laser Induced Fluorescence

Effects on LIF response

- Pore Fluid Saturation of LNAPL
- Soil Type (soil pore size)
- LNAPL Composition

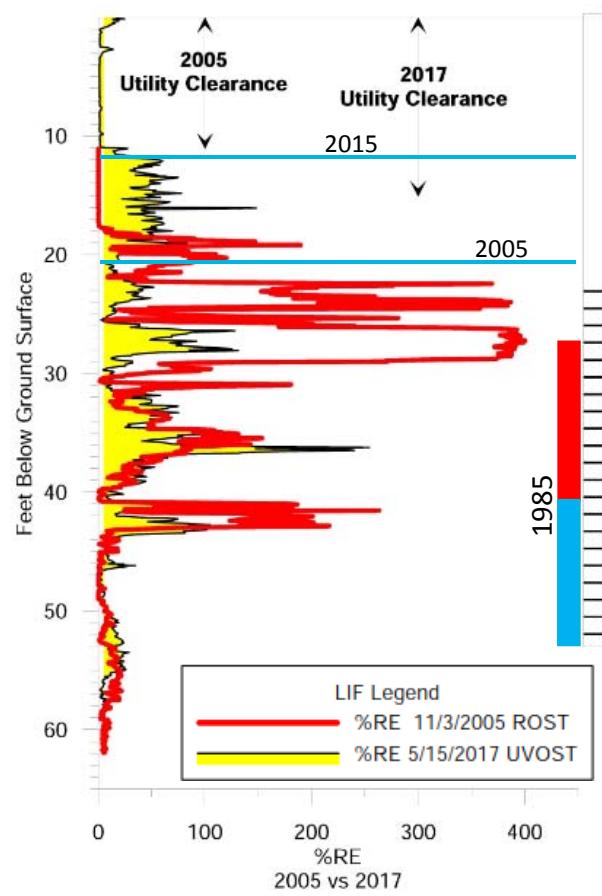
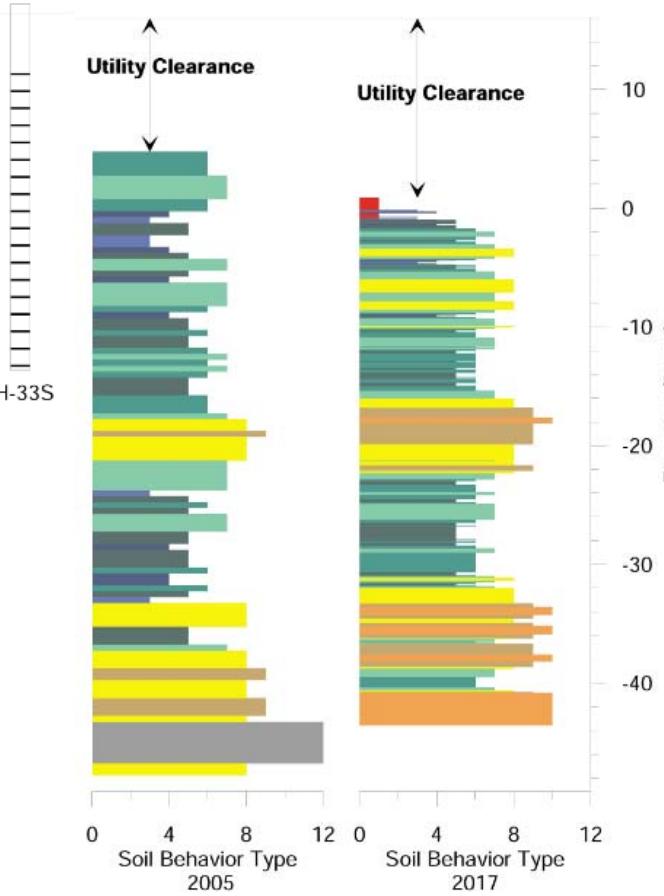
H-33 Area

H-33

LNAPL Recovered 1985-2005	286,272 gal
LNAPL Recovered 2006-2017	168 gal
LNAPL thickness 2017	0.04 ft

H-33S

LNAPL Recovered 2013-2017	277,200 gal
LNAPL thickness 2017	4.23 ft

- ROST and UVOST provide similar results
- High reflectance in sand is at or approaching residual saturation levels of LNAPL
- LIF is a great tool to determine LNAPL location in the formation
- LIF not a good tool to determine LNAPL recoverability
- Recoverable LNAPL primarily comes from the groundwater surface
- LNAPL thickness in well is not a good indicator of recoverability
- Transmissivity and cumulative recovery curves are better indicators of recovery end point than LIF or LNAPL thickness

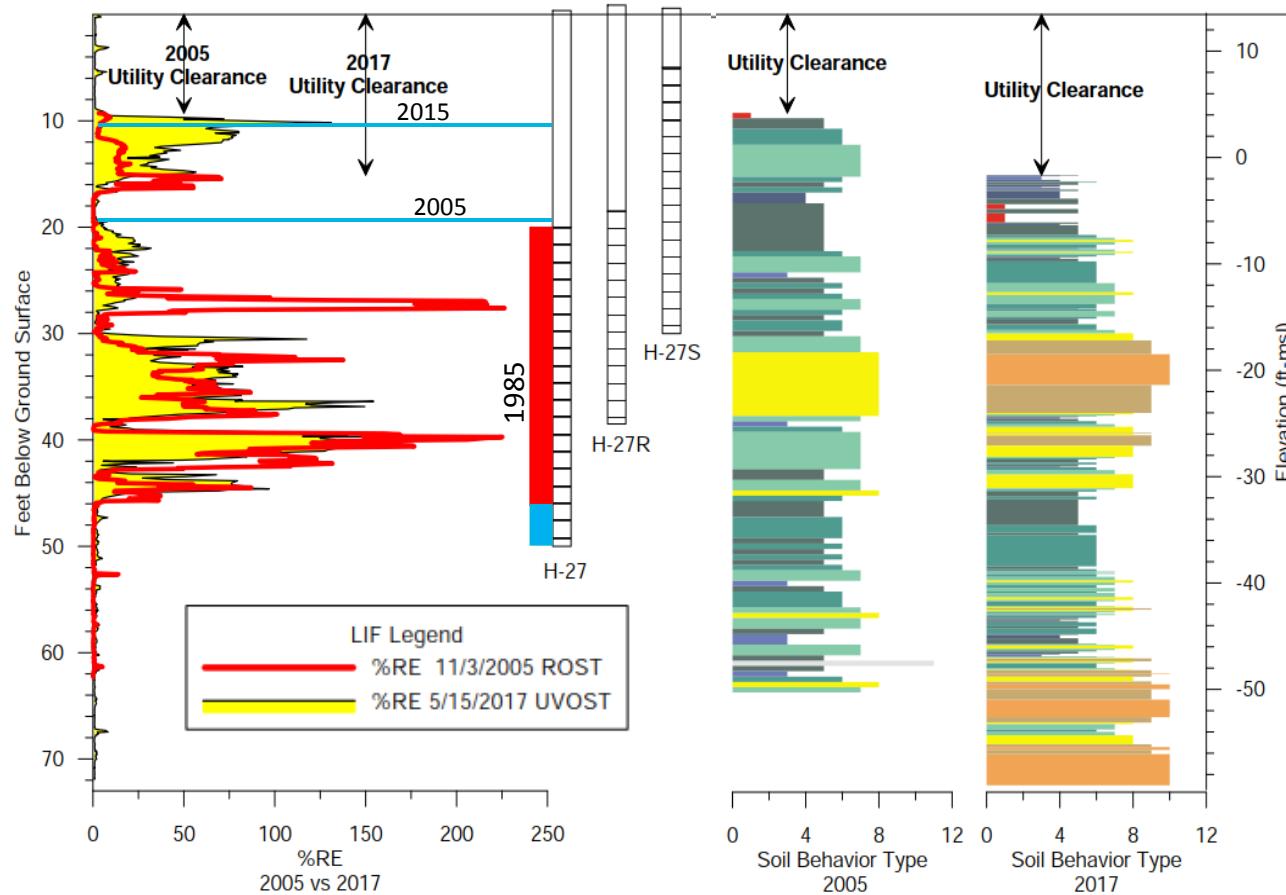
H-27 Area

H-27

LNAPL Recovered 1985-2005 854,700 gal
LNAPL Recovered 2006-2017 504 gal
LNAPL thickness 2017 2.53 ft

H-27R

LNAPL Recovered 1990-2002 22,260 gal
LNAPL Recovered 2006-2017 0 gal
LNAPL thickness 2017 0.48 ft

H-27S

LNAPL Recovered 2013-2017 130,326 gal
LNAPL thickness 2017 18.39 ft
