Successful Rapid Response Mitigation of High Strength Vapor Plume Underneath a Large, Active Navy Building

Lisa Goode, Neal Durant – Geosyntec Consultants

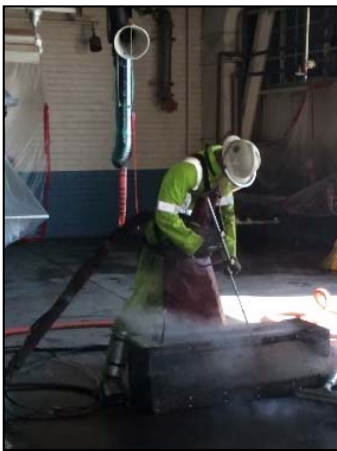
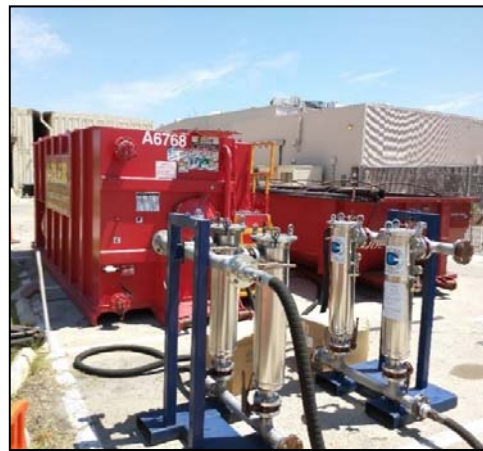
Hydroblasting (wet)

- Jets of high pressure water
- Cleans and etches concrete surface
- Creates a clean surface for sealant adhesion

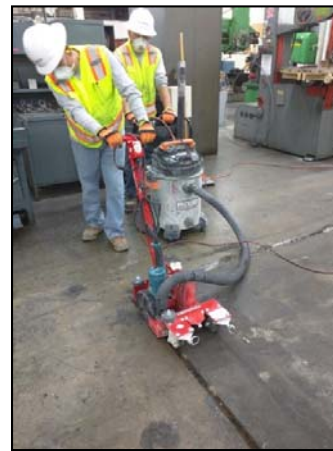
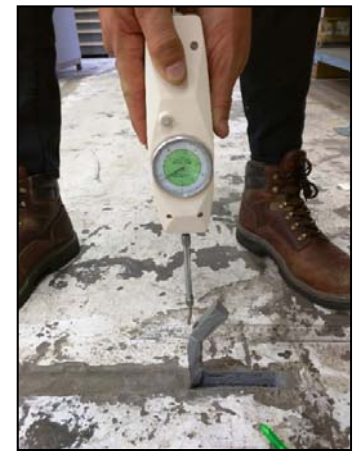
Mechanical (dry)

- Saw cutting and grinding
- Vacuum attachment for dust collection
- Reduced cost and improved efficiency

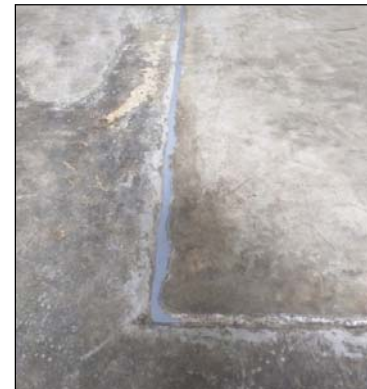
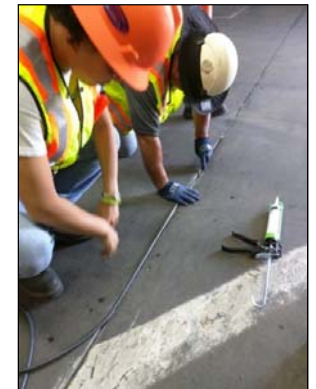
Backer rod - For support in larger joints

Sealant - Flexible, chemical-resistant self-leveling silicone concrete joint sealant (CSL315)

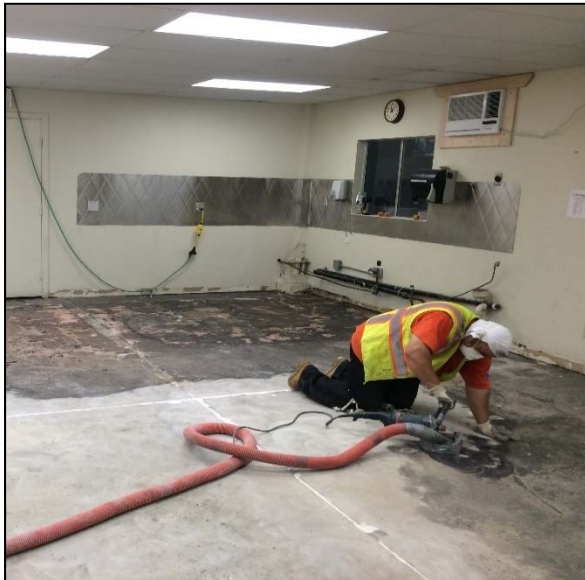
Sealed other vapor entry points

- Sealed the lunch room floor with Retro-Coat
- Sealed a void space between walls
- Sealed plumbing penetrations in restrooms

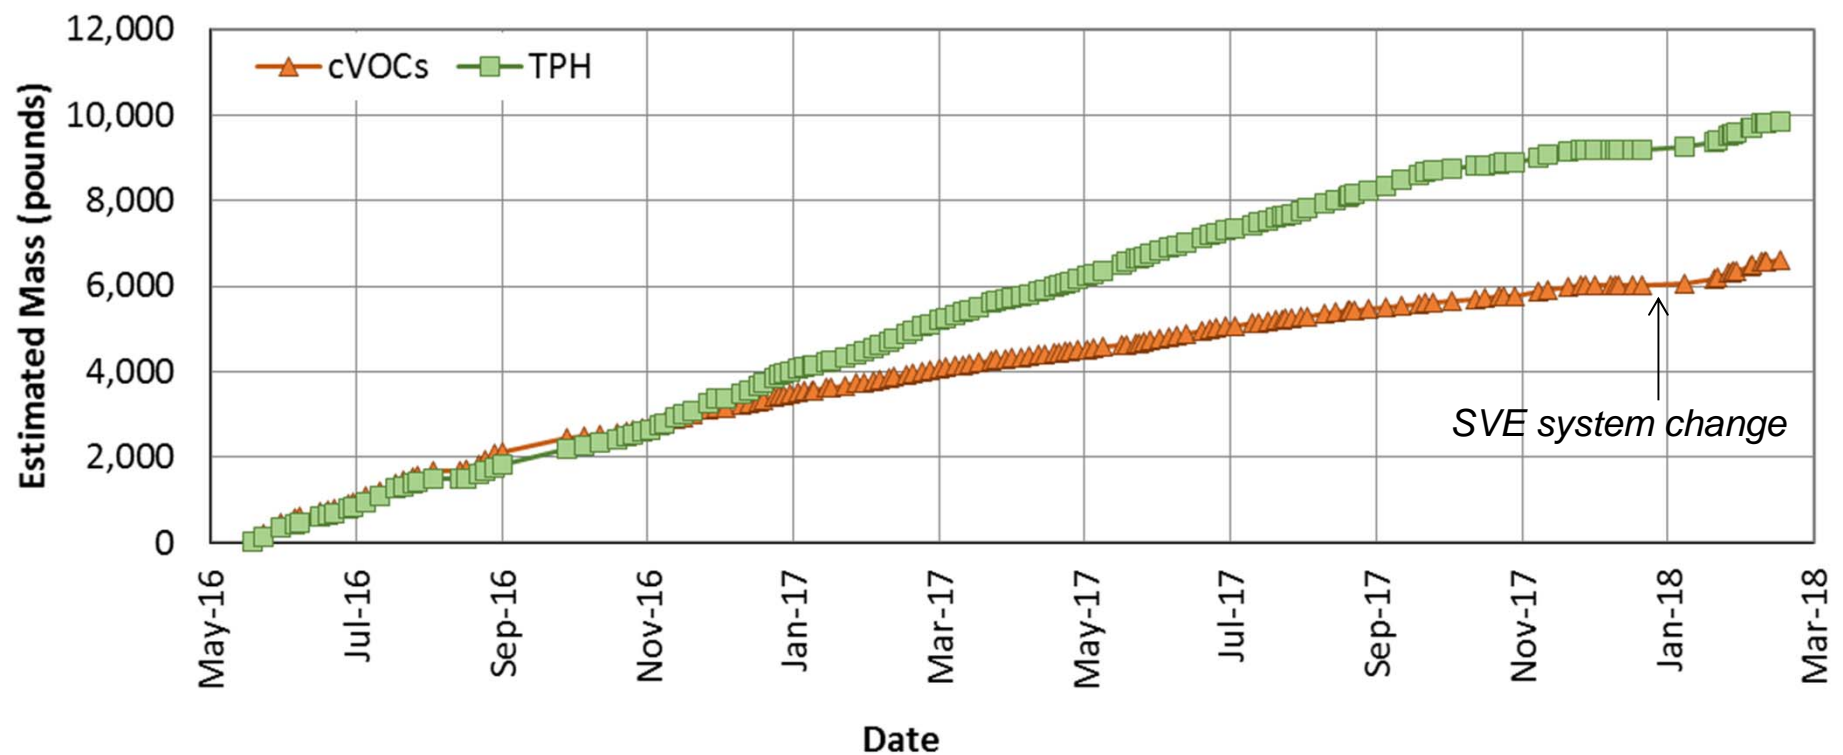
Cumulative Mass Removal Trends
(estimated from influent flow rates and concentrations)

>16,000 pounds (>2,000 gallons) of chlorinated VOCs and TPH collected over 21 months of operation
