Capillary Rise Study

Interactive Visualizations of 5 Million Sensor Measurements of the Capillary Fringe Lead to an Optimized Soil Remedy

Cameron Dixon, PE (AECOM, Boston, Massachusetts, USA)
Tomasz Kalinowski, Ph.D. (AECOM, Syracuse, New York, USA)
Christopher Brownfield, PE (AECOM, Morrisville, North Carolina, USA);
Scott Mikaelian, PE (AECOM, Piscataway, NJ, USA)
Mark Terril, PE (PPG, Pittsburg, PA)

Thursday April 12, 2018

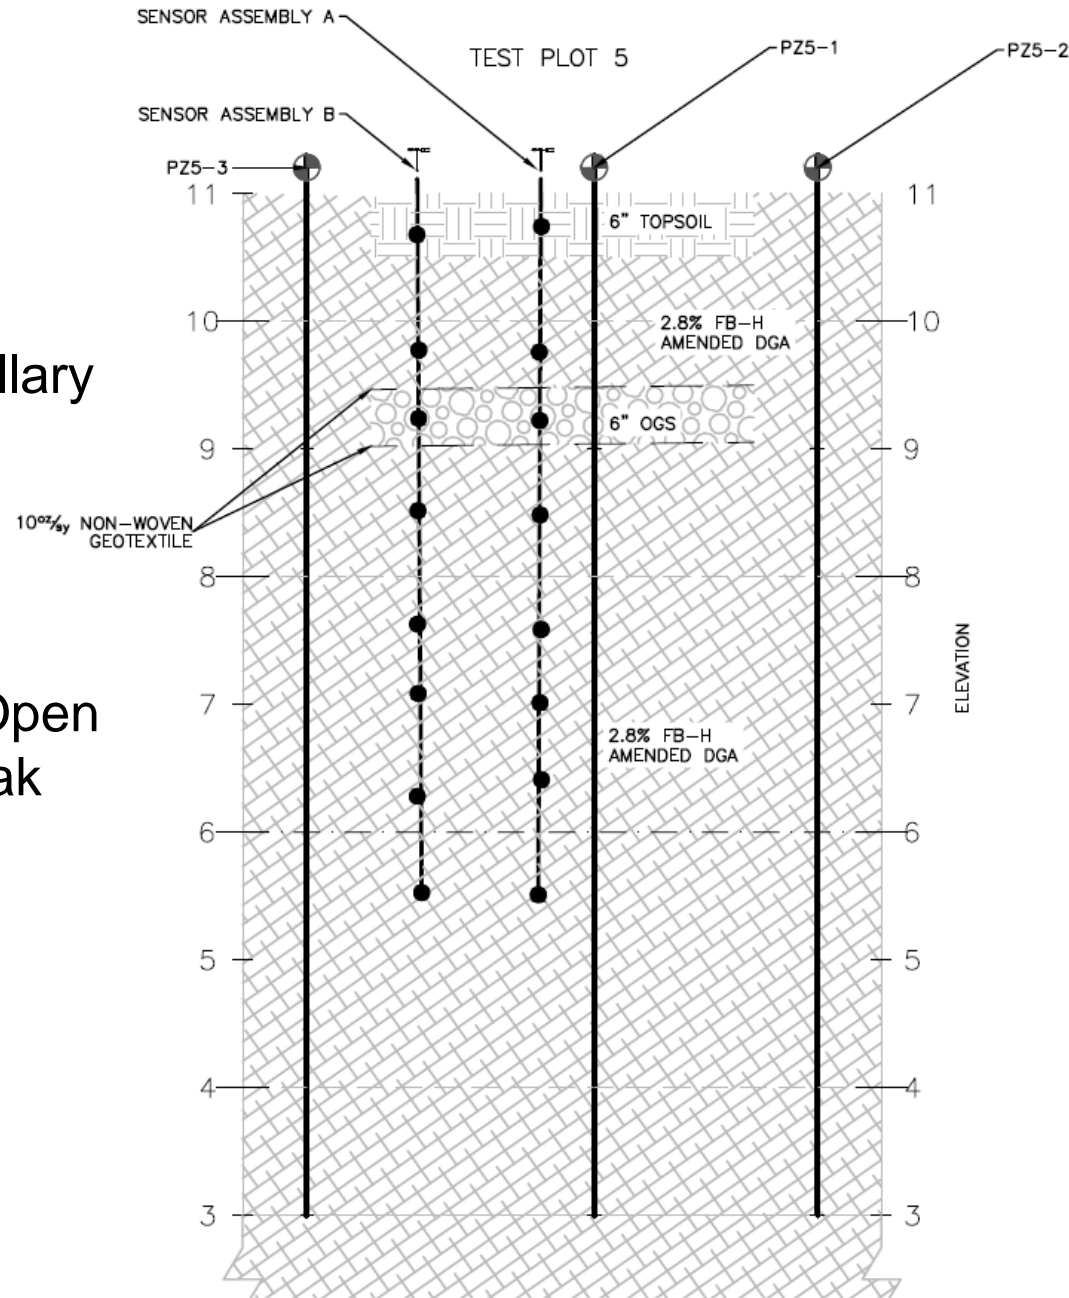
Test Plot Construction

– Test Plot 5

- Amended DGA
- 6" Open Grade Stone Capillary Break from El. 9 to El. 9.5
- 6" of topsoil at surface

– Objective

- Evaluate effectiveness of Open Grade Stone Capillary Break

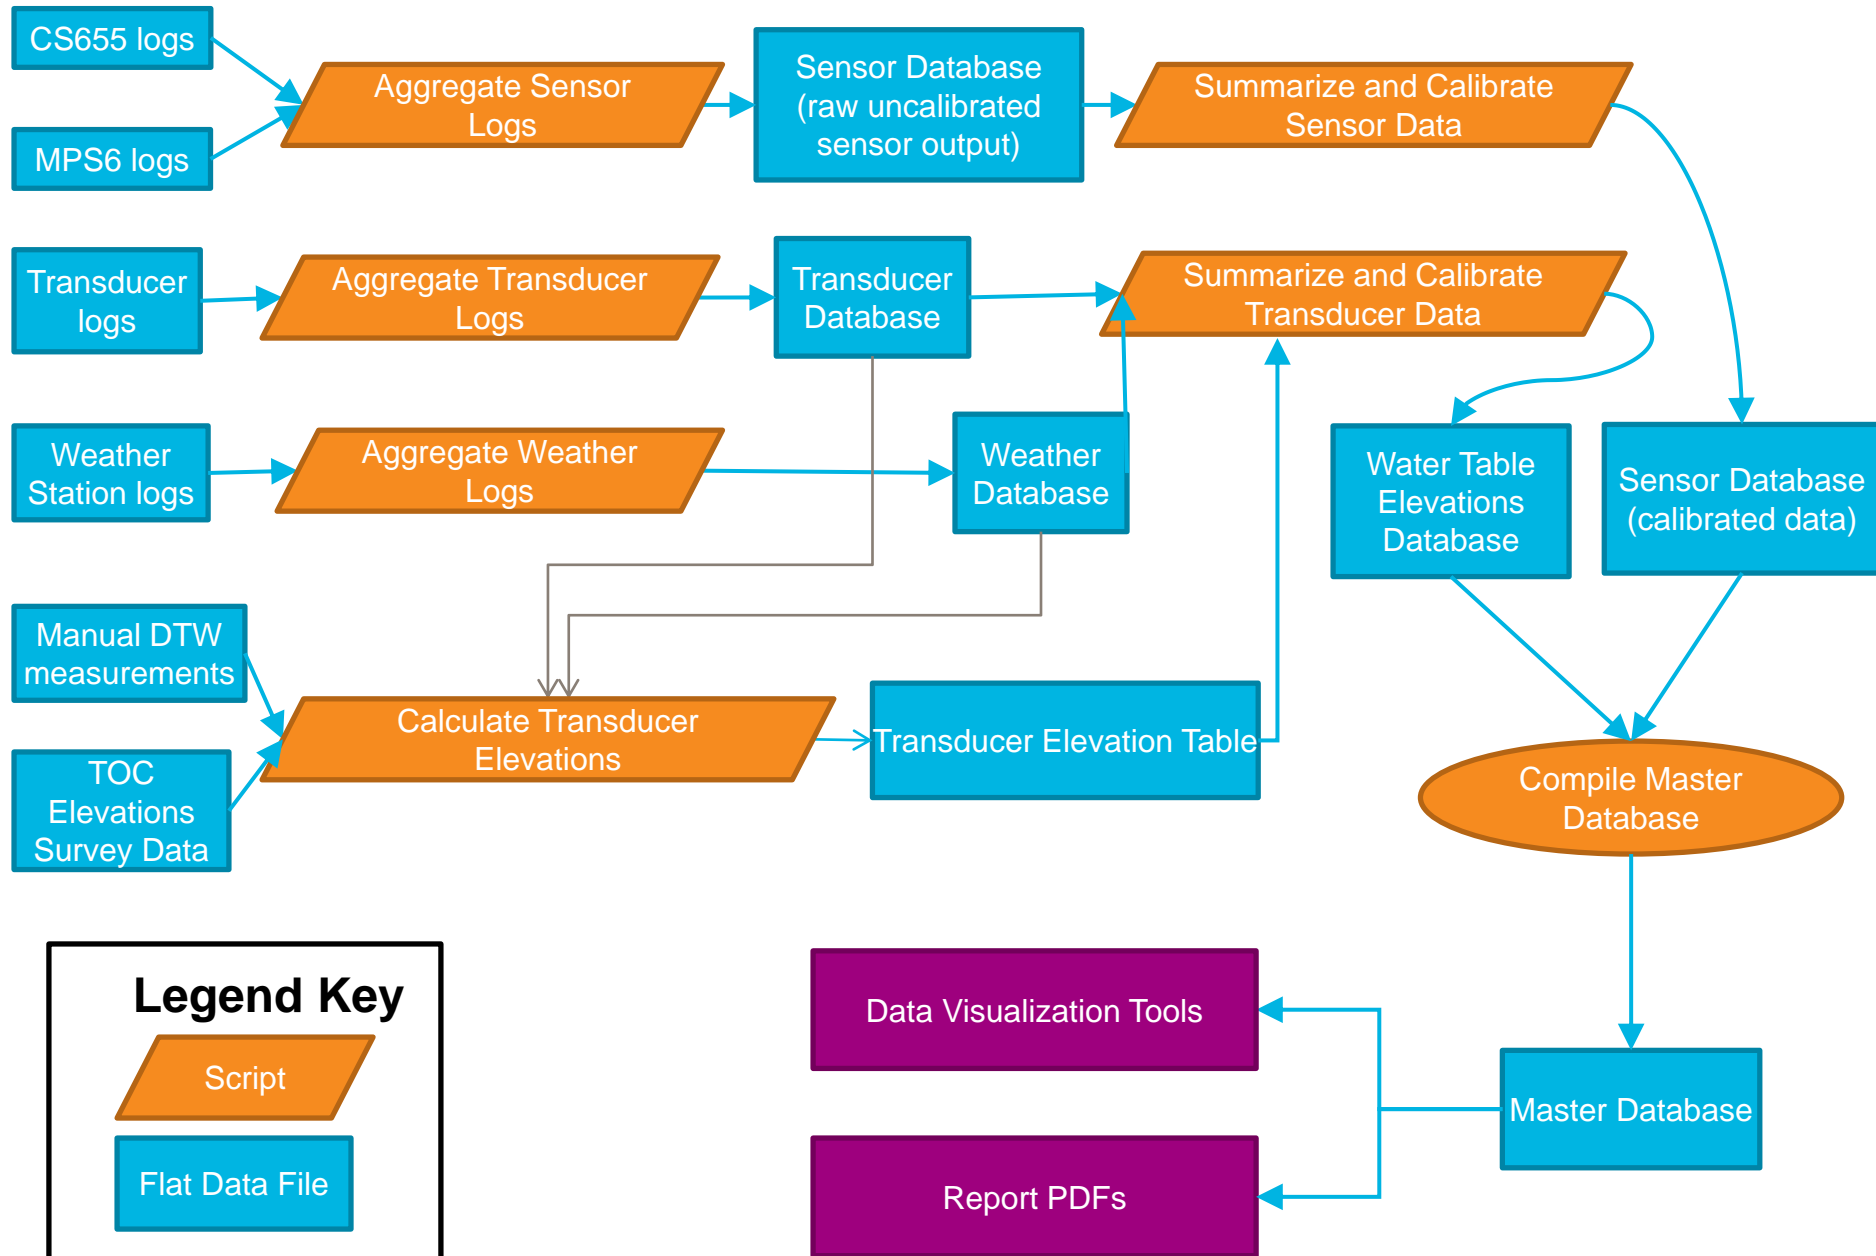
Data Collection and Processing

- 129 sensors in the field recordings readings every hour
 - 5 soil plots (experimental groups)
 - 2 sensor nests per plot
 - 6 or 8 sensors levels per nest
 - 2 sensors per level
 - 5 transducers (piezometers) per soil plot
- Weather station recording 8 values every 15 minutes – used to normalize / interpret transducer data
- 1,410,360 complete records generated
 - 1 record per sensor location per hour

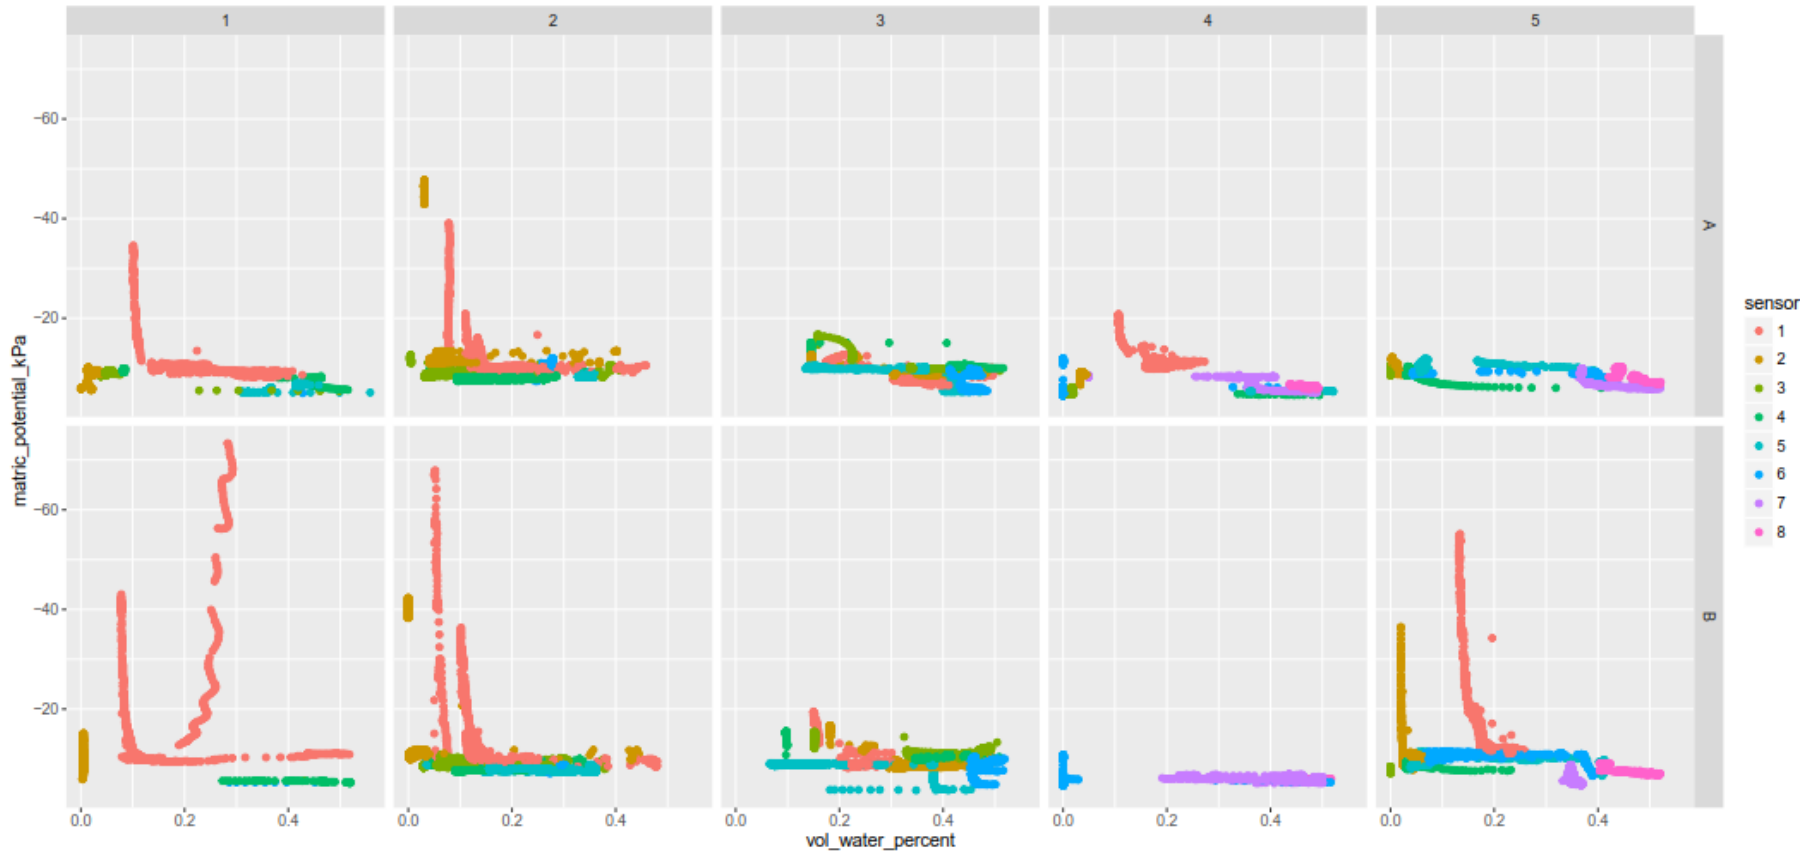
Data Visualization Issues

No patterns visible in planned graphics.

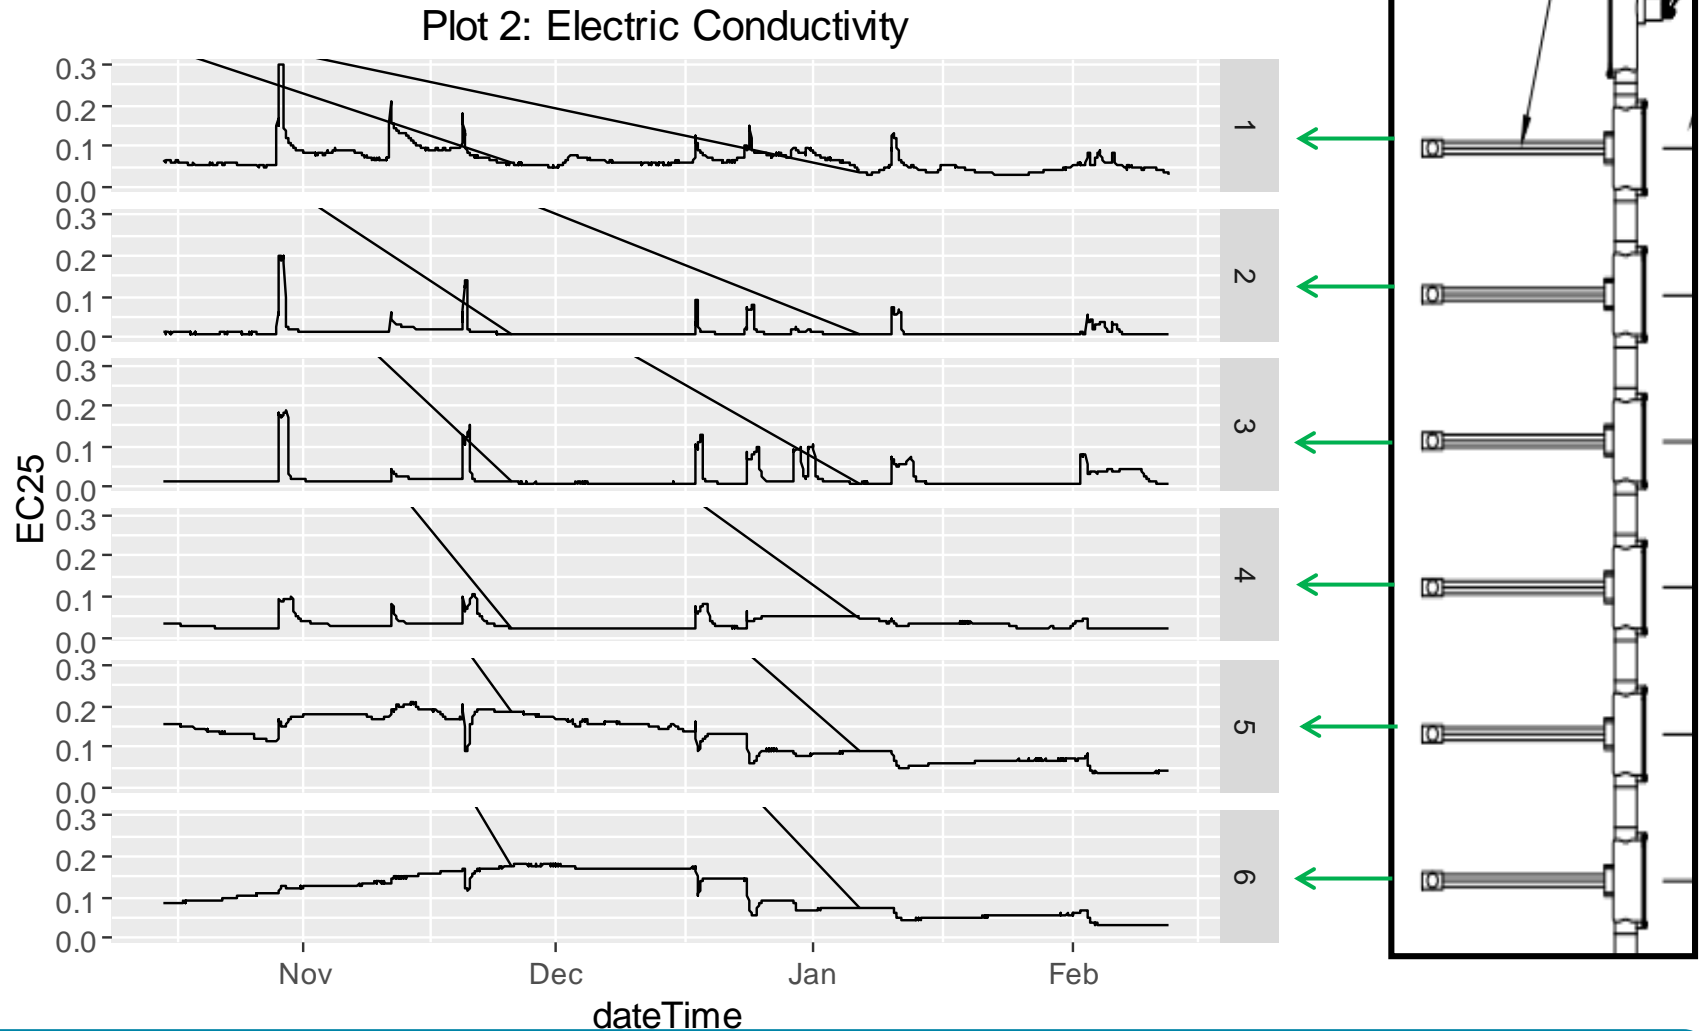
Visualization - Sensor Output

Temperature Normalized Electrical Conductivity over Time - Stacked by Sensor Position.

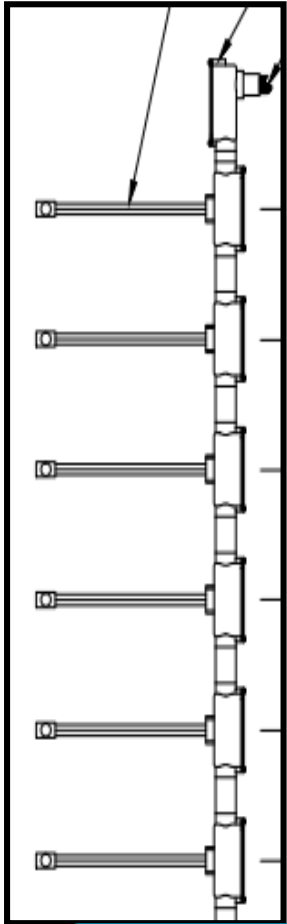
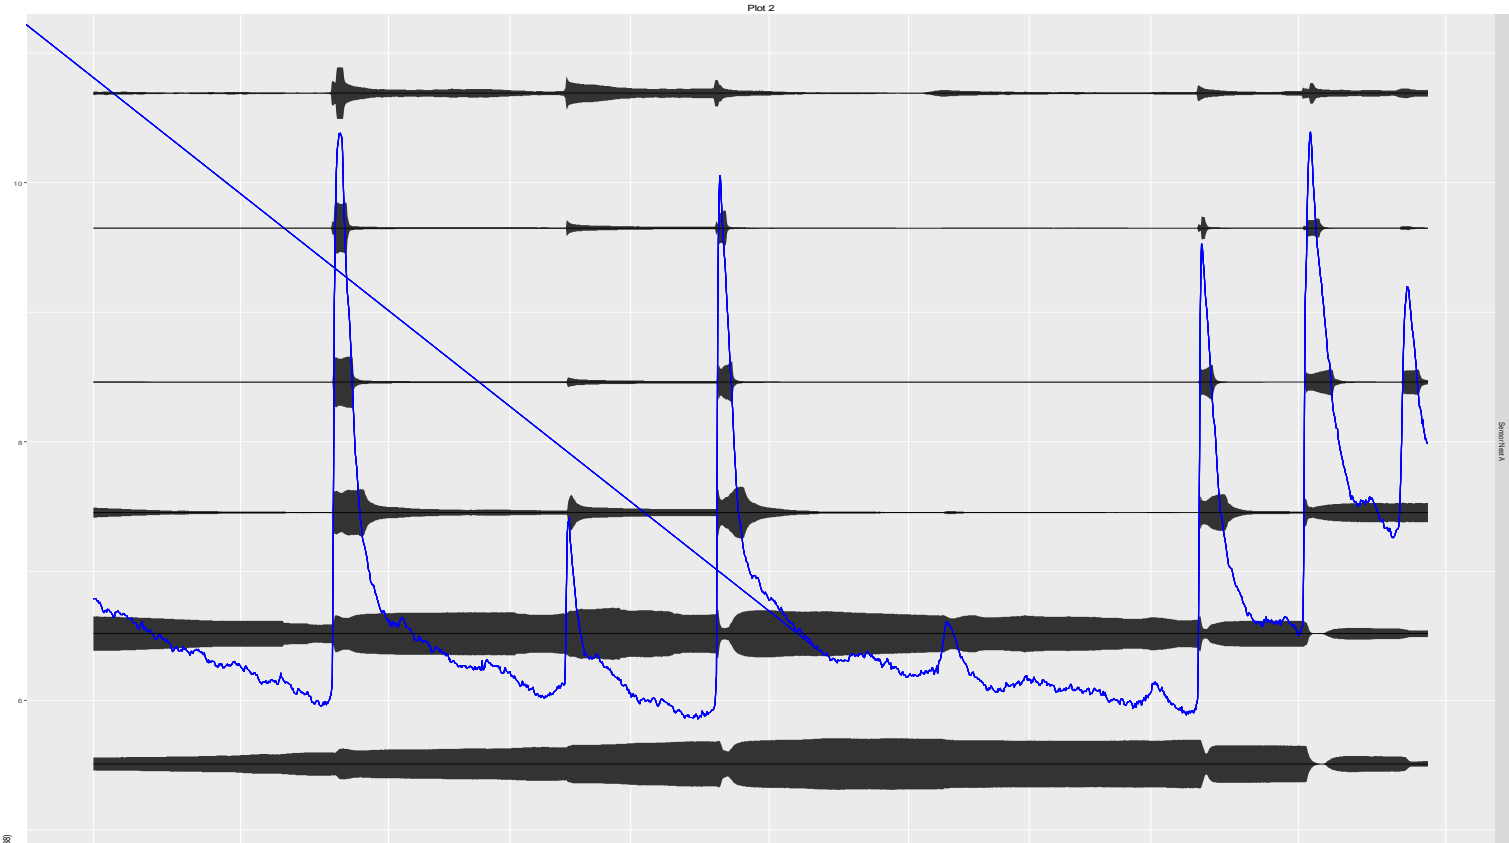
Visualization – Sensor Output relative to Groundwater Elevation

Visualizing four variables in one graph:

- + Time
- + Sensor Value (Violin Plot)
- + Sensor Elevation
- + WT Elevation

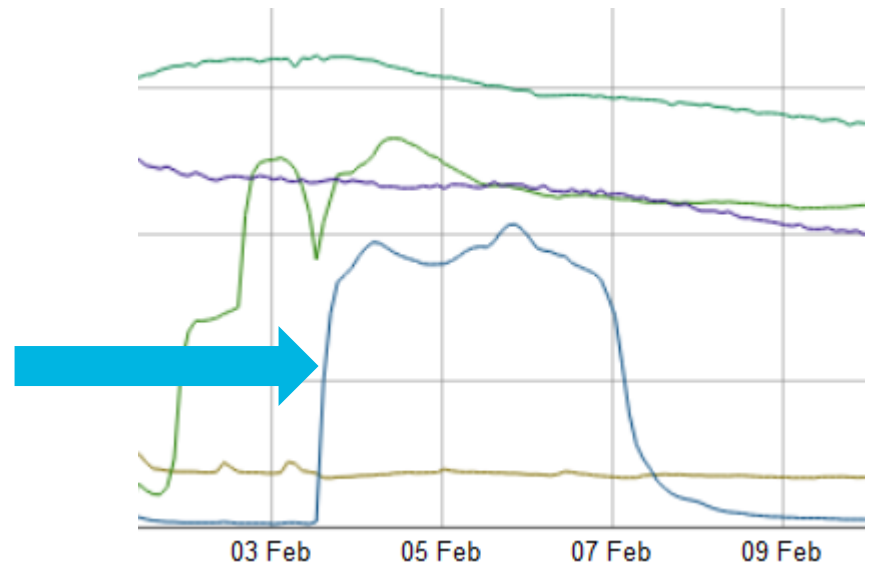
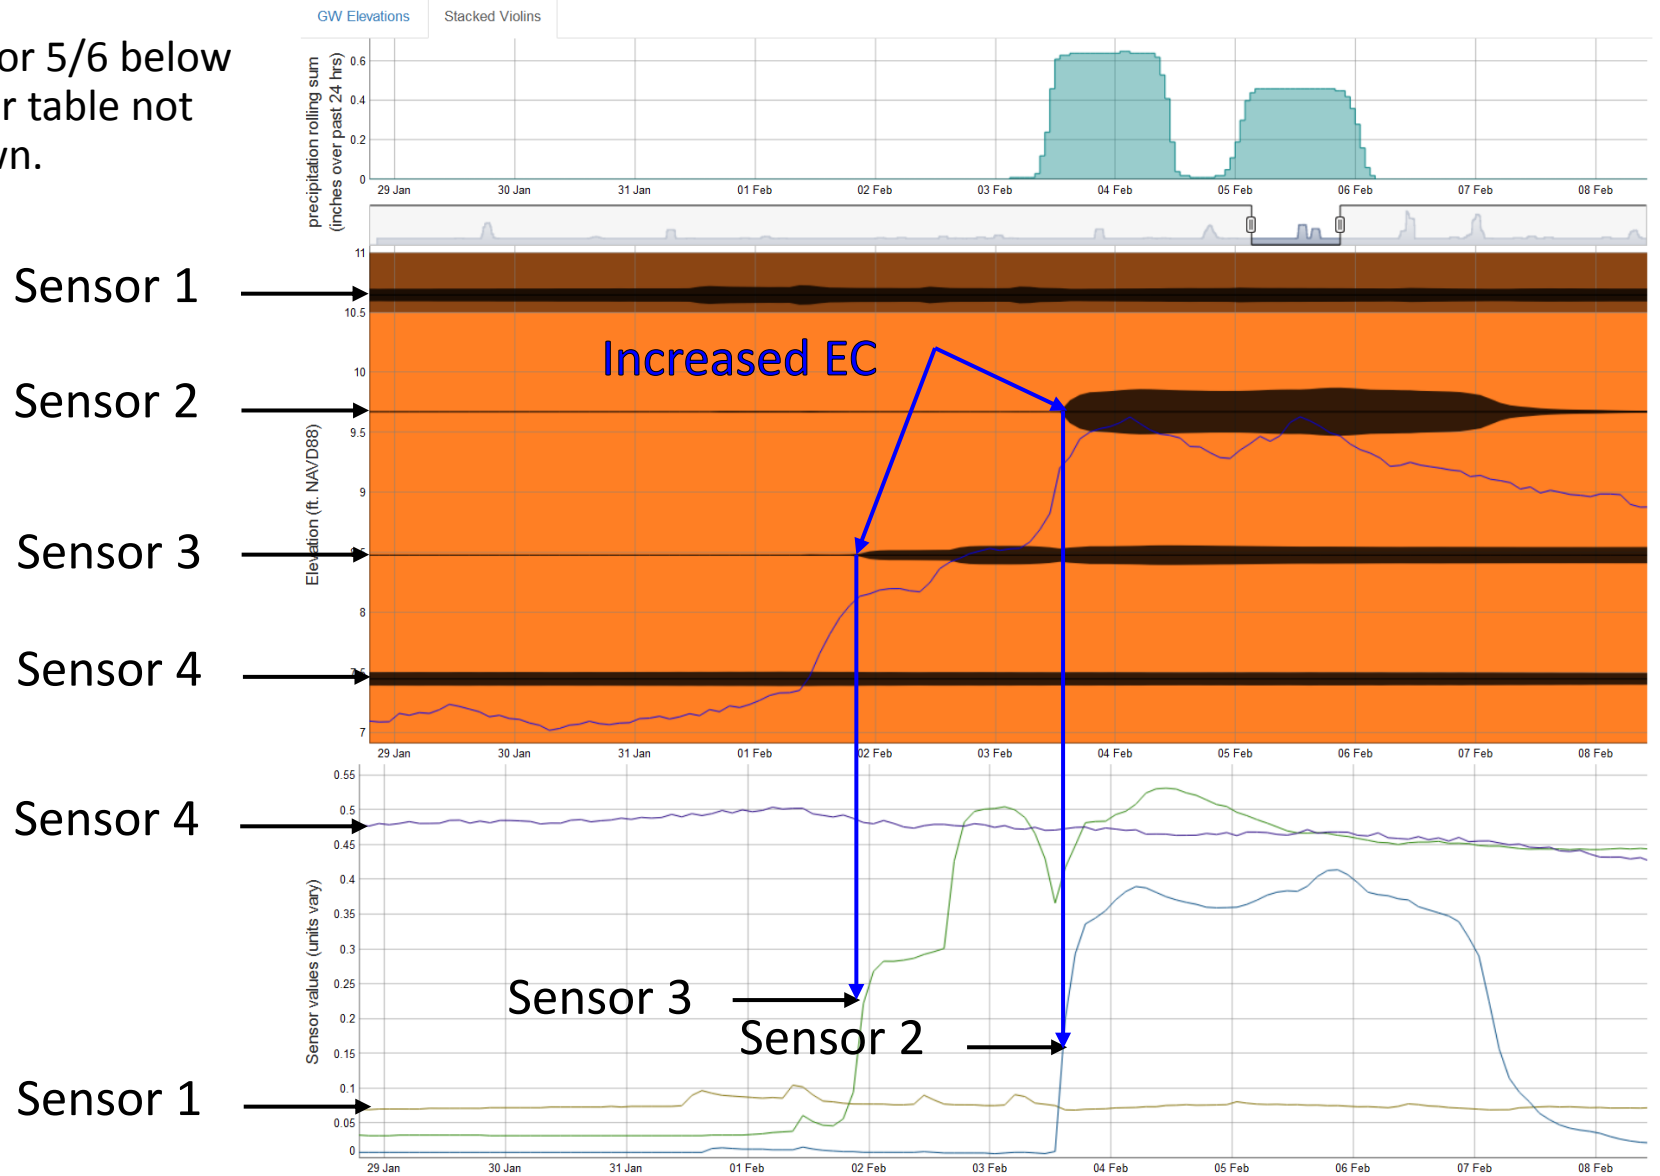
Interpretation – Identify Sustained Sensor Change Above Water Table

- Sustained increases in EC indicate saturation.
- Saturation above the water table means the sensor is in the capillary fringe,

Sensor 5/6 below
water table not
shown.

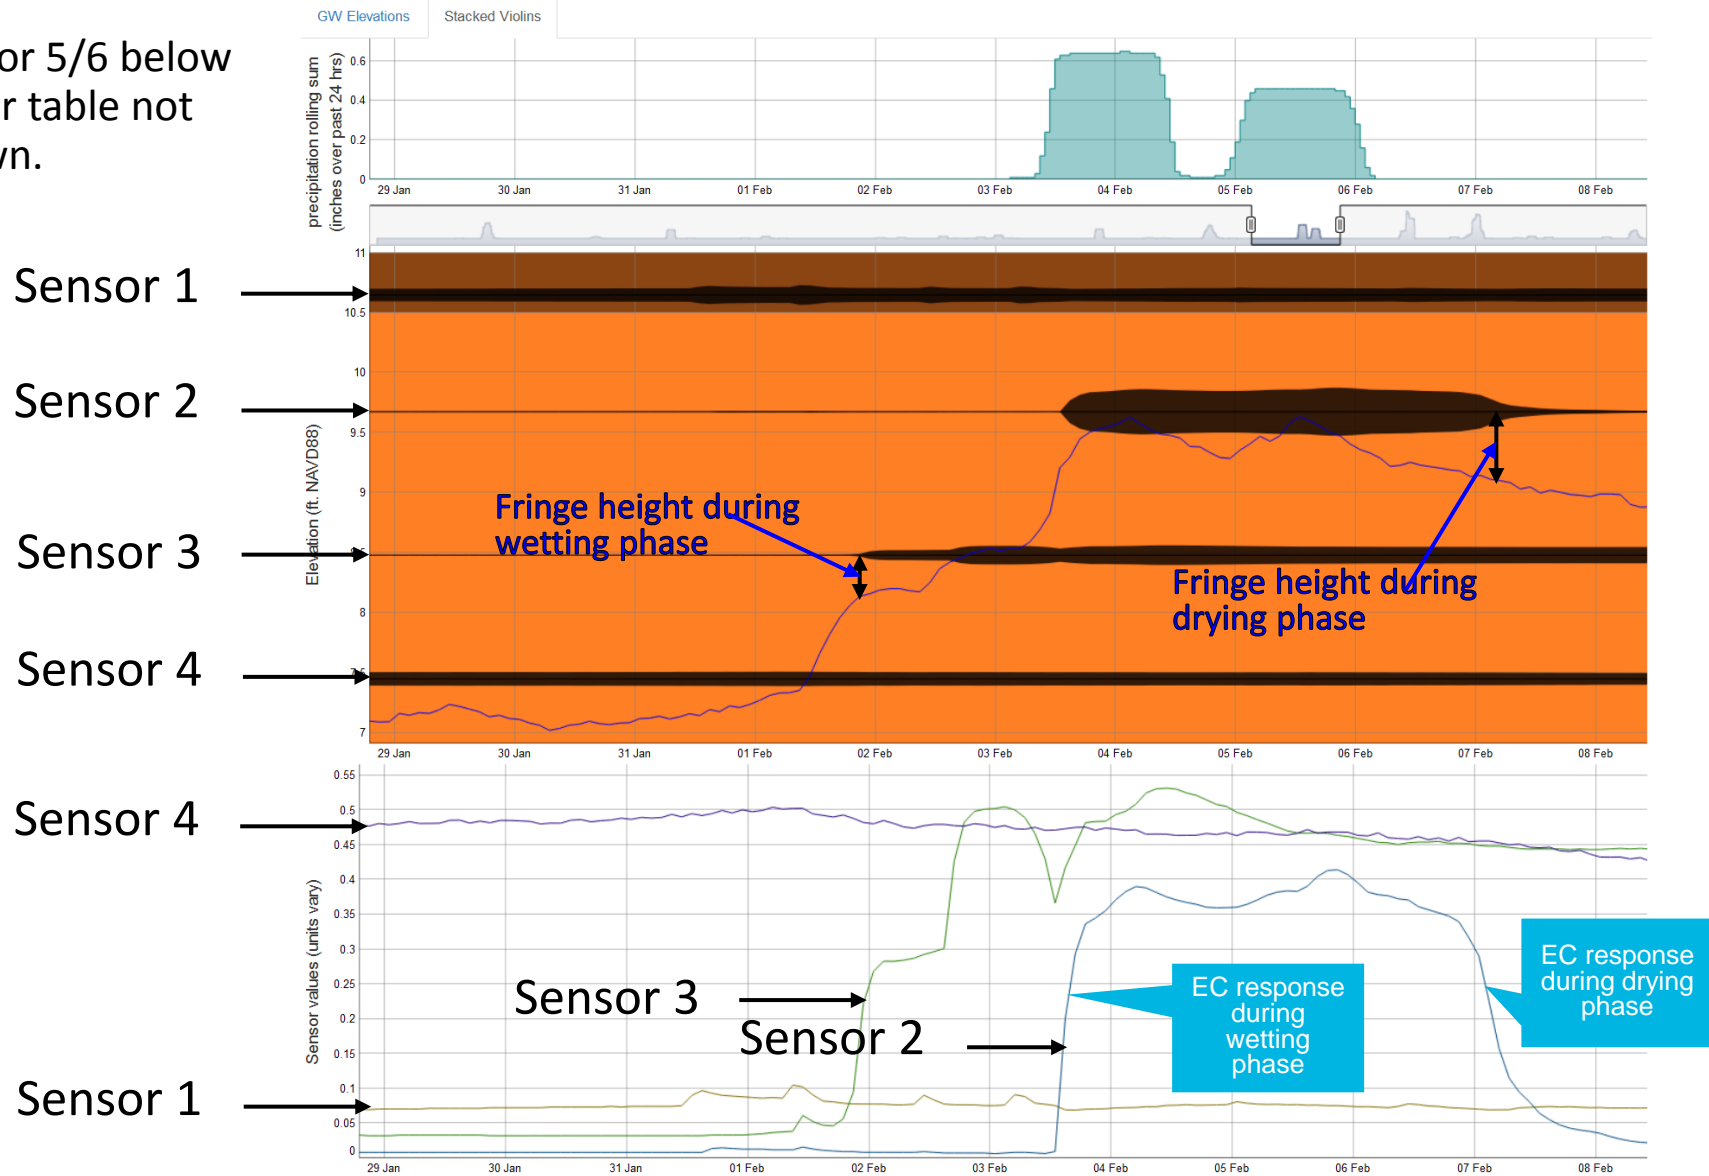
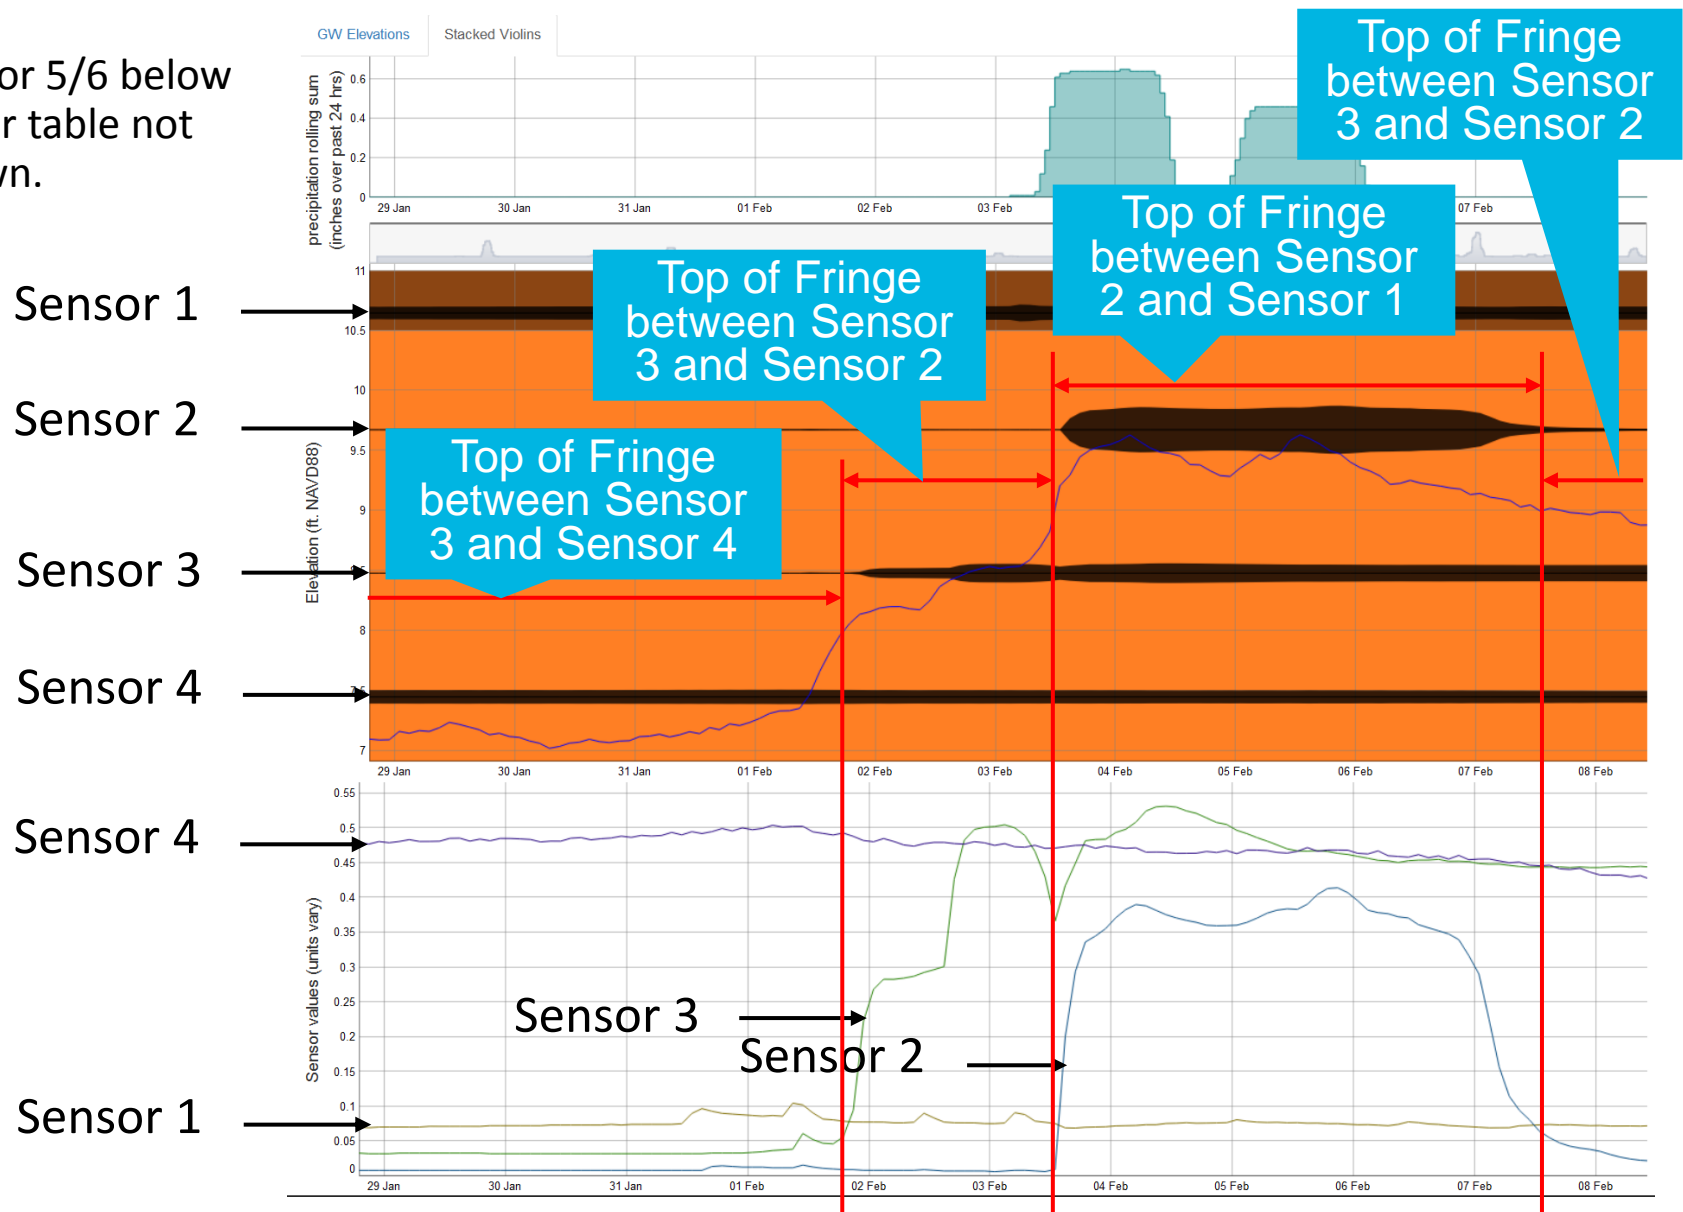
Interpretation - Water Table Changes – Wetting vs. Drying

Sensor 5/6 below water table not shown.

Sensor 5/6 below
water table not
shown.

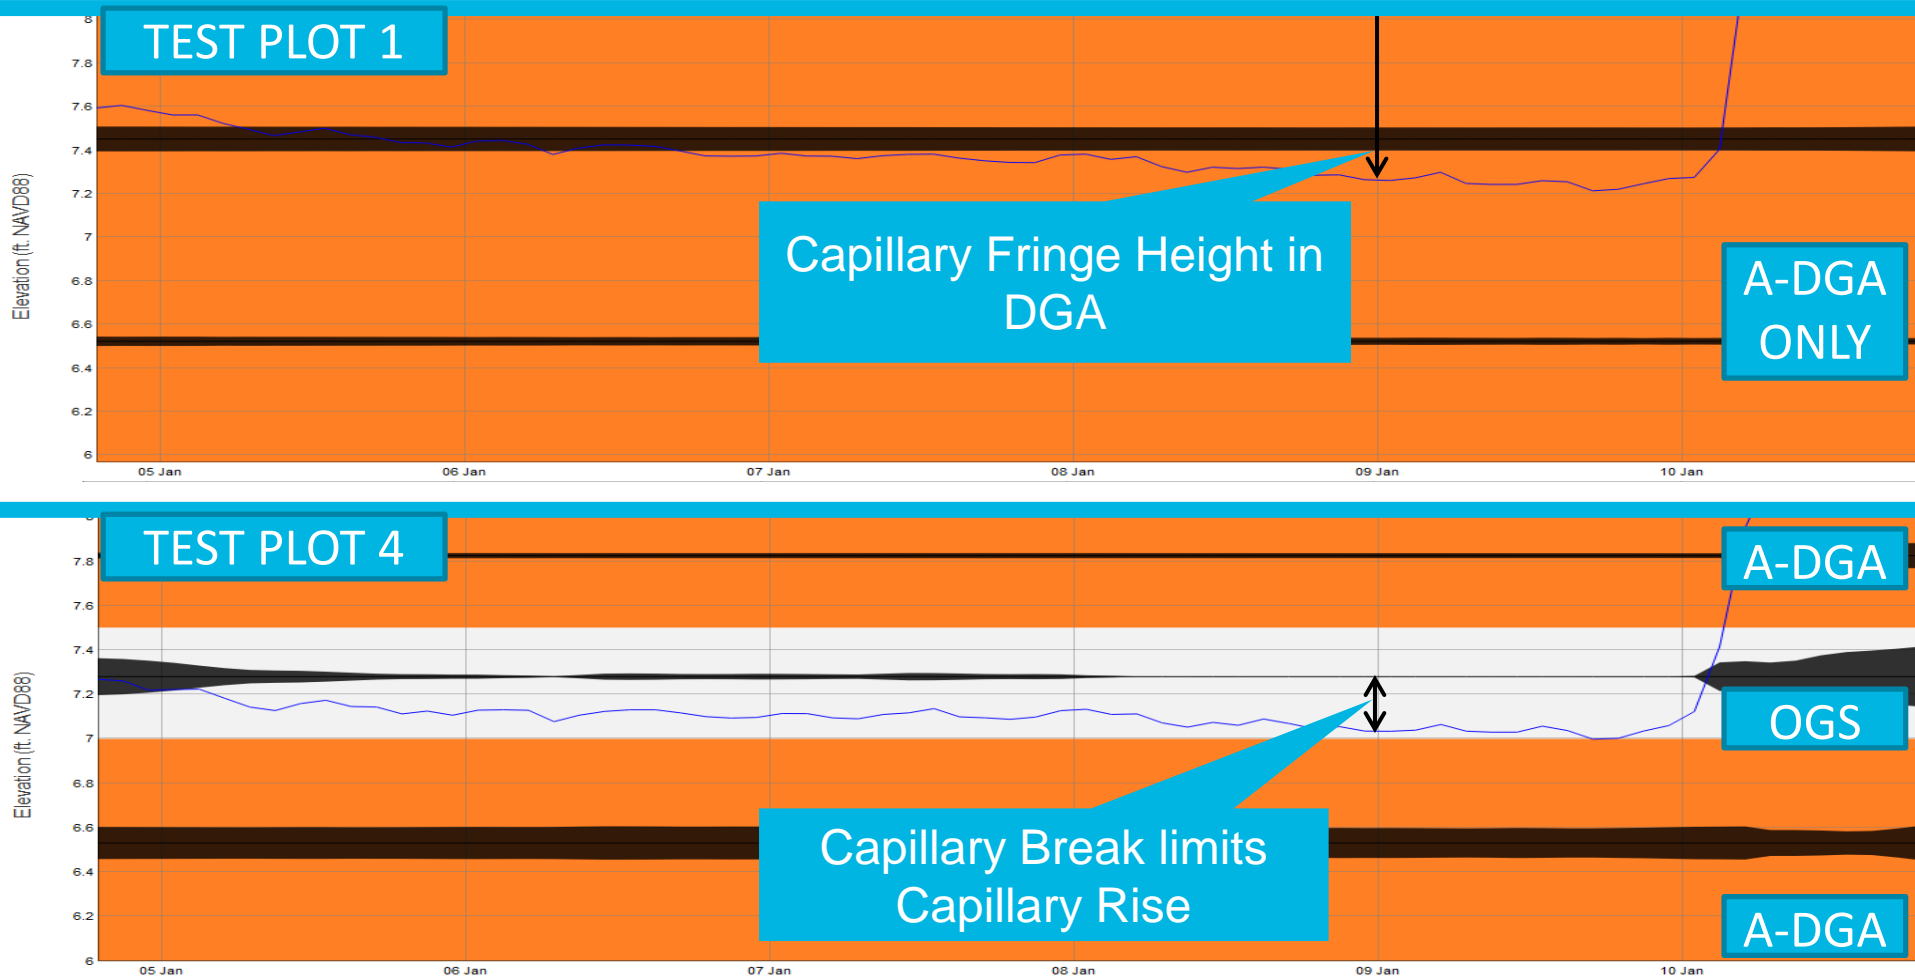
Interpretation - Open Grade Stone Capillary Break

Direct Comparison of Capillary Fringe Height shows Capillary Break Effectiveness

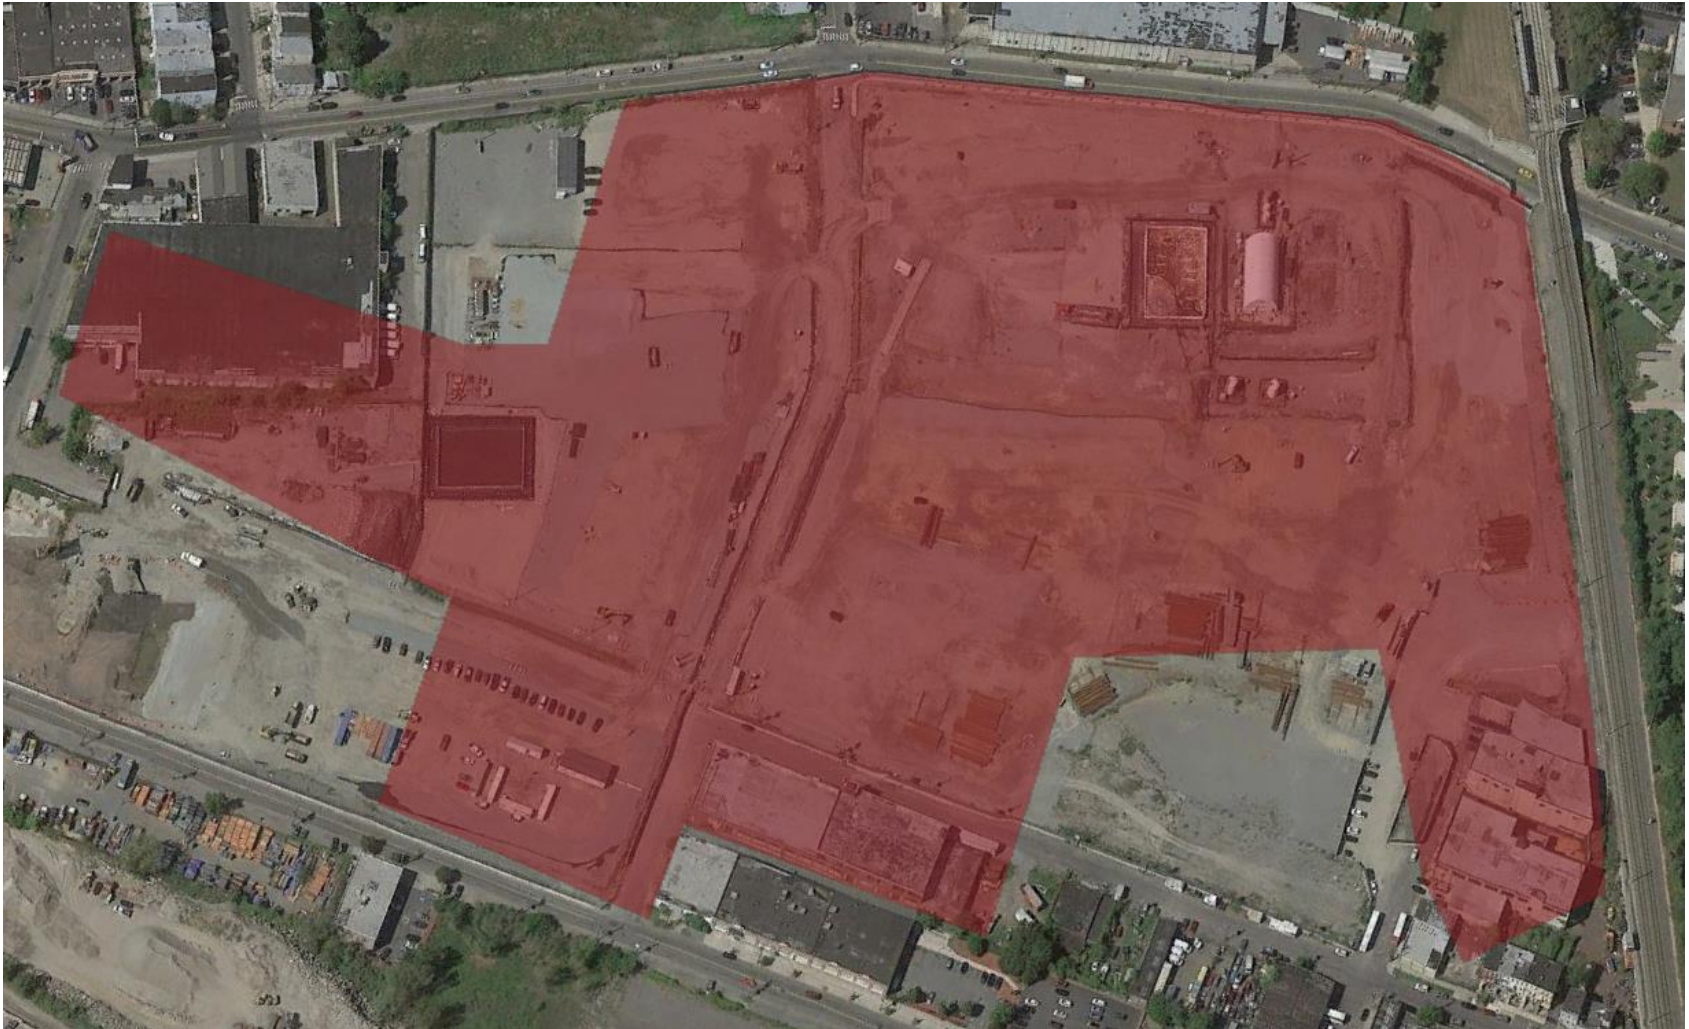
Big Problem

- Regulator required 28 acres of impervious liner above GW plume

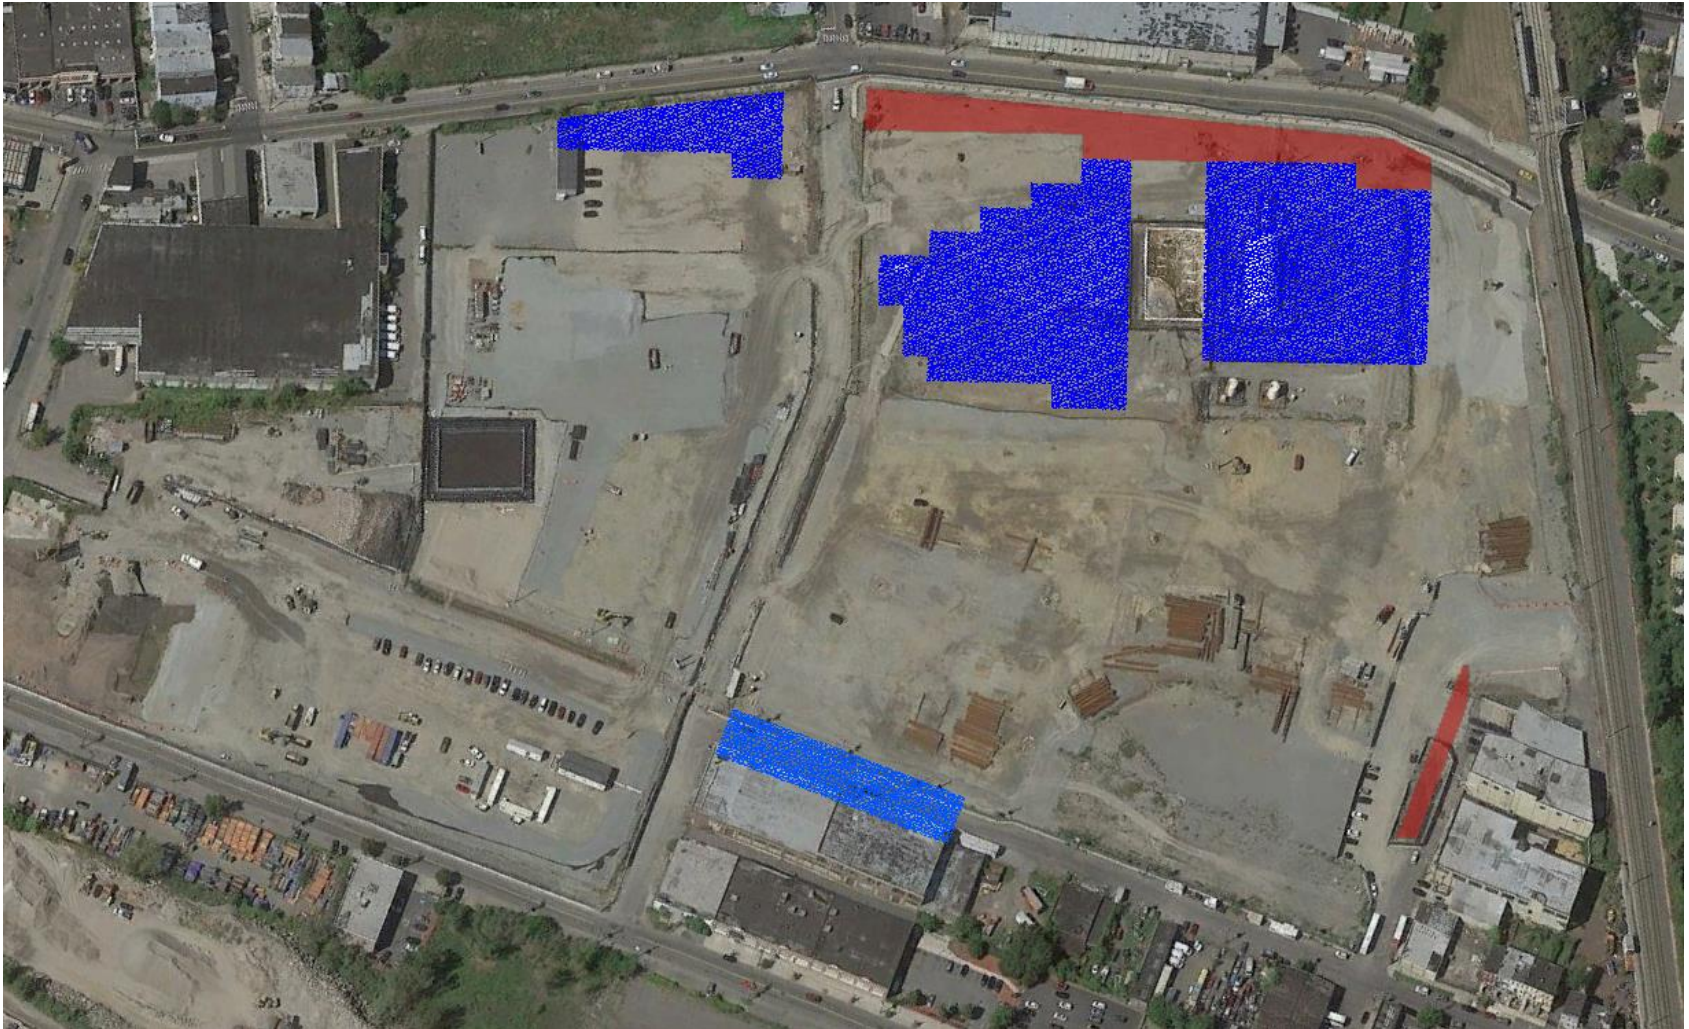
Big Solution

- Regulator accepted 0.8 acres of impervious liner and 3.6 acres of washed stone capillary break
