Remediation of Mercury Contamination at a Former ChlorAlkali Plant Using Integrated Cap and Containment Technologies

Authors: Gavan Butterfield, James Stening, Gary Schmetrmann, Caroline Vernon, Frederic Cosme, Al.D.Laase
Golder Associates Pty Ltd, Sydney, NSW, Australia; Orica Australia Pty Ltd, Botany, NSW, Australia

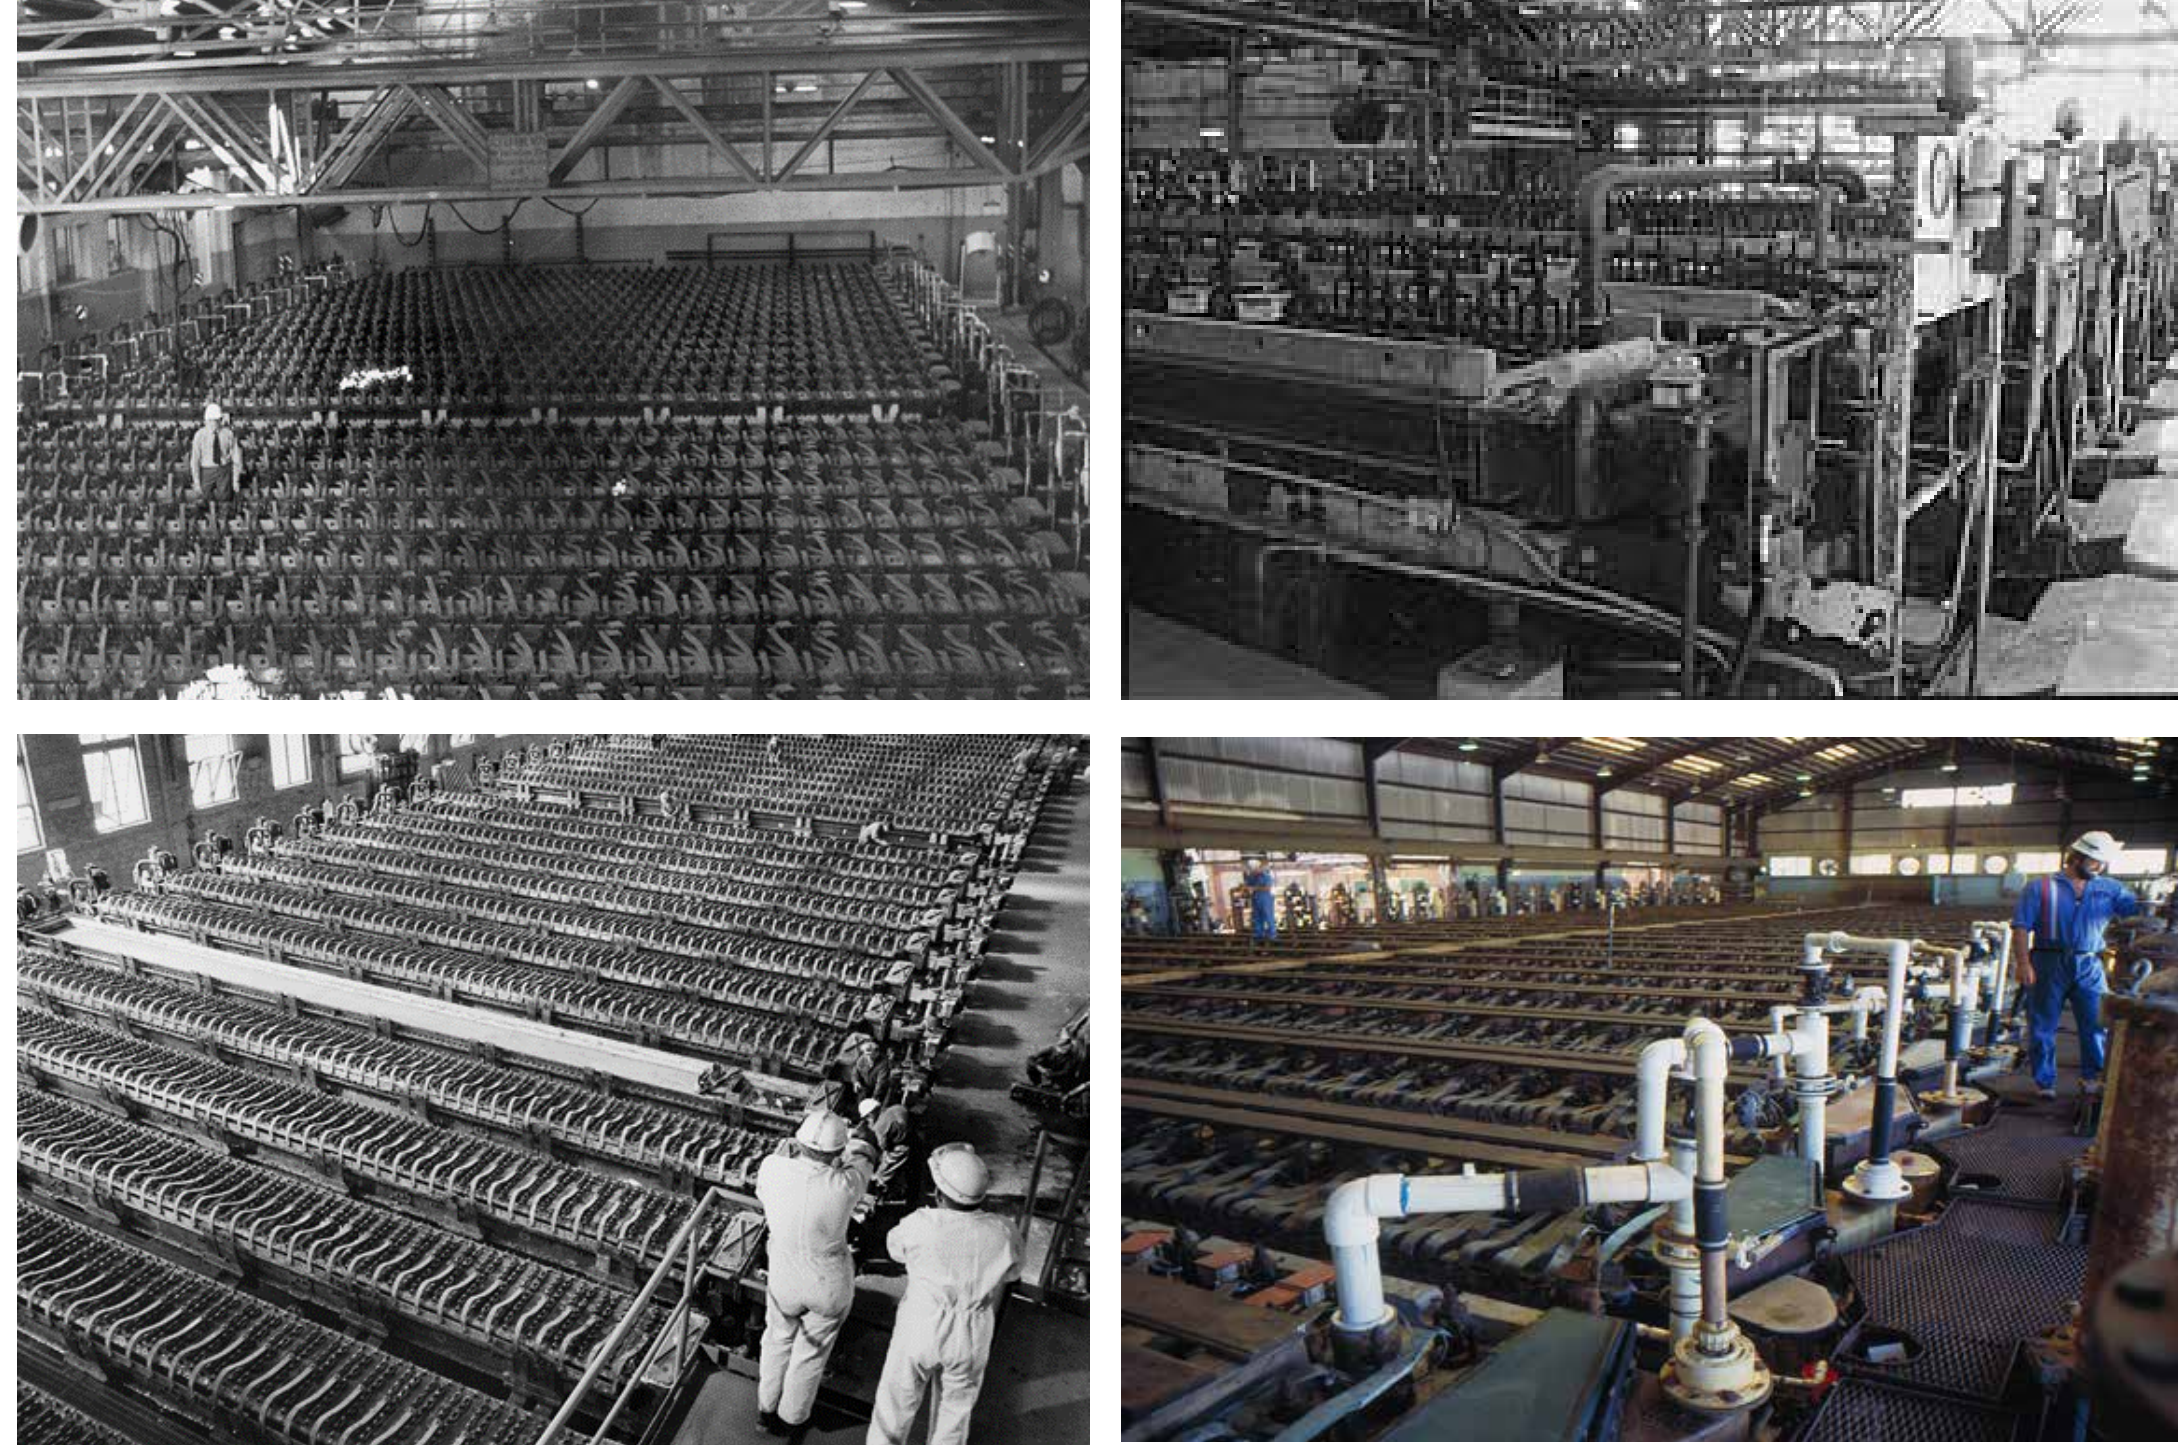
Block G Cell Room Floor infrastructure

Block G housed a mercury cell electrolysis process which produced chlorine, hydrogen, caustic soda, hydrochloric acid, sodium hypochlorite and ferric chloride.

The mercury cell electrolysis used a Liquid Mercury Cathode.

Losses of mercury to ground were likely to have been high as fugitive process emissions and during equipment maintenance.

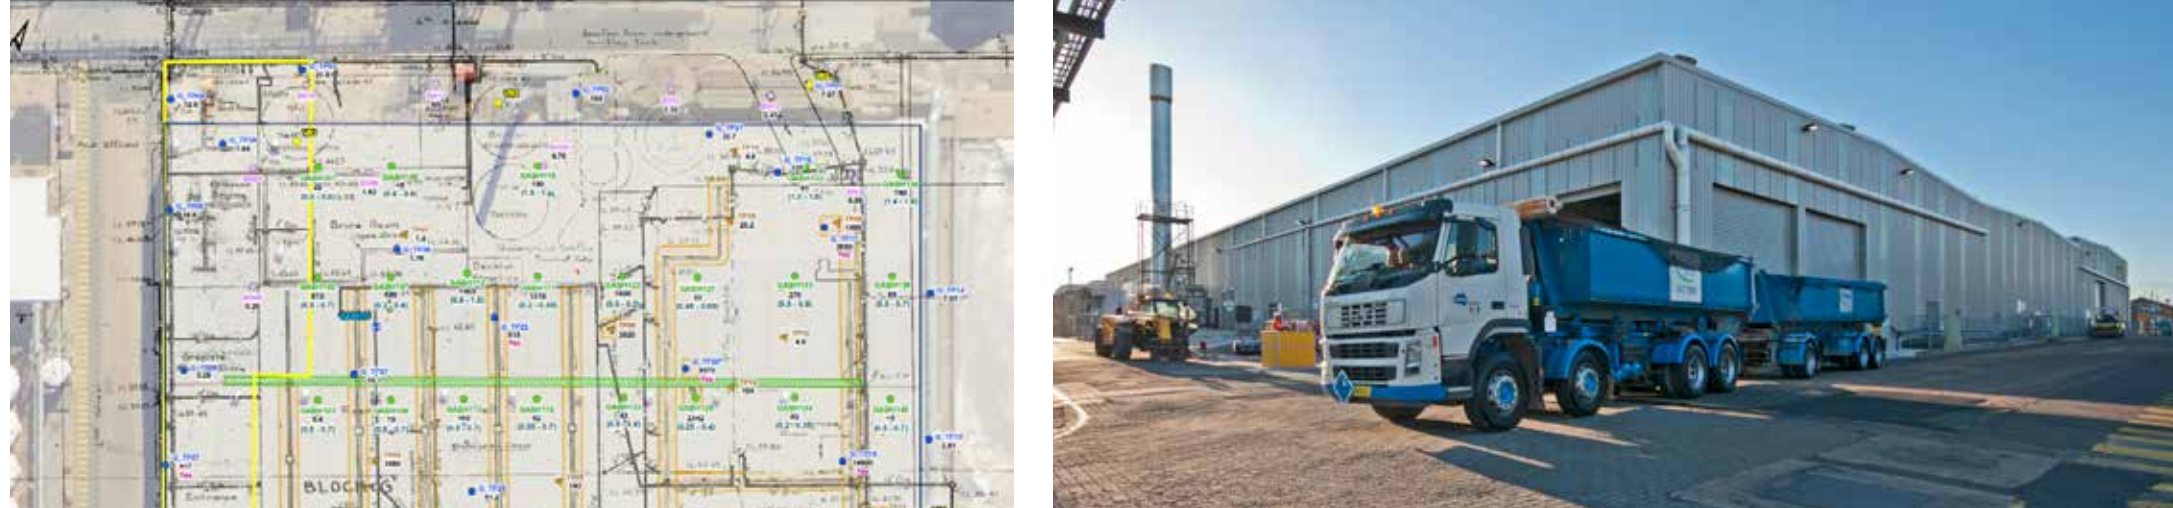
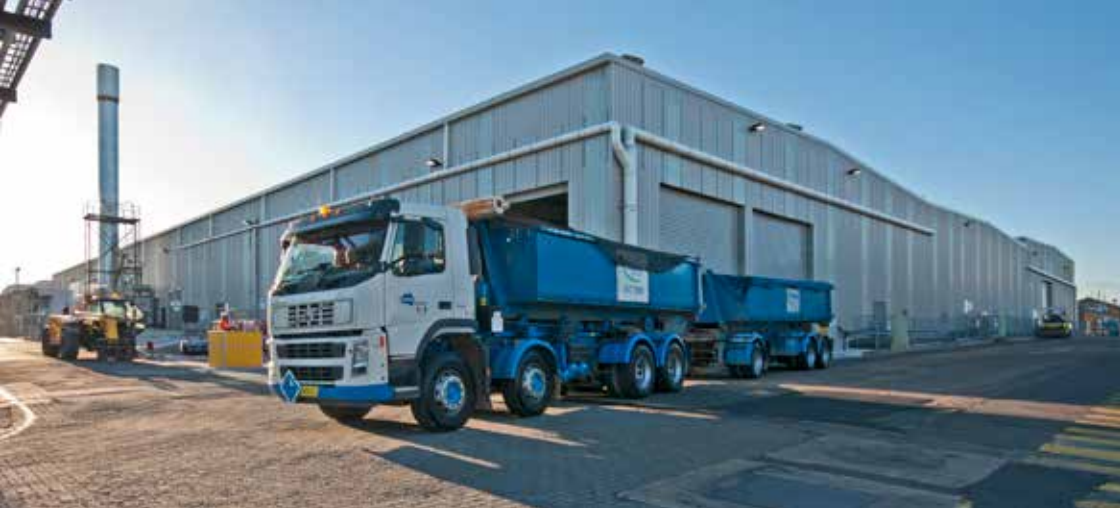
Elemental mercury (as pools or ‘prills’) was recovered where possible.

The sides and bases of the drain alignment excavations were characterized using a Niton XRF Analyzer with confirmatory analysis.

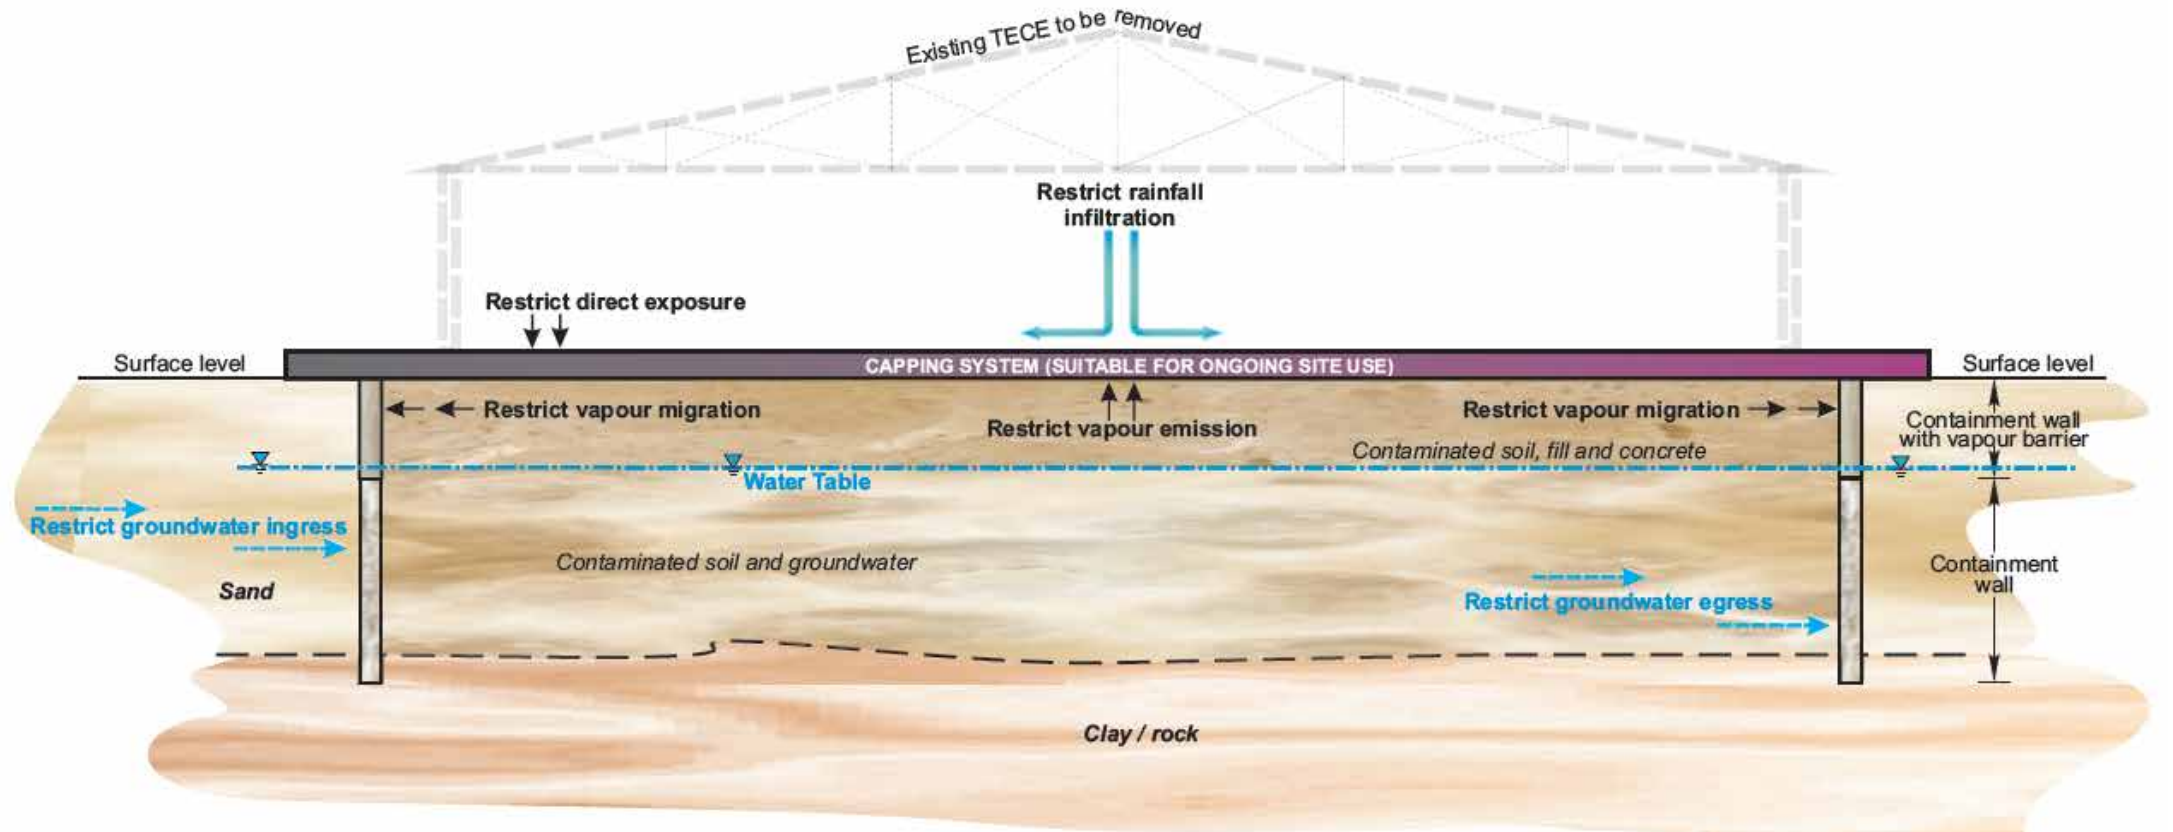
Concept – Integrated Design Remediation Action Plan

Dual Purpose Closed Cut-off Wall

- Hydraulic isolation (1×10^{-9} m/s)
- Lateral vapour emissions
- 25 m deep (clay/rock)

Multi-layered Capping System

- Infiltration
- Drainage landform
- Vertical vapour movement
- Gas venting (contingency)
- Gas monitoring (validation)

Functional Surface Slab

- Salt stockpile re-location
- Operational platform
- Salt stockpile
- Heavy machinery

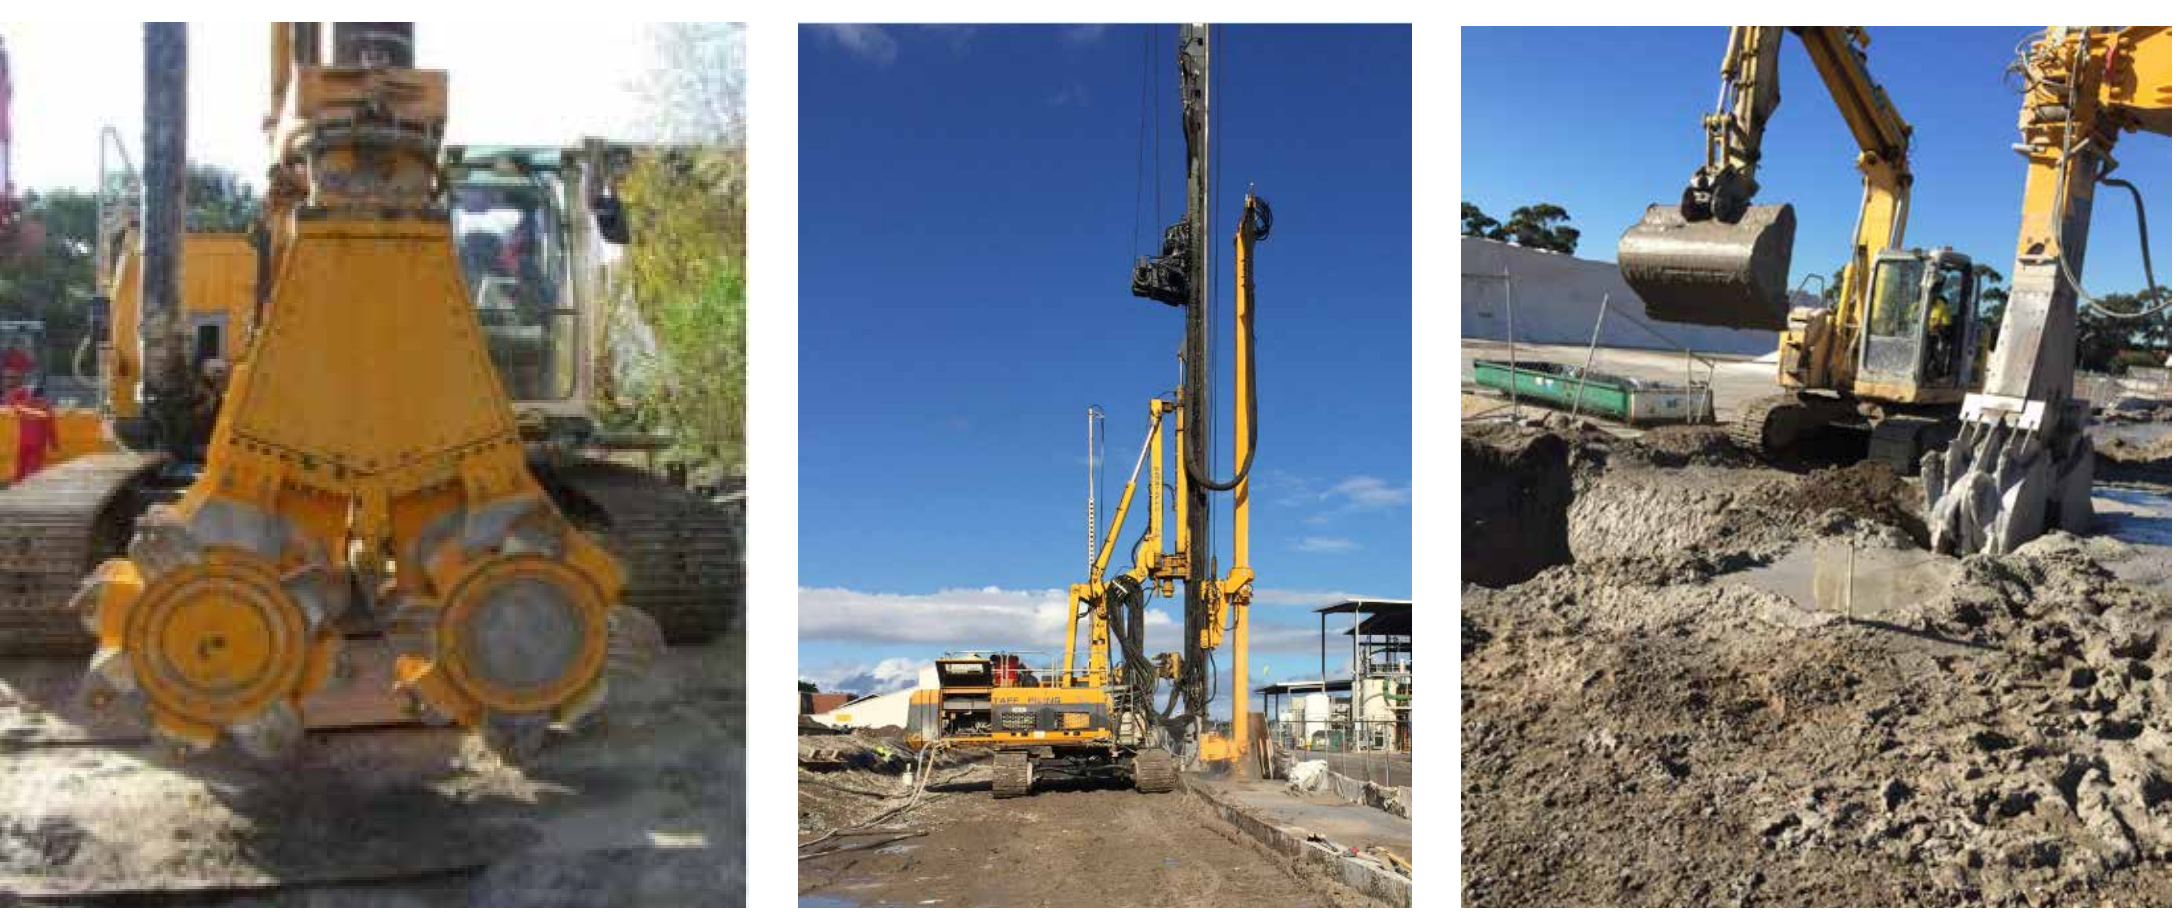
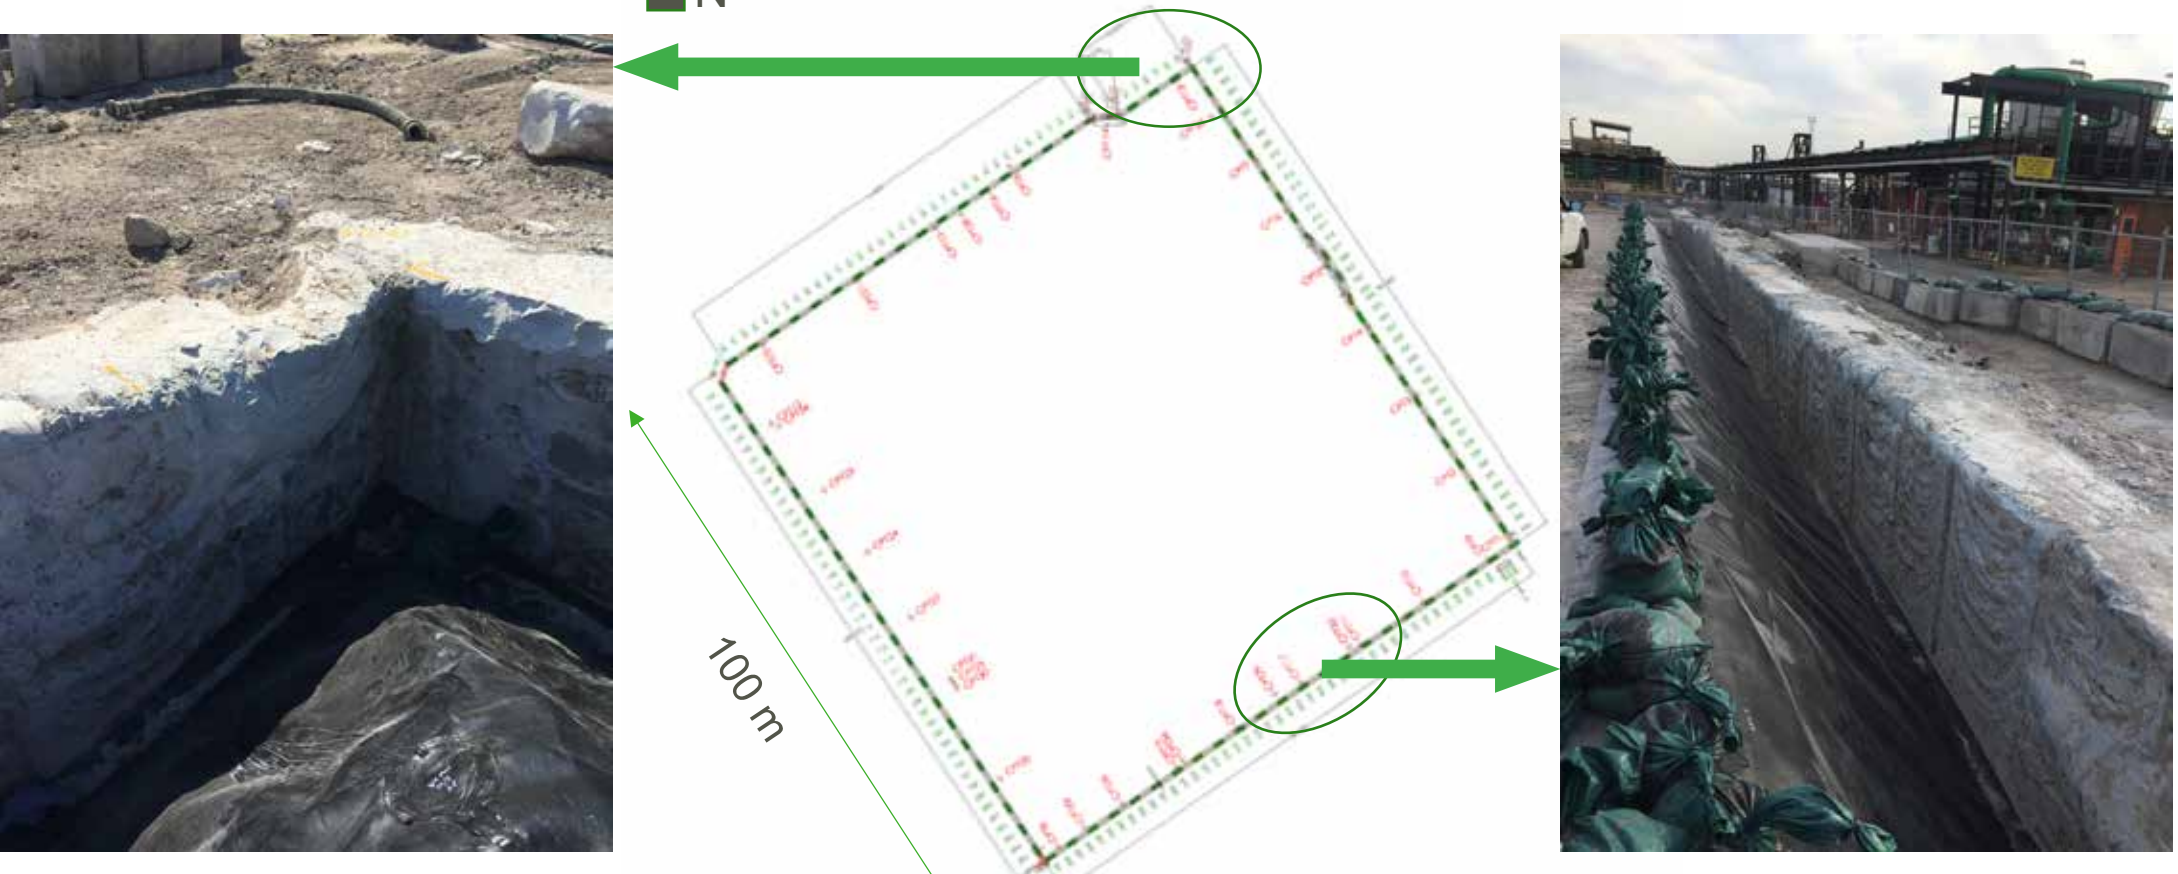
The cut-off wall was installed using a Cutter-soil mix installation technology:

- Depth capability (25 m+)
- Target impermeabilities (1×10^{-9} m/s)
- Key-In and panel verticality verification
- Integration with capping system

Cutter-soil mix technology was used to install 188 contiguous soil bentonite panels. The panels were installed in a counter clockwise direction, creating a closed continuous cut-off system. The soil bentonite mix was batched on site.

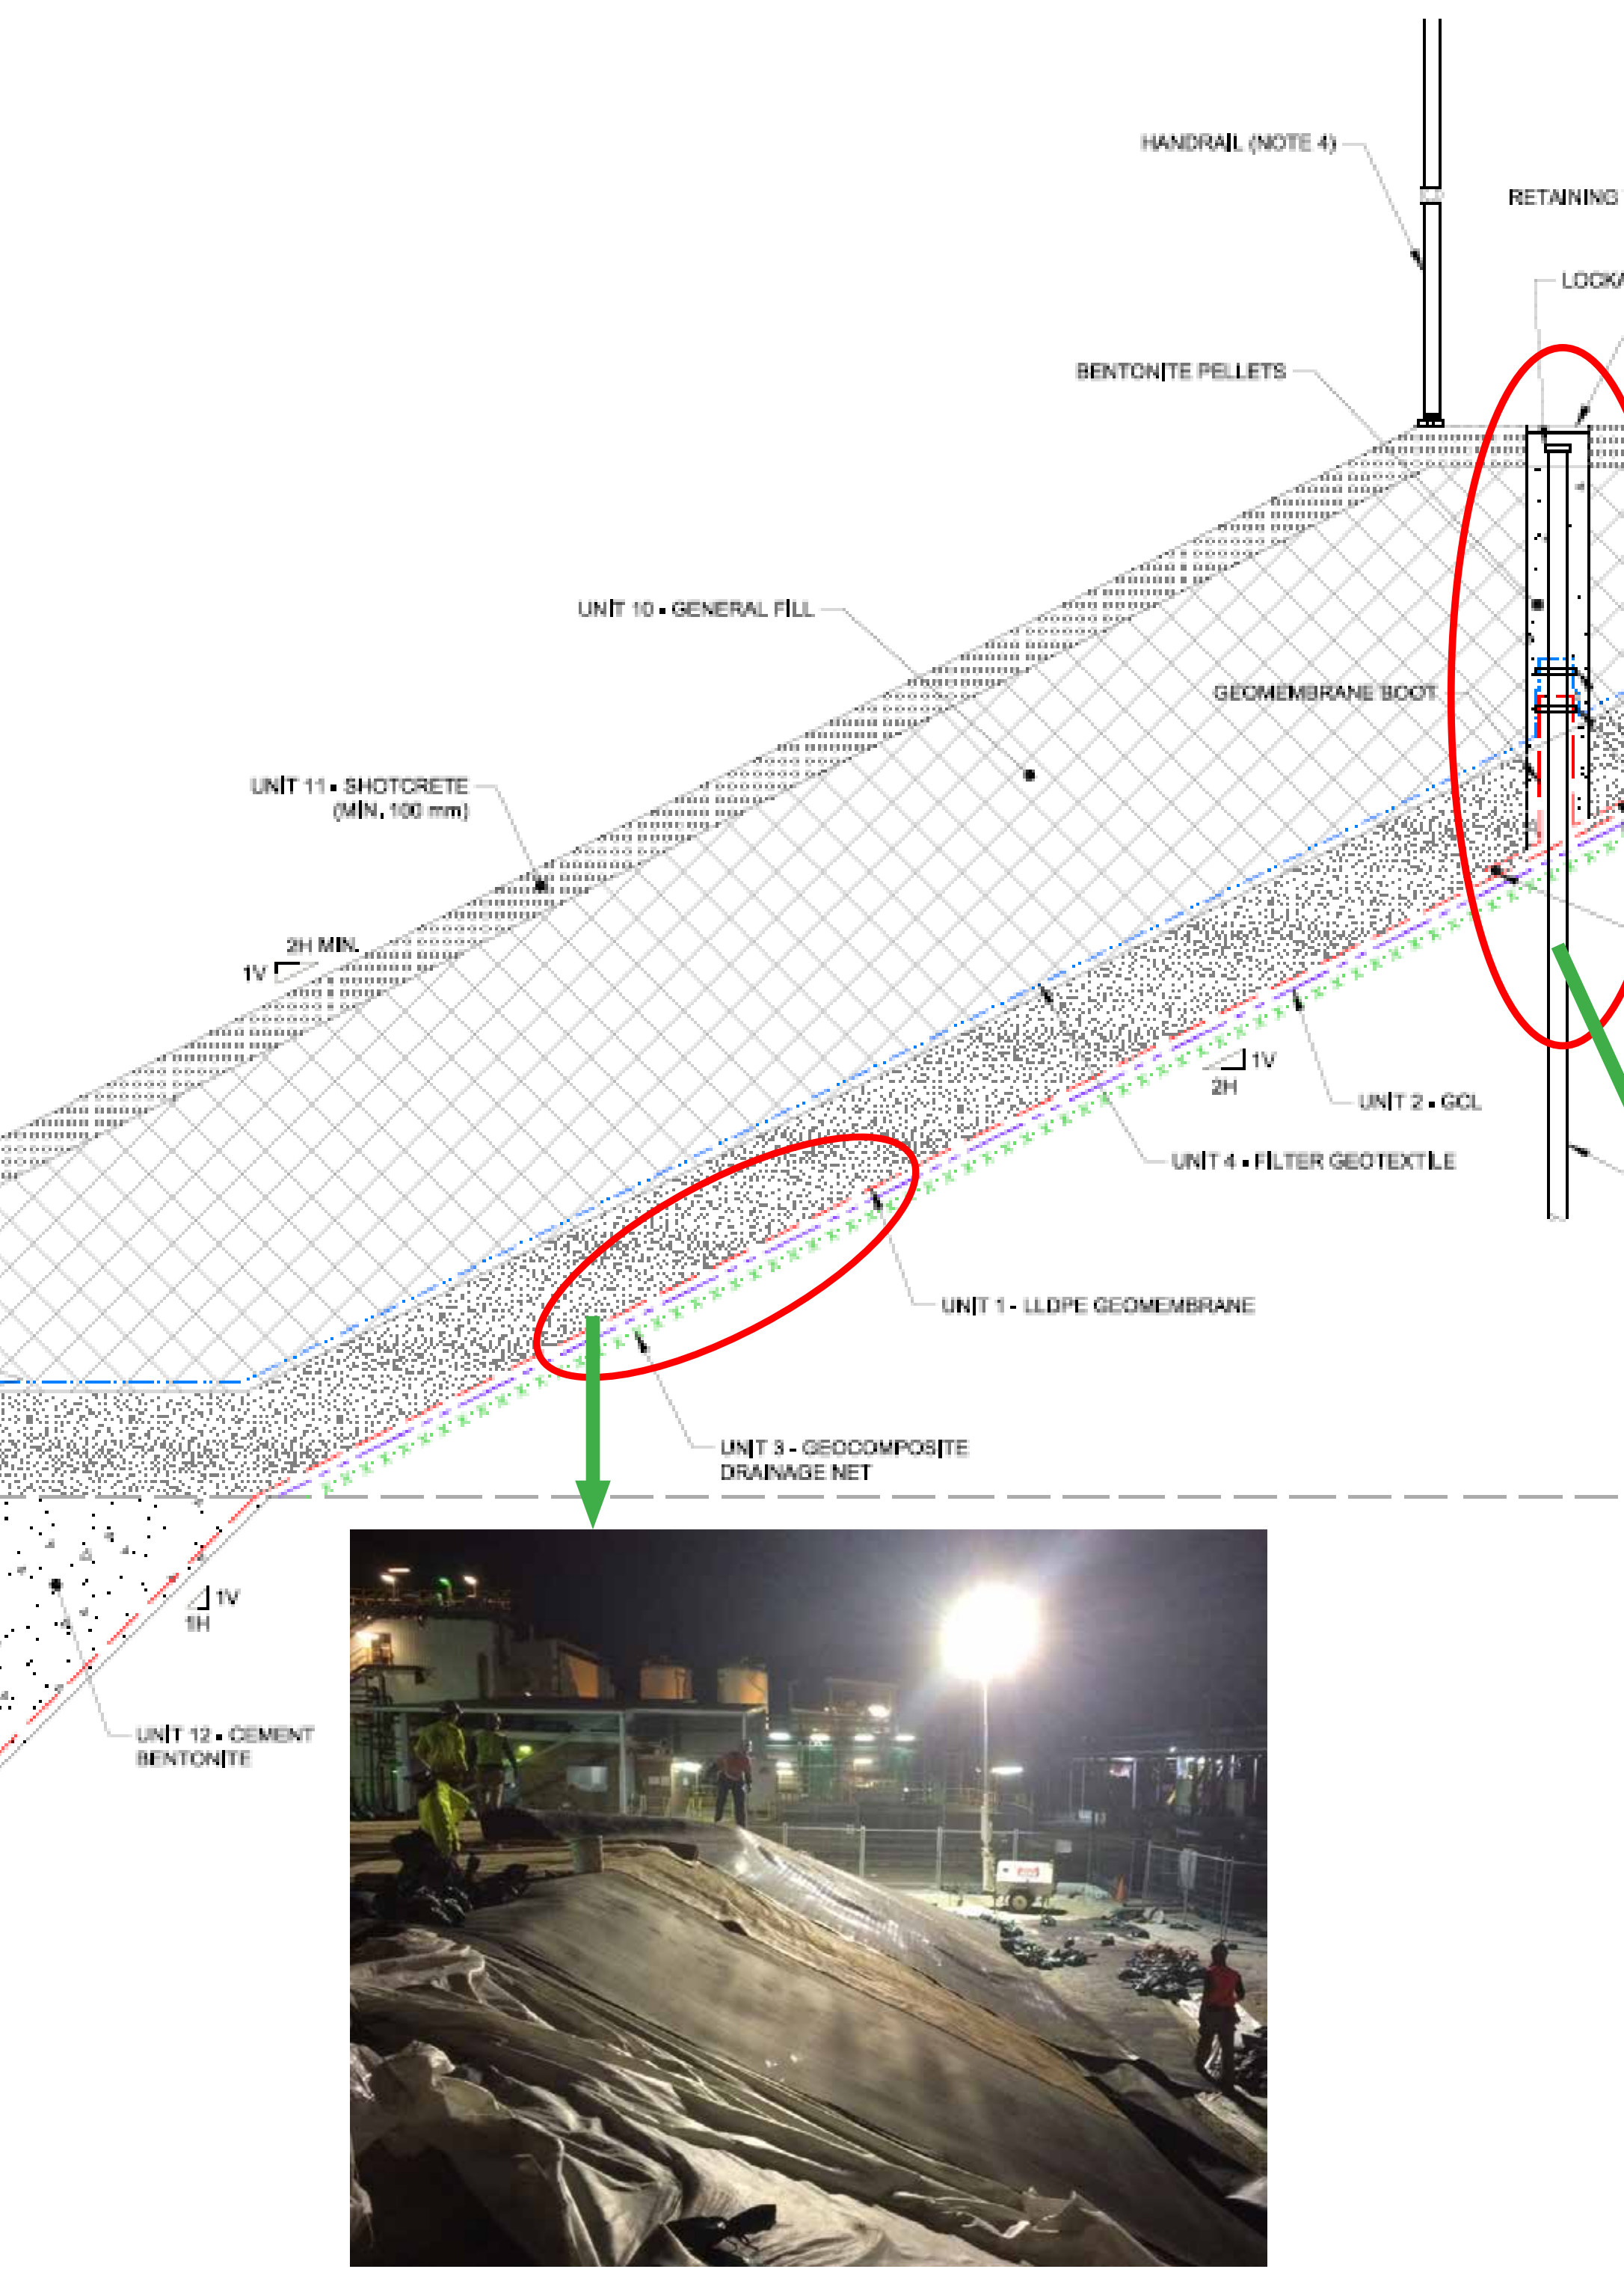
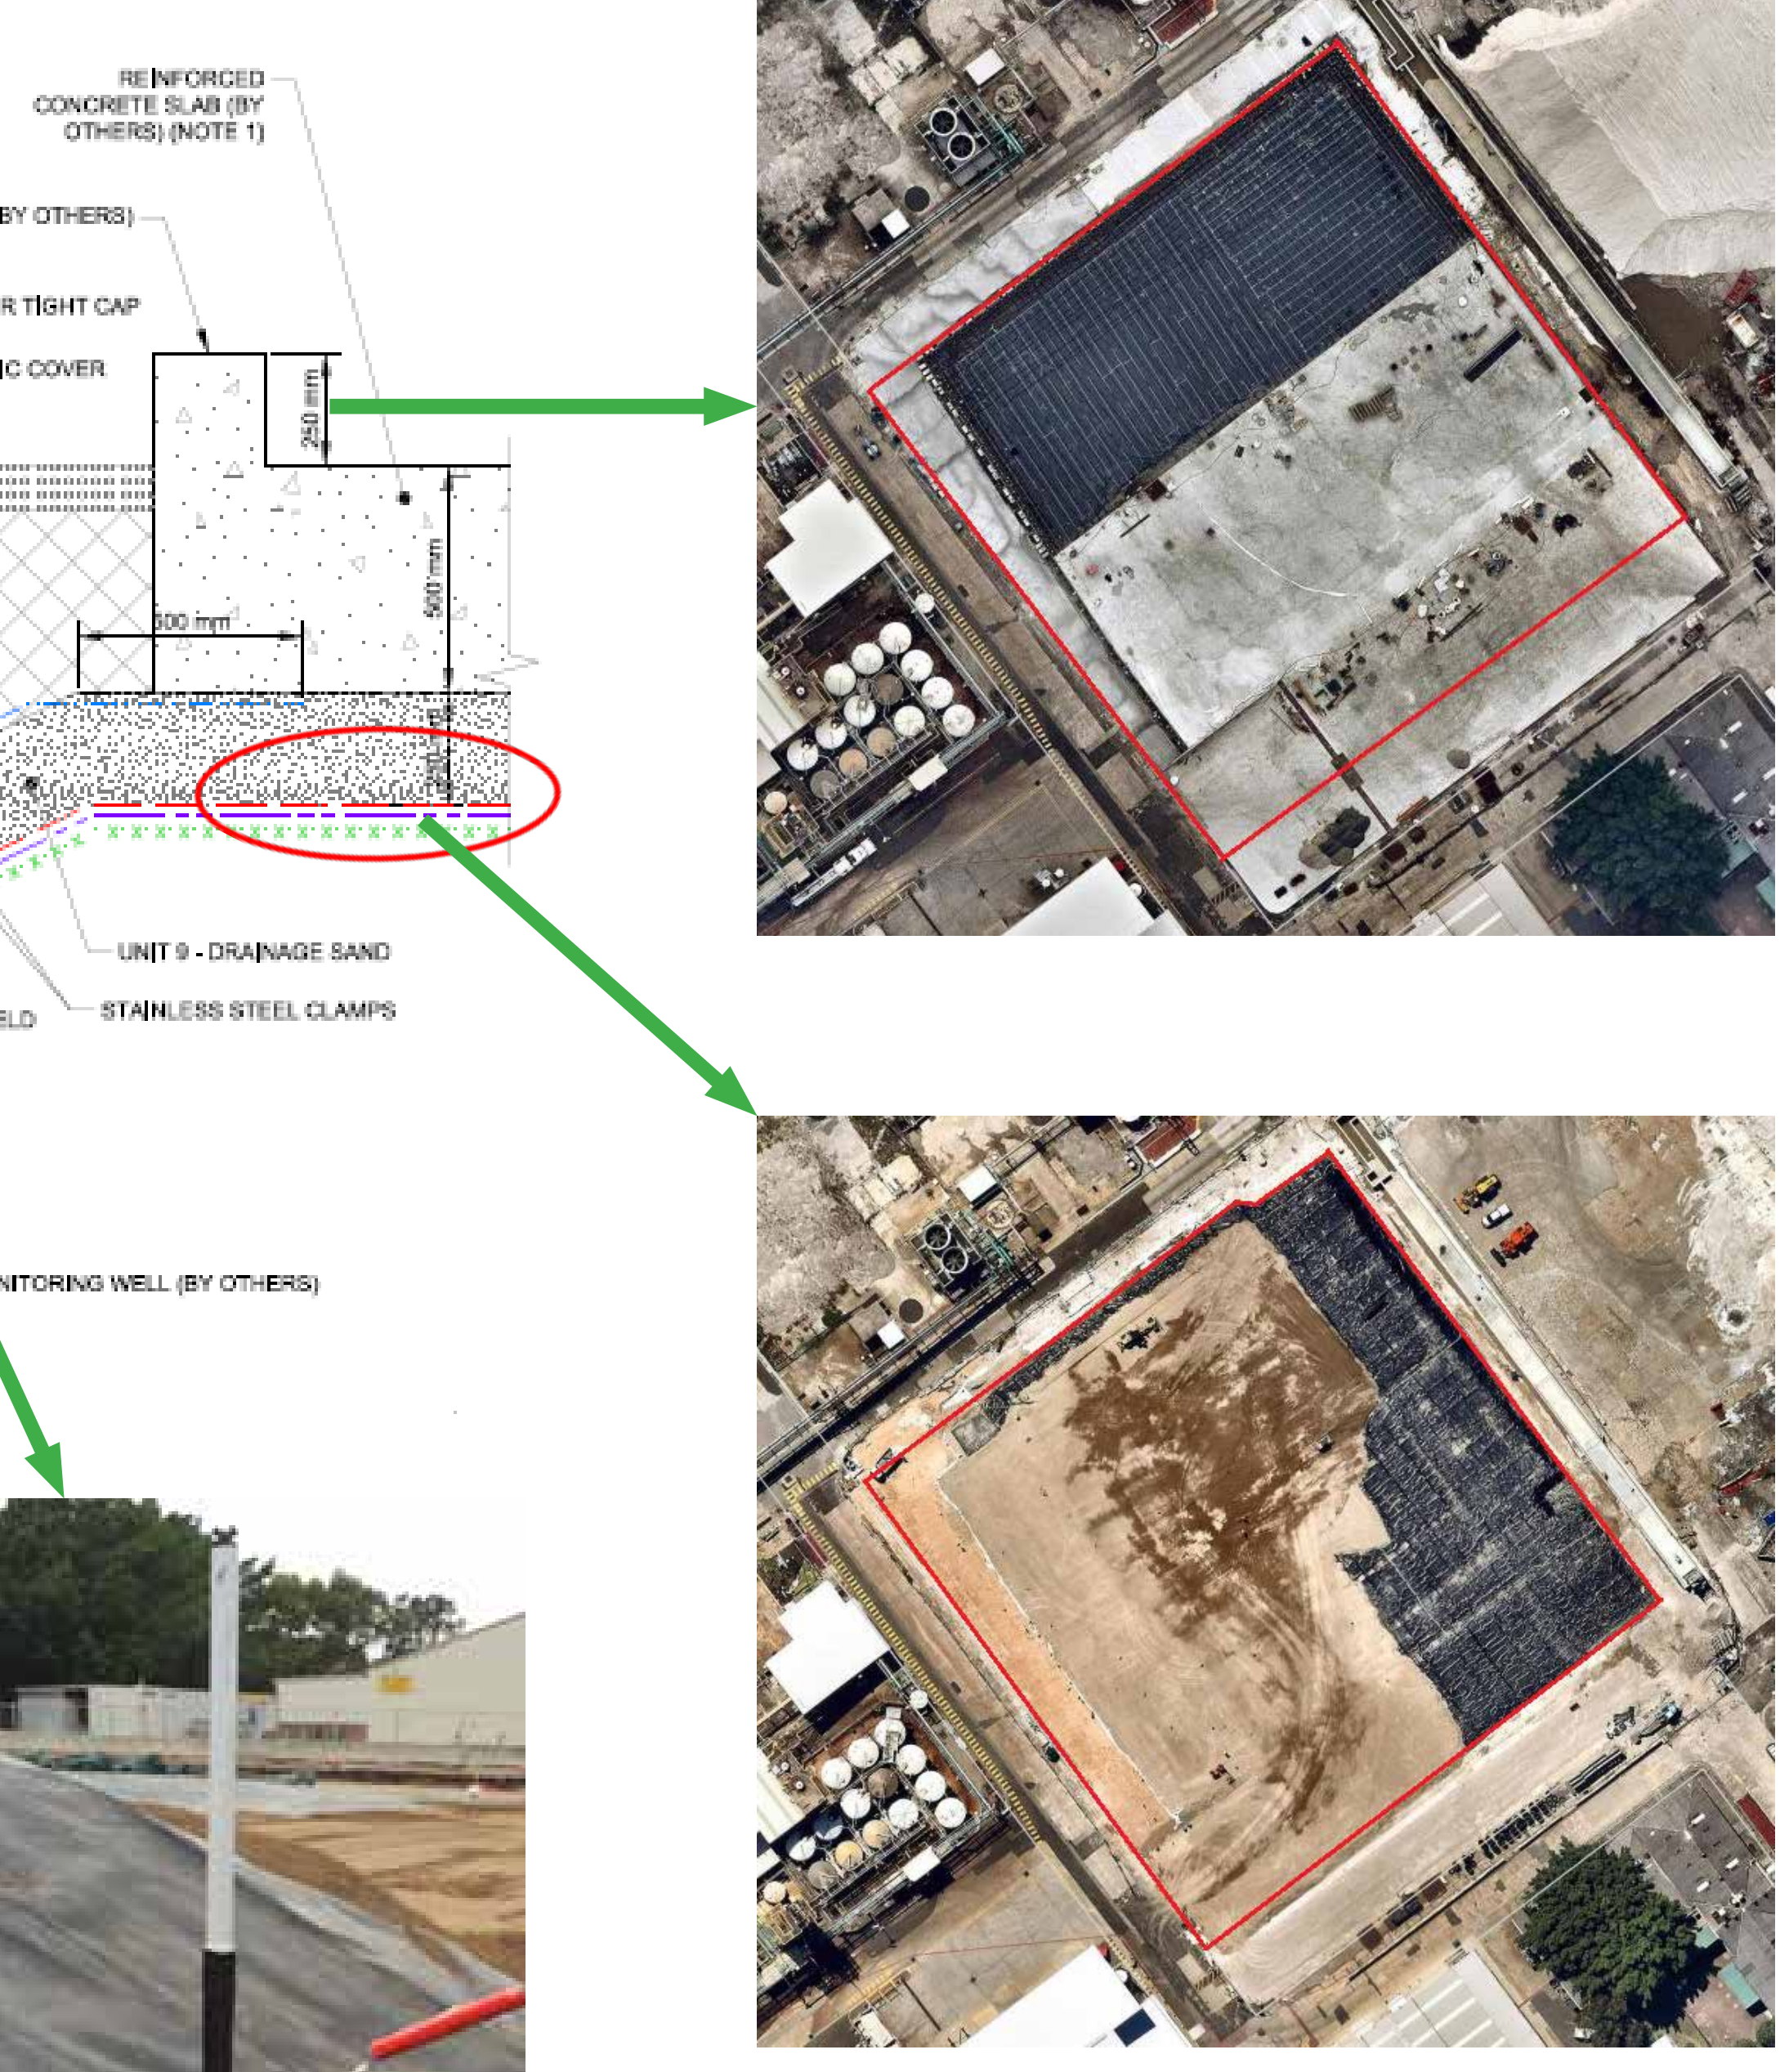
Capping System Design and Installation

A multilayered capping system incorporated a vapour barrier, contingency vapour collection system, a vapour monitoring system.

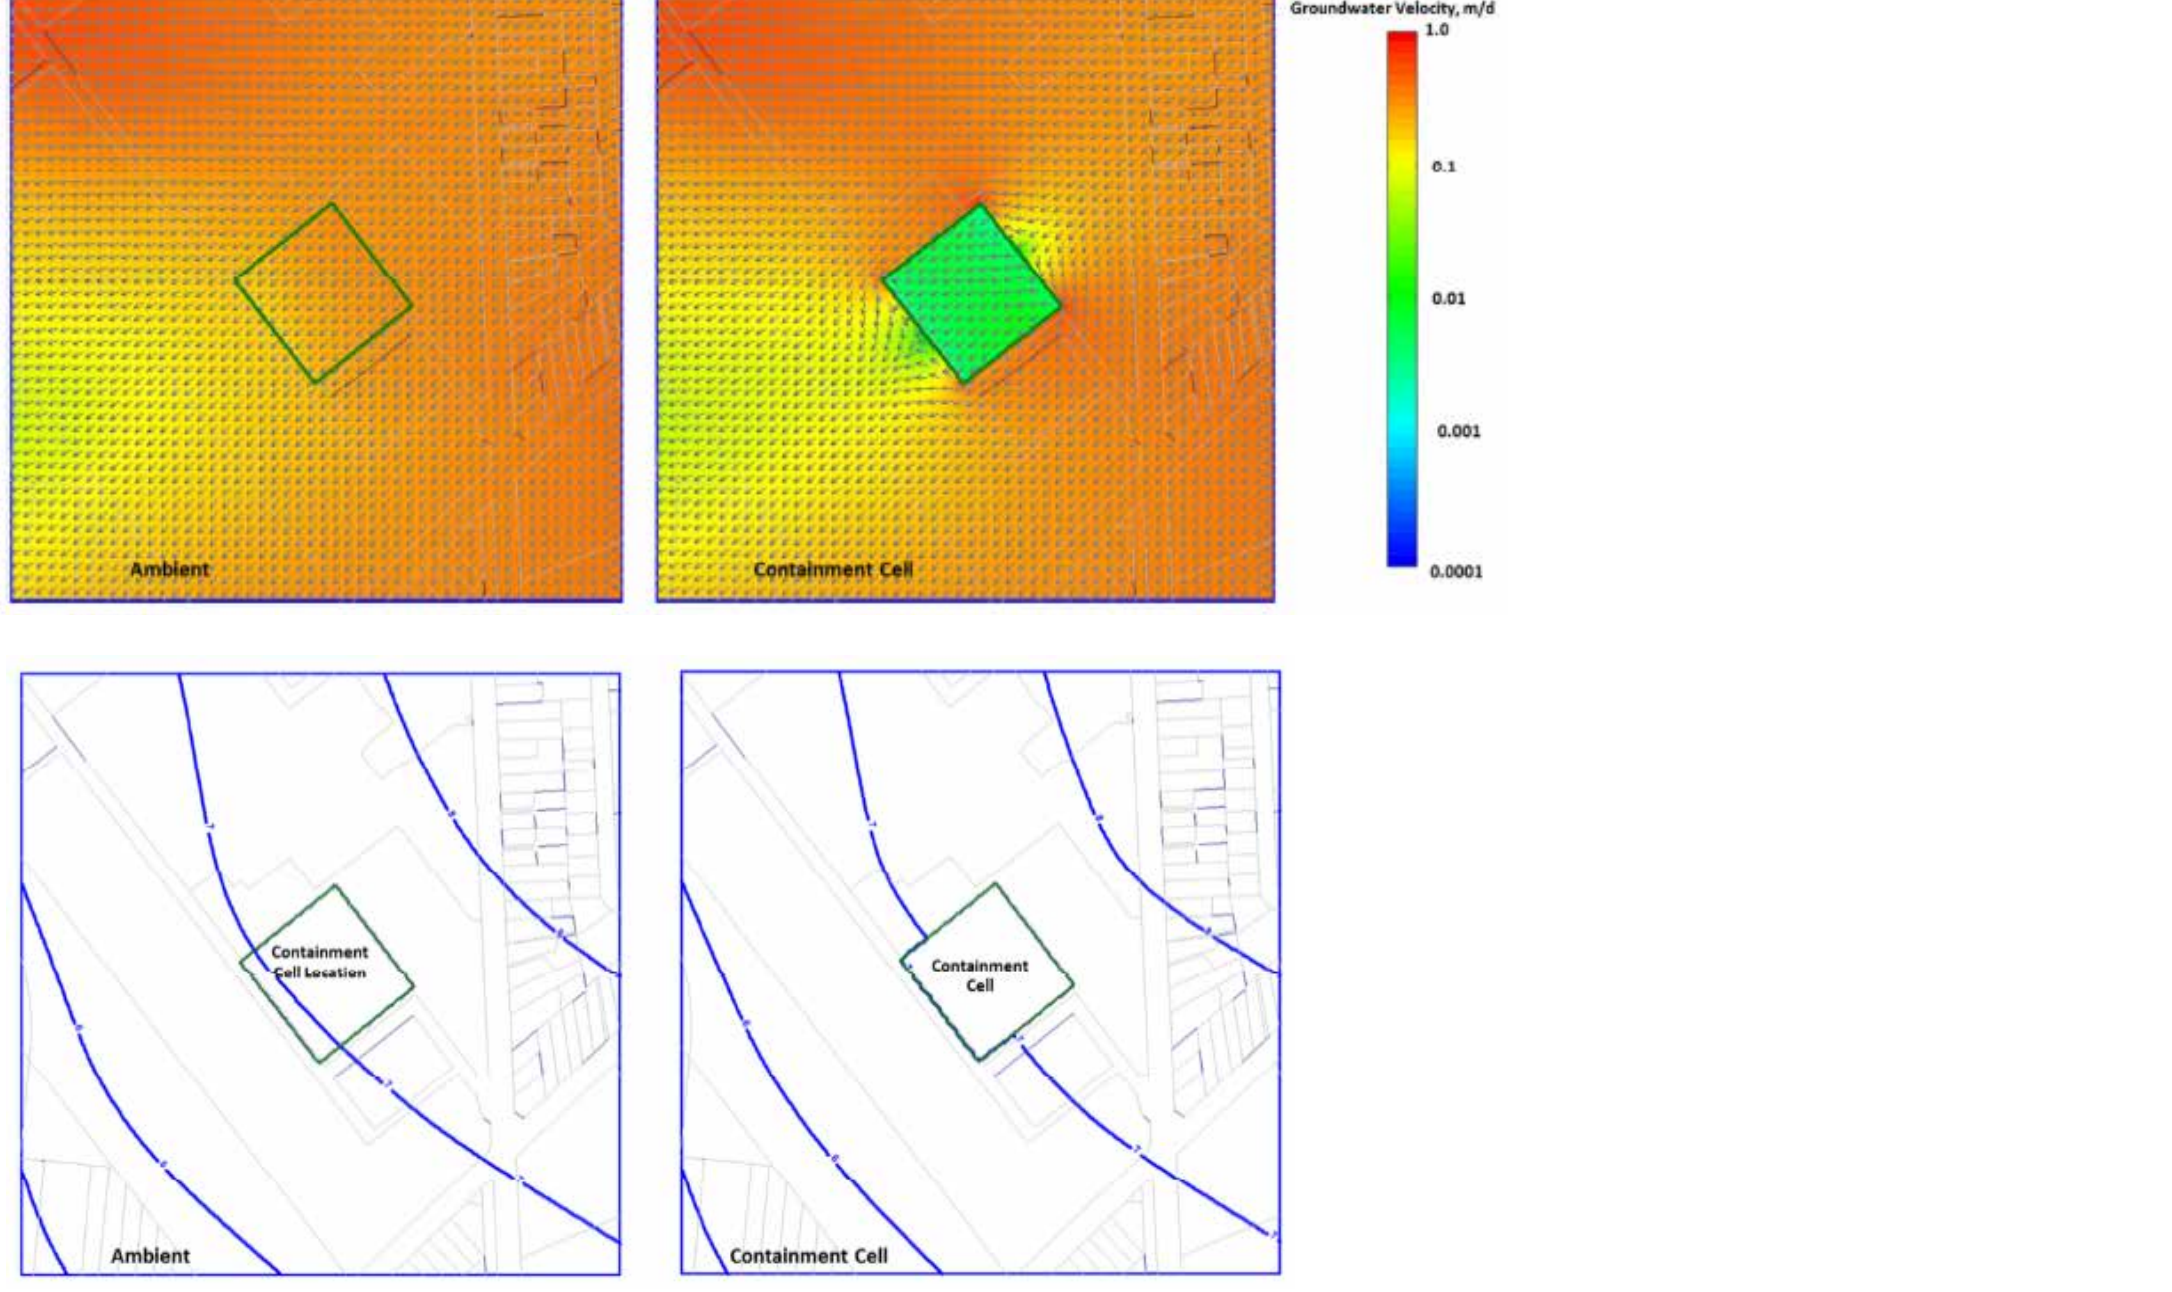
Numerical Modeling / Validation Approach

A numerical model prepared by A.D.Laase predicted a range of hydraulic head redistribution patterns and regional behaviours.
