Remediation of Mercury Contamination at a Former ChlorAlkali Plant Using Integrated Cap and Containment Technologies

Authors: Gavan Butterfield, James Stening, Gary Schmetrmann, Caroline Vernon, Frederic Cosme, Al.D.Laase
Golder Associates Pty Ltd, Sydney, NSW, Australia; Orica Australia Pty Ltd, Botany, NSW, Australia

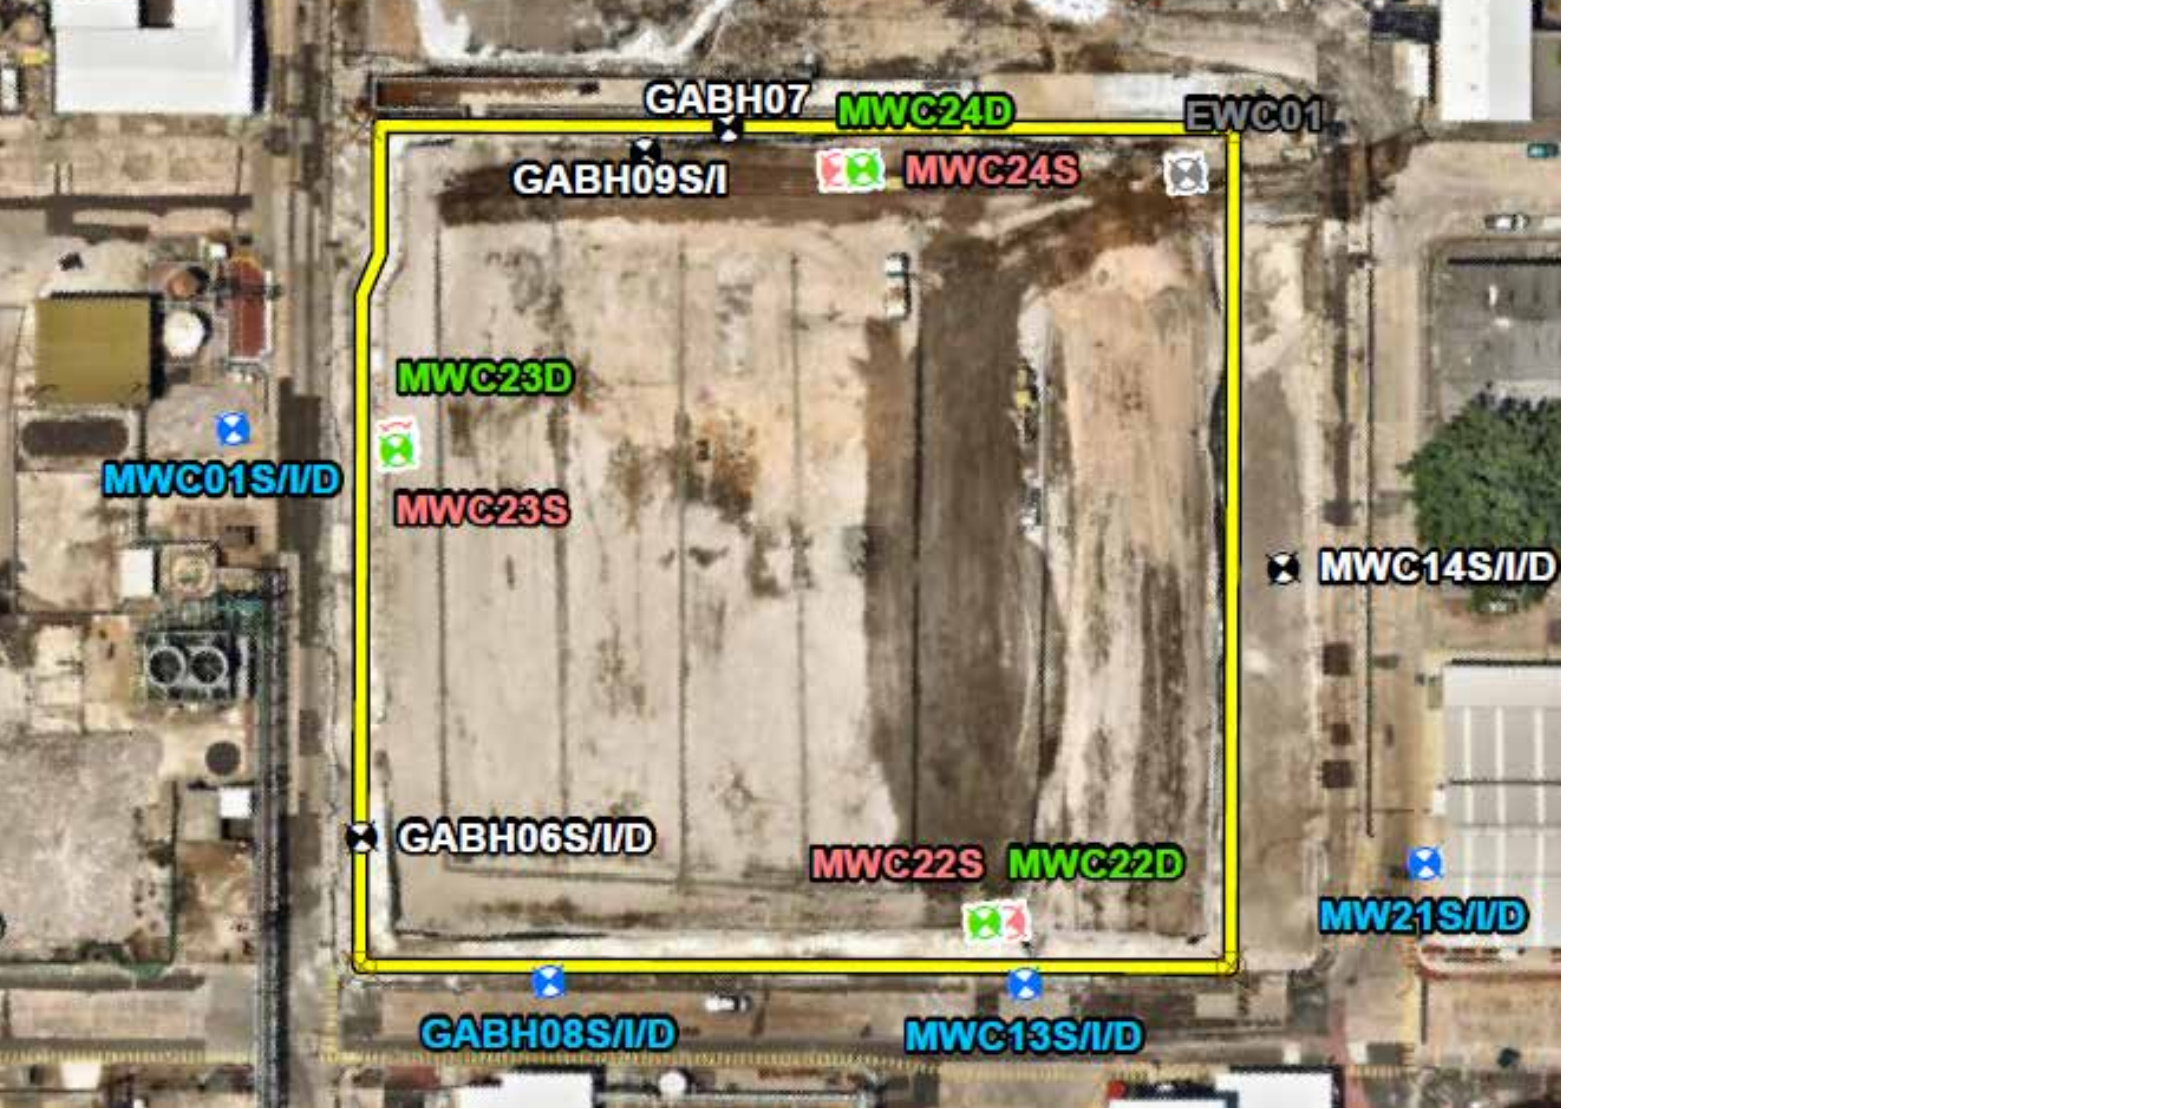
A series of paired shallow and deep monitoring wells was designed and installed to compare hydraulic head either side of the closed cutoff wall structure.

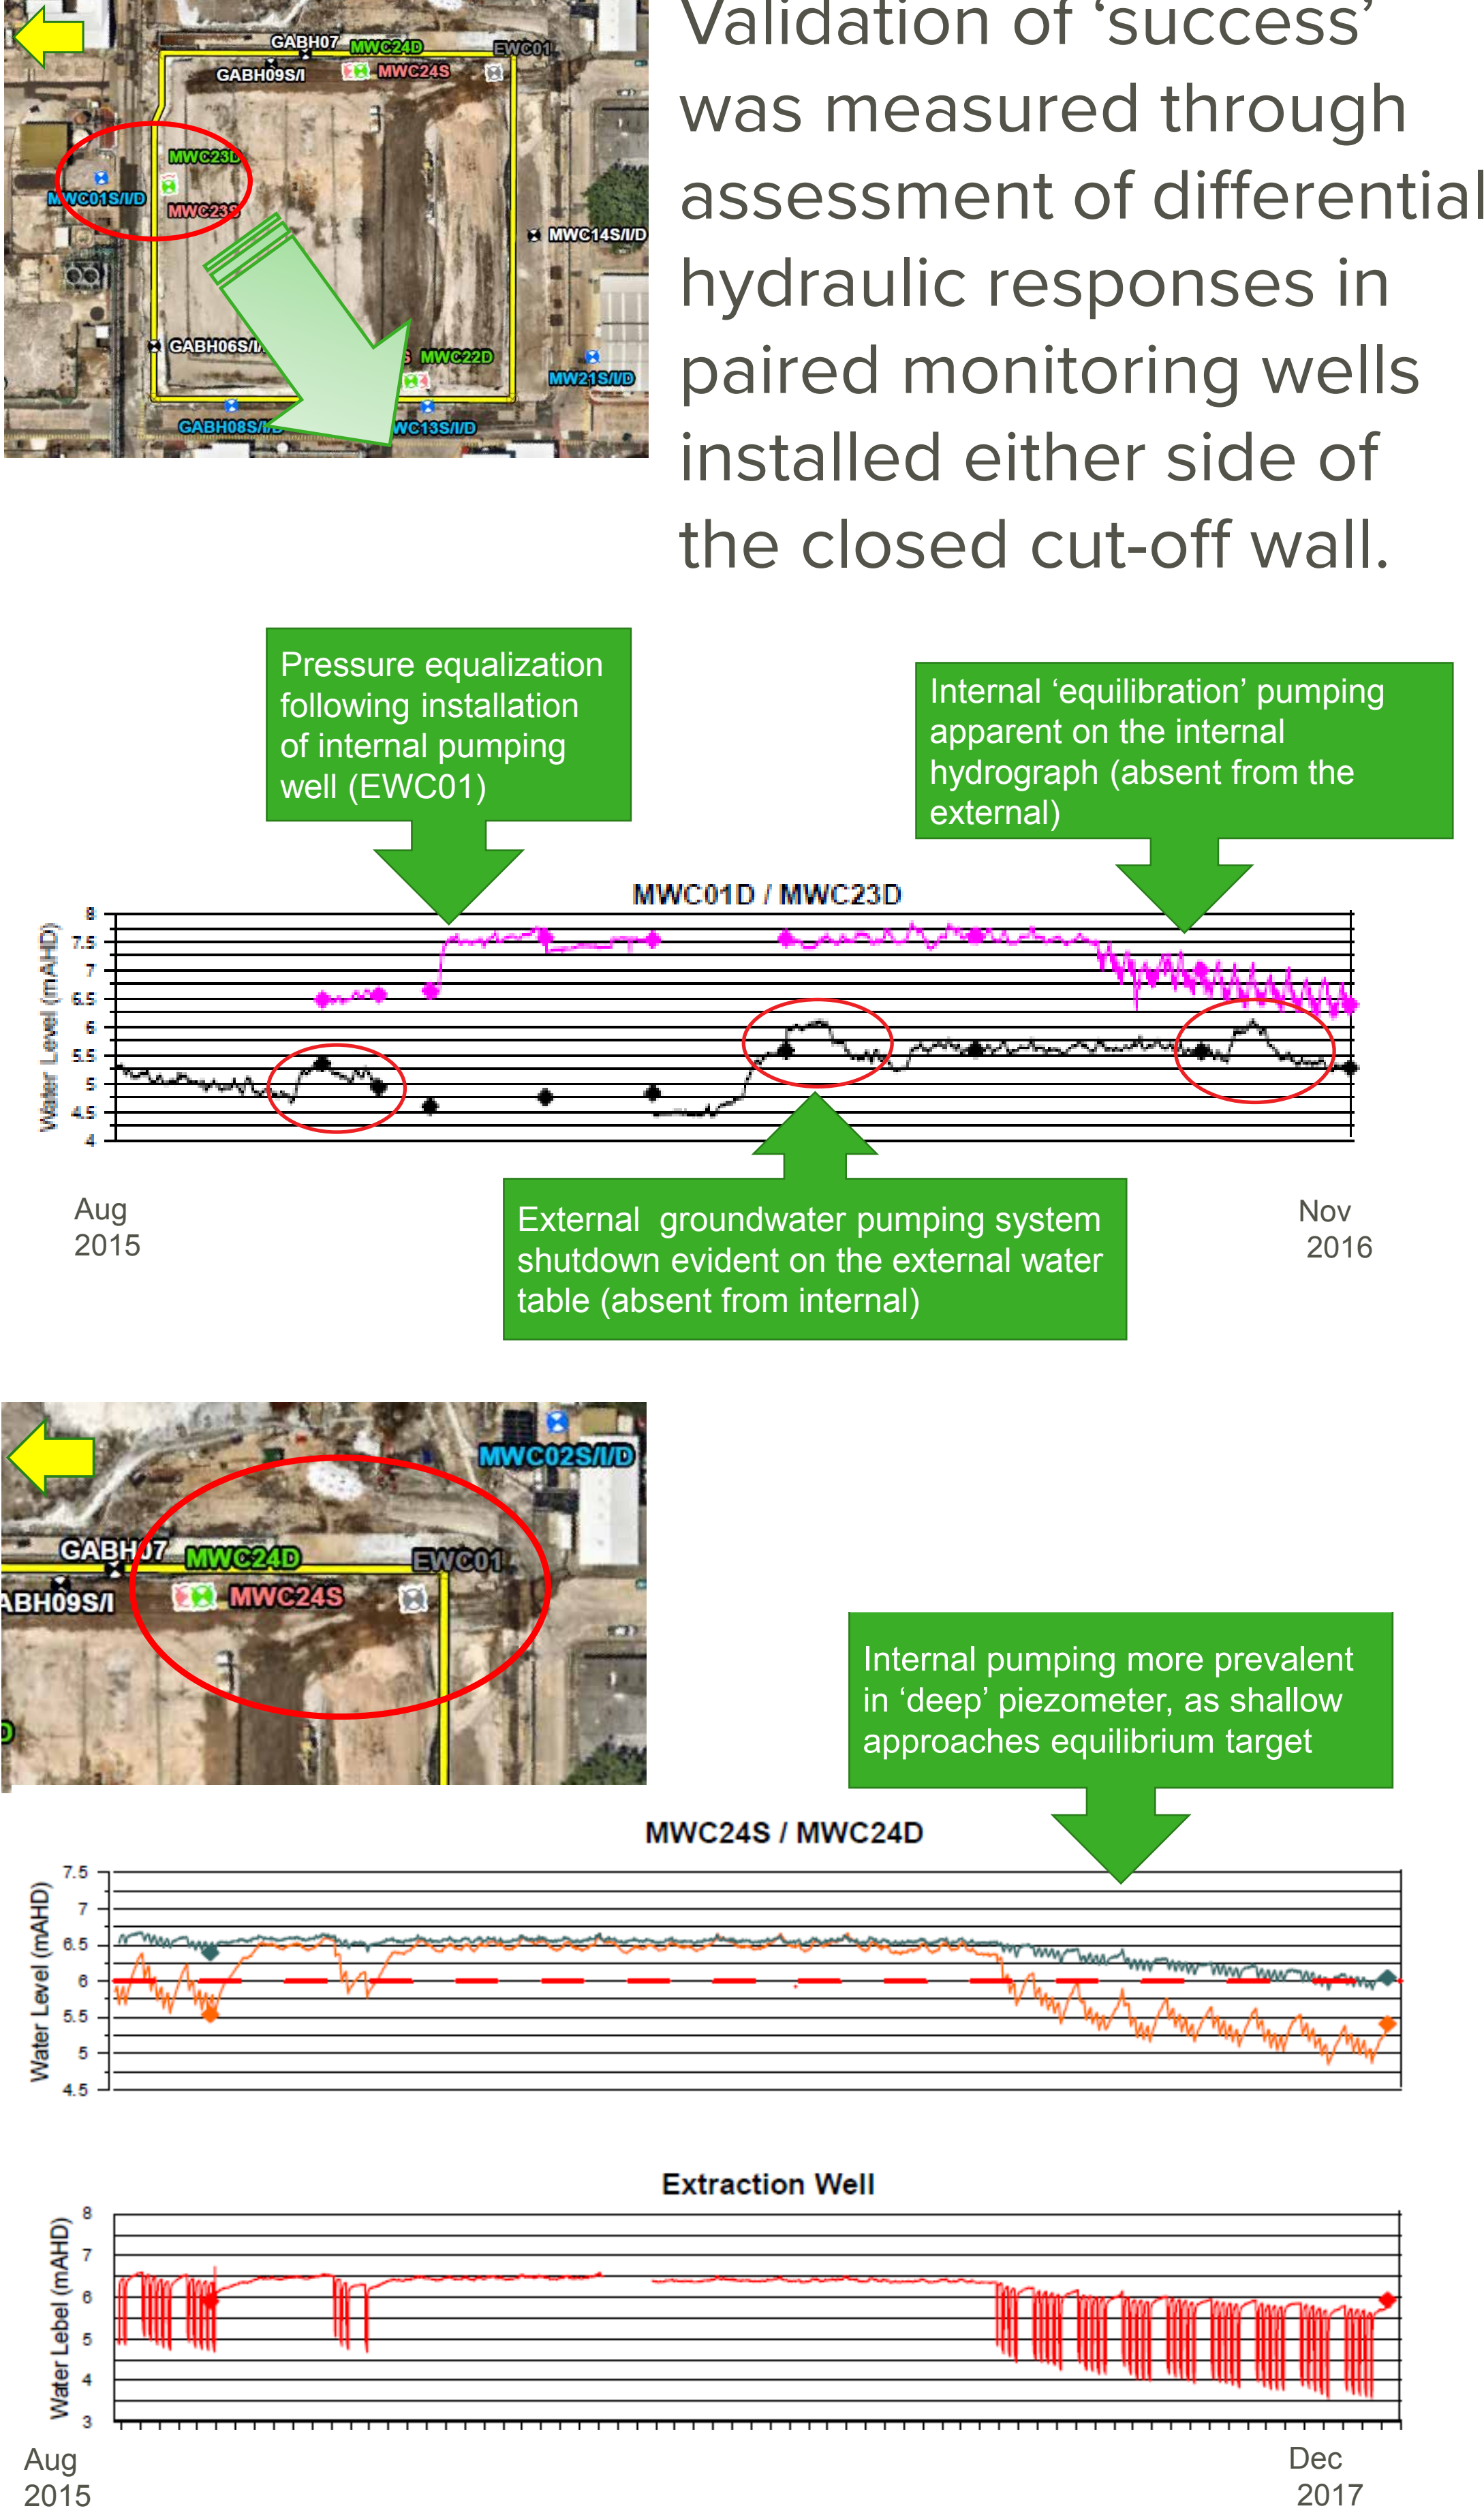
Hydraulic Validation

Validation of ‘success’ was measured through assessment of differential hydraulic responses in paired monitoring wells installed either side of the closed cut-off wall.

Pressure equalization following installation of internal pumping well (EW001)

Internal ‘equilibration’ pumping apparent on the internal hydrograph (absent from the external)

External groundwater pumping system shutdown evident on the external water table (absent from internal)

Internal pumping more prevalent in ‘deep’ piezometer, as shallow approaches equilibrium target
