# A Case Study of the Anatomy of a Dynamic High Concentration Chlorinated Solvent Plume and Consequences on Remedial Strategy

Author: Joe Duran (jduran@golder.com.au)- Golder Associates, Melbourne, VIC, Australia

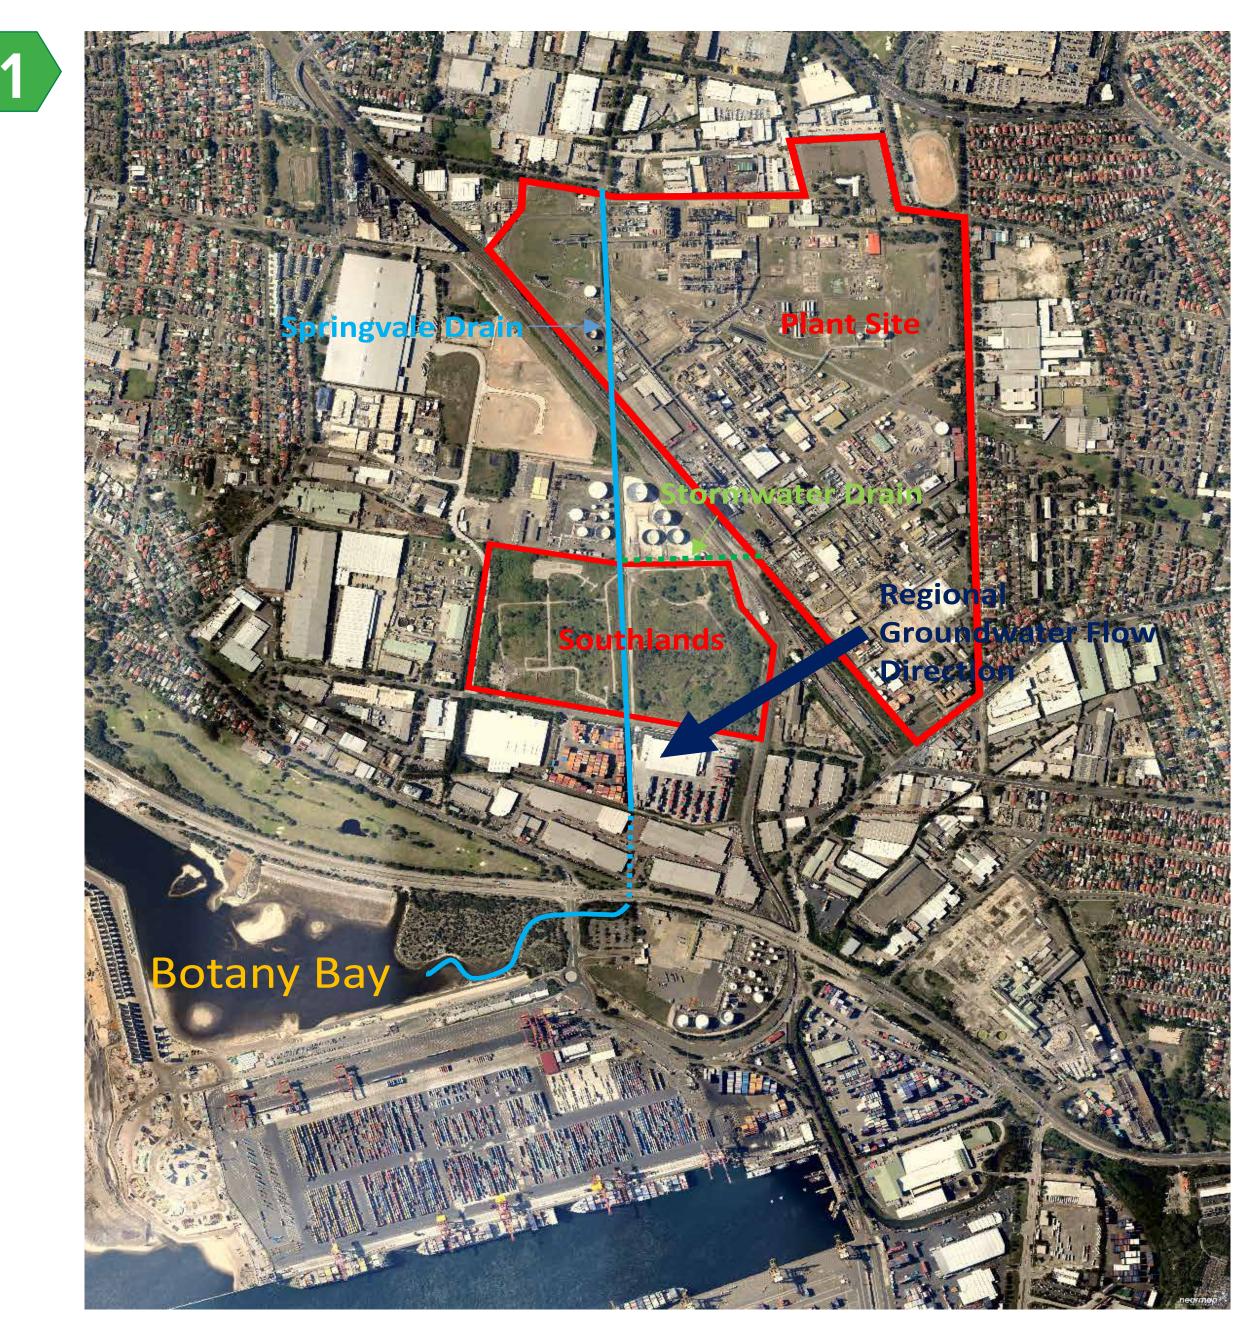
- The investigation had identified a number of potential DNAPL sources from the manufacturing of chlorinated solvents, and had identified a complex mixture and distribution of multi-sourced dissolved-phase chlorinated solvent plumes.
- Shallow groundwater discharge to surface water drains resulted in contamination of both surface water and sediments with subsequent transport to Botany Bay. The largest contaminant mass discharge to the environment occurred through the Southlands portion of Springvale Drain (40 kg/day), which represents approximately 40% of contaminant mass discharge to the environment, through just 4% of the groundwater flow.

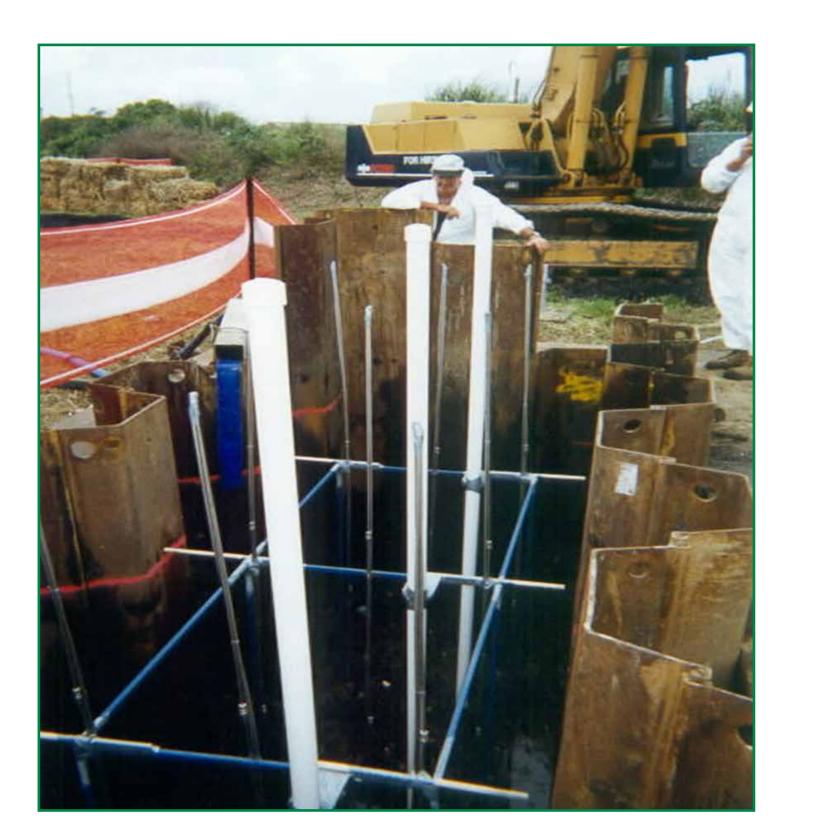
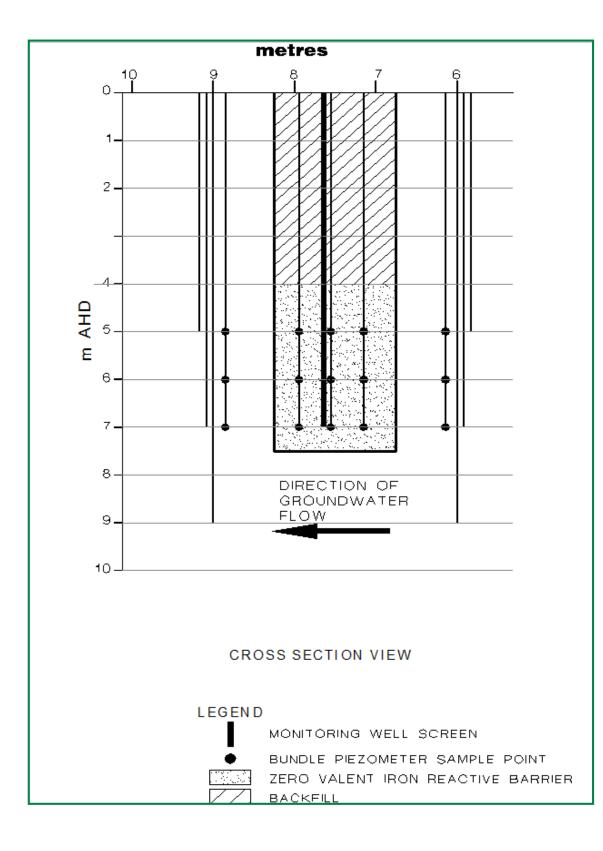
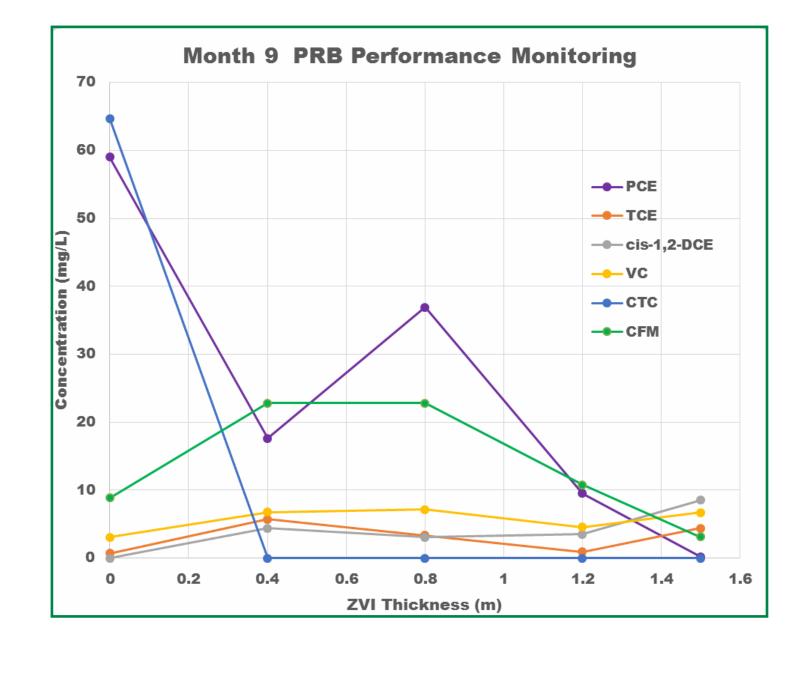
Remedial works for shallow groundwater discharge to surface drains included installation of a pilot scale Zero Valent Iron (ZVI) Permeable Reactive Barrier (PRB) in February 1999 (Duran et al, 2000)

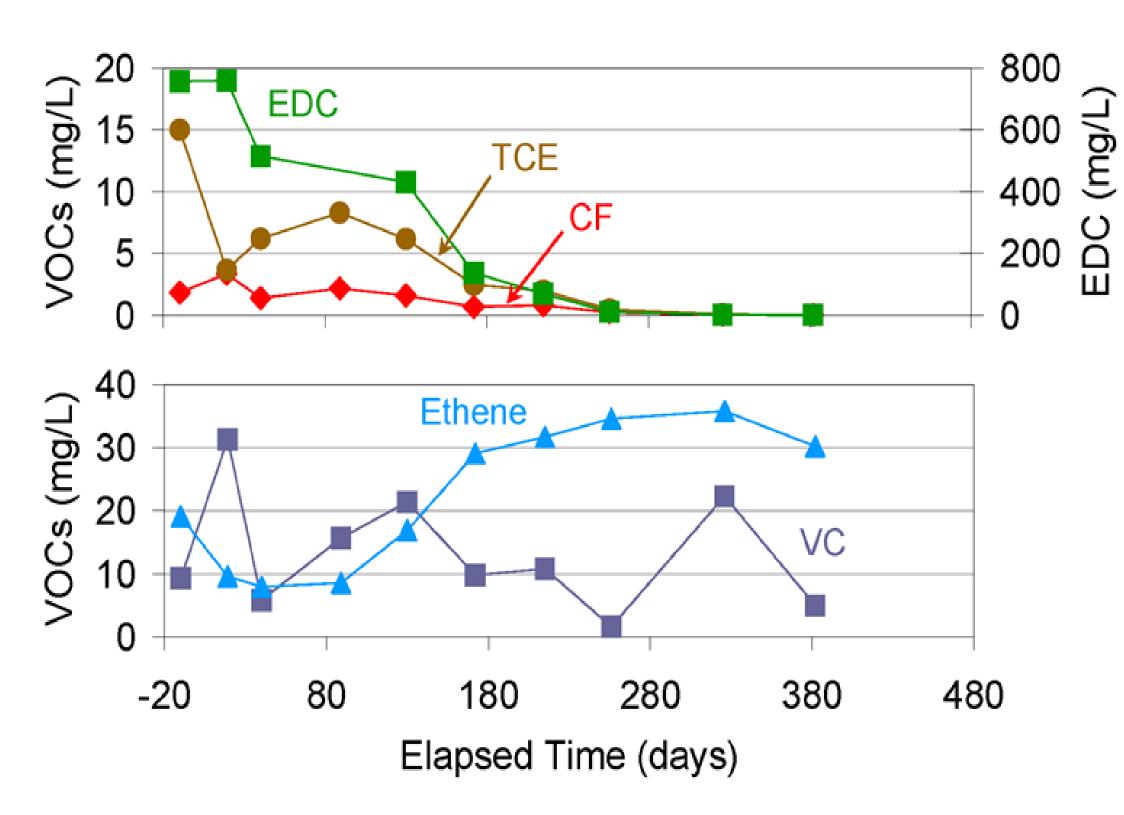
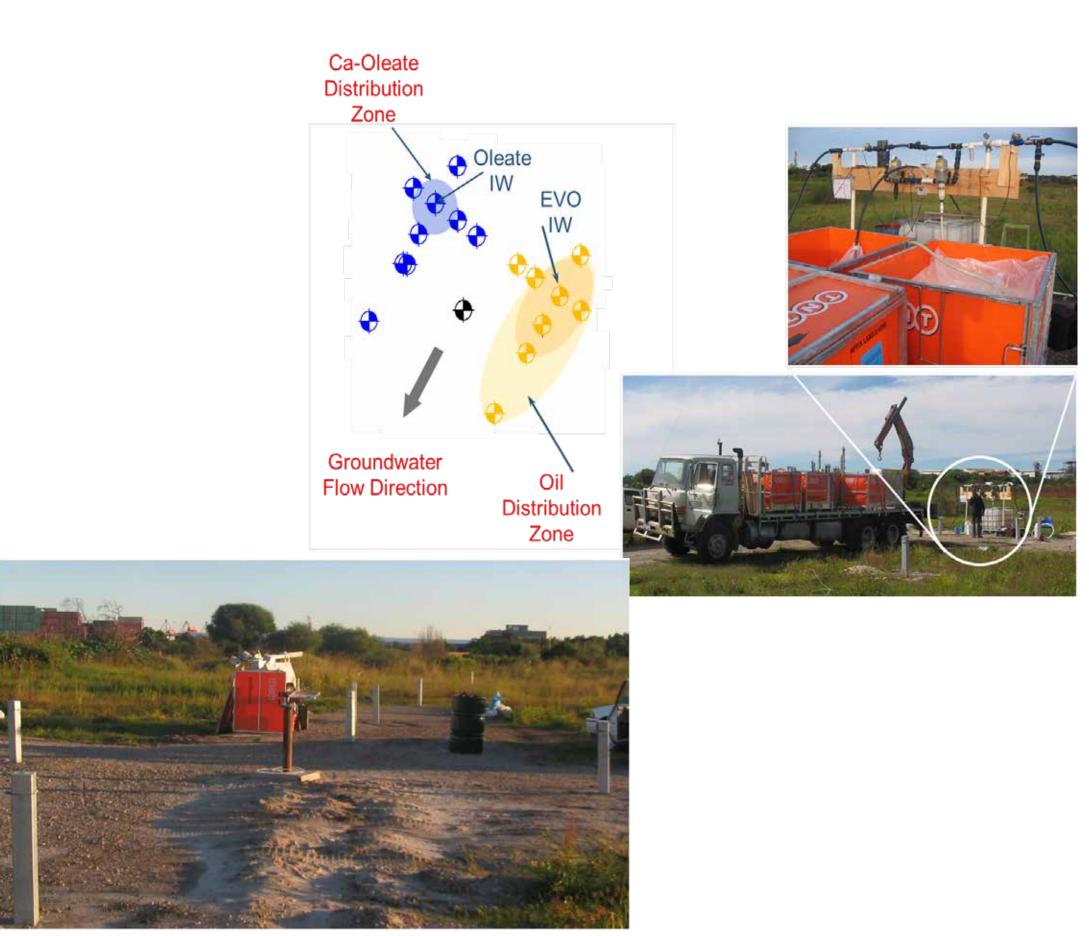
A bench scale, pilot scale and full-scale Enhanced In Situ Bioremediation program was nplemented (Konzuk et al, 2007).

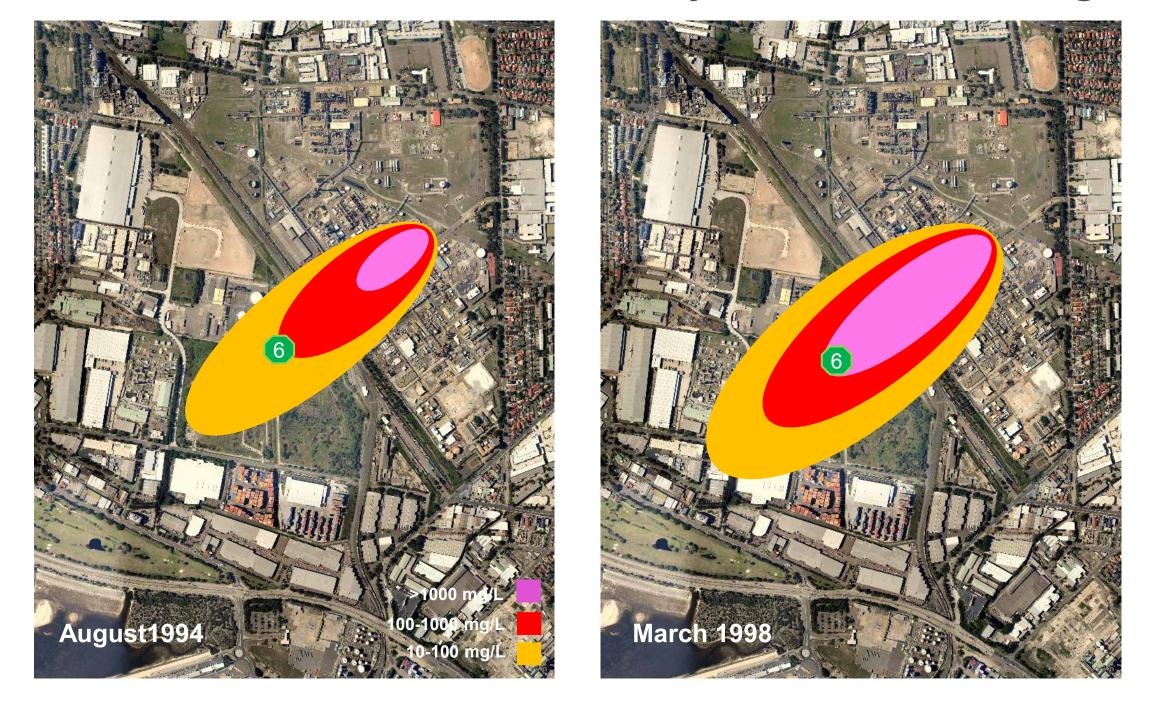
An extensive network of groundwater wells and a monitoring program was in place which was largely aimed at confirming the stability of the plumes and supporting the monitoring of proposed remedial activities. In March 1998, the concentration of 1,2-dichloroethane herein referred to as ethylene dichloride (EDC), in a sentinel monitoring well, within the C1 Plume, increased by an order of magnitude

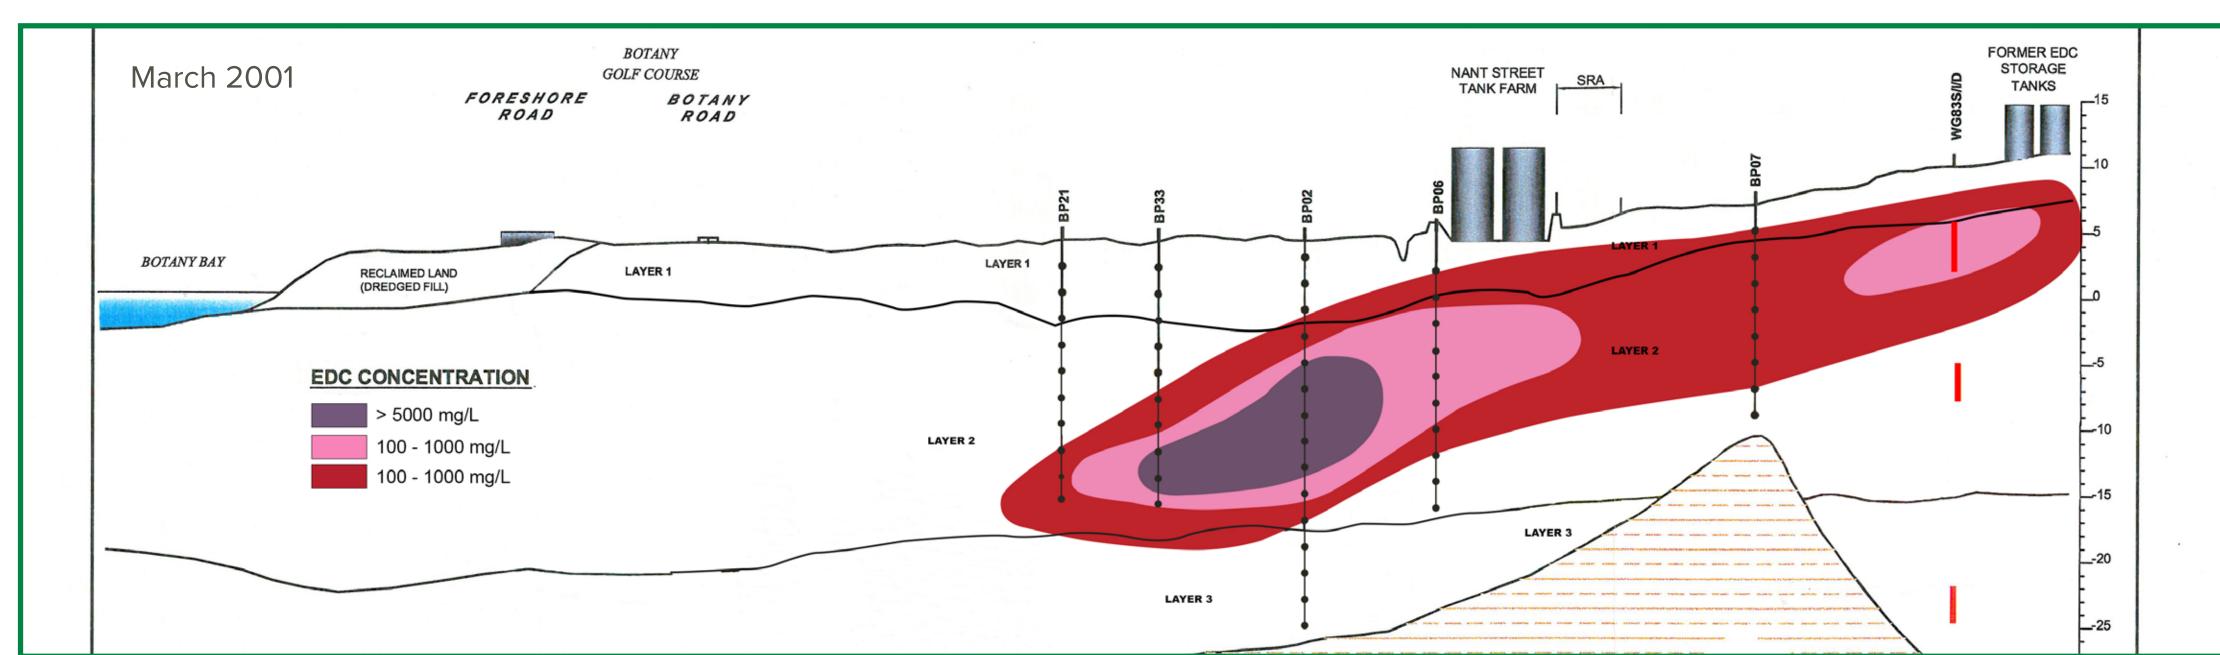
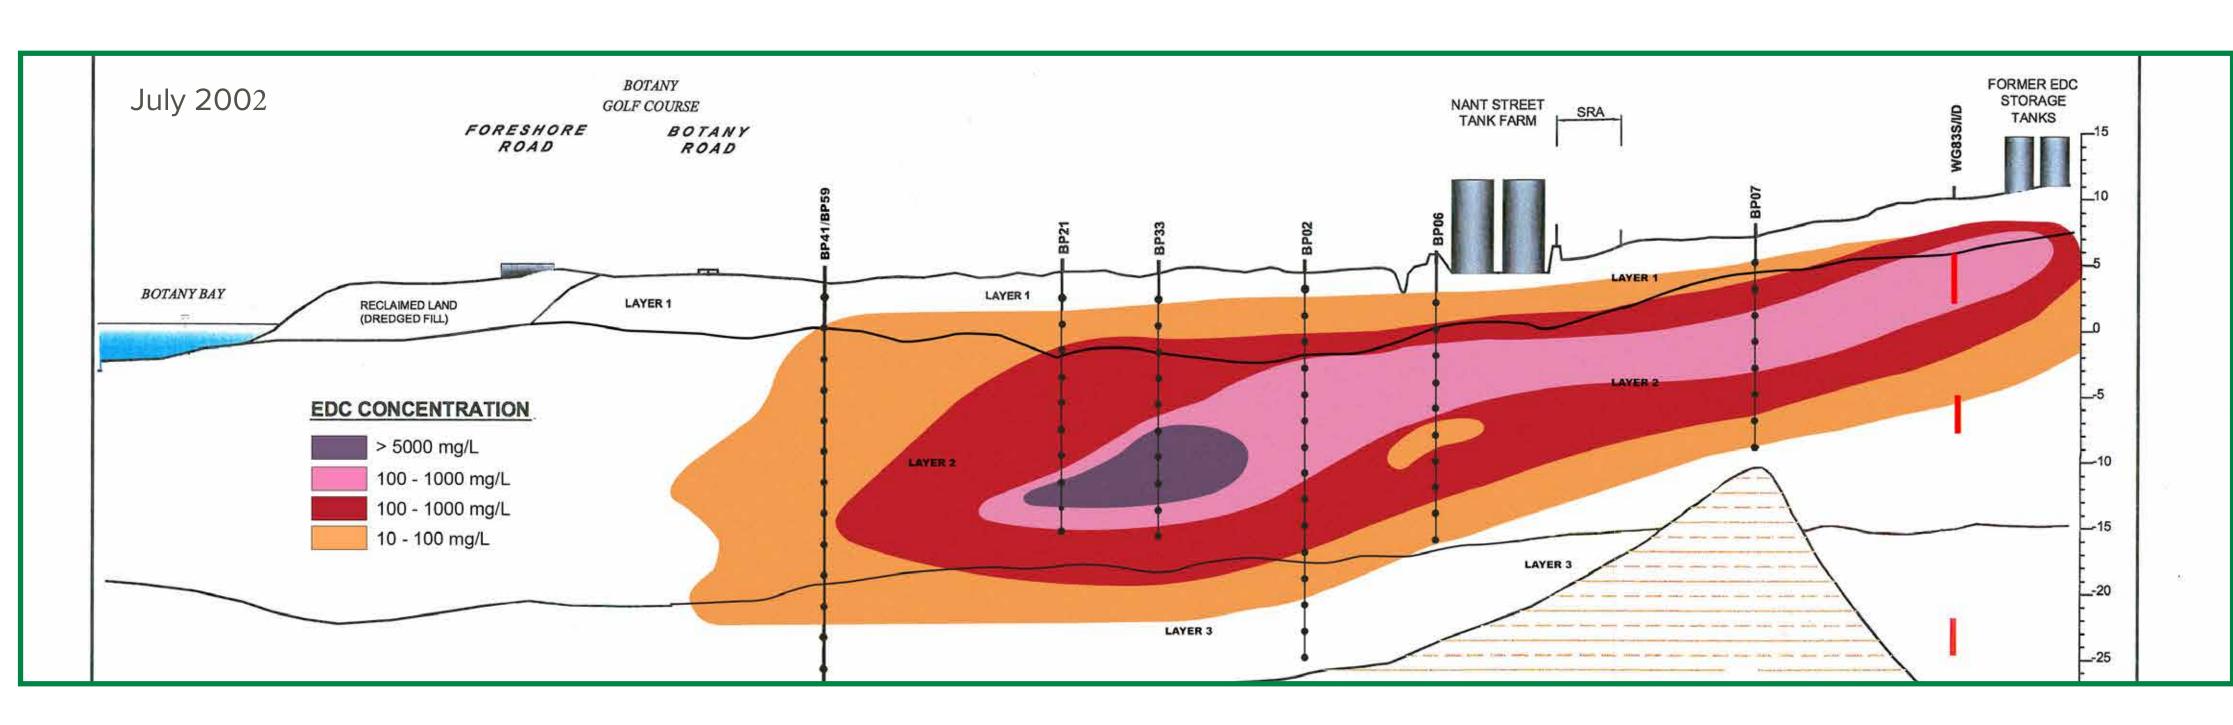
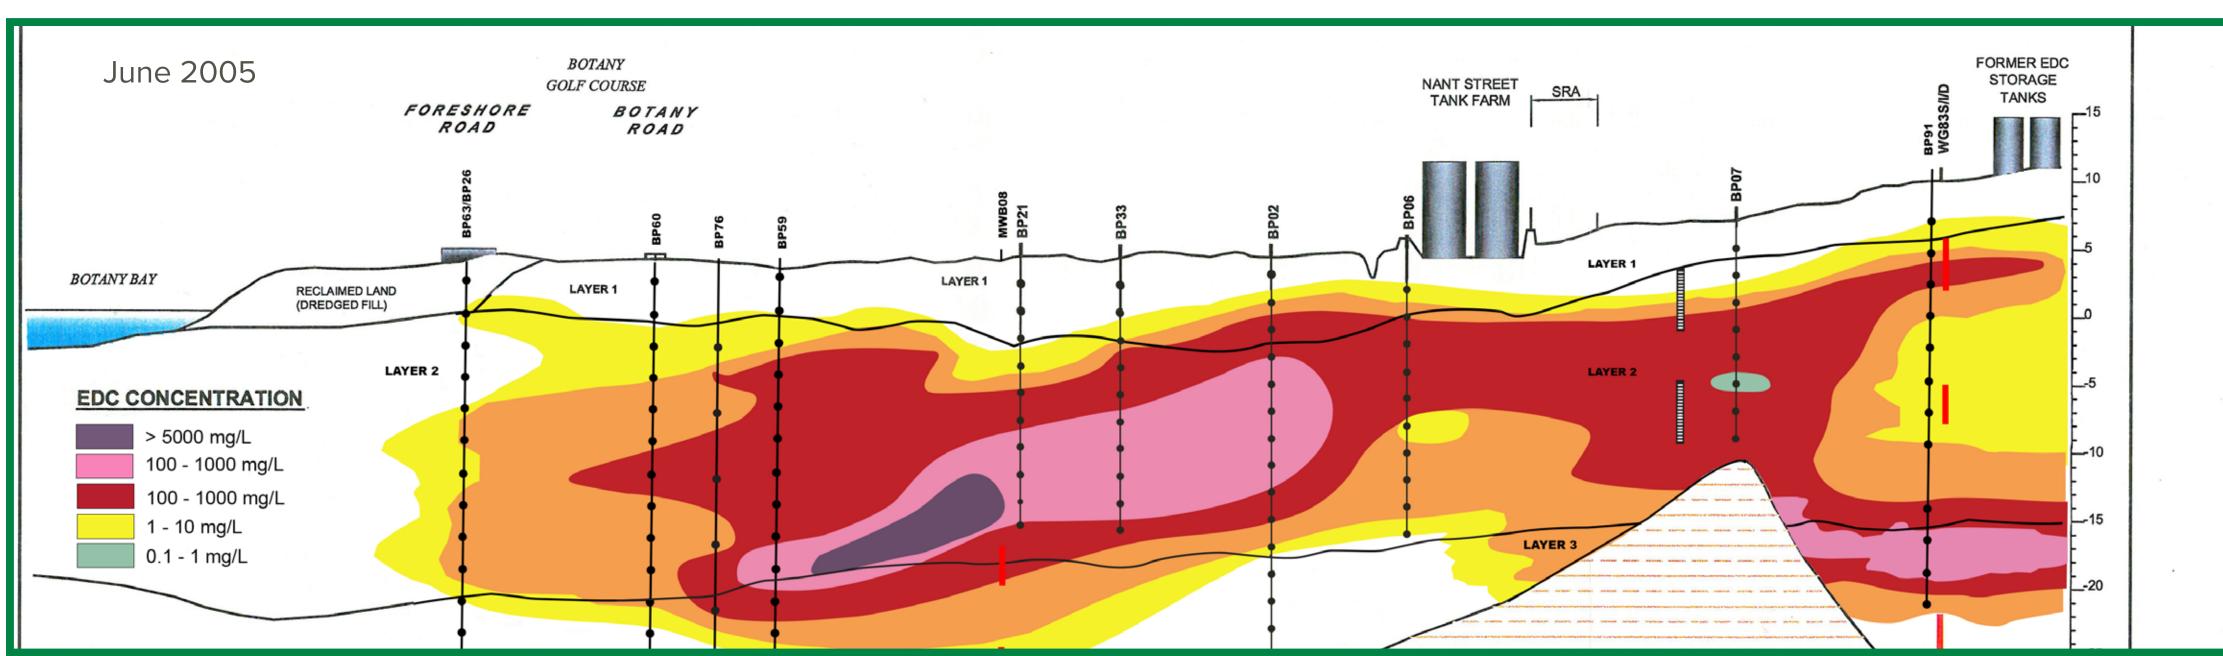
Investigations and intensive monitoring was implemented to understand the potential cause of the sudden increase in EDC concentrations which involved the installation a series of new multilevel piezometers.

The high resolution of the groundwater monitoring both spatially and temporally was able to establish with a high degree of precision the rate of plume migration, which was estimated to be in the order of 110 m/year.

The plume velocity was similar to estimated groundwater seepage velocity with a retardation factor of 1.36, consistent with the low sportive properties of EDC.

Characterization and monitoring of the plume between the inferred source and the plume front confirmed the presence of a high concentration core or "slug" of EDC with concentrations in excess of 5000 mg/L. The mass discharge of the plume core was estimated to be over 600 kg/day – Magnitude 10 Plume (Newell et al, 2011)

Other observations of the intensive monitoring of the plume suggested downwards vertical migration within the aquifer, contrary to the vertical hydraulic gradient, potentially as a result of density-driven flow due to the high concentration of the plume core.
