Boeing Plant 2 Sediment Remediation:

Post Remedy Monitoring and the Search for Long Term Success

ROBERT S. WEBB, P.E. (DOF - DALTON, OLMSTED & FUGLEVAND)

BATTELLE SEDIMENTS CONFERENCE
FEBRUARY 2019
NEW ORLEANS, LOUISIANA

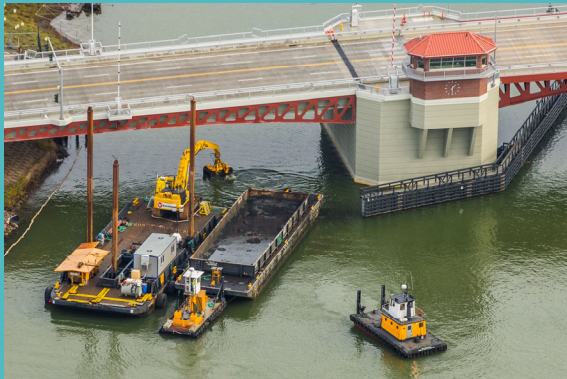
Mechanical Dredging RDM's

- ▶ Accurate delineation of elevation of contamination (EOC)
- ▶ Precision dredge plan
- ▶ Dredge with excavator
- ▶ RTK-GPS based bucket positioning
- ▶ Stair-step cuts on slopes
- ▶ Enclosed Environmental bucket
- ▶ No overfilled buckets
- ▶ Remove water from sediment barges and process – No Barge Overflow
- ▶ Place initial backfill
- ▶ Understanding by project staff
- ▶ Performance consistent with project objectives

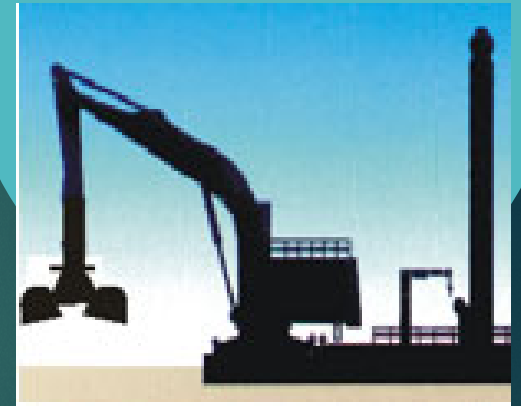
Benefit of Improved Accuracy of Excavator

- ▶ Dredging Area: 16.3 Acres
- ▶ Overdepth reduced by 1/3 to 1/2 ft.
- ▶ Volume reduction: 9,000 to 13,000 CY
- ▶ Eliminate sheet pile walls and silt curtains
- ▶ Greatly reduced residuals / release / resuspension
- ▶ Dredge/Landfill Savings: **\$2M to \$3M**

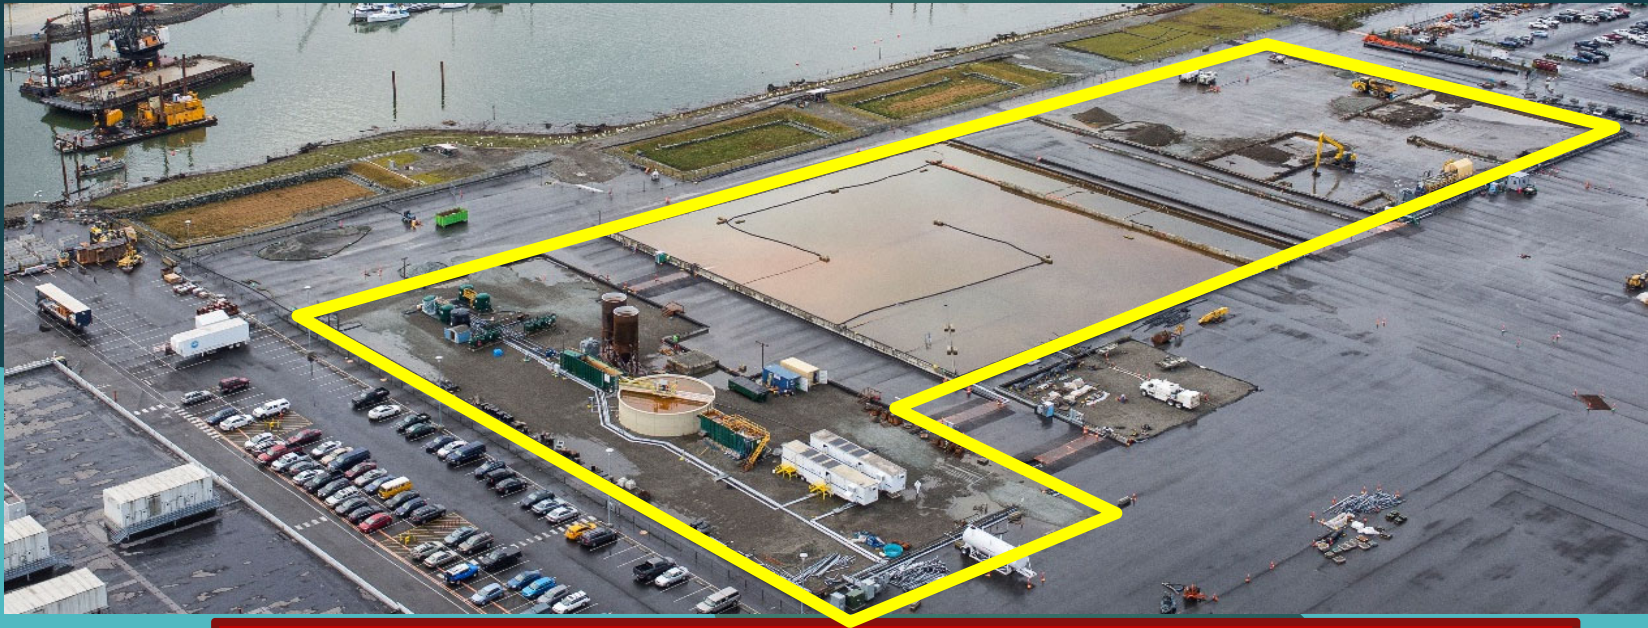
Actual Dredge Water System

- State Issued Water Quality Certificate
- No chemical flocculants – Electro coagulation used
- Short term Water Quality Variances not allowed
- Regulated as NPDES Outfall
 - Marine Chronic Criteria at point of discharge

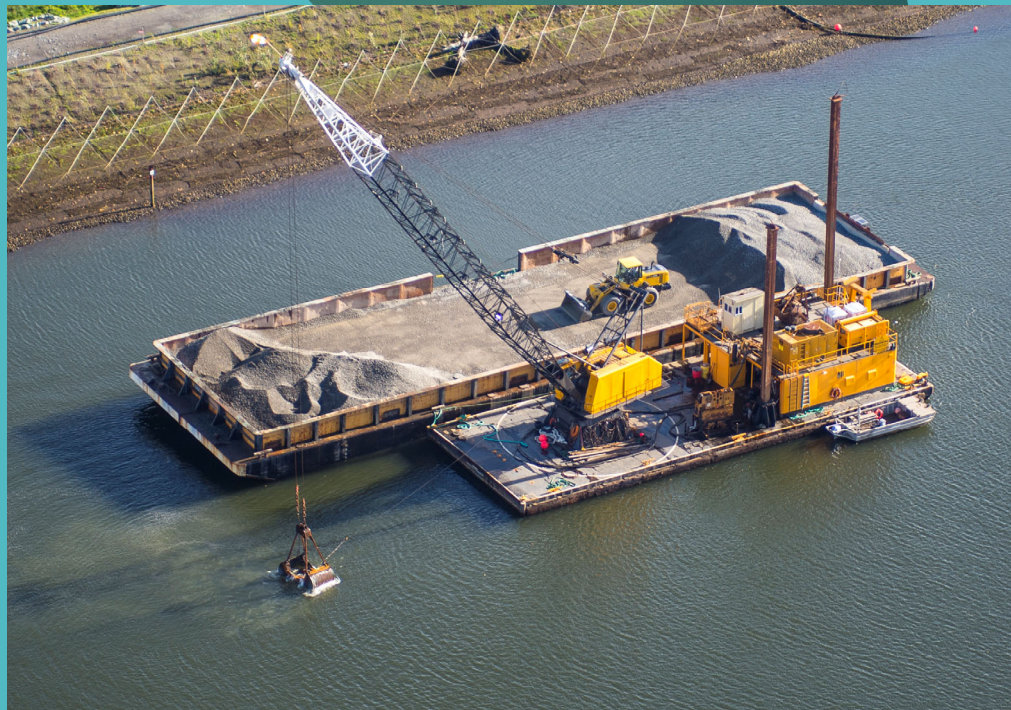
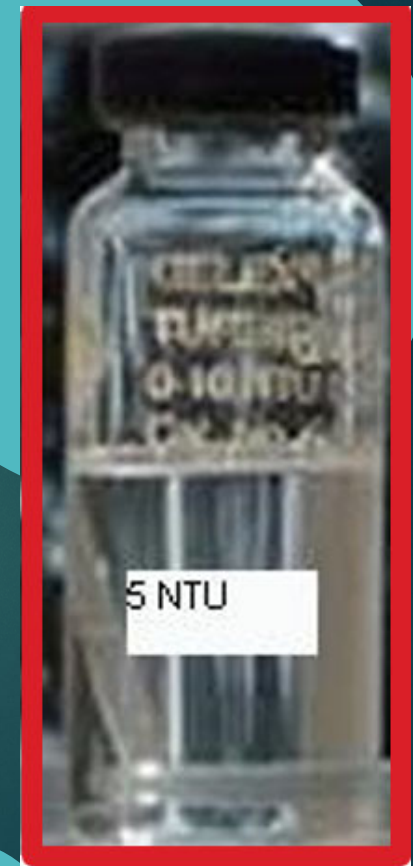
Backfilling to Original Grade 9

- ▶ Restore subtidal elevations for habitat concerns
- ▶ 265,000 Tons Backfill Material
- ▶ Washed Backfill Material
- ▶ **5 NTU Over Background Limit**
- ▶ **\$ 13 M**

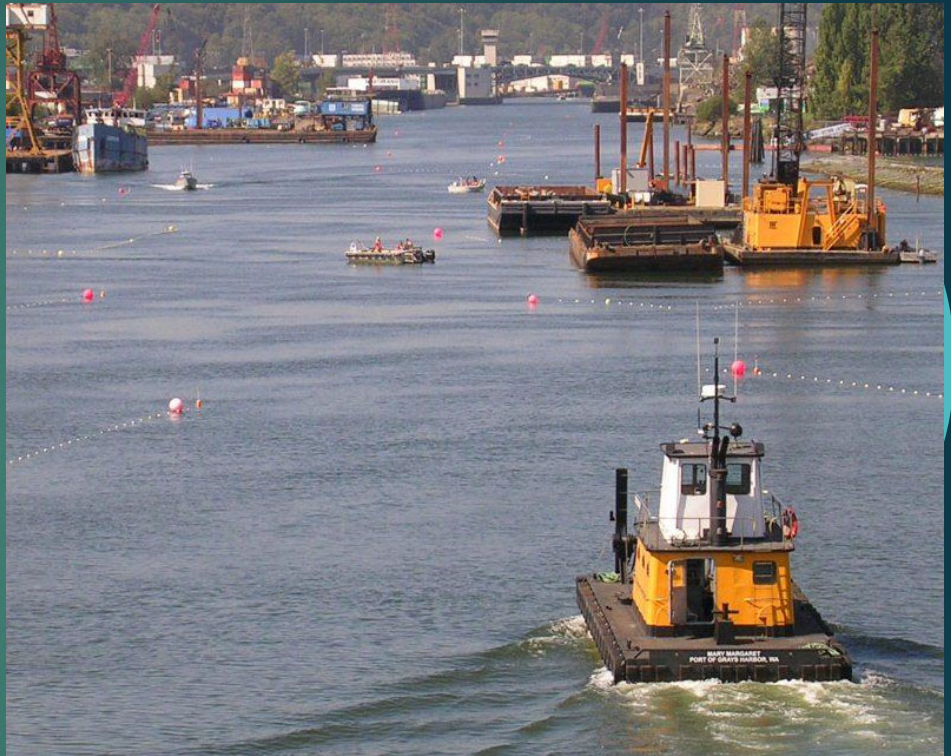
- Endangered Species Protection
- In water window typically September 1 – February 15 (5.5 months)
- Tribal Fishing Rights
 - Cannot impact fishers or nets
 - Reduces In-Water Season
- Actual Dredging Days
 - CS1 45 days
 - CS2 36 days
 - CS3 94 days

Sediment Remediation is **SEASONAL ACTIVITY**
Increases Project Durations and Costs
Dredging Over Multiple Seasons Increases Costs

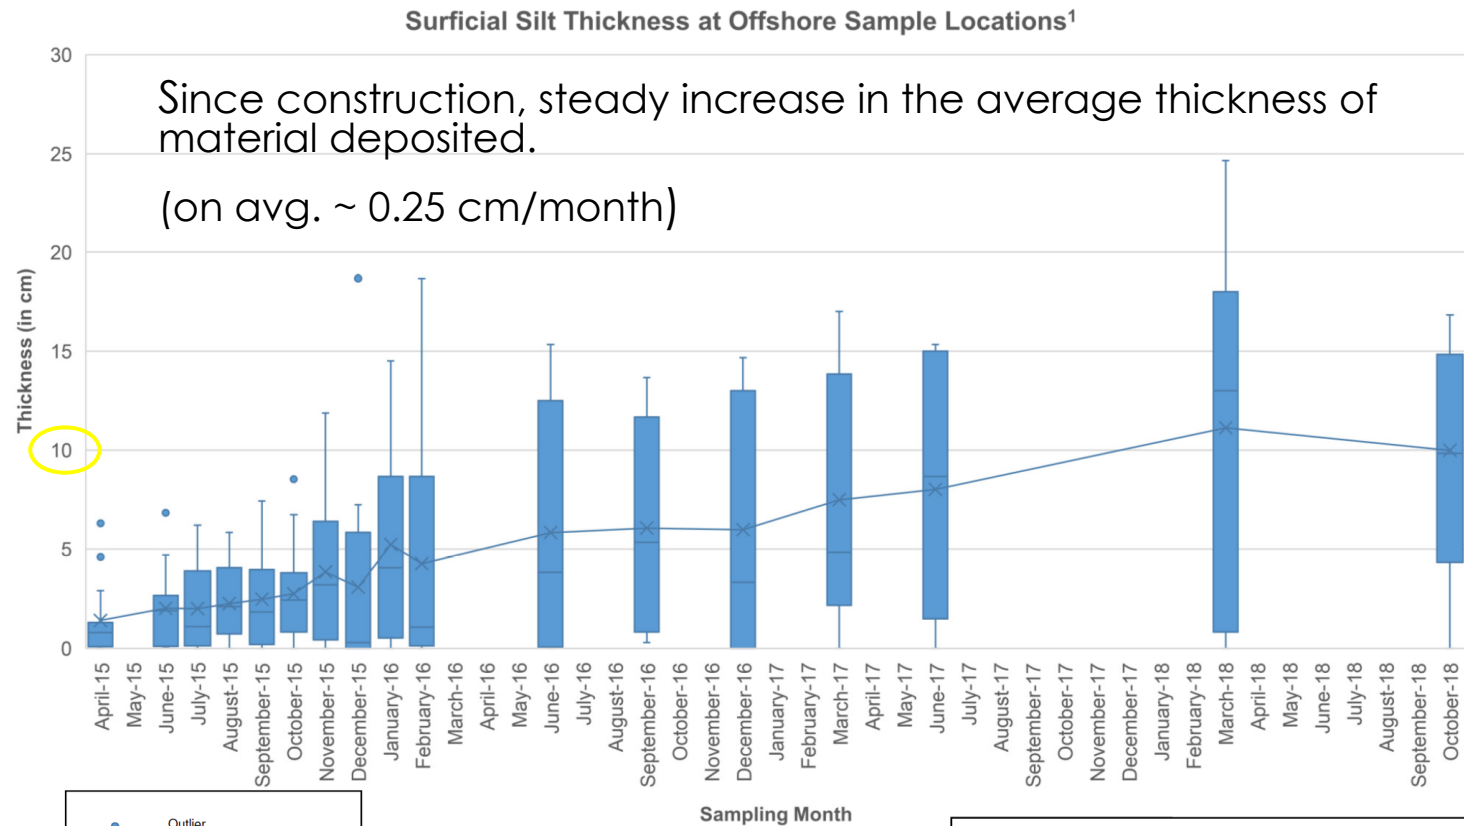
Figure 6

¹ Does not include Slip 4 samples

² Mean, median and maximum silt thickness may be an under representation of the total thickness since the underlying backfill material was not reached at all locations.

DEPOSITIONAL MATERIAL THICKNESS AT OFFSHORE SAMPLE LOCATIONS
Additional Duwamish Sediment Other Area Backfill
Sampling, Boeing Plant 2
Seattle/Tukwila, Washington
