Beneficial Use of an Abandoned Slip for Confined Space Disposal of Contaminated Sediment

Charles Guest and Walt Dinicola (Anchor QEA)
Patrice Dubé and Jean-Pierre Barry (Alcoa)
February 12, 2019

Baie-Comeau QUEBEC, CANADA

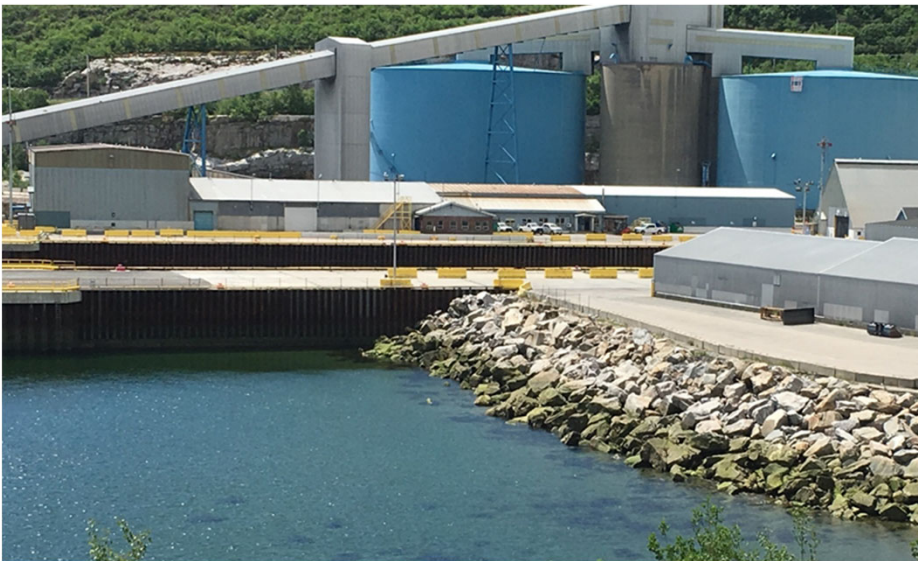
Before

Wharf 3 Stabilization

- Stone revetment to stabilize unrepaired wharf wall
- Constructed early to increase Wharf 3 access

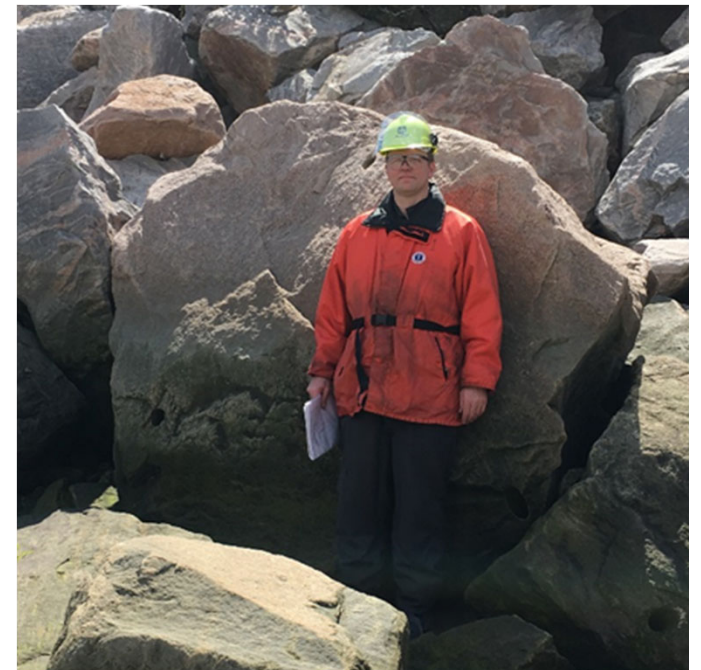
Containment Cell (CDF) Berm

- 4-layer aggregate berm
- 17 meters tall (51 feet)
- ~48,000 cy of sand and stone
- Reinforced unrepaired wharf walls
- Restricted access zone
- Constructed mostly from water

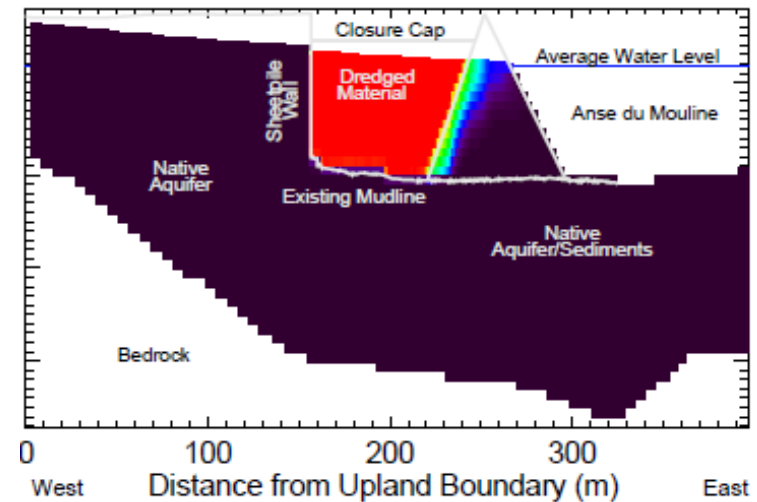
CDF Berm Engineering Evaluations

- Geotechnical investigations
- Ground improvement assessment
- Erosion protection/wave analysis
- Structural assessments
- Chemical fate and transport modeling

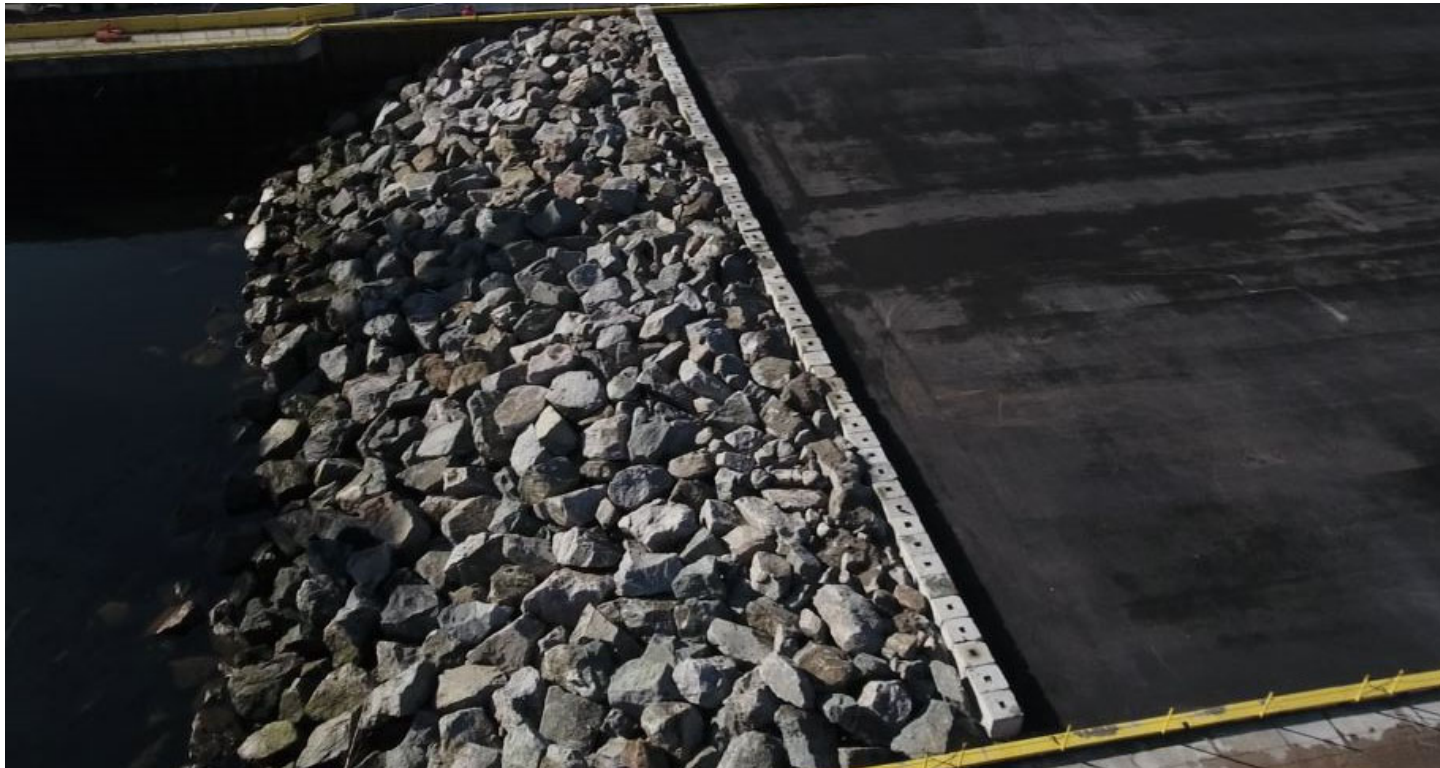
Containment Cell Closure

- Interim sand cover placed over dredged sediment
- Asphalt cap constructed after consolidation (~1 year)
- Future vehicle parking/light material laydown
