Construction Management Challenges of Combined Sediment Remedy

Tenth International Conference on Remediation and Management
of Contaminated Sediments
February 11 – 14, 2019
New Orleans, Louisiana

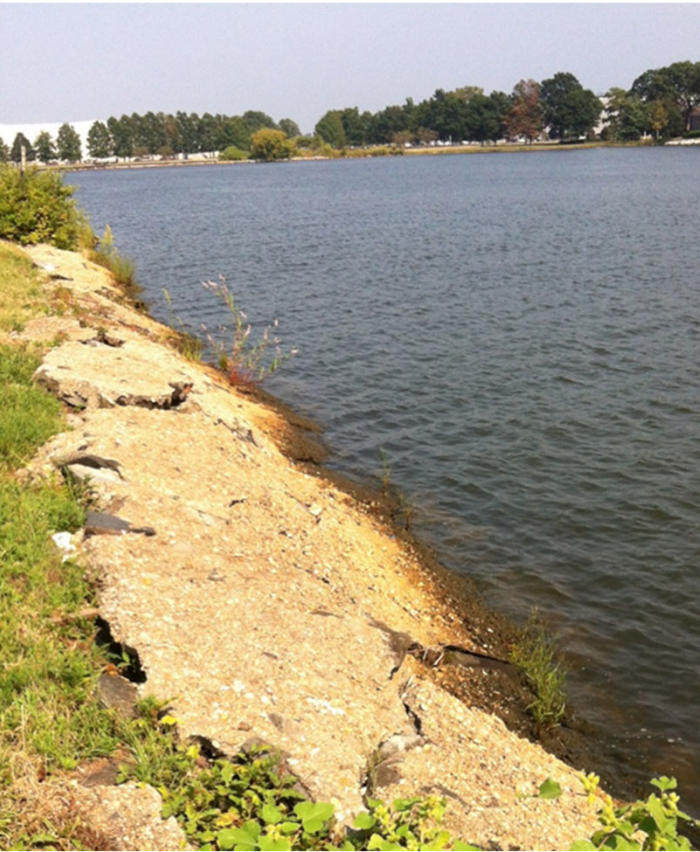
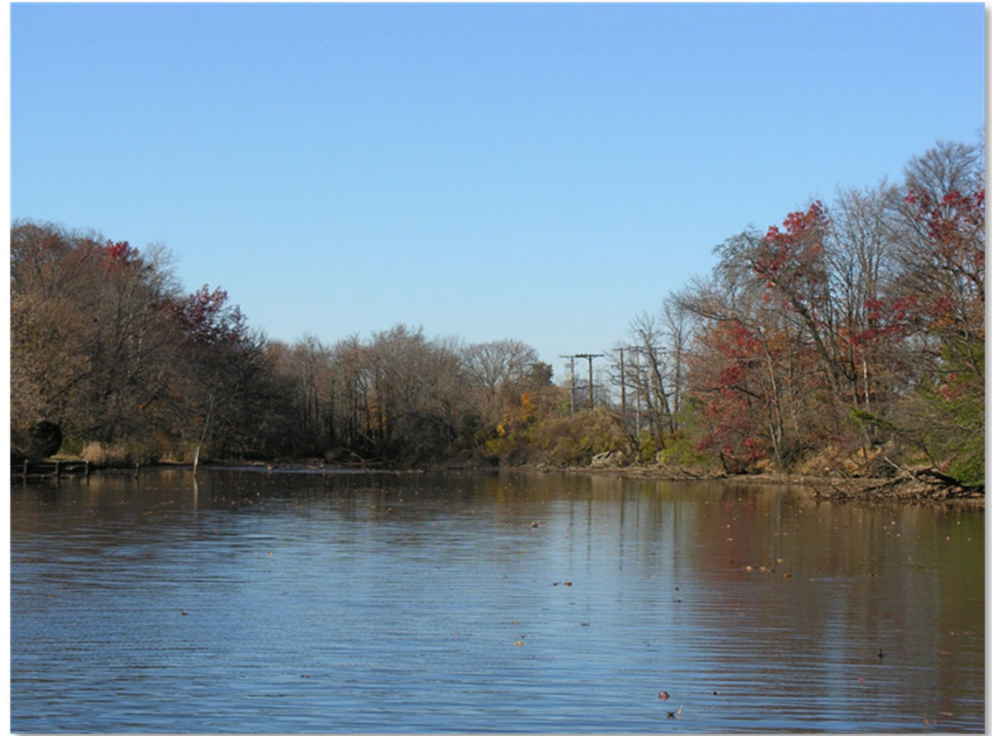
Site characteristics

- Tidal creek and estuary
- Industrial and residential area
- Partial navigation channel

- Recreational use: boating, swimming, fishing
- 8 to 10 feet water depth
- Elastic silt (80%-90% fines)

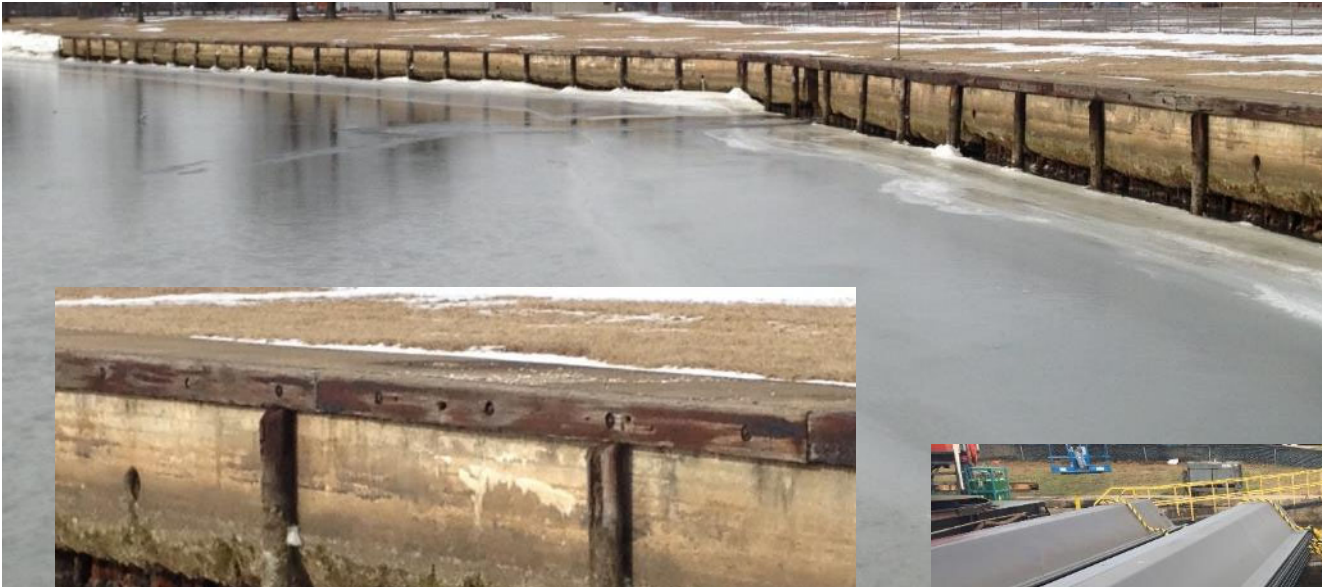
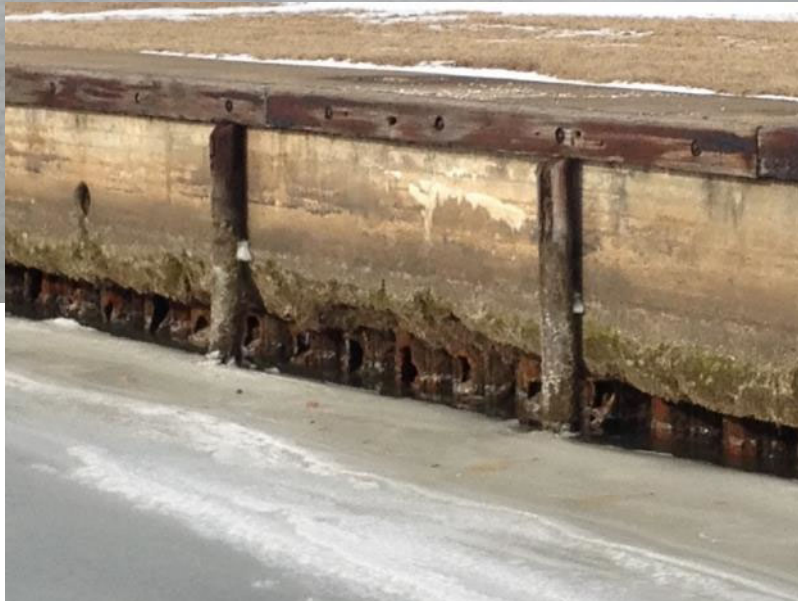
Bulkhead upgrades and reconstruction

Issues:

- Dredging in front of bulkhead
- Source control

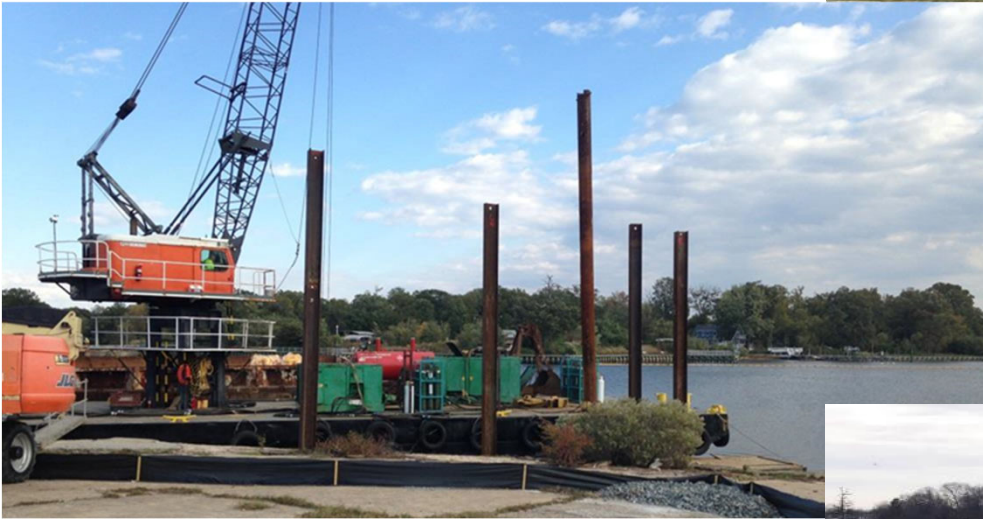
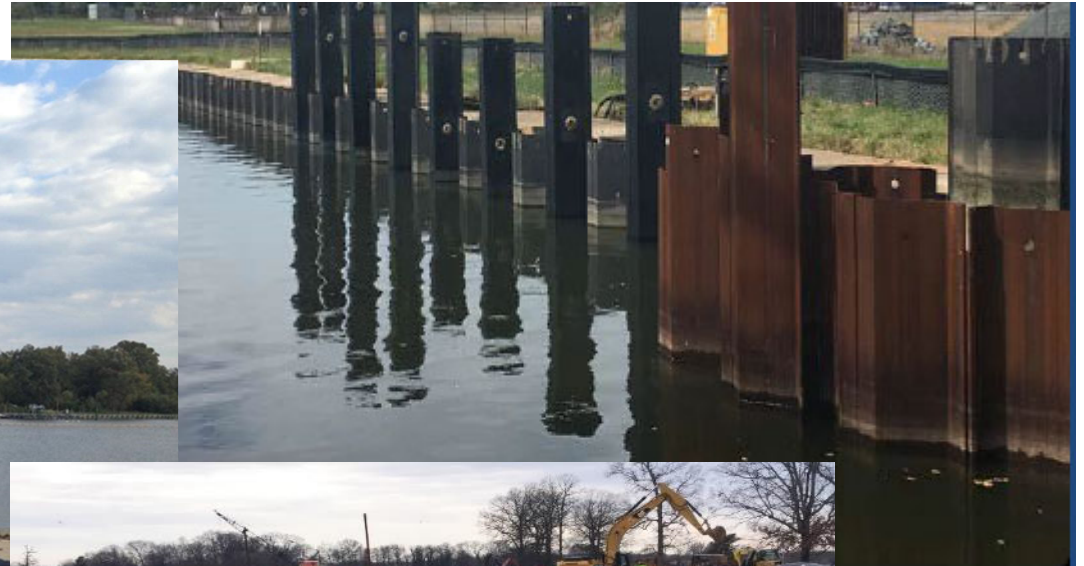
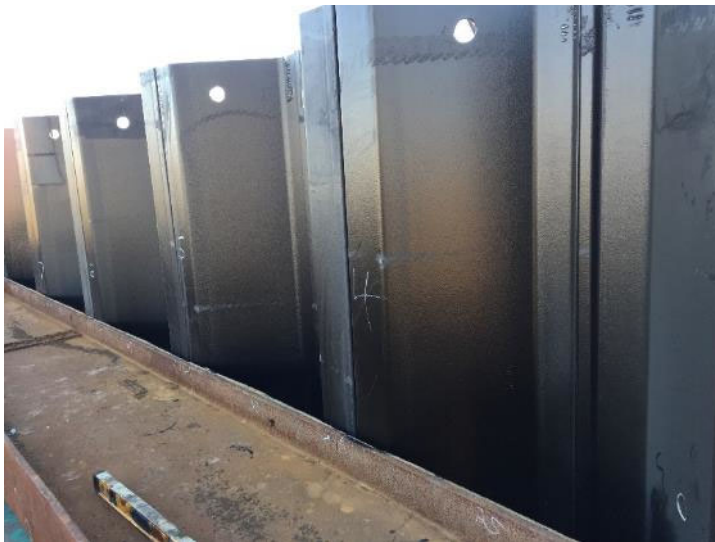
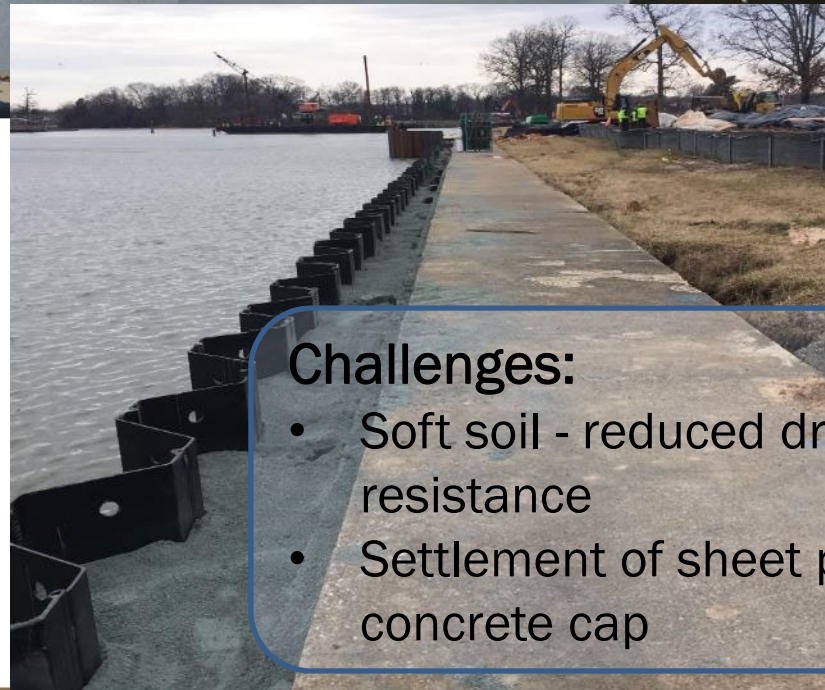
Bulkhead upgrades and reconstruction

- Soft soil - reduced driving resistance
- Settlement of sheet pile pairs, concrete cap

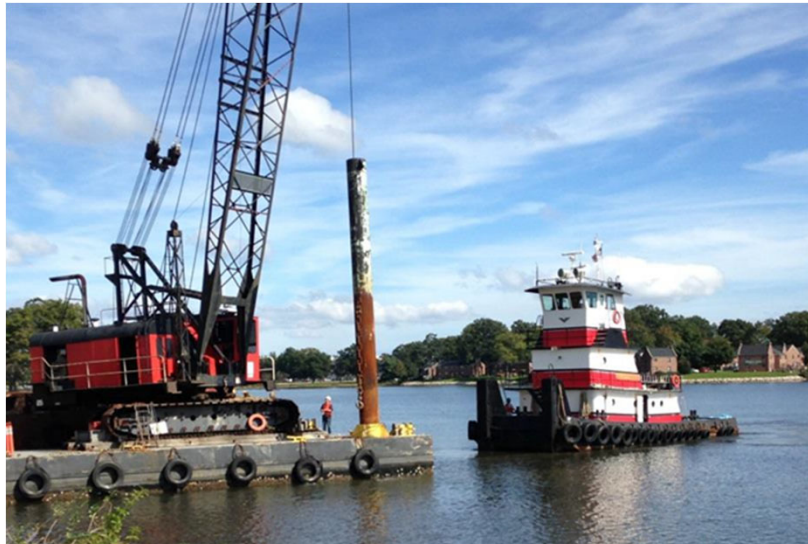
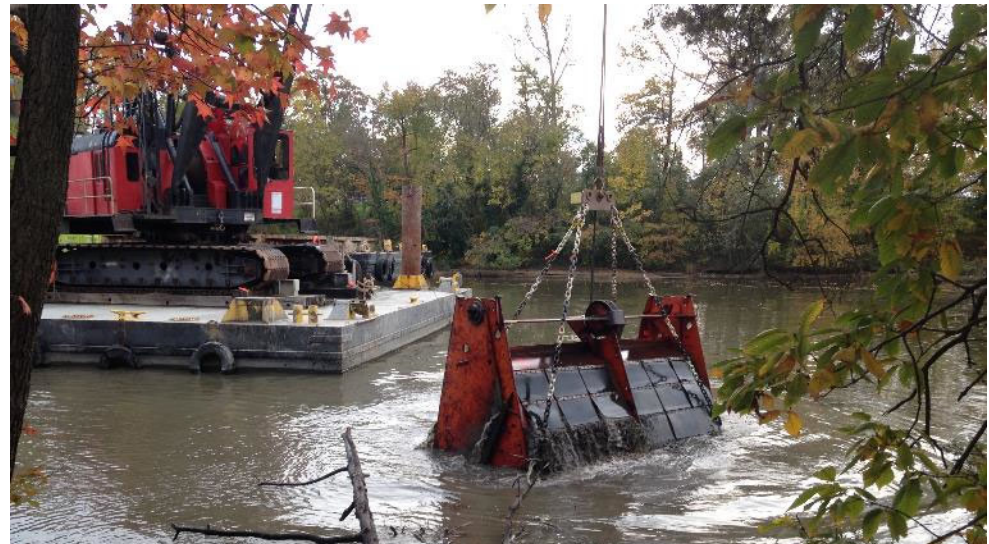
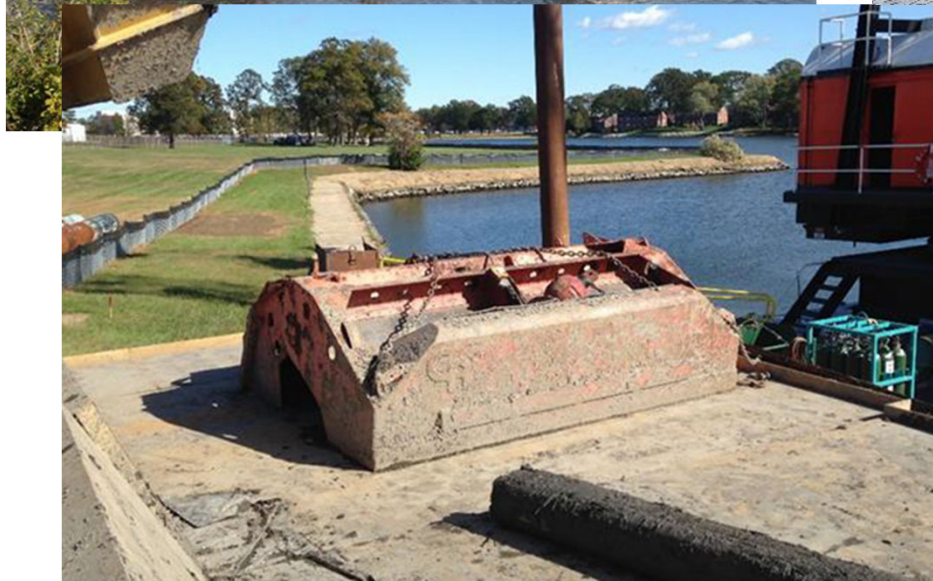
Dredging in cove

Met production, schedule turbidity goals!

Challenges:

- Contingency removal
- Discussions with regulatory agencies
 - thick RML, additional monitoring requirements

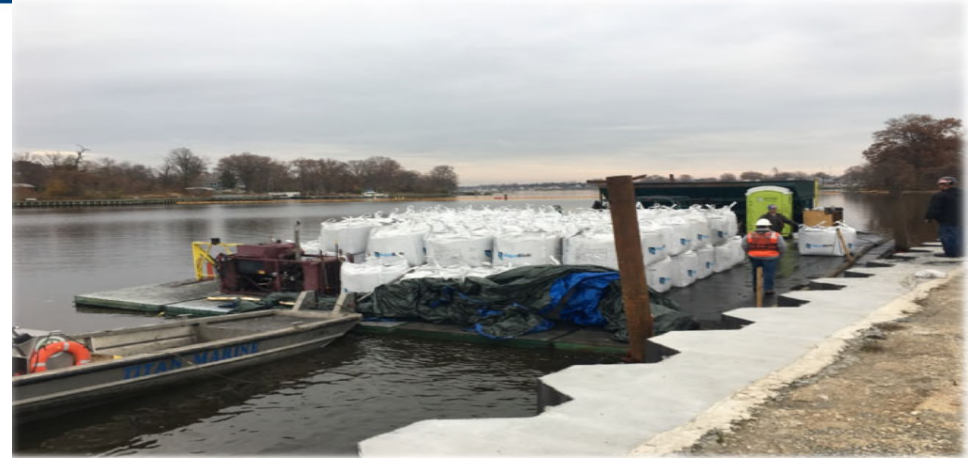
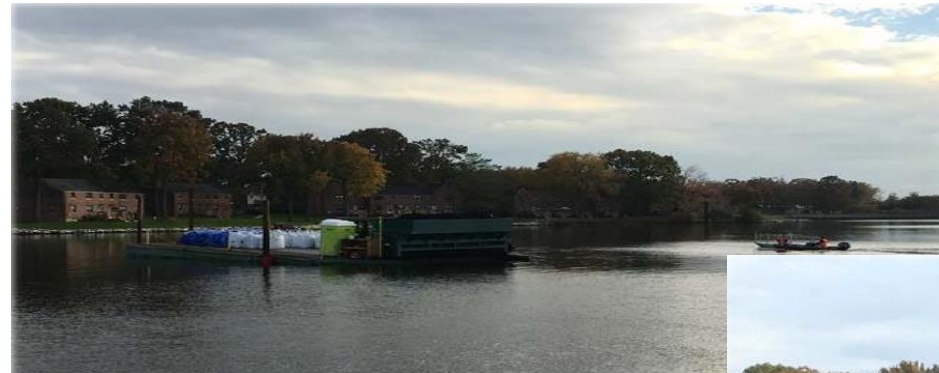
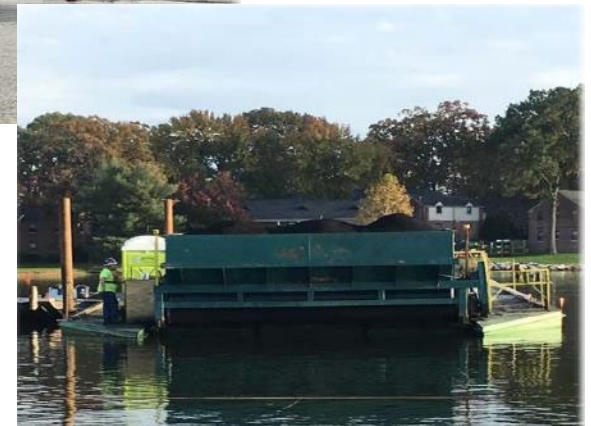
In situ treatment

- 13.7 Acres of *in situ* treatment
- 2,500 tons of Aquablok + PAC (10%)
- Cable Barge Spreader to place material

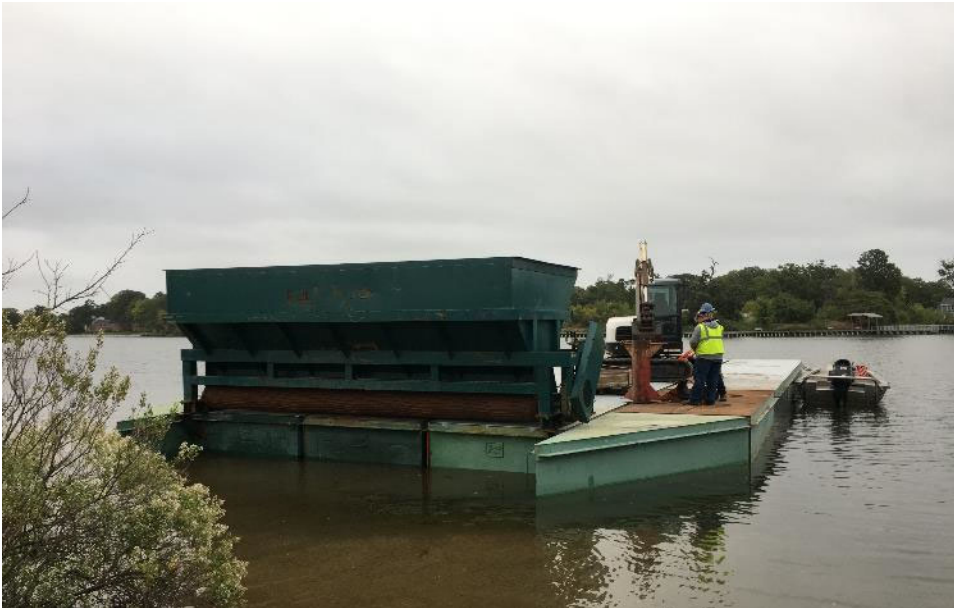
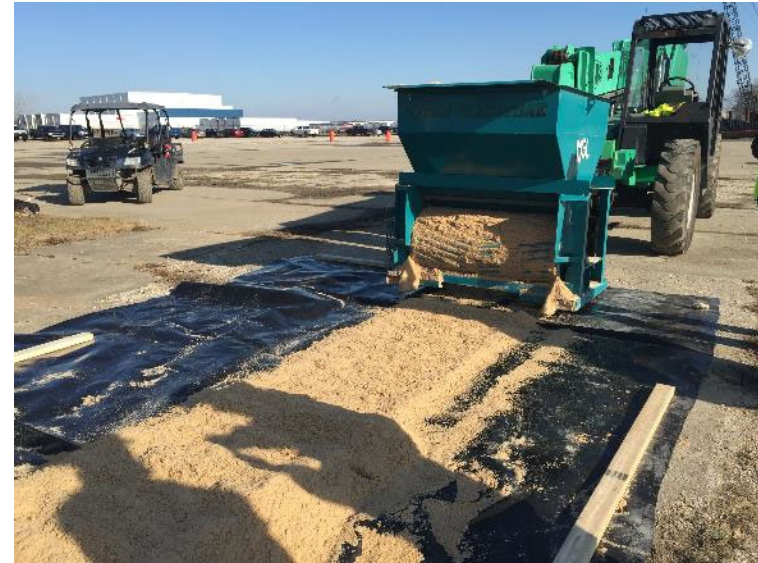
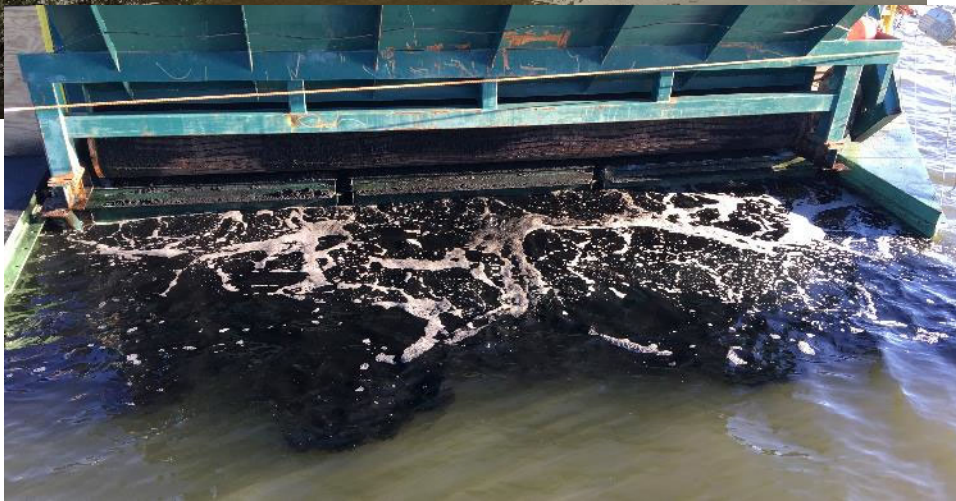
In Situ Treatment

- Upland demonstrations
- Field test runs to establish barge and spreader operation rates
- Target thickness of 1.36 inches – (tolerance of 1 inch to 1.75 inches)

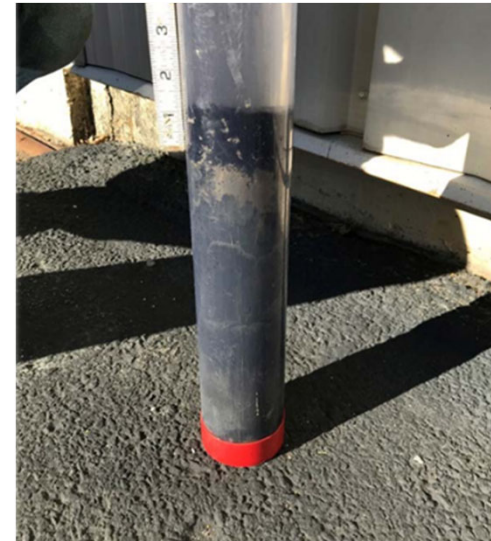
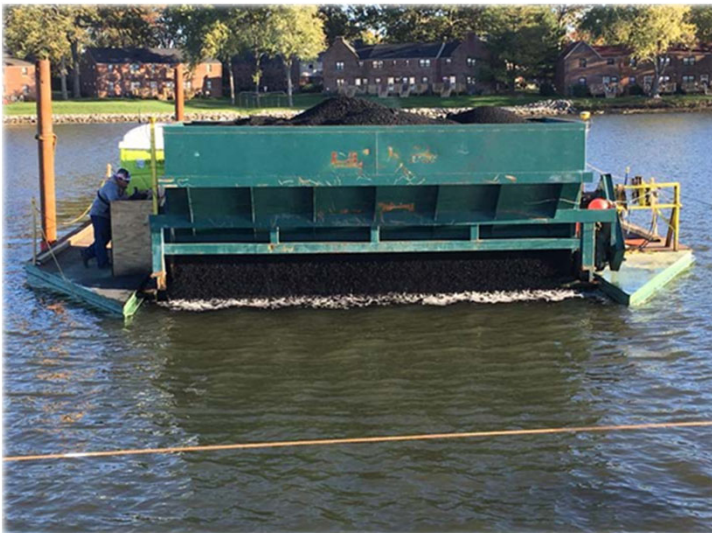
In Situ Treatment

- Verification of PAC placement
 - Tracked daily by usage and covered area
 - Aggregate thickness measurements
 - Total organic carbon and black carbon analysis
 - Sample buckets collected for material

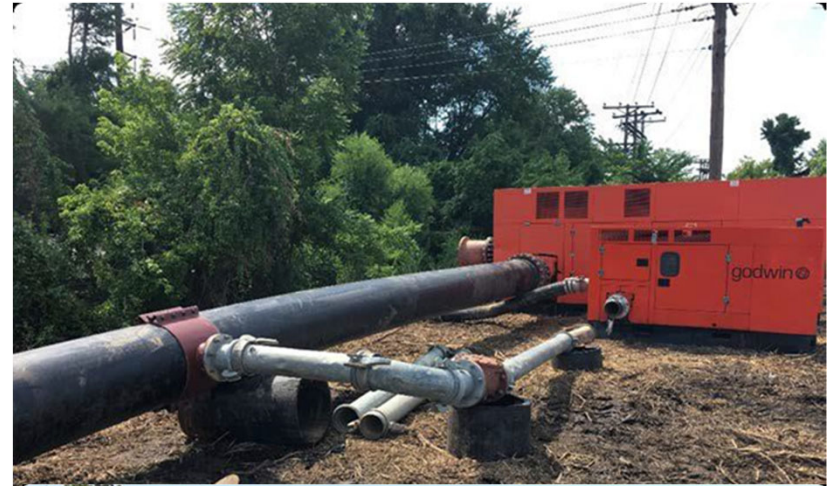
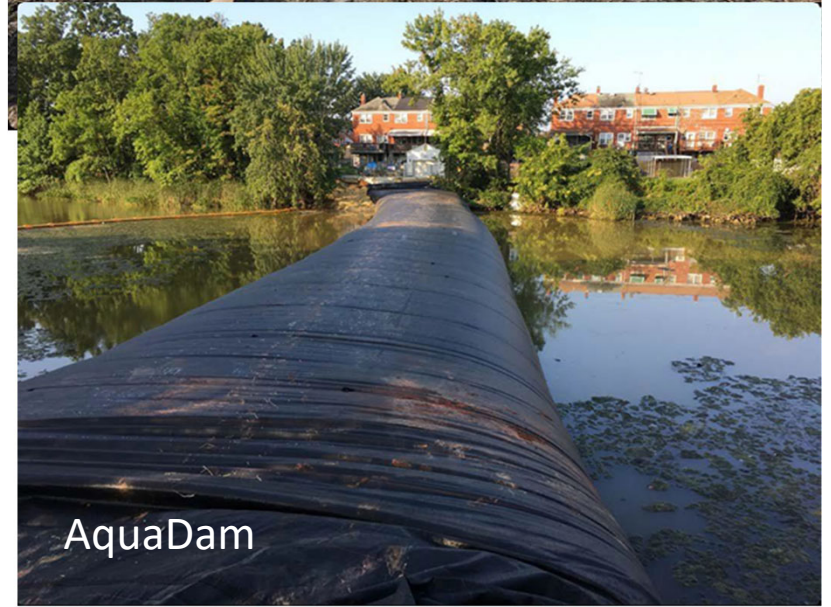
Sandbag cofferdam

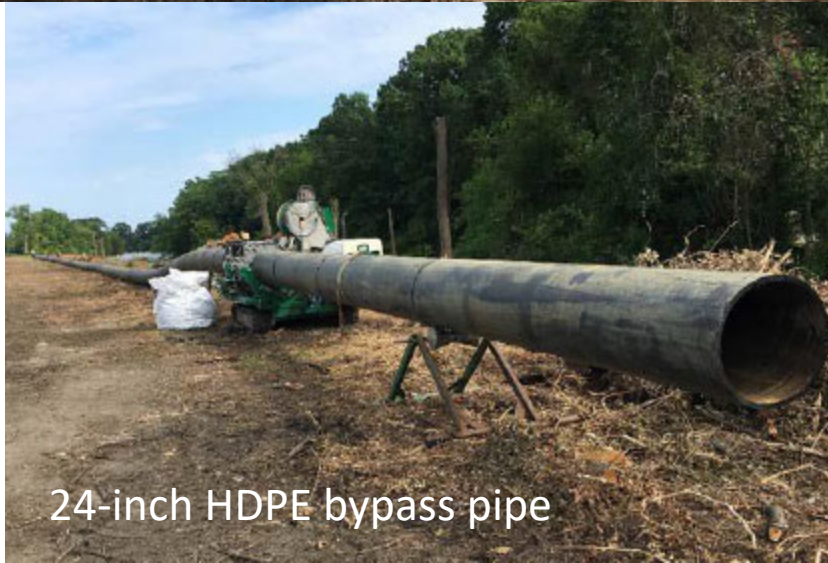
AquaDam

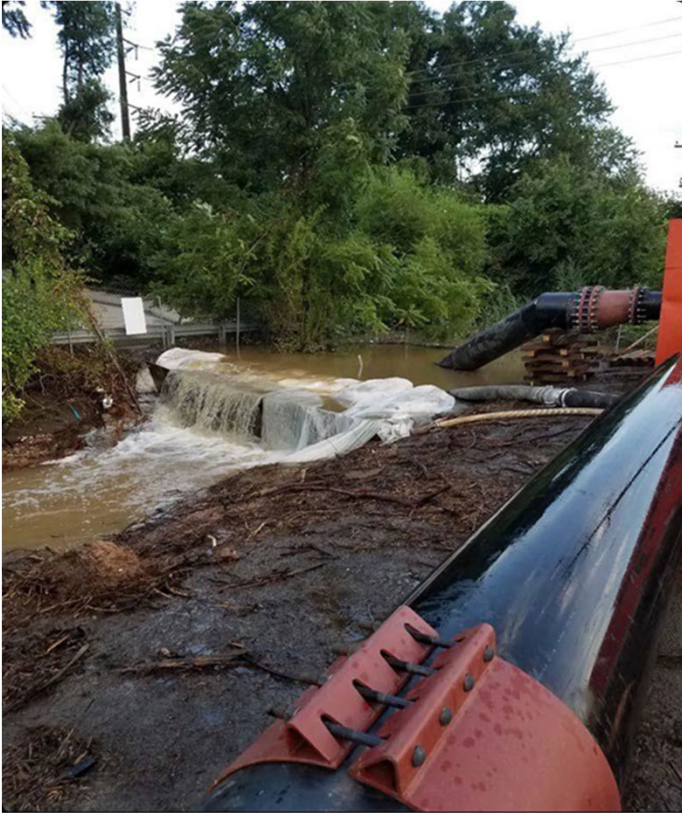
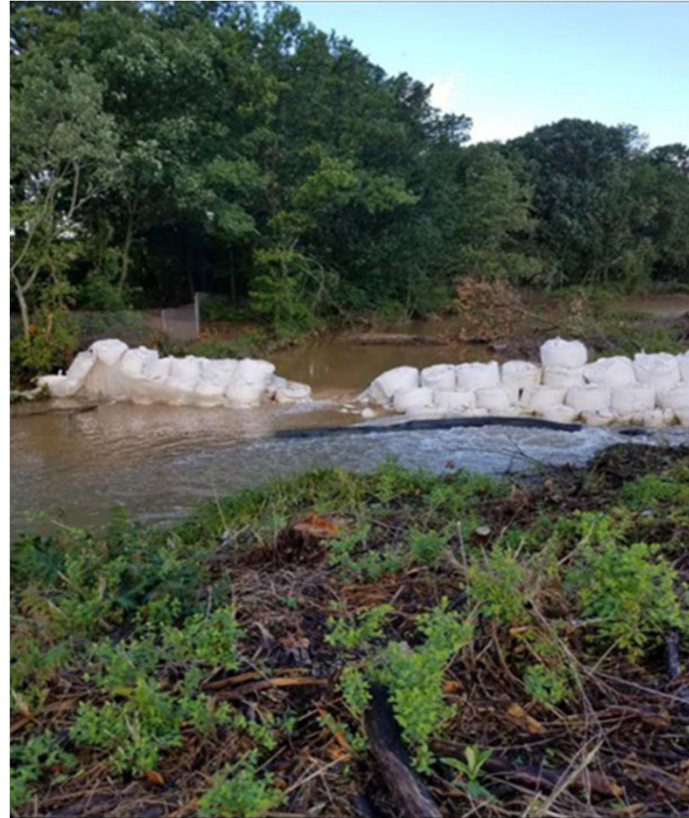
Dewatering challenges

- 25- to 50-yr storm!
- Overtopping and breach of sandbag cofferdams
- Construction dewatering BMPs planned for 2- to 10-year storm per the state guidelines

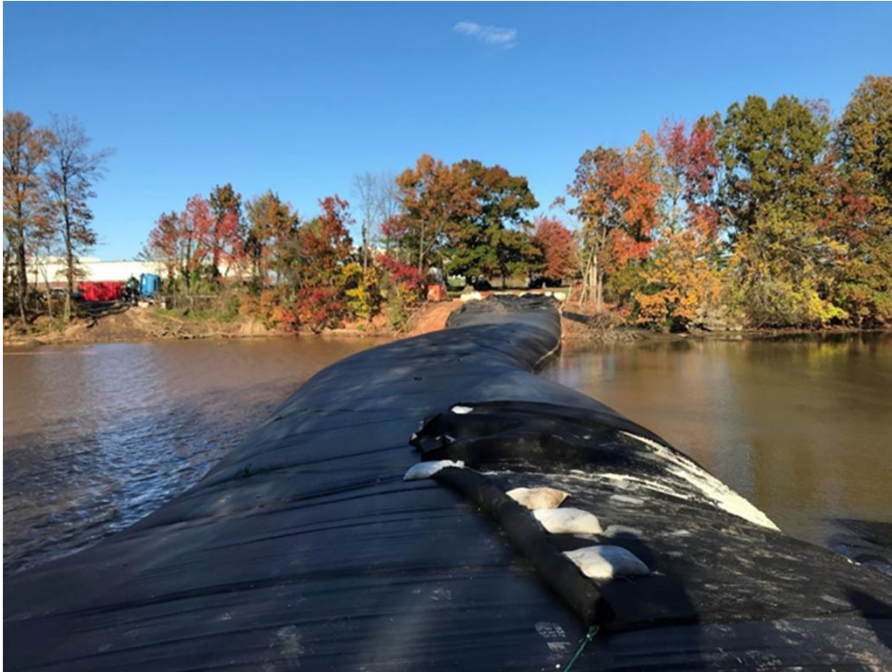
- Leak/piping under the AquaDam

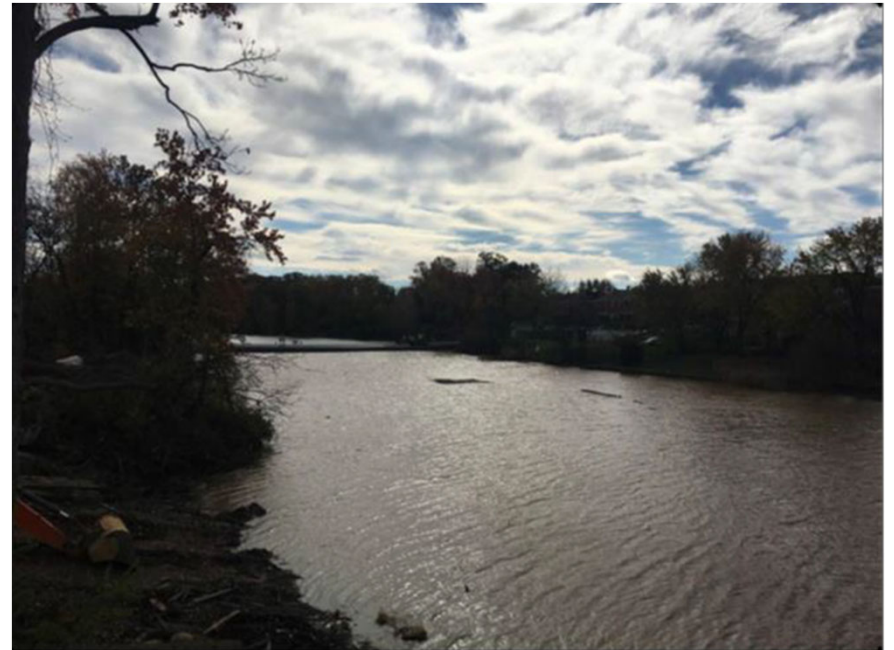
- Flooding of excavation area

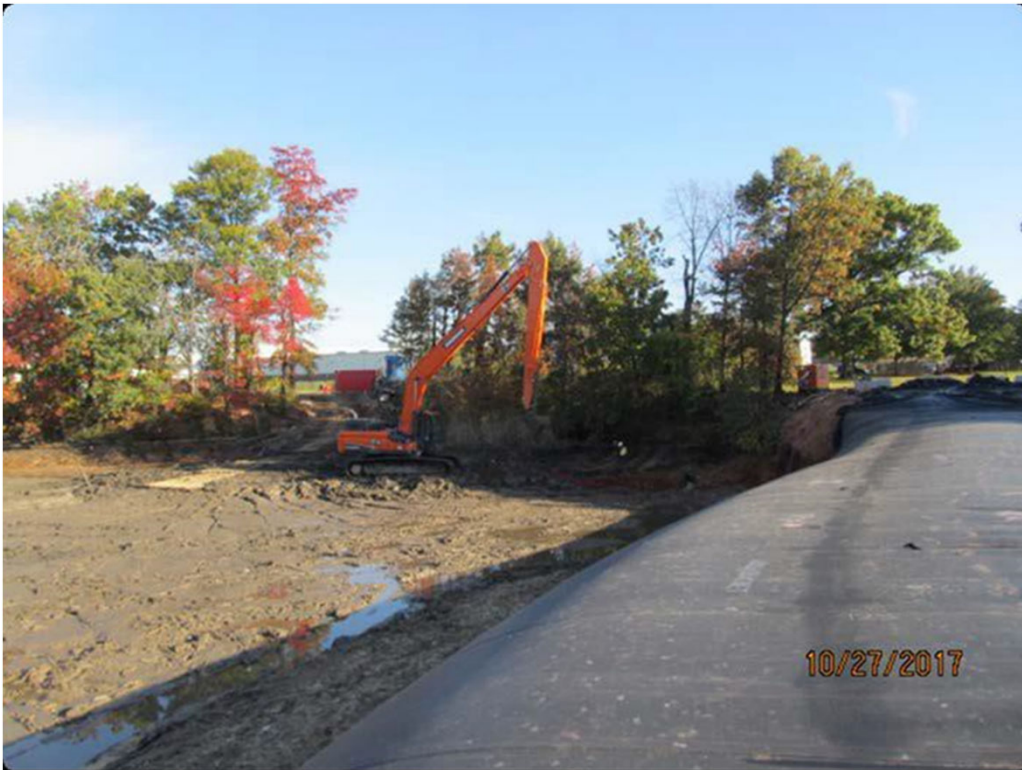
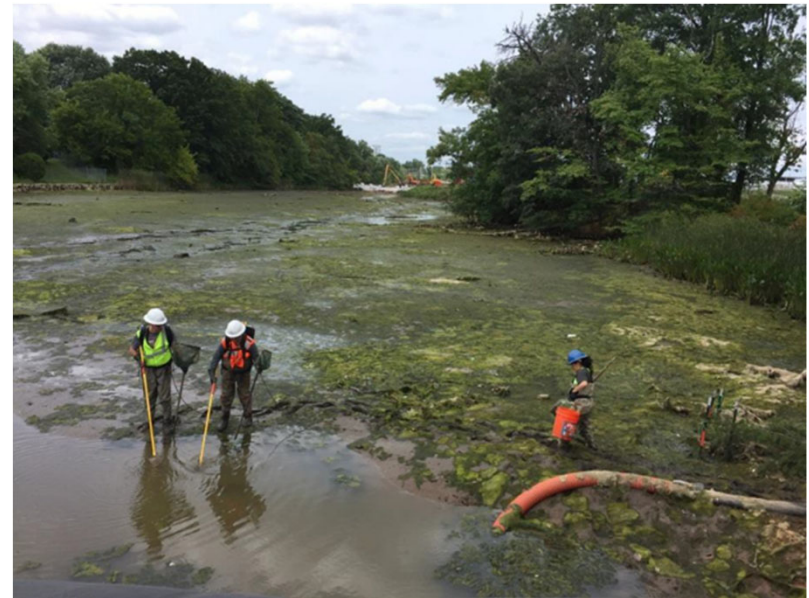
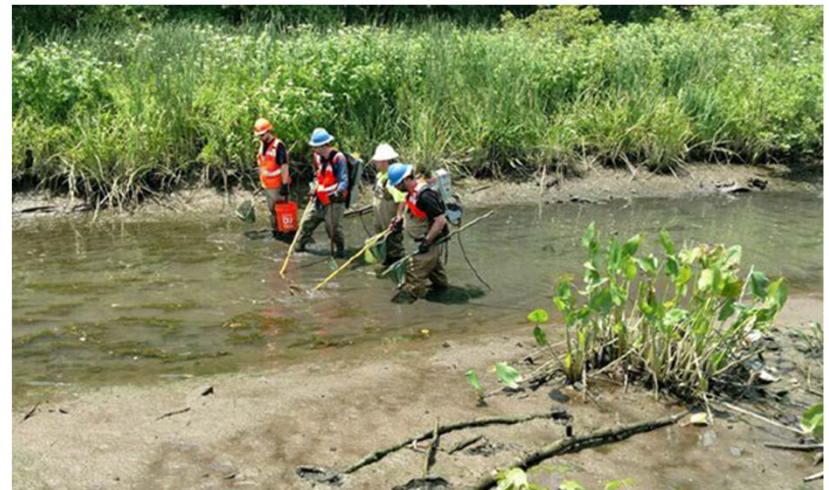
Excavation in creek

- Dewatering
- Fish take
- Excavation

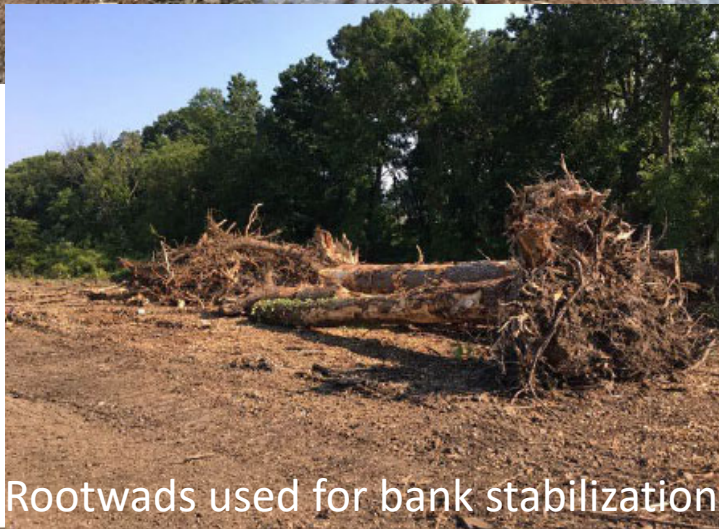
Rootwads used for bank stabilization

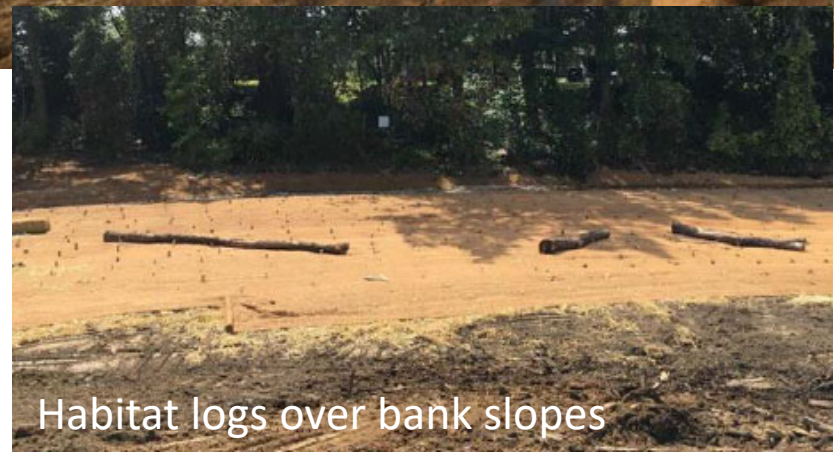
Habitat logs over bank slopes

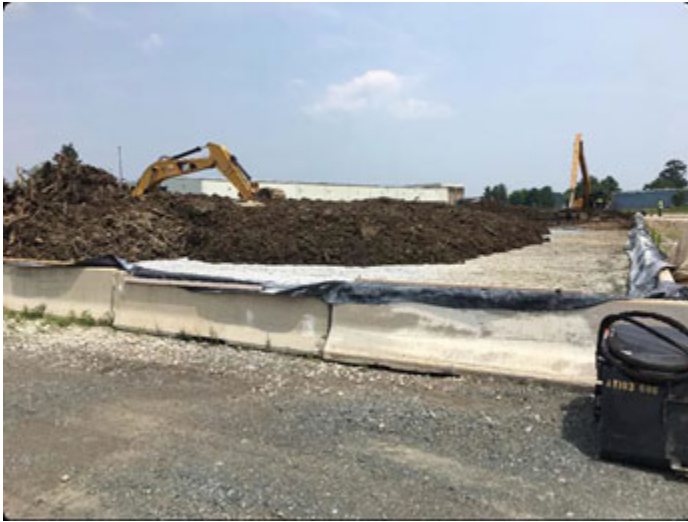
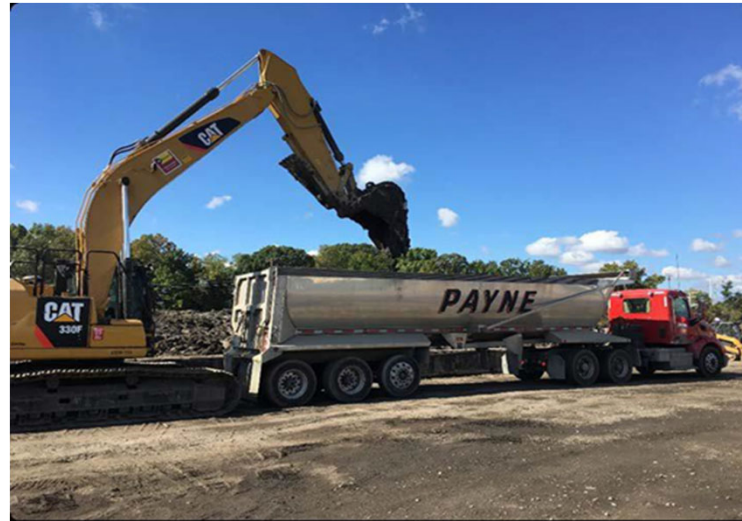
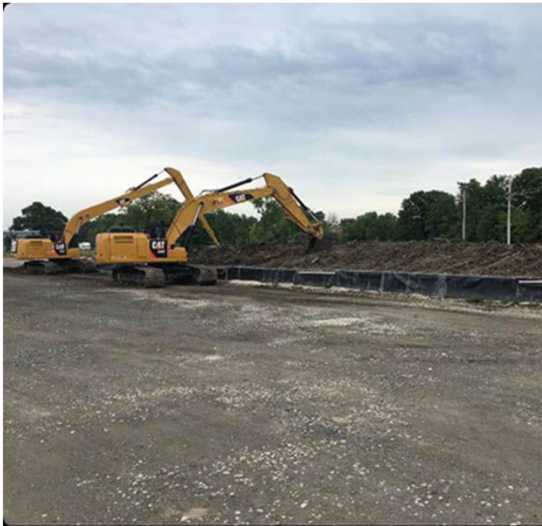
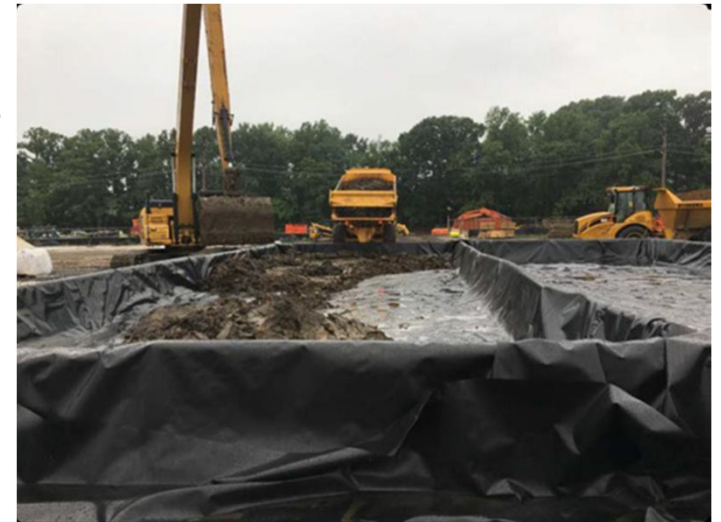
Upland dewatering operations

Challenges:

- Meeting paint filter test and strength requirements
- Waste profiling
- Potential hazardous waste

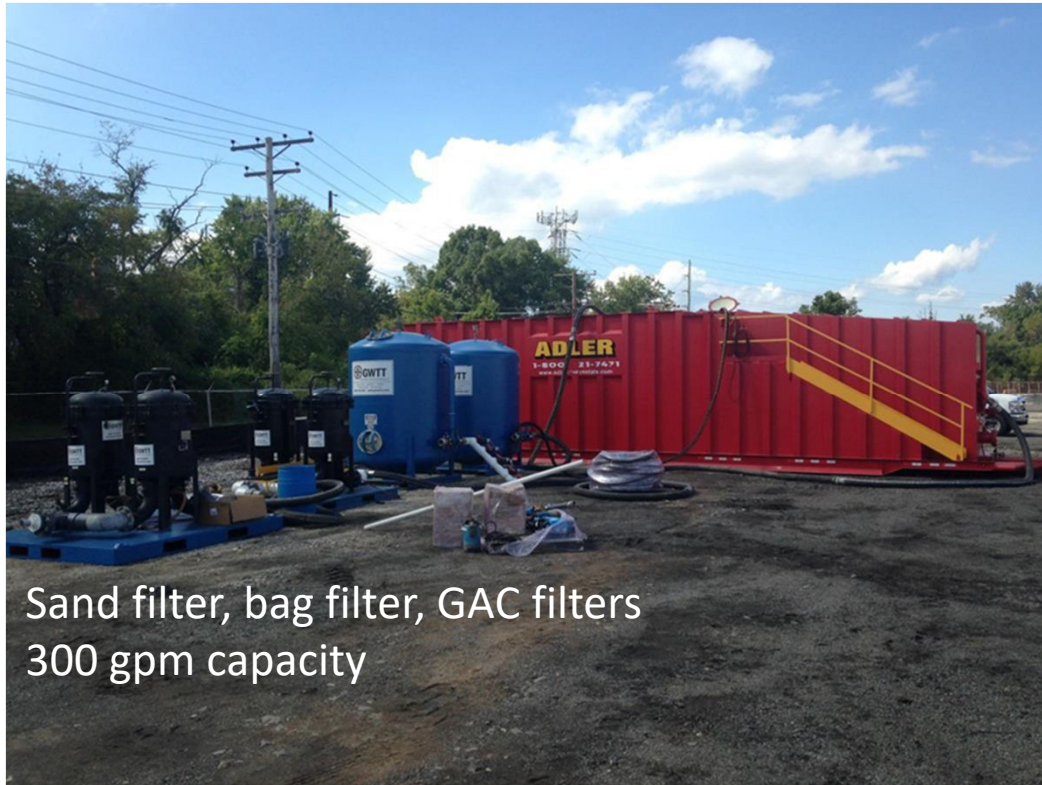
Water treatment and discharge operations

Sand filter, bag filter, GAC filters
300 gpm capacity

- Discharge to POTW
- Discharge to the creek through NPDES
- Challenges during storm
- Met discharge permit requirements
