# Habitat Reconstruction at the Hudson River PCBs Superfund Site:

The Roles of Active Planting and Natural Recolonization/Recruitment

Mike Traynor (mtraynor@louisberger.com) - Louis Berger, Albany, NY and Tom Shinskey - Louis Berger - Morristown, NJ

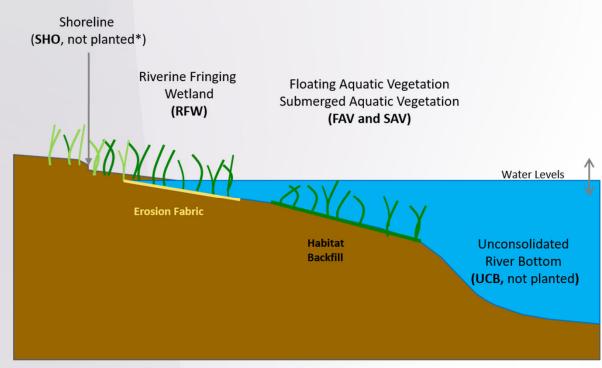
#### **Reconstructed Habitats**

<sup>\*</sup> SHO reconstruction includes planting if disturbed above design elevation, depending on energetics.

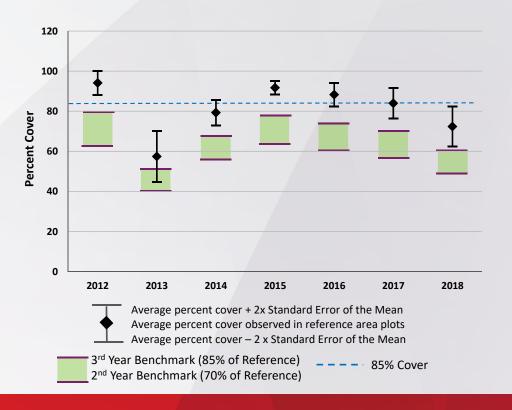
#### **RFW Reference Areas Percent Cover 2012-2018**

- Benchmark monitoring requires RFW reconstruction areas data to be compared to reference wetland data
- Benchmark monitoring is non-destructive (no harvesting) and is meant to get a sense of reconstruction areas trajectories
- Wetlands in their 2<sup>nd</sup> year of monitoring should exhibit 70% of reference levels while areas in their 3rd or greater year should exhibit 85% of reference area cover
- Invasive species observed in reconstruction areas within the first 2 years need to be removed. After the 2<sup>nd</sup> year of monitoring, percent cover from volunteer species should exceed 40%

RFW reference area percent cover levels since 2012 and how this relates to benchmark monitoring thresholds

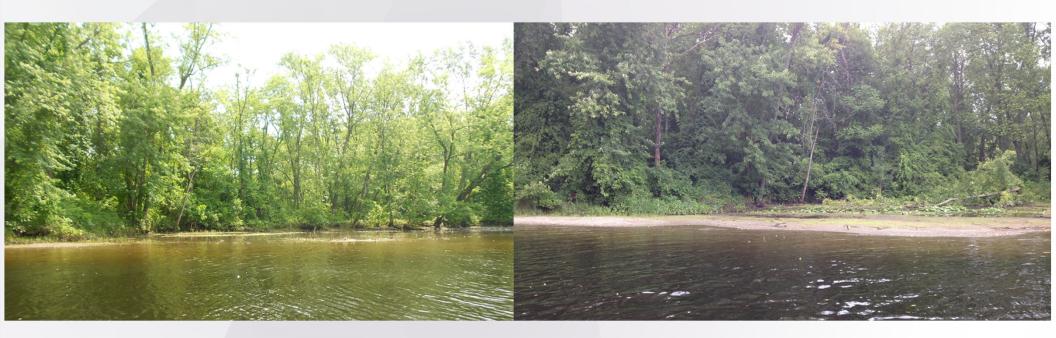
Conditions at approximately 4,800 cfs river flow

Conditions at approximately 2,700 cfs river flow

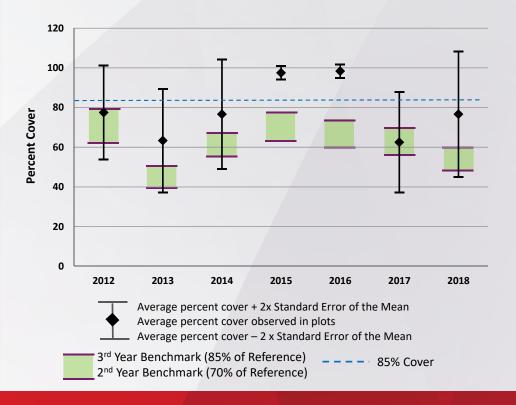
#### CU02 RFW Percent Cover 2012-2018

Dredged 2009, Seeded and Planted 2009 and 2010 Monitoring started in 2012 (due to 2011 high flows)

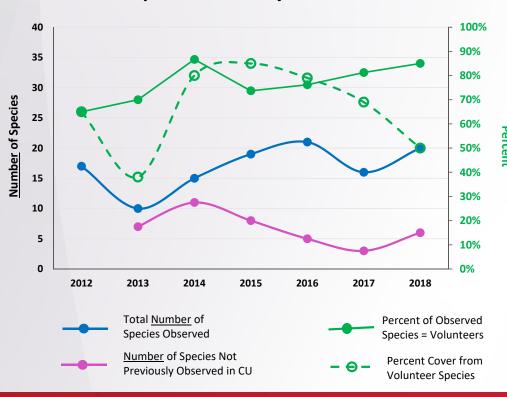
#### **CU02 RFW Species Diversity Measures 2012-2018**

**CU02 Percent Cover and Diversity Over Time**

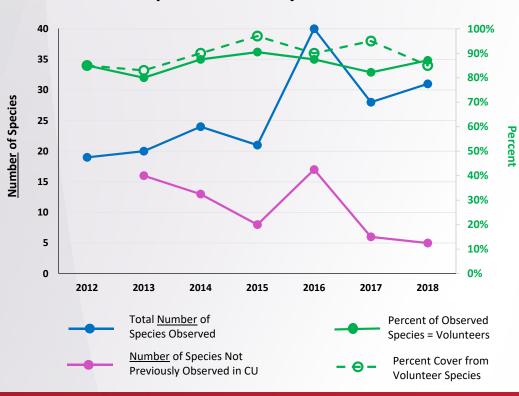
#### **CU08 RFW Species Diversity Measures 2013-2017**

**CU08 Percent Cover and Diversity Over Time**

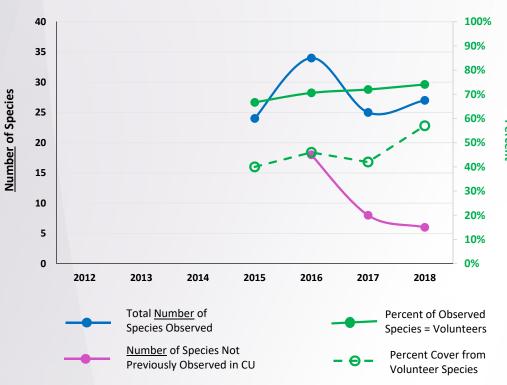
#### **CU53 RFW Species Diversity Measures 2015-2017**

**CU53 Percent Cover and Diversity Over Time**

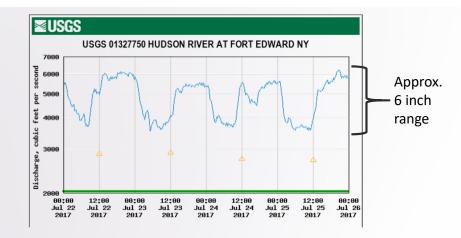
119.0 ft (+/-) is approx. surface water elevation at 8,000 cfs

Dredging Design Water Surface Elevation (wse) At 5,000 cfs ~ 118.00 ft (NGVD88)

117.0 ft (+/-) is approx. surface water elevation at 2,000 cfs

**Annual and Seasonal Mean Annual Surface Water Elevations** are Highly Variable

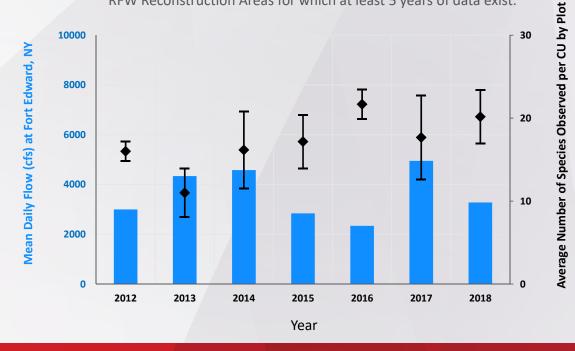
#### Mean Daily Flows and Average Species per Plot in CU's 2, 7, 8, 9, 10, and 19\*. 2012-2018

\* RFW Reconstruction Areas for which at least 5 years of data exist.

- Data do not appear to suggest that species richness varies directly with flows or water levels as measured in mean daily flow
- Data do suggest that most RFW areas experienced lower percent covers and species richness levels in 2017 (a relatively high water year) after steady increases from 2013 to 2016
- Other potential stressors include herbivory and disruption by wave action from boats and fetch. The extent to which CUs indicate impacts from these stressors is also highly variable

**River Flows and Species Richness Through Time**

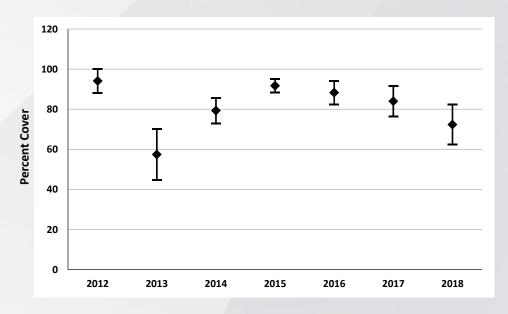
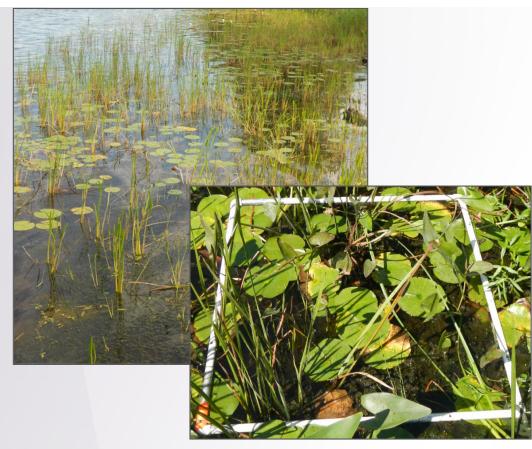
#### **RFW Reference Areas Percent Cover 2012-2018**

Average percent cover + 2x Standard Error of the Mean Average percent cover observed in reference area plots Average percent cover – 2 x Standard Error of the Mean

Reference area plot data trends and reconstruction area results

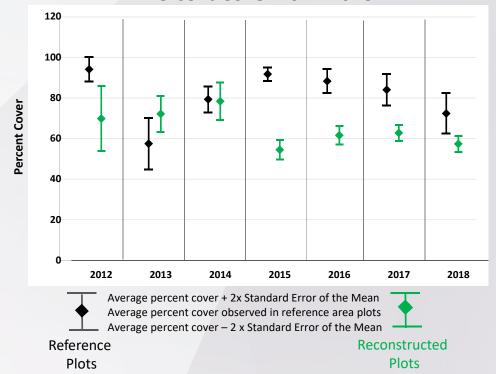
#### **RFW Reference and Reconstructed Areas** Percent Cover 2012-2018

- Reconstructed plots do not appear to directly reflect reference plot year-to-year trends until after 2015
- Starting in 2015 approximately 18.5 of the over 29 acres of RFW reconstructed began benchmark monitoring in 2015
- The overall drop in percent cover observed starting in 2015 reflects an increase in monitored Zone B areas, which have generally not exhibited as much vegetation cover as Zone A areas.

Reference area plot data trends and reconstruction area results
