Phased Amendment Delivery at Urban Brownfield to Address Mixed Plume

Battelle | Bioremediation and Sustainable Environmental Technologies 2019

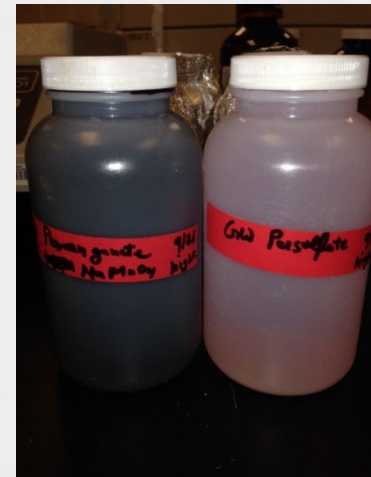
TREATABILITY STUDY

- Bench-scale study at the Langan Treatability Facility at the New Jersey Institute of Technology (NJIT)
- Evaluation of ISCO via sodium permanganate and alkaline-activated persulfate
- Determine design parameters for an in-situ remedy implementation.

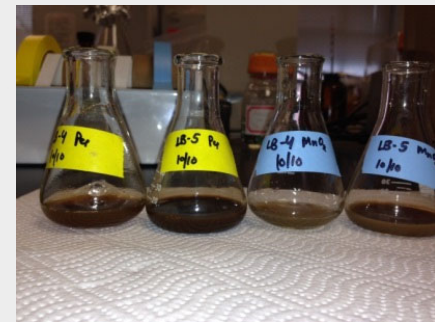
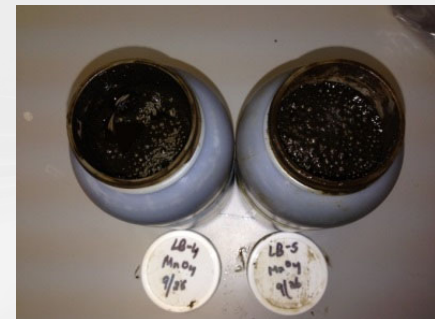
TREATABILITY STUDY

- Soil Oxidant Demand (SOD)- 9 g/kg
- Mixed Plume Removal Efficiency
 - Permanganate
 - Total VOCs- 45%
 - Persulfate
 - Total VOCs- >70%

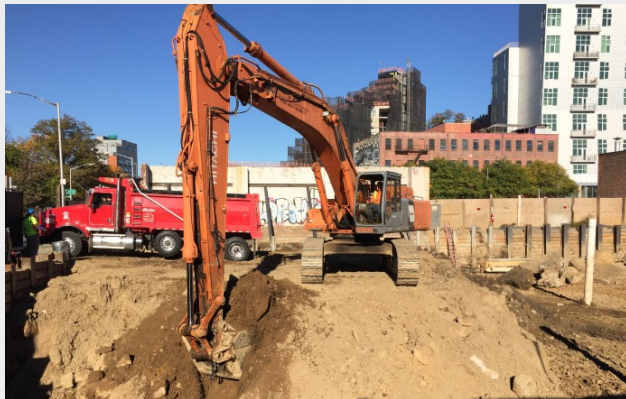
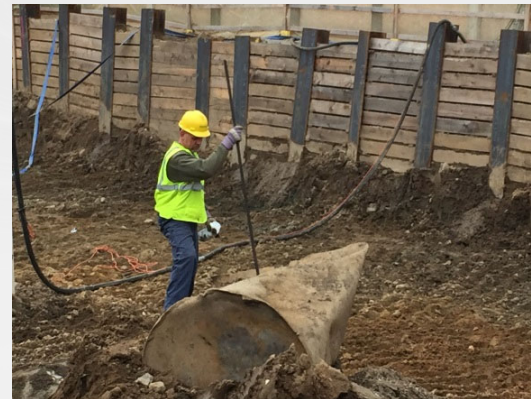
SOURCE REMOVAL

- Decommissioning/removal of two 275-gallon ASTs and four 550-gallon USTs
- Excavation of impacted soil to about 10 feet below grade surface
 - 2,437 tons of historic fill
 - 14,023 tons of petroleum contaminated fill

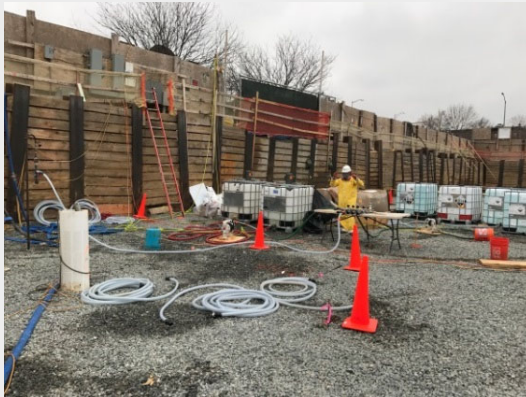
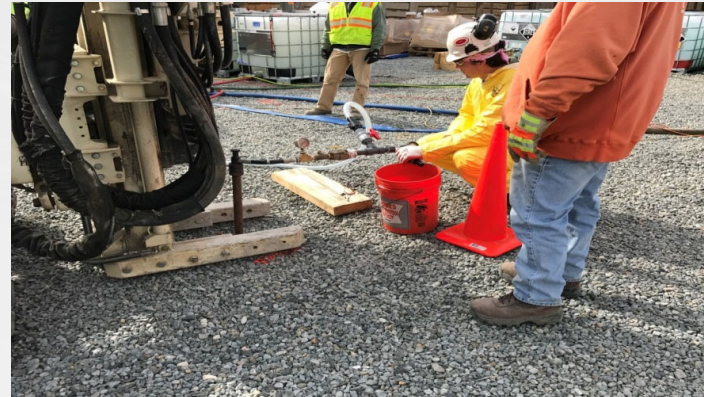
BASE-ACTIVATED SODIUM PERSULFATE INJECTIONS

- Direct-injection of a base-activated persulfate to pretreat mixed petroleum/CVOC groundwater contamination
 - 11,800 lbs sodium persulfate
 - 20,520 lbs sodium hydroxide

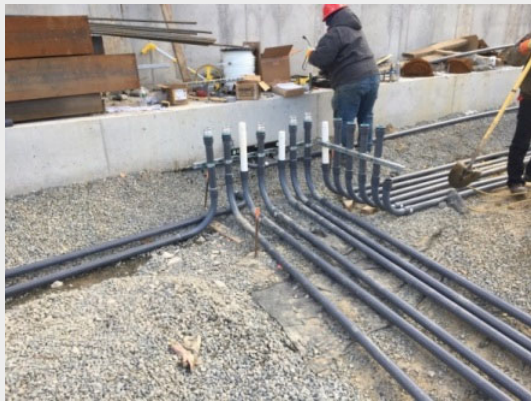
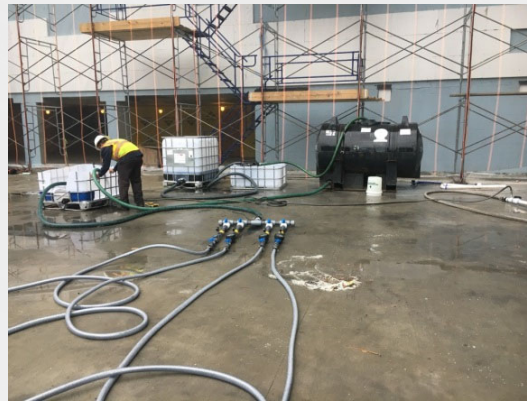
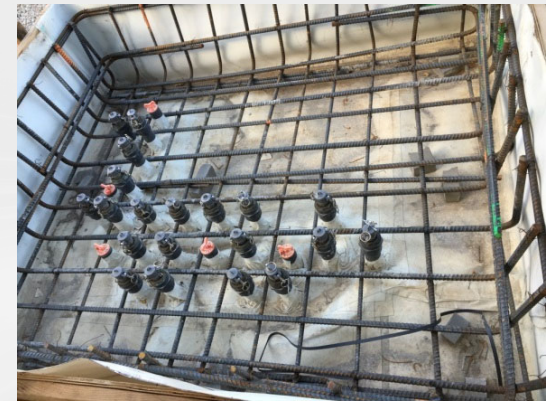
PlumeStop® Injections

- Injection of PlumeStop® for residual petroleum and CVOCs
 - 56,400 pounds via well network
 - 15,600 pounds via direct push

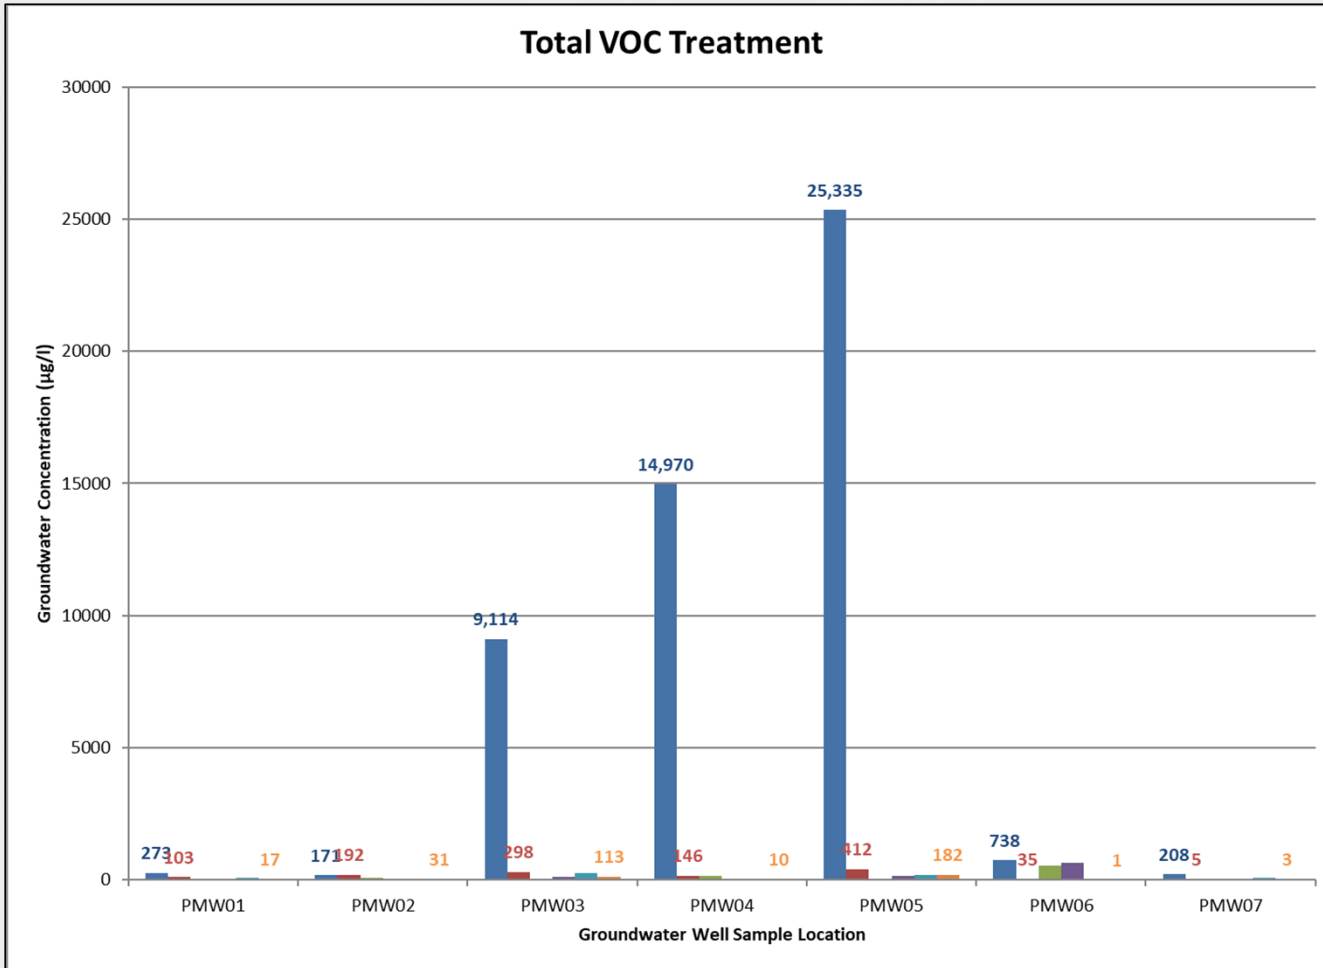
Total VOC Treatment

- ISCO field implementation was completed in March 2017
 - Results show up to two orders of magnitude reduction in total VOCs as compared with pre-treatment concentrations
- PlumeStop[®] injections were completed in November 2017
 - Results show an additional order of magnitude reduction (across four quarterly sampling events- March 2018- December 2018)

■ Baseline
 ■ Post Source Removal/Persulfate
 ■ Post PlumeStop- Q1
 ■ Post PlumeStop- Q2
 ■ Post PlumeStop- Q3
 ■ Post PlumeStop- Q4

Post-Source Removal/Persulfate Injection		Post PlumeStop® Injection- Q1		Post PlumeStop® Injection- Q2		Post PlumeStop® Injection- Q3		Post PlumeStop® Injection- Q4	
	<i>mean</i>	<i>median</i>	<i>mean</i>	<i>median</i>	<i>mean</i>	<i>median</i>	<i>mean</i>	<i>median</i>	<i>mean</i>	<i>median</i>
Total VOCs	77%	97%	81%	98%	82%	98%	84%	97%	96%	99%
CVOCs	-7%	65%	90%	99%	80%	99%	72%	97%	71%	99%
BTEX	86%	99%	100%	100%	100%	100%	100%	100%	100%	100%

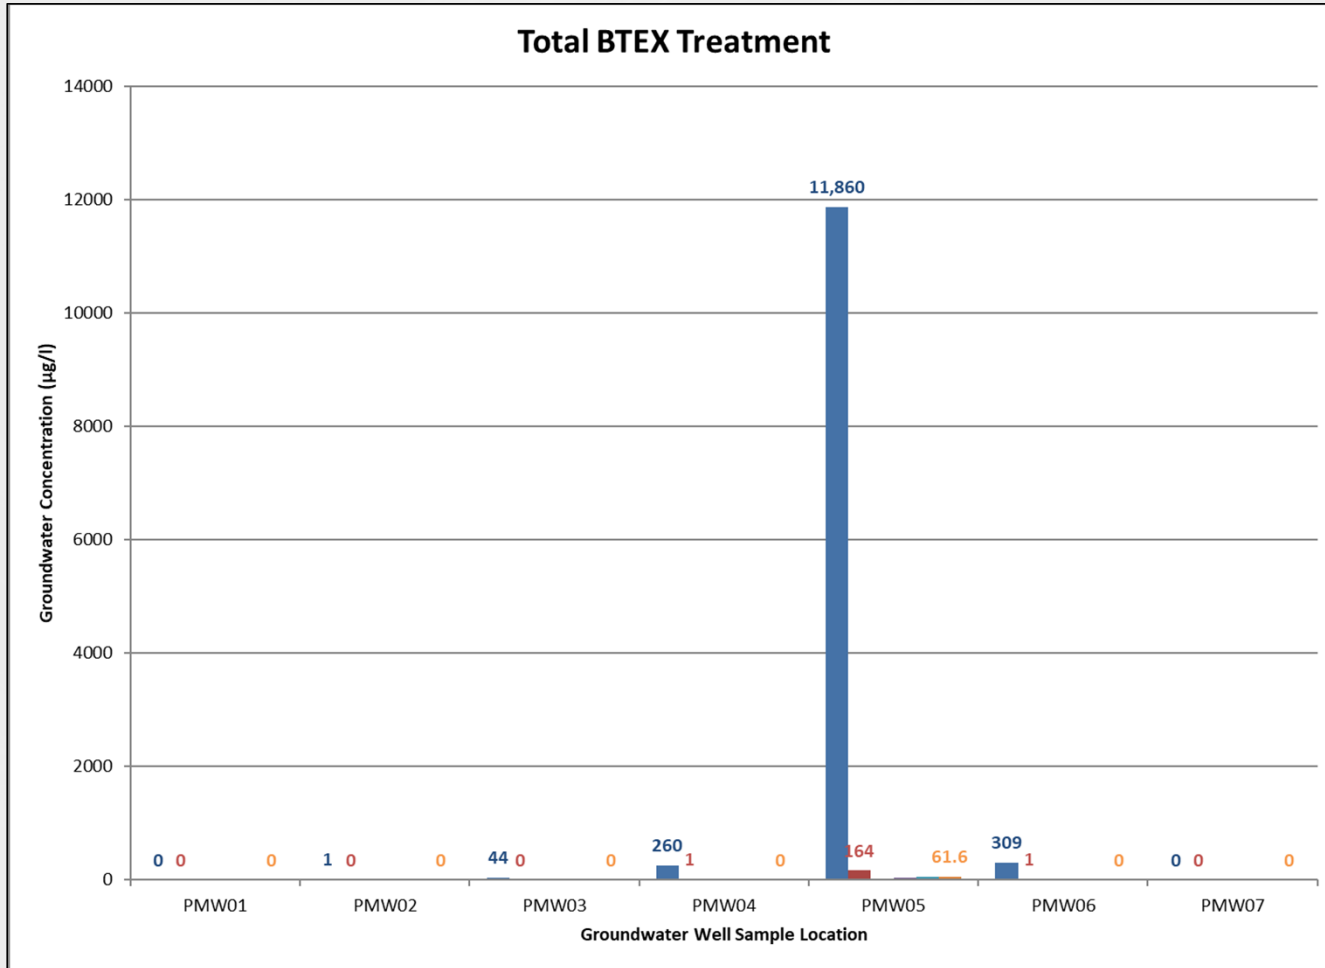
Total BTEX Treatment

■ Baseline
 ■ Post Source Removal/Persulfate
 ■ Post PlumeStop- Q1
 ■ Post PlumeStop- Q2
 ■ Post PlumeStop- Q3
 ■ Post PlumeStop- Q4

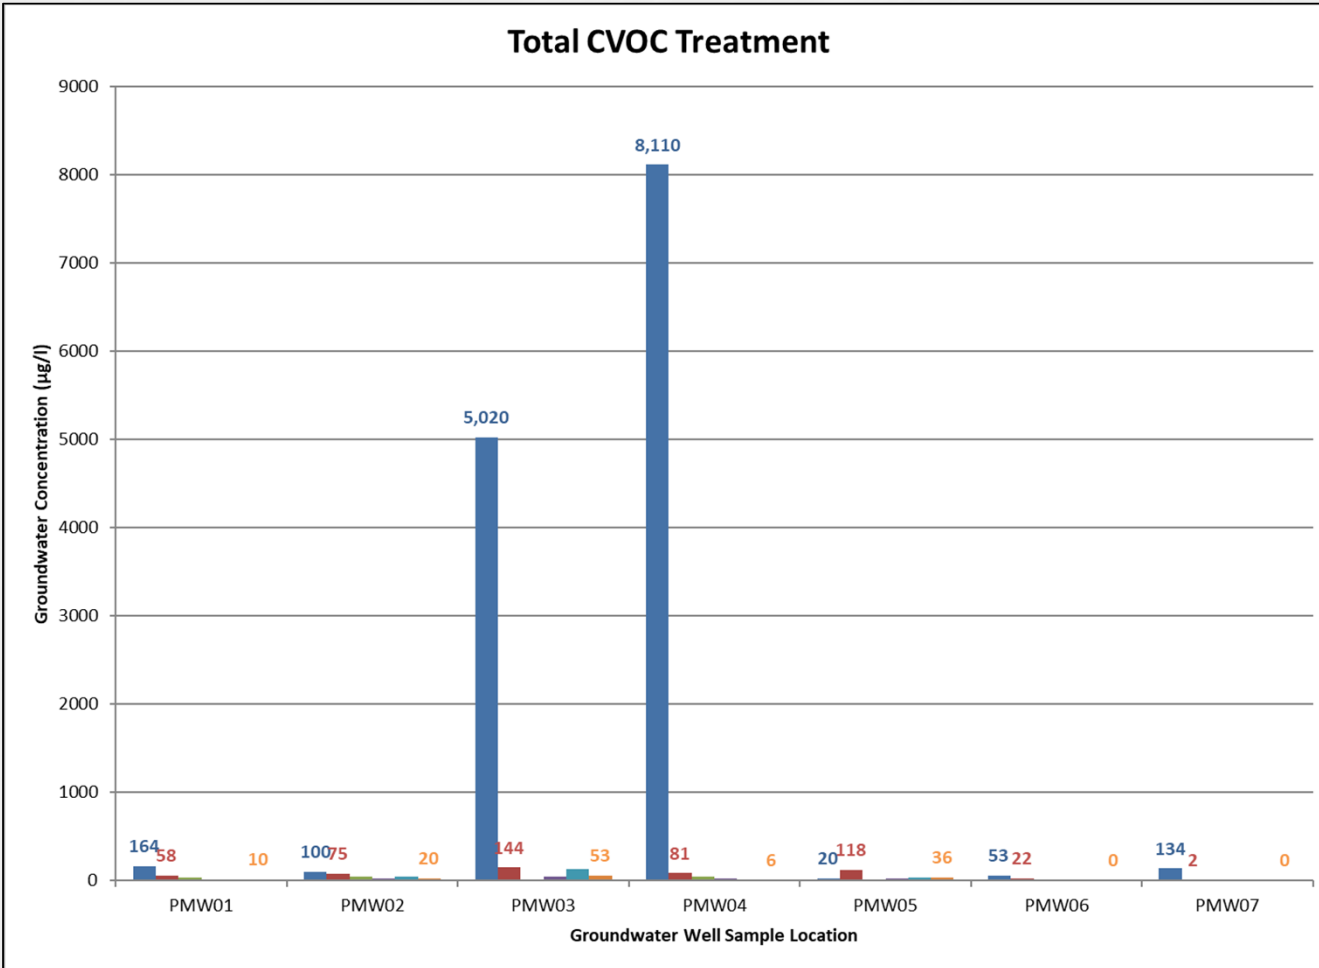
Total CVOC Treatment

■ Baseline
 ■ Post Source Removal/Persulfate
 ■ Post PlumeStop- Q1
 ■ Post PlumeStop- Q2
 ■ Post PlumeStop- Q3
 ■ Post PlumeStop- Q4

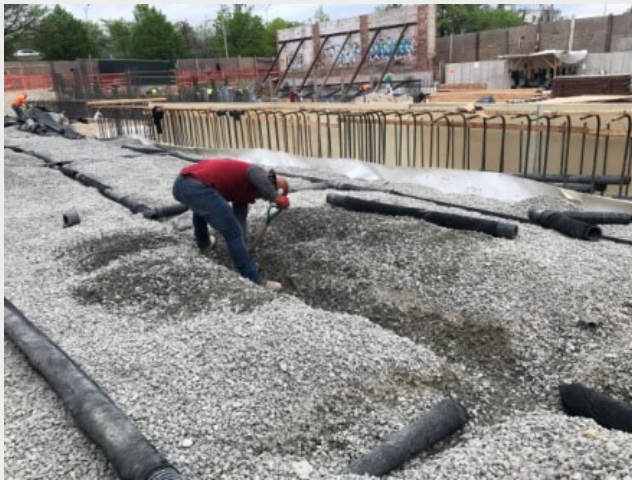
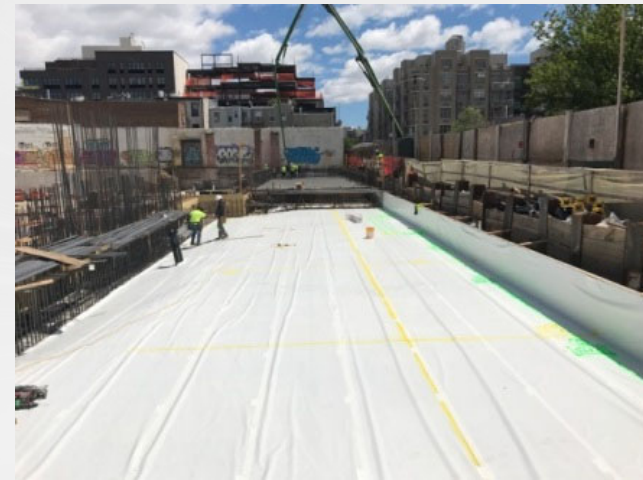
ADDITIONAL PROTECTIVE MEASURES

- Installation of depressurization system to address potential SVI
- Installation of waterproofing/vapor barrier
