# Innovative Unmanned Aerial Survey to Assess Impacts to a Shoreline Landfill

Michael Meyer (Battelle, Seattle, WA, USA), Stephen Rosansky (Battelle, Tampa, FL, USA), Dennis Goddard (Trihydro Corporation, New Braunfels, TX, USA), Matthew Jones (Trihydro Corporation, Ferndale, WA, USA), Justin Peach (Naval Facilities Engineering Systems Command Northwest, Silverdale, WA, USA) (*retired*)

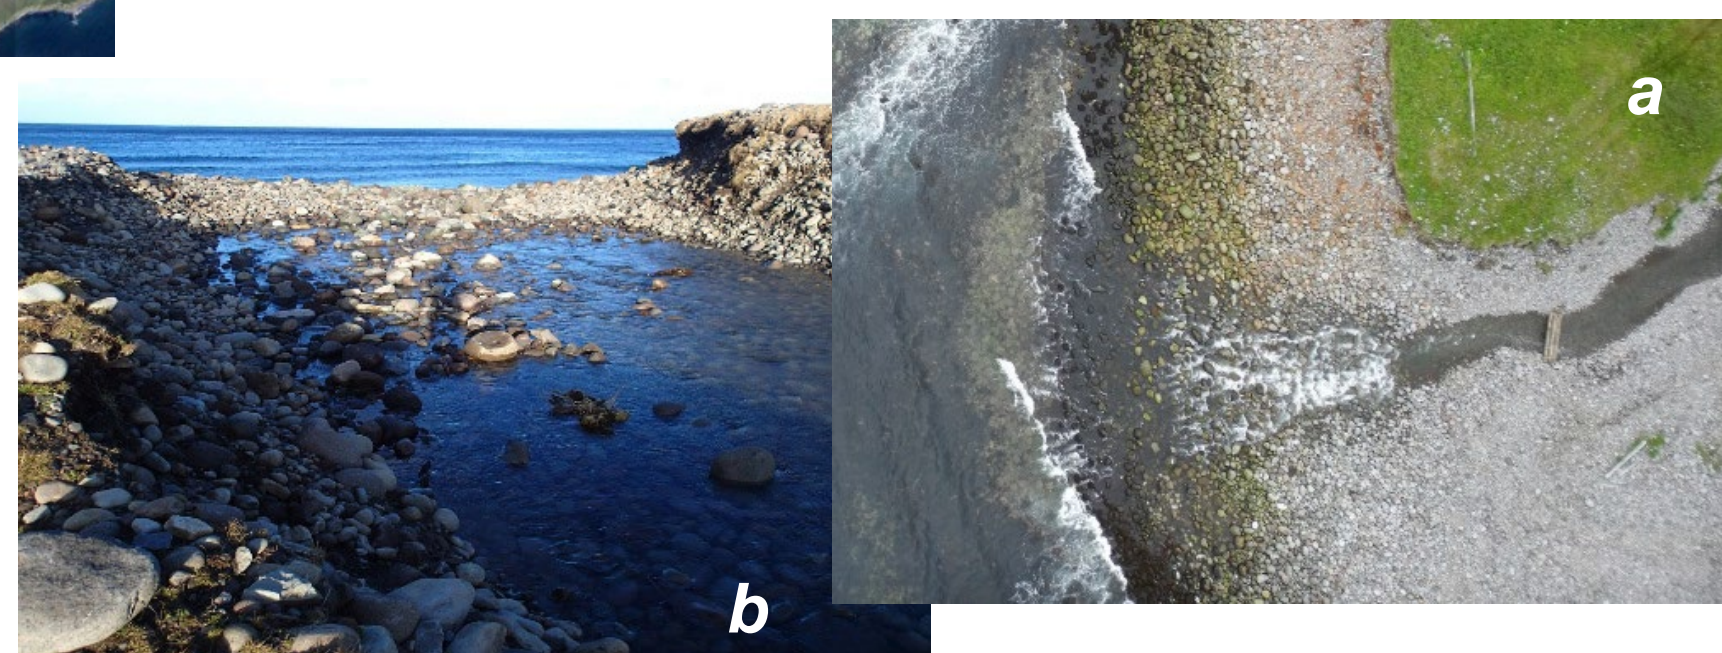
Andrew Lake has a surface area of approximately 2,100 acres and receives water from short, steep creeks draining the mountains to the east and west (U.S. Navy, 1997a). Outflow from the lake occurs through the permeable, natural causeway, and a narrow spillway at the northwest corner of the lake. Without intervention by the Navy, the spillway becomes progressively blocked with coarse material deposited by the Bering Sea (Figure 2).

Figure 2. Free flowing spillway (a) and blocked spillway (b)

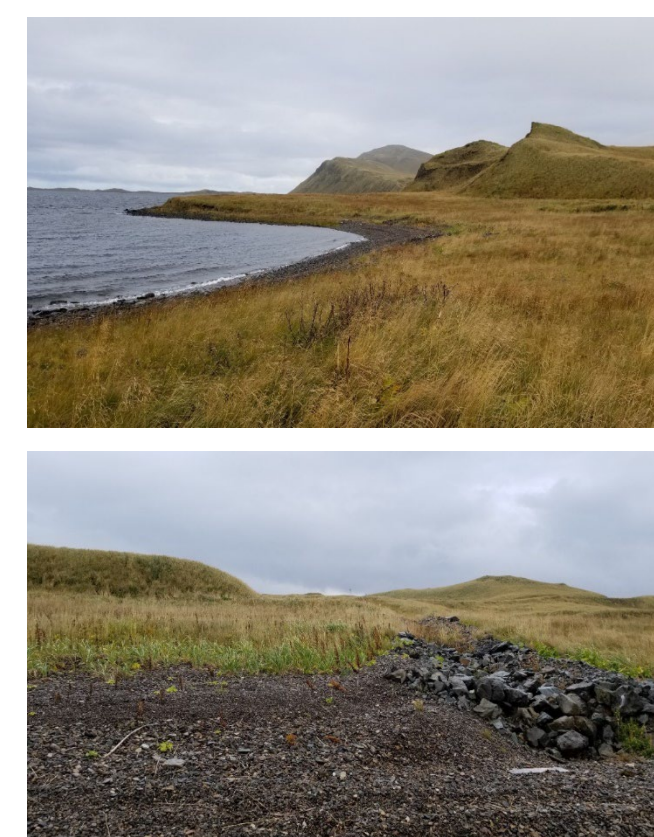
Figure 3. Views of the SWMU 4 Landfill

The SMUW 4 landfill encompasses between 3.0 and 4.1 acres and operated during the 1940s (Figure 3). The landfill waste body is approximately 6 ½ feet thick and believed to consist of solid wastes generated from the construction and subsequent demolition of Albert Mitchell Airfield (U.S. Navy, 1997a). The remedy consists of a surface cap, two armored drainages crossing the cap, and no shore armoring (U.S. Navy 1997b). The landfill cover placement was terminated several feet from the shoreline to prevent sediment contamination of Andrew Lake during construction.

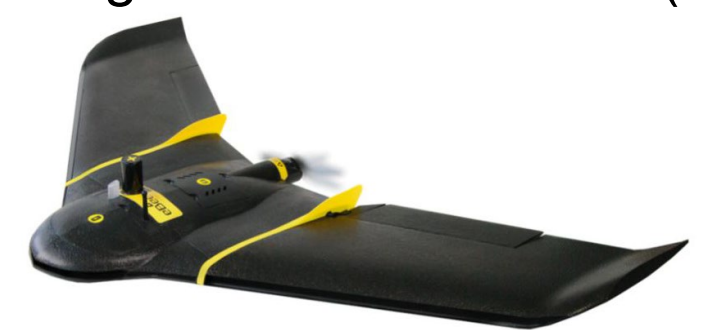
Figure 4. Unmanned aerial system- SenseFly eBee+

The UAS approach for generating elevation data was particularly well suited to the difficult conditions on Adak Island. The UAS generated data more quickly than a traditional land survey on foot and was able to fly beneath cloud cover that would have precluded use of manned aircraft at higher altitudes. The UAS was able to collect data despite gusty winds up to 35 knots, and executed preplanned safety measures several times to avoid raptor strikes.

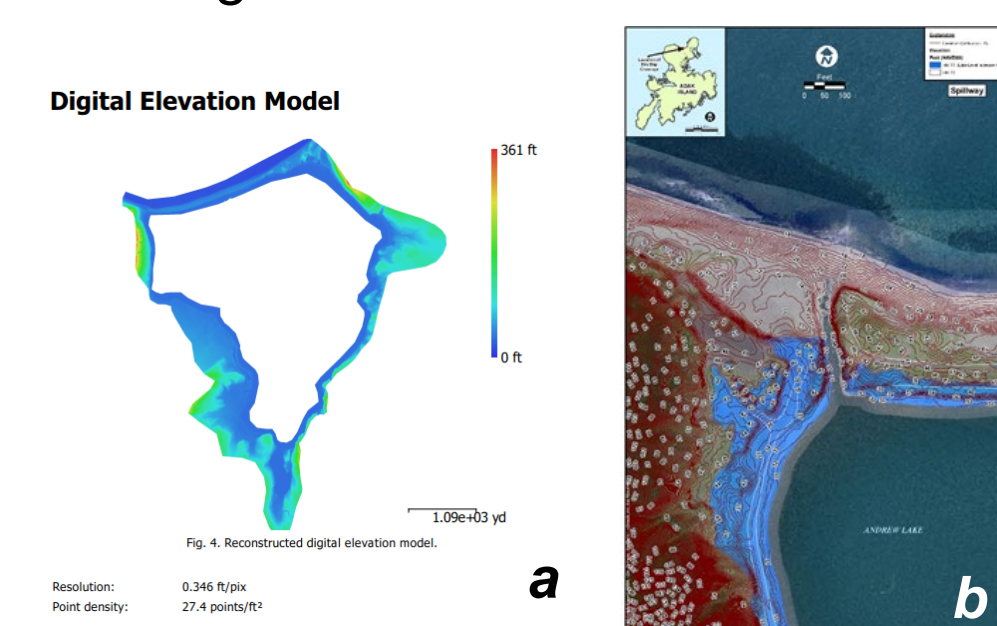
In the field existing benchmarks were first located and verified. Survey control points were set, consisting of 77 photo-identifiable primary control points and 342 secondary check points. A survey grade Trimble R10 real-time kinematic (RTK) global positioning system (GPS) was used to establish control points and calibrate to the local site control system. A two-person UAS crew and a SenseFly eBee+ unmanned survey aircraft equipped with an RTK antennae collected high-resolution, comprehensive data over the Andrew Lake area (Figure 4). Nineteen flights were performed, ranging from 30 to 45 minutes each and generating 4,438 photos. Flight imagery provided 1.0-inch ground sample distance (GSD) orthoimagery and a DEM supporting a 1-foot contour interval. Agisoft Photoscan Professional photogrammetry software was used to process the 4,432 collected images and generate tiled-Tagged Image File Format (TIFF) orthophotos and a georeferenced GeoTIFF raster DEM, which is essentially a matrix of 6-inch squares, each assigned an elevation value and covering the area of interest (Figure 5a).

The geospatially referenced DEM raster layers were loaded into the geographic information system (GIS) map file. For the regional extent of Andrew Lake, the 12-inch DEM raster grid was used to develop a 1-foot contour interval using the Esri GIS contour generation tool (Figure 5b). For the area including and immediately surrounding SWMU 4 the finer resolution 6-inch DEM raster was used to generate a similar set of 1-foot interval surface contours. The raster DEM files were symbolized using a blue color code indicating increasing 1-foot increments from 1 to 4 feet of lake level increase (Figure 6). Lake level increases from 4 to 18 feet were shown in 2-foot increments until the area of concern was completely inundated or the lake level reached an 18-foot increase (at which point the causeway would theoretically overtop).

Figure 5. Digital elevation model (a) and detailed topographic information from UAS survey (b).
