In-Stream Remediation of Coal-Tar-Impacted Sediments and Fractured Bedrock

Raymond D'Hollander, PE, P.Eng. | Heather Philip | Paul Roth

2019 Sediments Conference | Tenth International Conference on Remediation and Management of Contaminated Sediments | February 11-14, 2019 | New Orleans, Louisiana

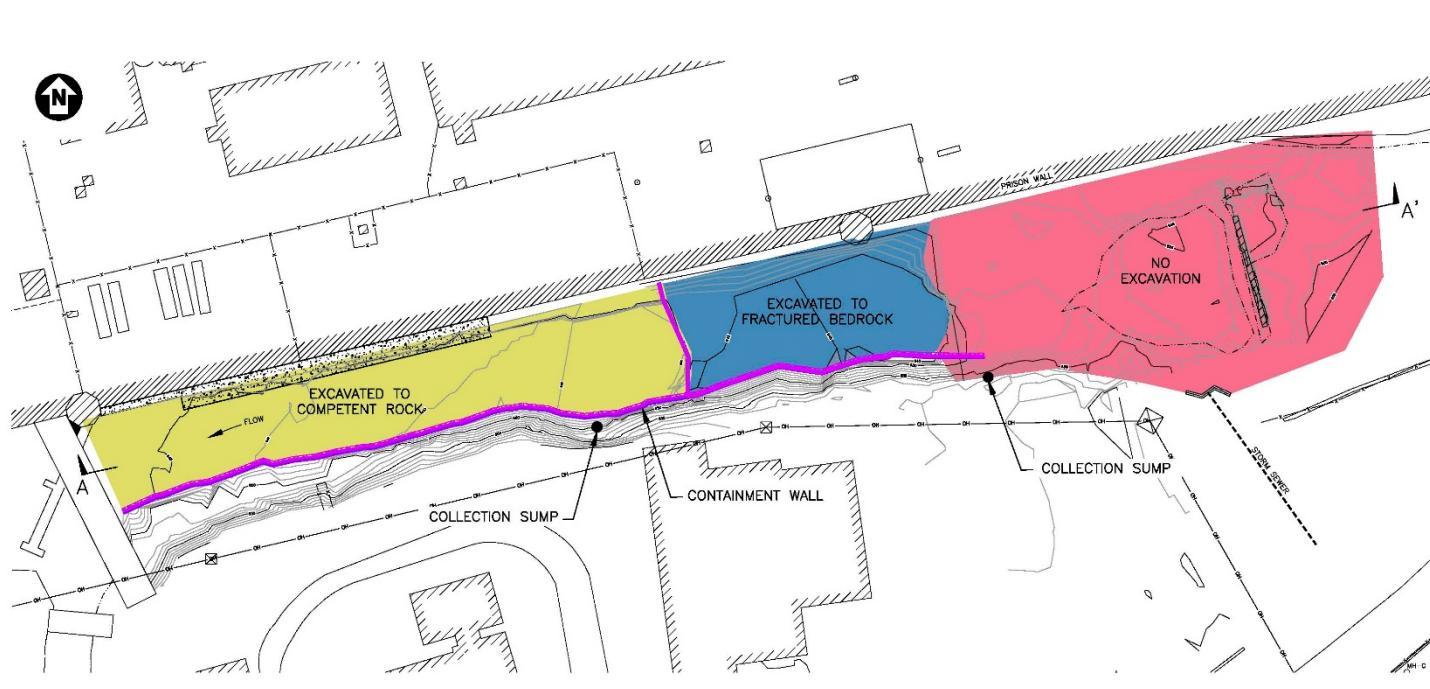
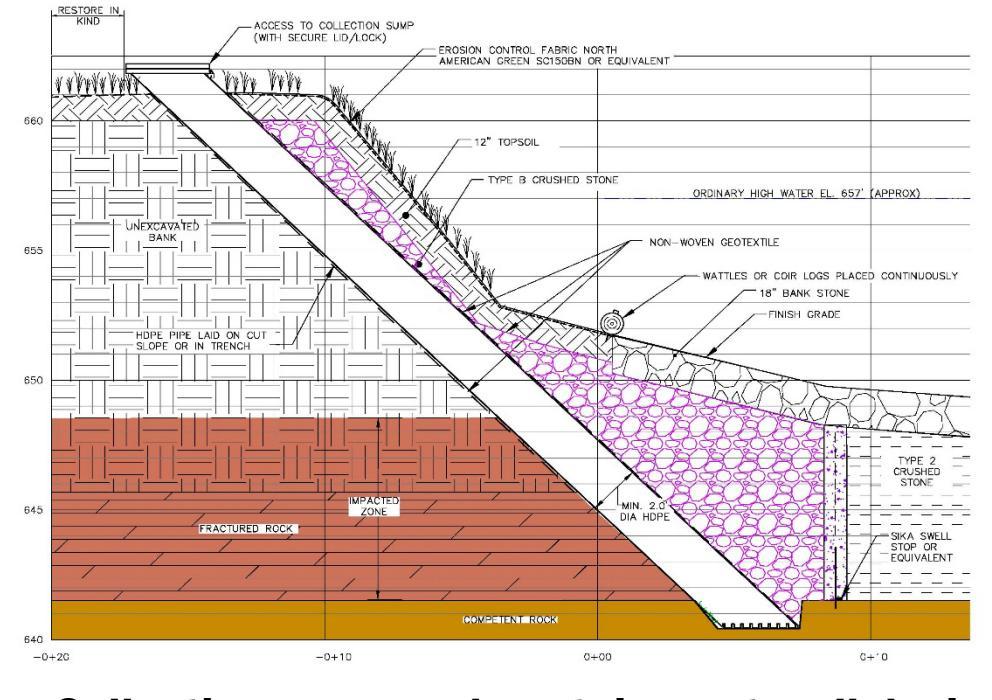
Using site geology to your advantage

Sediment removal exposed fractured bedrock with coal tar NAPL seeping from numerous fractures.

Fractured bedrock overlies competent bedrock with few fractures. • Natural barrier for coal tar NAPL flow

• Excavation terminated on top of competent bedrock layer

- Collection trench along toe of fractured bedrock in bank
- Collection sumps installed at downgradient end
- Concrete wall sealed to competent bedrock to prevent lateral coal tar NAPL migration
- Seal coat of concrete placed on fractured bedrock in stream channel to seal fractures
