PERFLUOROALKYL SUBSTANCES SOURCE TRACKING AT THE FORMER PEASE AIR FORCE BASE

CHRISTIAN BUERKLE (christian.buerkle@aptim.com), MICHAEL QUINLAN, AND BEN PORTER (APTIM, CANTON, MASSACHUSETTS, USA) PETER FORBES (AIR FORCE CIVIL ENGINEERING CENTER, LIMESTONE, MAINE, USA) RUDY RAWCLIFFE (NORTHEAST GEOPHYSICAL SERVICES, BANGOR, MAINE, USA)

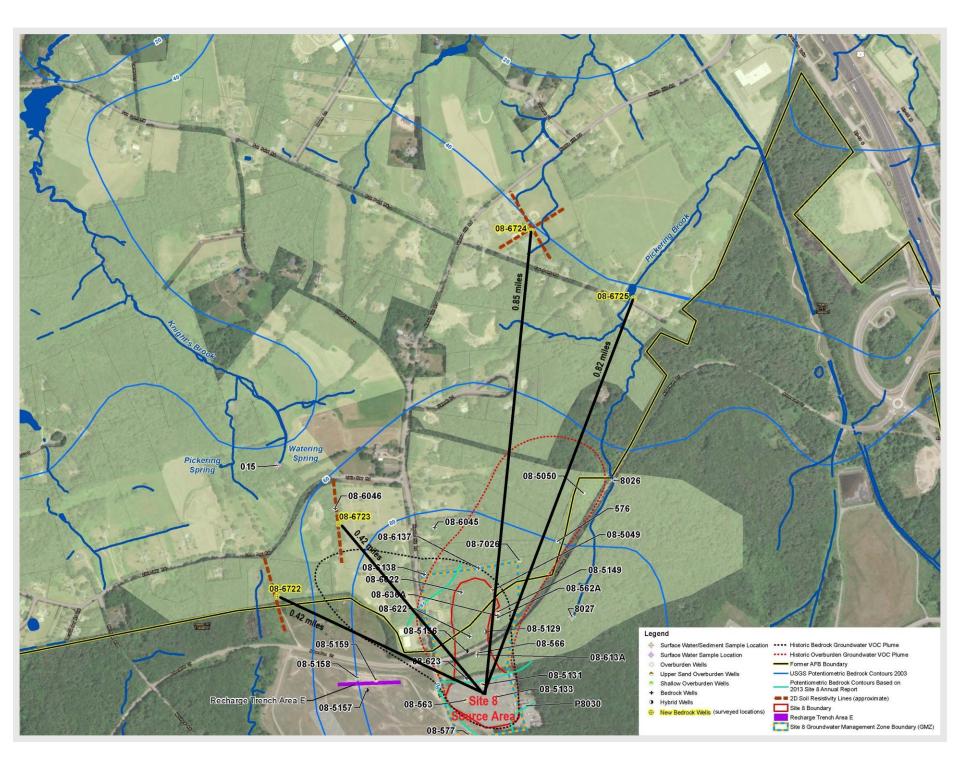
INSTALLATION OF FOUR BEDROCK WELLS DOWNGRADIENT OF SITE 8

- ➤ 2-D resistivity testing used to locate areas with fractured bedrock
- ► Installed four bedrock wells (08-6722 through 08-6725)
- Downhole geophysical logging completed at all four boreholes
- New well groundwater samples for PFAS analysis collected > Packers used to sample different fracture zones at three of four wells

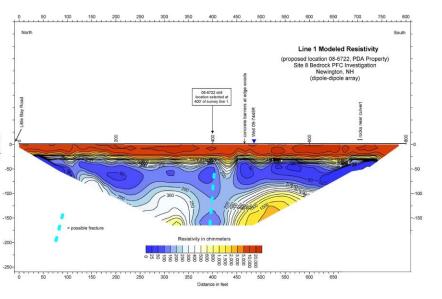
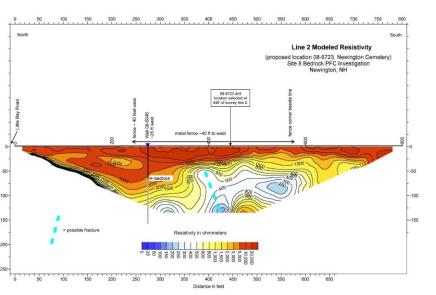
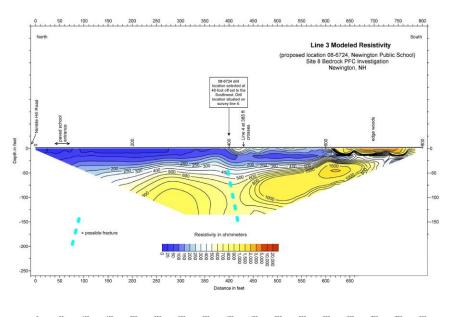
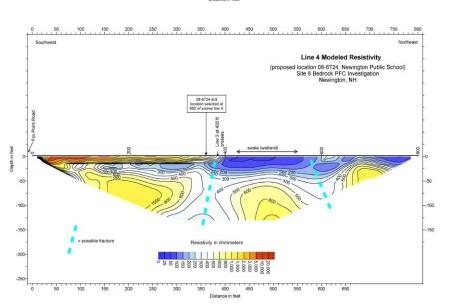
2-D RESISTIVITY TESTING

- Soil resistivity (dipole-dipole array) used to evaluate a 2-D portion of the subsurface
 - > Resulting images used to choose specific target locations of highest conductivity indicating a water-bearing zone within the

► 2-D resistivity testing successful in locating transmissive zones in bedrock

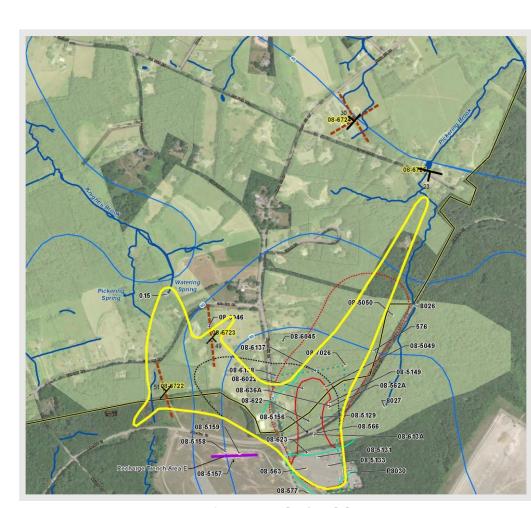
Possible extent of 2015 PFOA/PFOS contamination. Plume shape affected by bedrock fracture orientation

- ► Investigation confirmed PFAS is migrating in bedrock
 - > Primarily along the orientation of northeaststriking and northwest-striking fracture sets
