Utilizing Multiple Methods to Remediate Groundwater in Heterogeneous Soils: Three Florida Case Studies

Lee Bienkowski (l.bienkowski@ellisassoc.com) (Ellis & Associates, Inc., an ECS Group of Companies, Jacksonville, FL, USA)

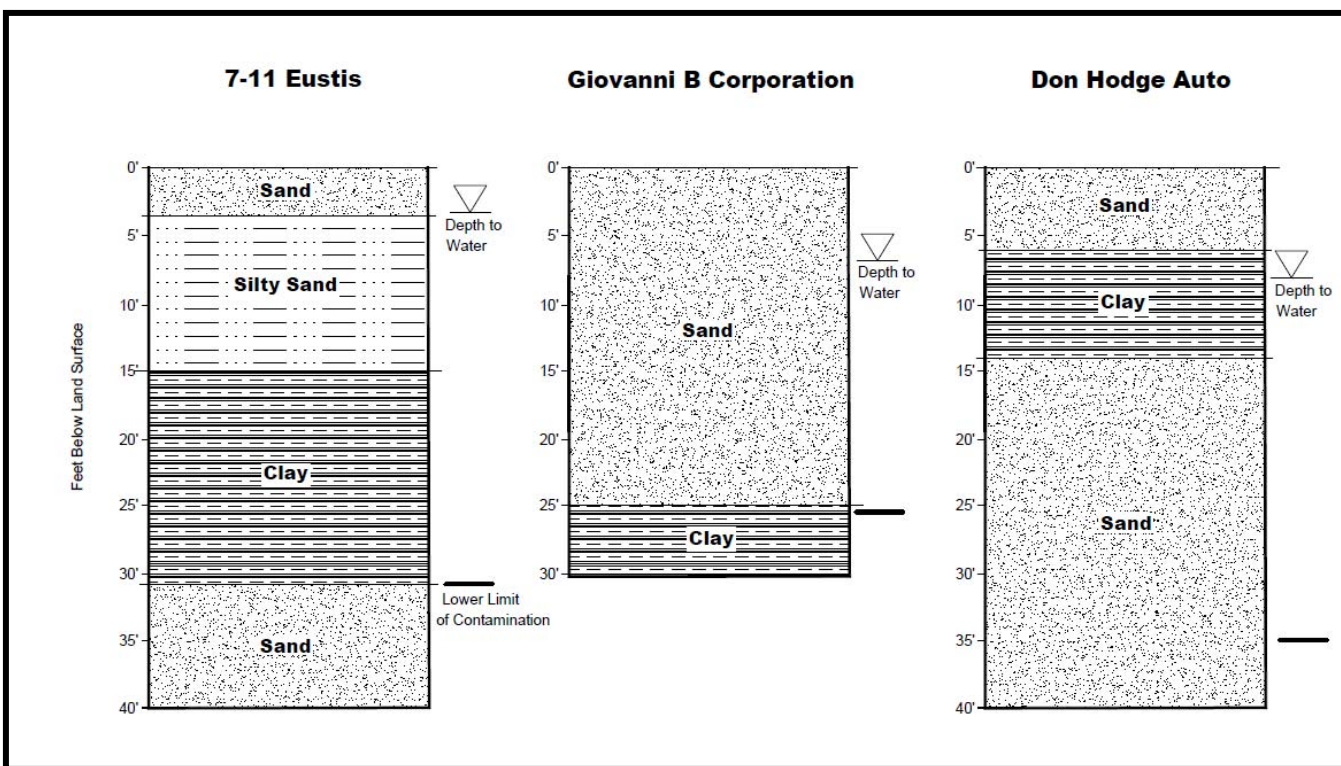
Site Lithology. Lithologic columns from the three selected sites are illustrated on Figure 2. In all three cases, the upper portion of the impacted aquifer is composed of sand or silty sand. The upper sand unit is underlain by clay at depths ranging from 6 feet [1.8 meters (m)] below land surface (bls) to 25 feet (7.6 m) bls, and the thickness of the clay within the impacted aquifer ranges from 5 feet (1.5 m) to 15 feet (4.6 m). The lithology of 7-11 Eustis consists of 4 feet (1.2 m) of sand underlain by 11 feet (3.4 m) of silty sand and 15 feet (4.6 m) of clay with another sand layer below that. Giovanni B Corporation's lithology consists of 25 feet (7.6 m) of sand underlain by a minimum of 5 feet (1.5 m) of clay. The lithology of Don Hodge Auto is 6 feet (1.8 m) of sand with 8 feet (2.4 m) of clay followed by a minimum of 26 feet (7.9 m) of sand.

FIGURE 2. Lithologic columns of all three sites.

7-11 Eustis. BTEX contamination in the groundwater at this former service station site was originally detected in 1986. The benzene plume delineated by 1990 covered approximately 11,400 square feet (ft²) [1,059 square meters (m²)] with a maximum concentration of 2,100 micrograms per liter (ug/L) benzene and a maximum depth of 30 feet (9.2 m) bls. The average depth to water is 3 feet (0.9 m) bls and 15 feet (4.6 m) of the impacted zone consists of clay.

Giovanni B Corporation. BTEX contamination in the groundwater at this former service station site was originally detected in 1993. Two separate xylenes plumes were delineated by 1994 – one originating from the underground storage tanks (USTs) and the other from the fuel dispensers. Together they covered approximately 6,000 ft² (557 m²) with a maximum concentration of 6,150 µg/L total xylenes and a maximum depth of 30 feet (9.2 m) bls. Only the lowermost portion of the impacted zone consists of clay.

Don Hodge Auto Service. BTEX contamination in the groundwater at this active automobile repair facility was originally detected in 1991. The total xylenes plume was delineated by 2000 with an aerial extent of approximately 16,000 ft² (1,486.4 m³) with a maximum concentration of 7,900 ug/L total xylenes and a maximum impacted depth of 35 feet (10.9 m) bls. A 9-foot (2.7 m) thick clay layer occupies the upper portion of the impacted zone.

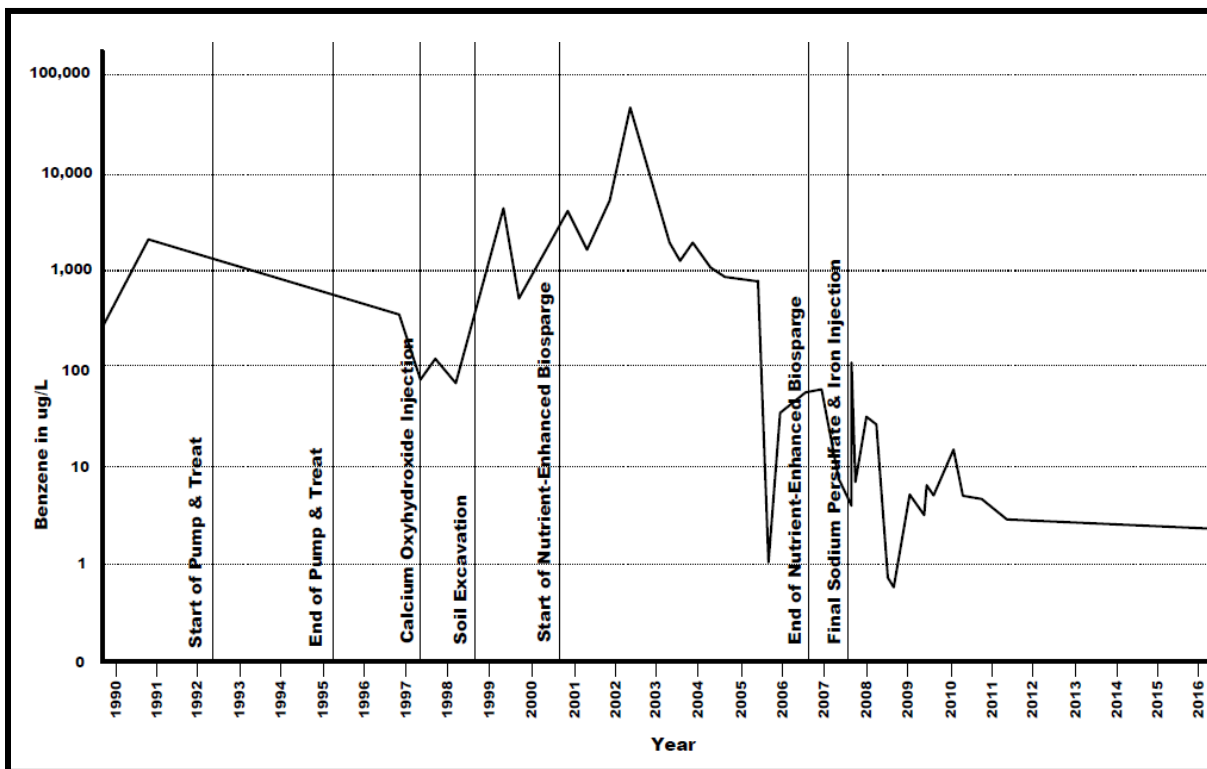
FIGURE 3. Benzene concentrations in MW-1, 7-11 Eustis.

7-11 Eustis Results. Three years of pump and treat remediation at 7-11 Eustis resulted in an 84 percent reduction in benzene concentrations in the source area. Calcium oxyhydroxide injection further reduced the benzene concentration by an additional 79 %, but the September 1998 soil excavation liberated BTEX constituents that had been adsorbed in the clay layer, which increased the benzene concentration by six times. Biosparging with periodic nutrient injection further increased the benzene concentration initially, but after six years of system operation, the benzene concentration was reduced by 88 percent. The injection of sodium persulfate continued the progress of bringing benzene at 7-11 Eustis below the GCTL. A graph of benzene concentrations over time for this site is shown on Figure 3.

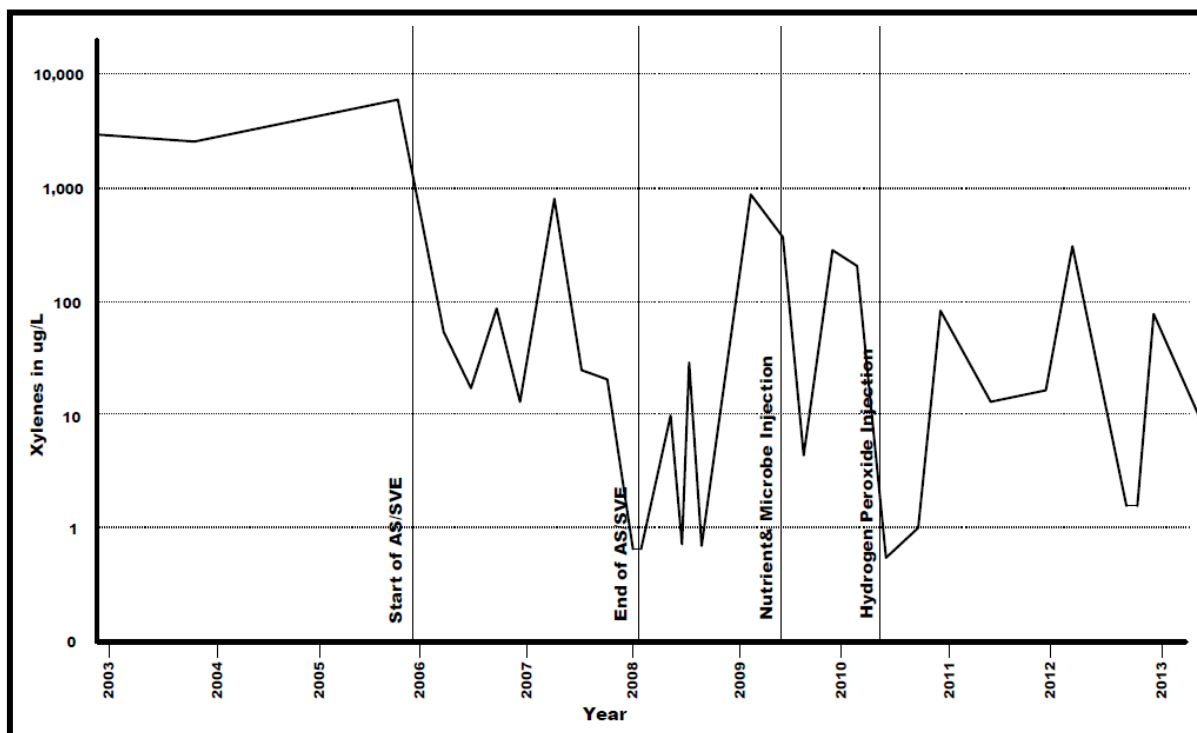
FIGURE 4. Xylenes concentrations in MW-14, Giovanni B Corporation.

Giovanni B Corporation Results. A year and half of AS/SVE remediation resulted in a nearly 100 percent reduction in xylenes concentrations in the source area. However, approximately one year after the system ceased operating the concentrations began to rebound. The subsequent injection of microbes and nutrients reduced contaminant concentrations by 99.5 percent within six months but rebounded again by the end of a year. Although an injection of hydrogen peroxide reduced contaminant concentrations to below the GCTLs within three months, rebound occurred three times over the following three years before remediation was considered complete. A graph of xylenes concentrations over time for this site is shown on Figure 4.

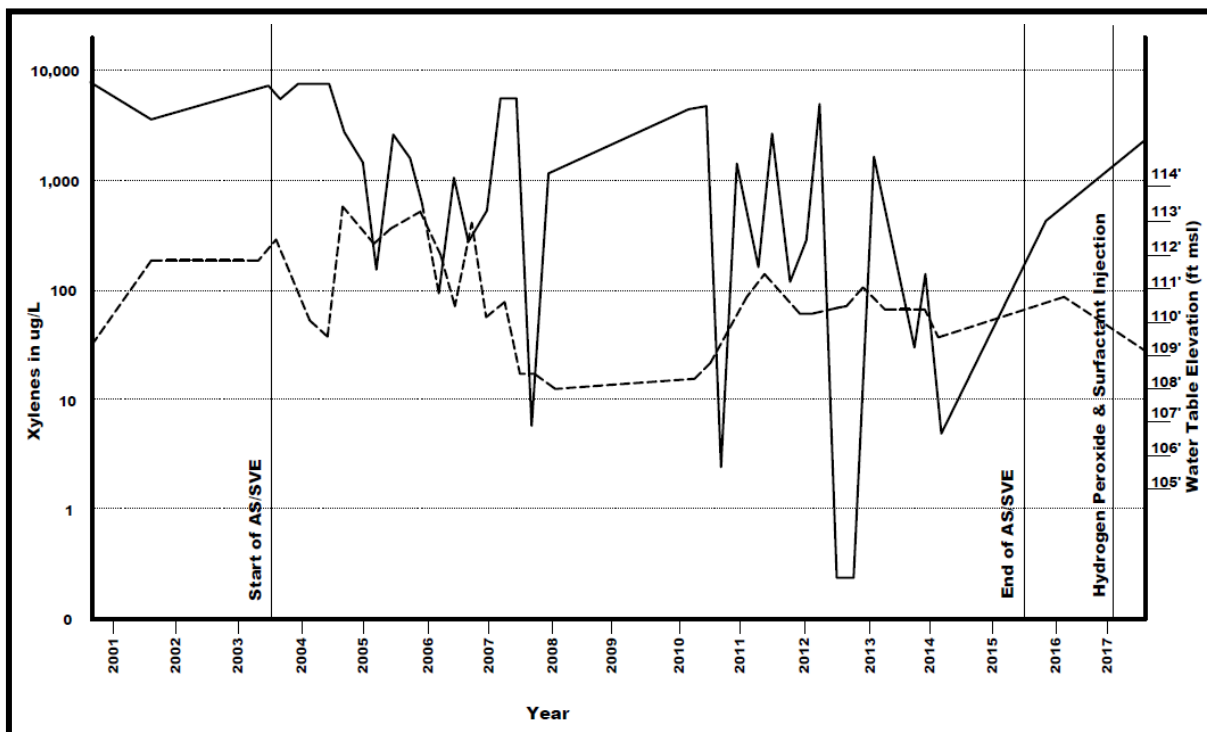
FIGURE 5. Xylenes concentrations in MW-1, Don Hodge Auto Service.

Don Hodge Auto Service Results. At the Don Hodge Auto Service an AS/SVE system operated for 12 years, successfully reducing BTEX concentrations by 86 percent. Although the basic concentration trend during the 12 years of AS/SVE remediation was

downward, the xylenes concentrations fluctuated wildly between sampling events. The variation in the top of the water table is approximately 5 feet (1.5 m), most of which occurs within the clay layer. It appears likely that the rising water table entering the smear zone liberated contaminants adsorbed in the clay, increasing the dissolved concentrations after each rise in the water table. The January 2017 injection event increased contaminant concentrations by introducing surfactants. Subsequent sampling events will show whether the increased availability of dissolved hydrocarbons will eventually lead to reduction in concentration without rebound. A graph of the xylenes concentrations at Don Hodge Auto Service is included as Figure 5.
