Multiple Remediation Technologies: Challenging Contaminated Site in Colombia

Authors: Sidney Aluani (saluani@sgw.com.br), Cristina Spilborghs, Eduardo Pujol, Fabiola Tomiatti, Natália Nascimento, Rafaell Moura, Tatiane Xavier (SGW Services, São Paulo, SP, BRAZIL) Jim Mueller (Provectus Enviromental Products, - Freeport, IL, USA), Mike Skalzi and Wade Meese (IET, - Pipersville, PA, USA)

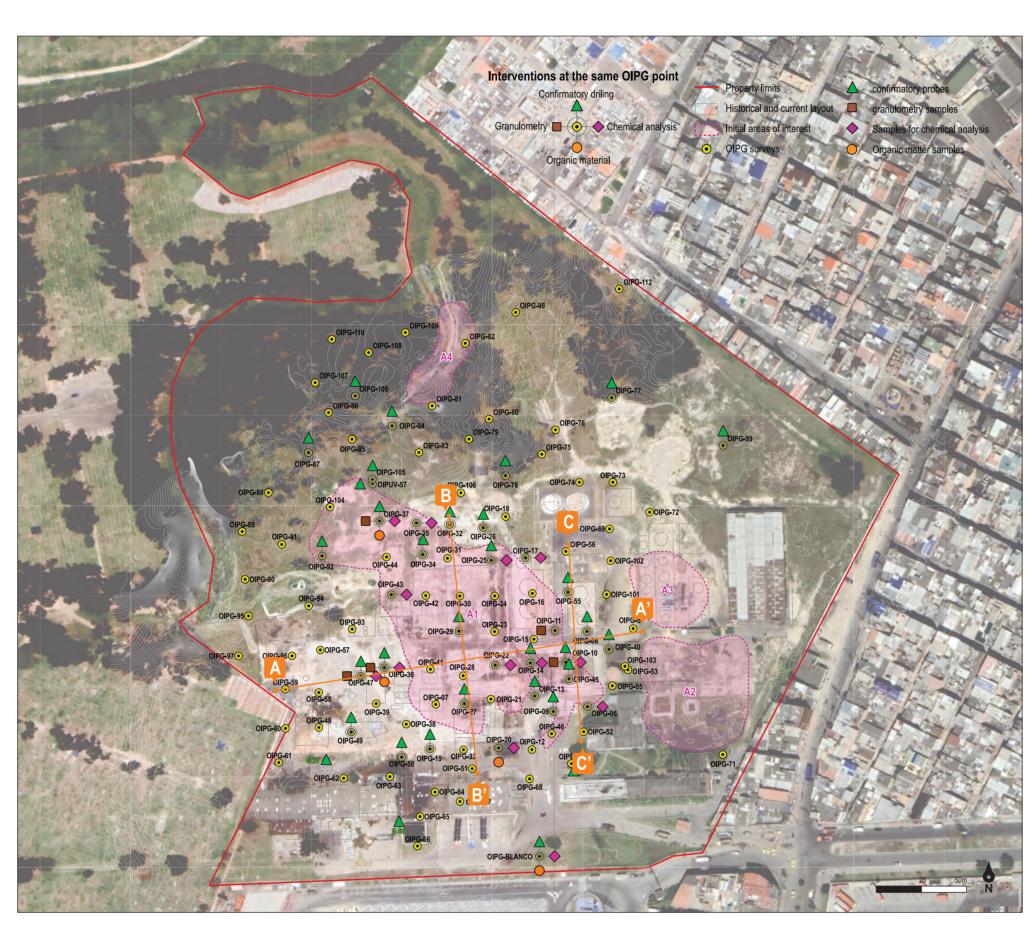
Clayey silt

Sandy silt

Pressure graph (HPT Press.)

Flow Chart (HPT Flow)

SGW decided to stop all remediation actions and step back to investigation mixing traditional and high-resolution investigation tools. Centimetric direct and indirect investigations were carried out. Hundreds of OIP and HPT, dozens of MIP points and additional drillings were performed.

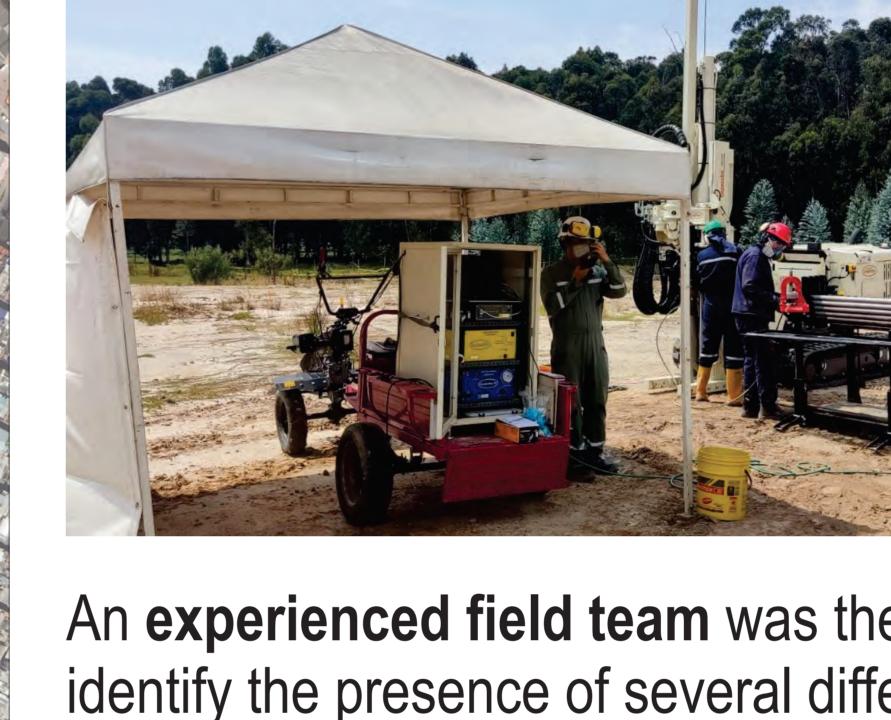
a precise and refined stratigraphic model.

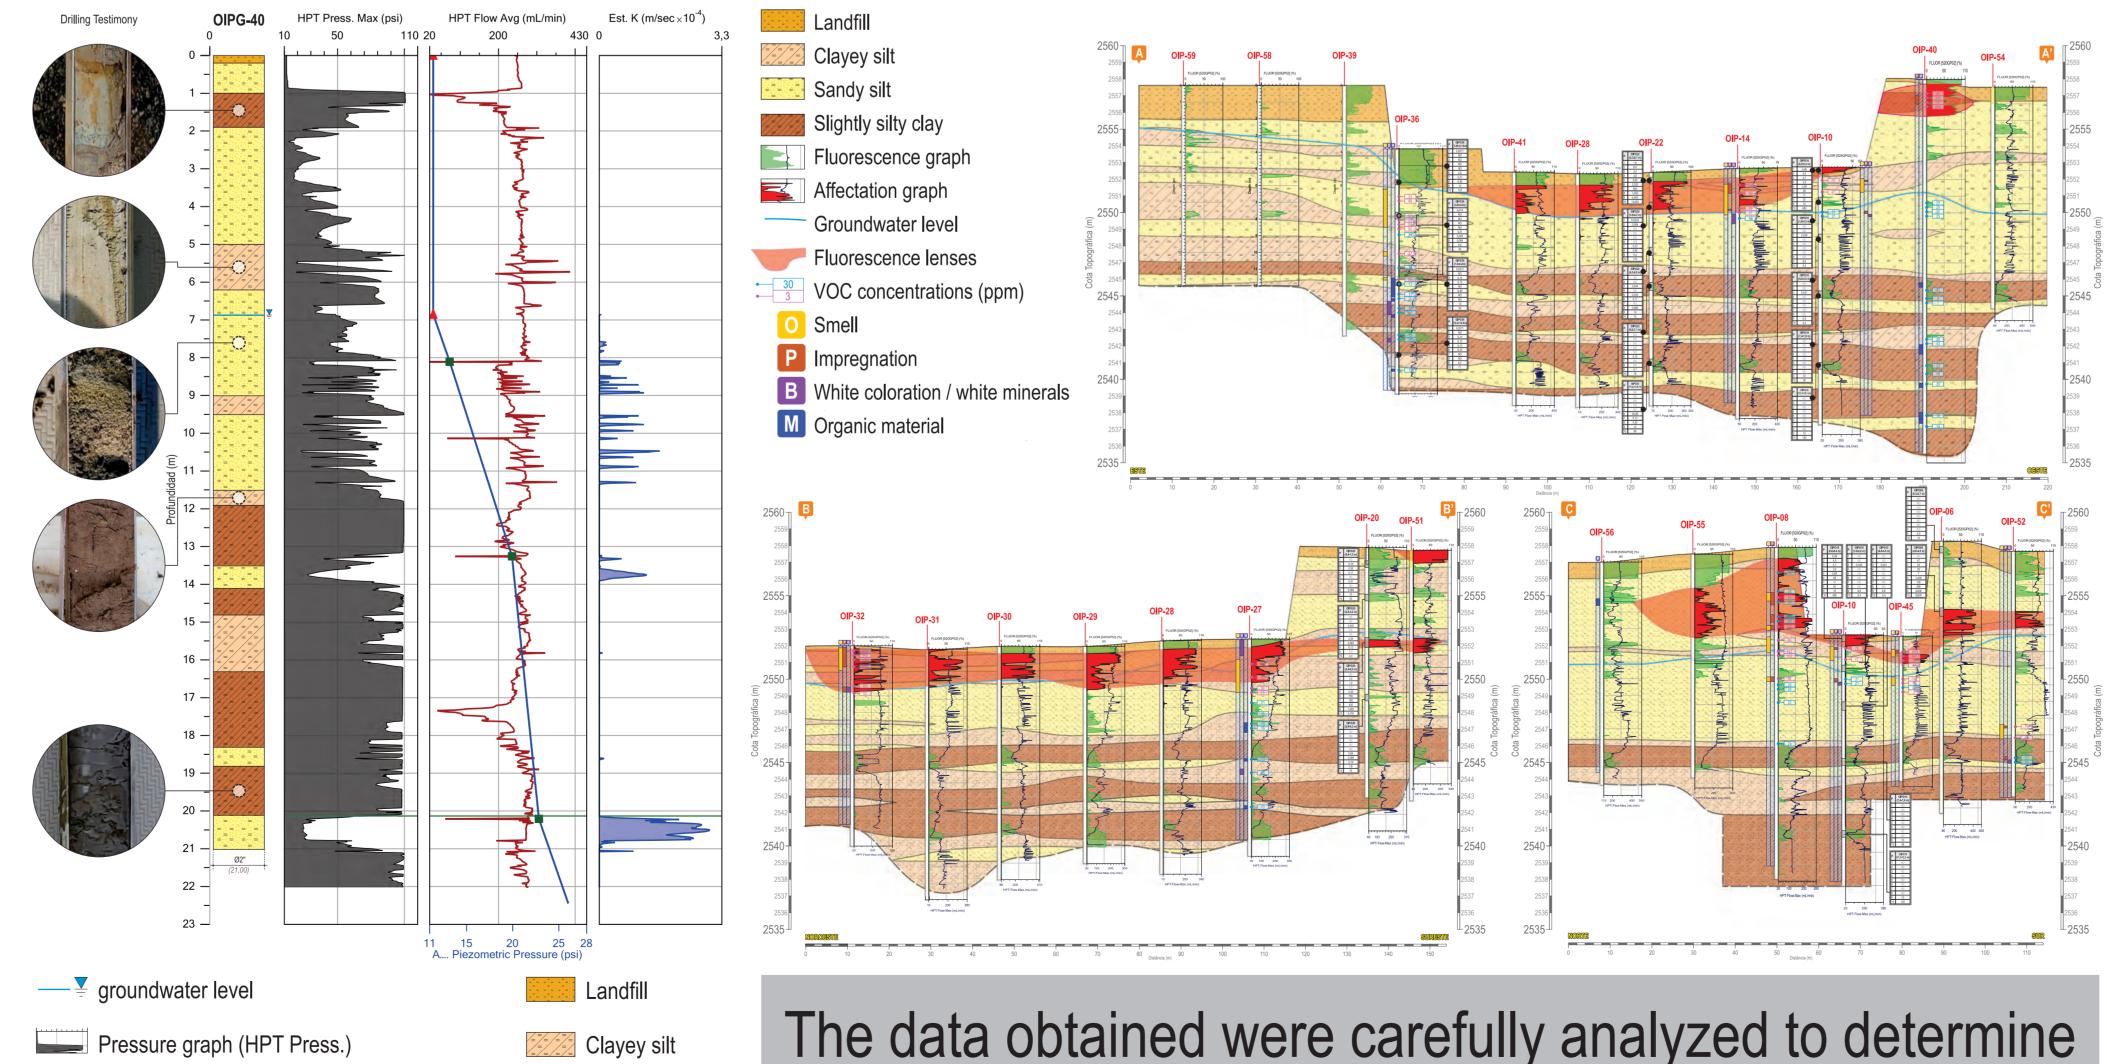
An experienced field team was the key to identify the presence of several different hydrocarbons at the site and update the site conceptual model. o-
