A Machine Learning Approach for Transmission Line Hardening

Juan Pablo Montoya-Rincon¹, Doctoral Student
Prof. Jorge E. Gonzalez^{1,2,3}
Dr. Michael Jensen³

March 30, 2023

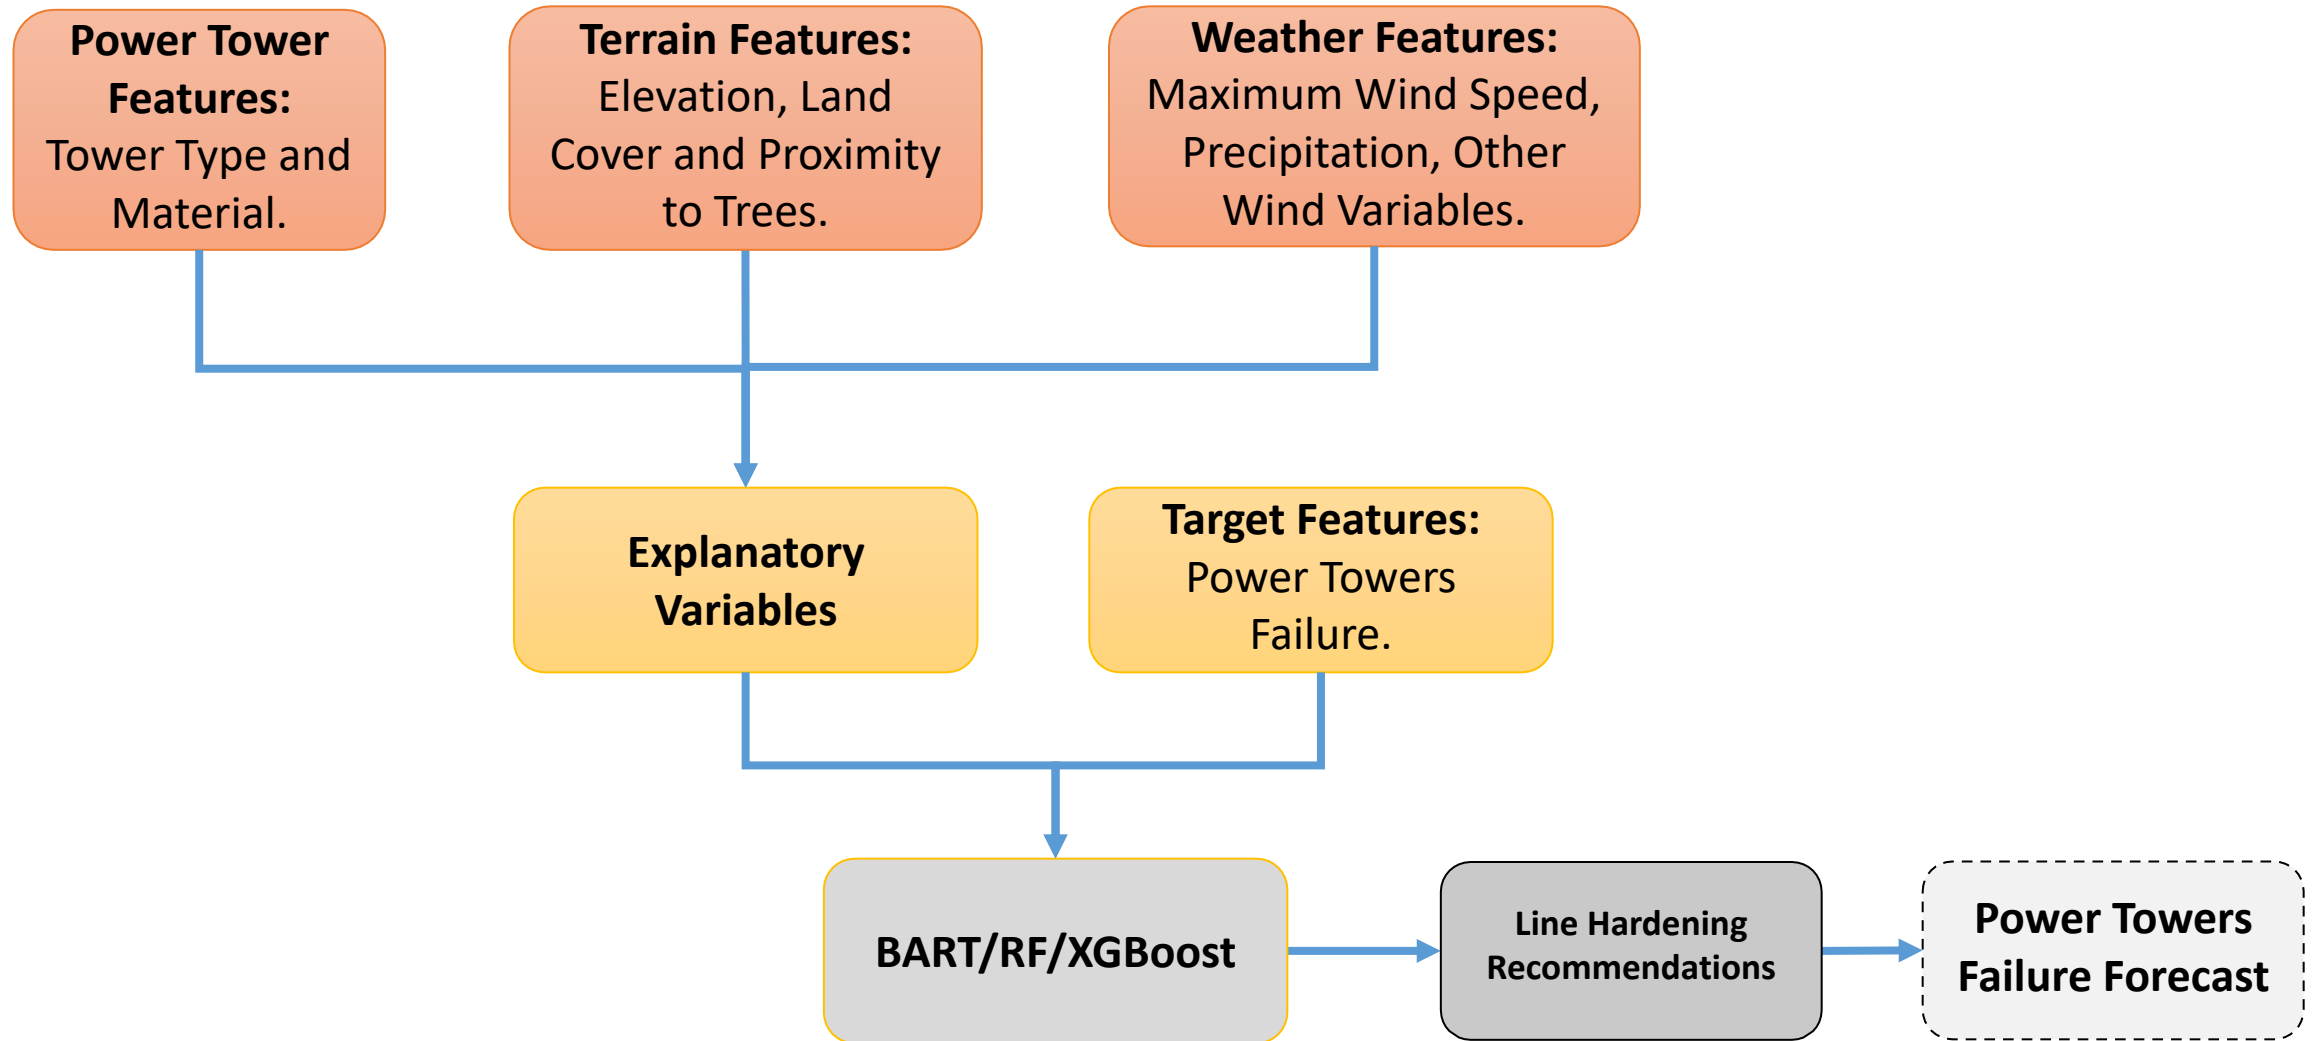
General Framework for resiliency of the transmission system.

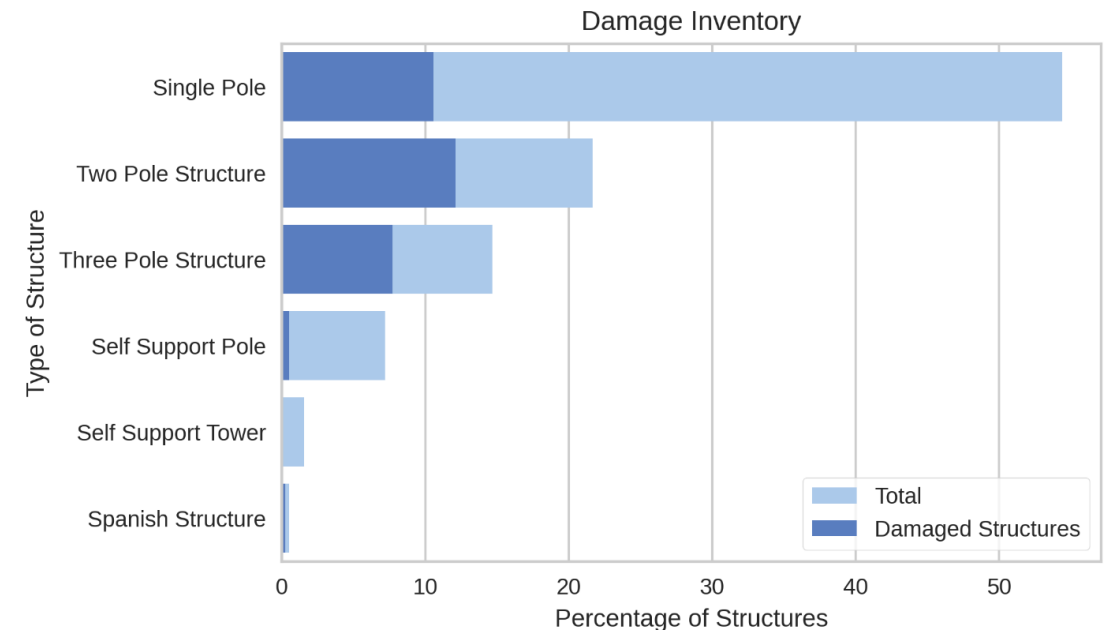
Damage inventory for one of the 115kv transmission lines

The hardening study consist of replacing the weak structures with higher damage rate by stronger more resilient ones. In the three considered hardening scenarios, the types of towers below were replaced by **Steel self-support poles**:
